Landslides (2018) 15:1233–1251
 DOI 10.1007/s10346-018-0973-5
 Received: 4 December 2017
 Accepted: 26 February 2018
 Published online: 13 March 2018
 © Springer-Verlag GmbH Germany,
 part of Springer Nature 2018

Multidisciplinary research of landslide at UNESCO site of Lower Hodruša mining water reservoir

Keywords Banská Štiavnica · Landslide · Lower Hodruša mining water reservoir

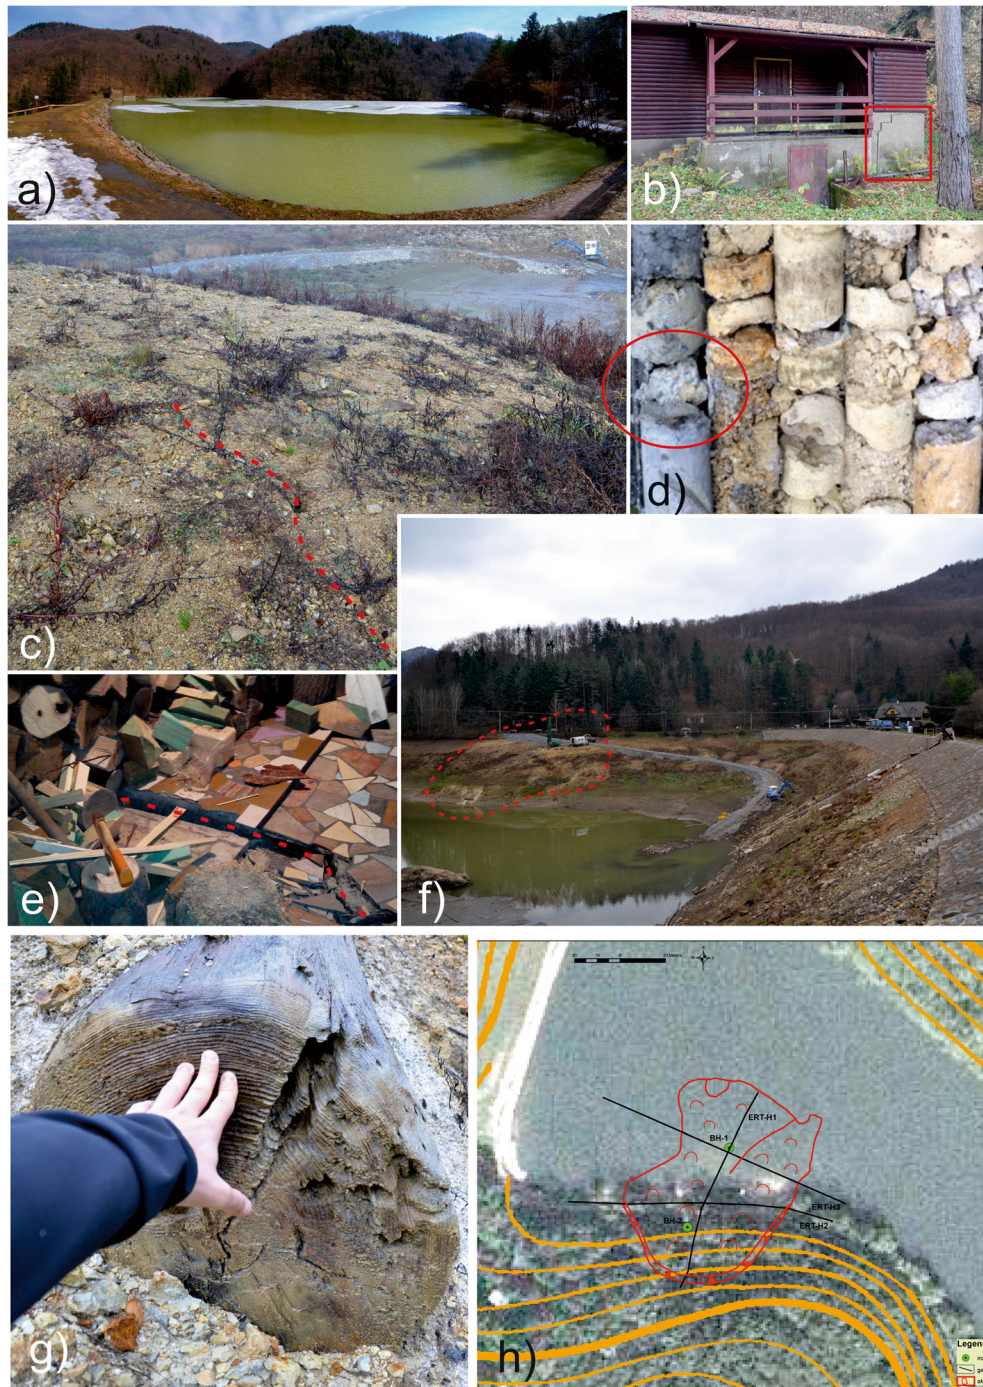
The recreational chalets are currently affected by varying degrees of structural damage in the form of hairline and open cracks in the external walls (Fig. 4b, e). The access road has subsided by 20 cm, and the accumulation is marked with cracks in three levels with a width of up to 10 cm—end of February 2014—cracks with a width of 0.5–1 cm, regular monitoring of crack development; in following months, they were observed to

widen and appear also inside the chalets; 13 May 2014—the cracks are up to 3 cm wide; September to October 2014—largest movement recorded—opening of cracks in tens of centimetres (Fig. 4c); further movement was observed after survey work on 14 November 2014—widening by around 1 cm.

Technical work and geophysical measurements realised in December 2014 detected the shear plane at a depth of 4.8 m at borehole BH-2 and 5.9 m in the vicinity of borehole BH-1 (Fig. 4d). It is represented by grey clay with a soft to very soft consistency that is highly plastic, sticky and contains 15% rough fragments. The fossil basal shear plane is at the border of the Quaternary sediments and Middle Miocene rocks represented by pyroxene andesite and quartz porphyry.

Fig. 4 Photodocumentation on active slope deformation. **a** General overview of Lower Hodruša mining water reservoir taken from the dam. **b** Detail photo of open cracks on one of the chalets situated in main scarp area. **c** Open cracks in accumulation part of the active landslide. **d** Material of shear plane. **e** Open cracks inside of chalet. **f** Photo of active slope deformation taken from the dam. **g** Old remediation works from the eighteenth century—oak wood posts. **h** Situation map of landslide with realised boreholes and geophysical measurements profiles

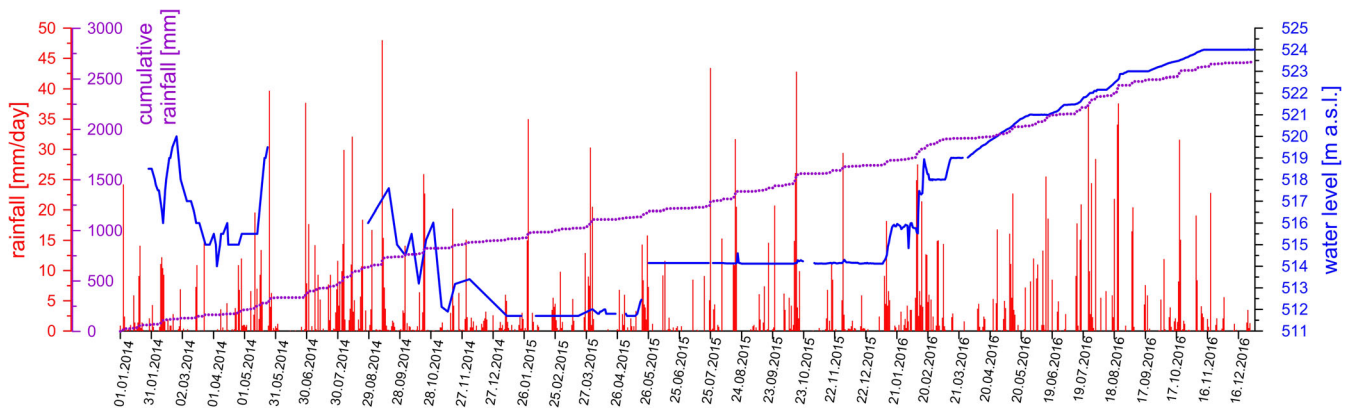
The situation in 2014–2016 was very similar (Fig. 5). This also saw a combination of a relatively dry year followed by a heavy precipitation combined with a long-term fall in the water level caused by the reservoir's gradual emptying for reconstruction of the dam. The distribution of precipitation in the first years of the described series is diametrically different from that in the subsequent years, when there were incidents of days or weeks with

Fig. 5 Total rainfall in millimetres/day and the water level in the reservoir from the year 2014 to 2016

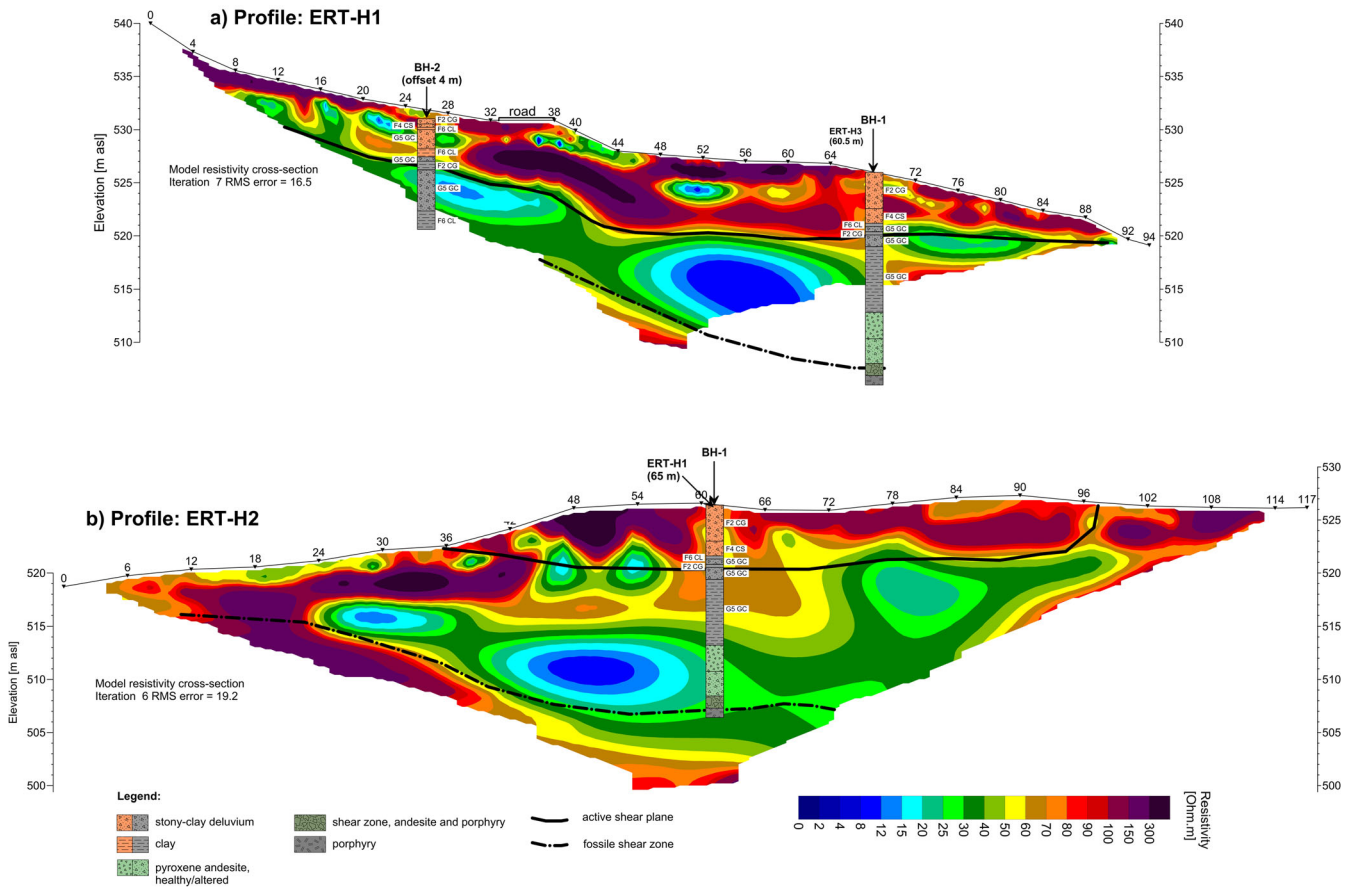
Fig. 7 ERT results. **a** Inverse resistivity cross-section of profile H1. **b** Inverse resistivity cross-section of profile H2, with lithological information from the drilling works and interpreted active/fossil shear plane

The inverse model (Fig. 7a) shows the landslide material making up the active part of the slope deformation as a heterogeneous body with a wide range of resistivity values (10–500 Ω/m). This range of values is caused by the landslide process itself, in which the integrity of the rock environment is disrupted and it separates into smaller blocks (higher resistivity) separated by a system of cracks filled with infiltrated water (lower resistivity). The shear plane of the active landslide (black line in the cross-section) appears as a sharp fall in resistivity between the landslide material and the underlying clay sediments from the fossil landslide, which have very low resistivity values (1–40 Ω/m). The ERT measurements were able to capture only partially the fossil shear surface found at a depth of 18–19 m in borehole BH-1, as shown by the broken line in the lower part of the inverse cross-section.

to observations on the surface. The active part of the landslide appears as an environment with high values of resistivity separated from the fossil slope deformation by zones of higher conductivity. The conductive zones can be interpreted as an active shear surface (black line), which corresponds to the active shear plane detected in borehole BH-1 at a depth of 5.6 to 5.9 m. The resistivity interface in the bottom part of the cross-section (broken line), which intersects with the fault zone detected at a depth of 18 to 19 m in the borehole, is interpreted as the fossil shear zone.

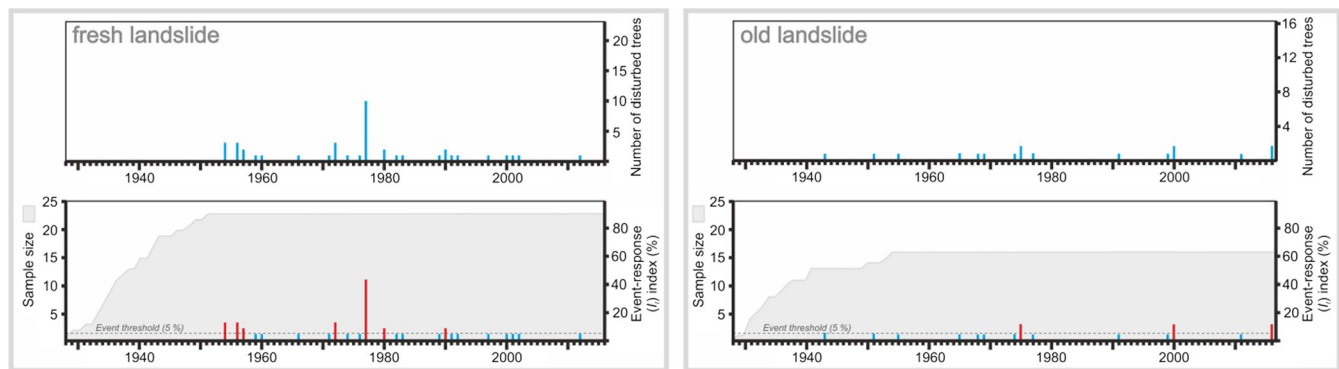
**Fig. 8** The chronology of landslide events expressed as an event-response (I_t) index

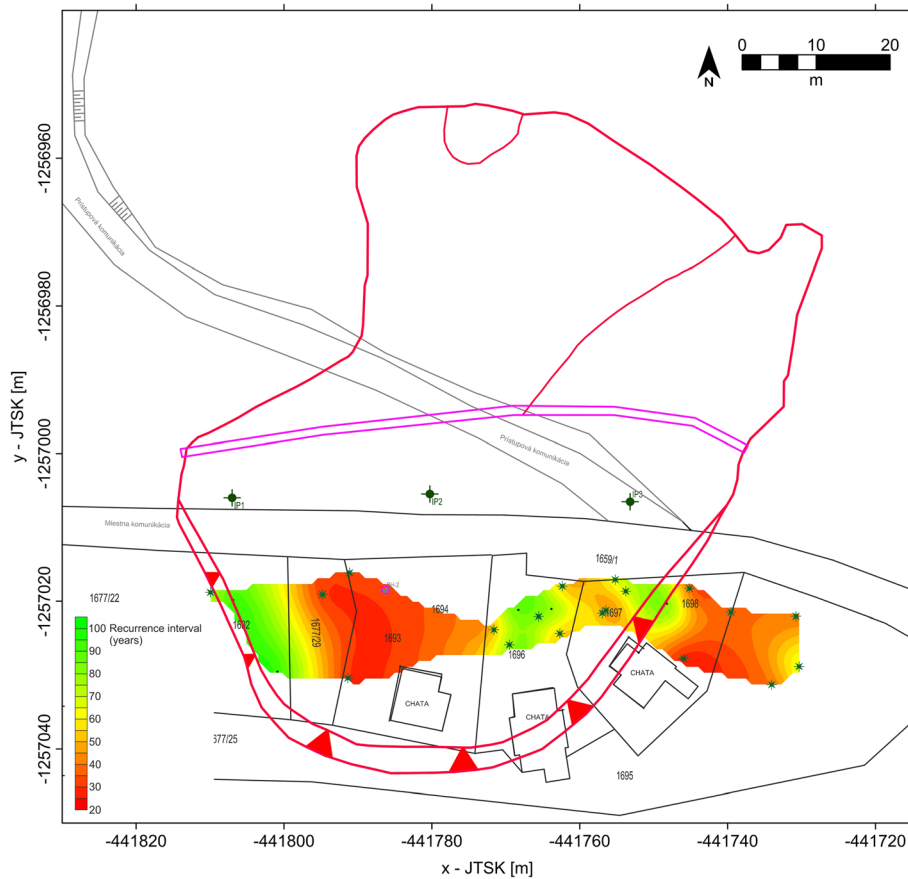
Fig. 9 The spatial distribution of recurrence intervals of landslide events on the area of young landslide

landslide reactivations was higher in the area of young landslide (mean decadal frequency = 0.9 events/decade; Table 3). Events on the young landslide area reached higher I_t values (16.7%) in comparison the old landslide area (12.5%) in general (Fig. 8). The lowest reconstructed recurrence intervals (the highest events frequency) from individual trees were less than 20 years. The zones with such activity were reconstructed along both sides of the young landslide area (Fig. 9).

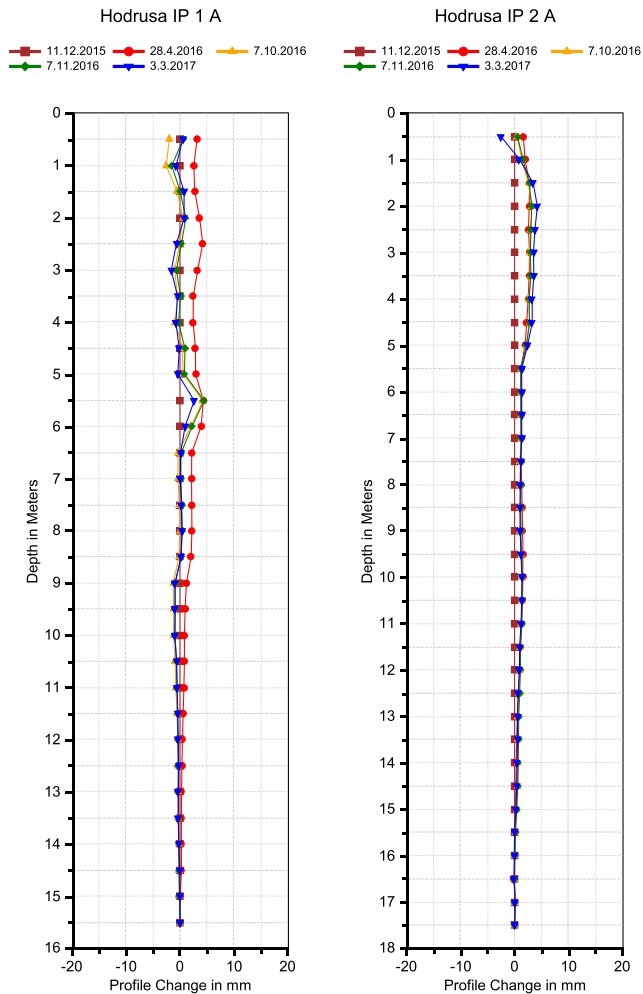
Fig. 10 Results of inclinometric measurements in boreholes IP1 (left) and IP2 (right)

The zero measurement at inclinometer borehole IP1 was taken on 11 December 2015 and a further four-stage measurements were taken over a 15-month period. Figure 10-left shows that the borehole does not exhibit any more pronounced movement. The most noticeable movements were registered at a depth of 1.0 m–10.0 mm and a depth of 5.5 m–5.0 mm with the direction of movement towards the east, as can be seen in Fig. 10-right. This section of the landslide can be considered stabilised.

The zero measurement at inclinometer borehole IP2 was taken on 11 December 2015 and a further four-stage measurements were taken over a 15-month period. Figure 10 shows that the borehole does not exhibit any more pronounced movement. The most noticeable movements were registered at a depth of 0.5 m–7.8 mm and a depth of 2 m–5.0 mm with the direction of movement towards the east, as can be seen in Fig. 10. This section of the landslide can be considered stabilised. Standard results for inclinometric measurements include the size of movement and its azimuth (angle from north). The inclinometric boreholes IP1 and IP2 are built in such a way that the expected direction of movement and direction A are both approximately northwards (deviation $\pm 10^\circ$). The recorded direction of movement is actually perpendicular to this direction, i.e. direction B, west–east. Given this circumstance and given that the measured movements are very small, almost negligible, we have decided not to specify the exact azimuth of the recorded movements.

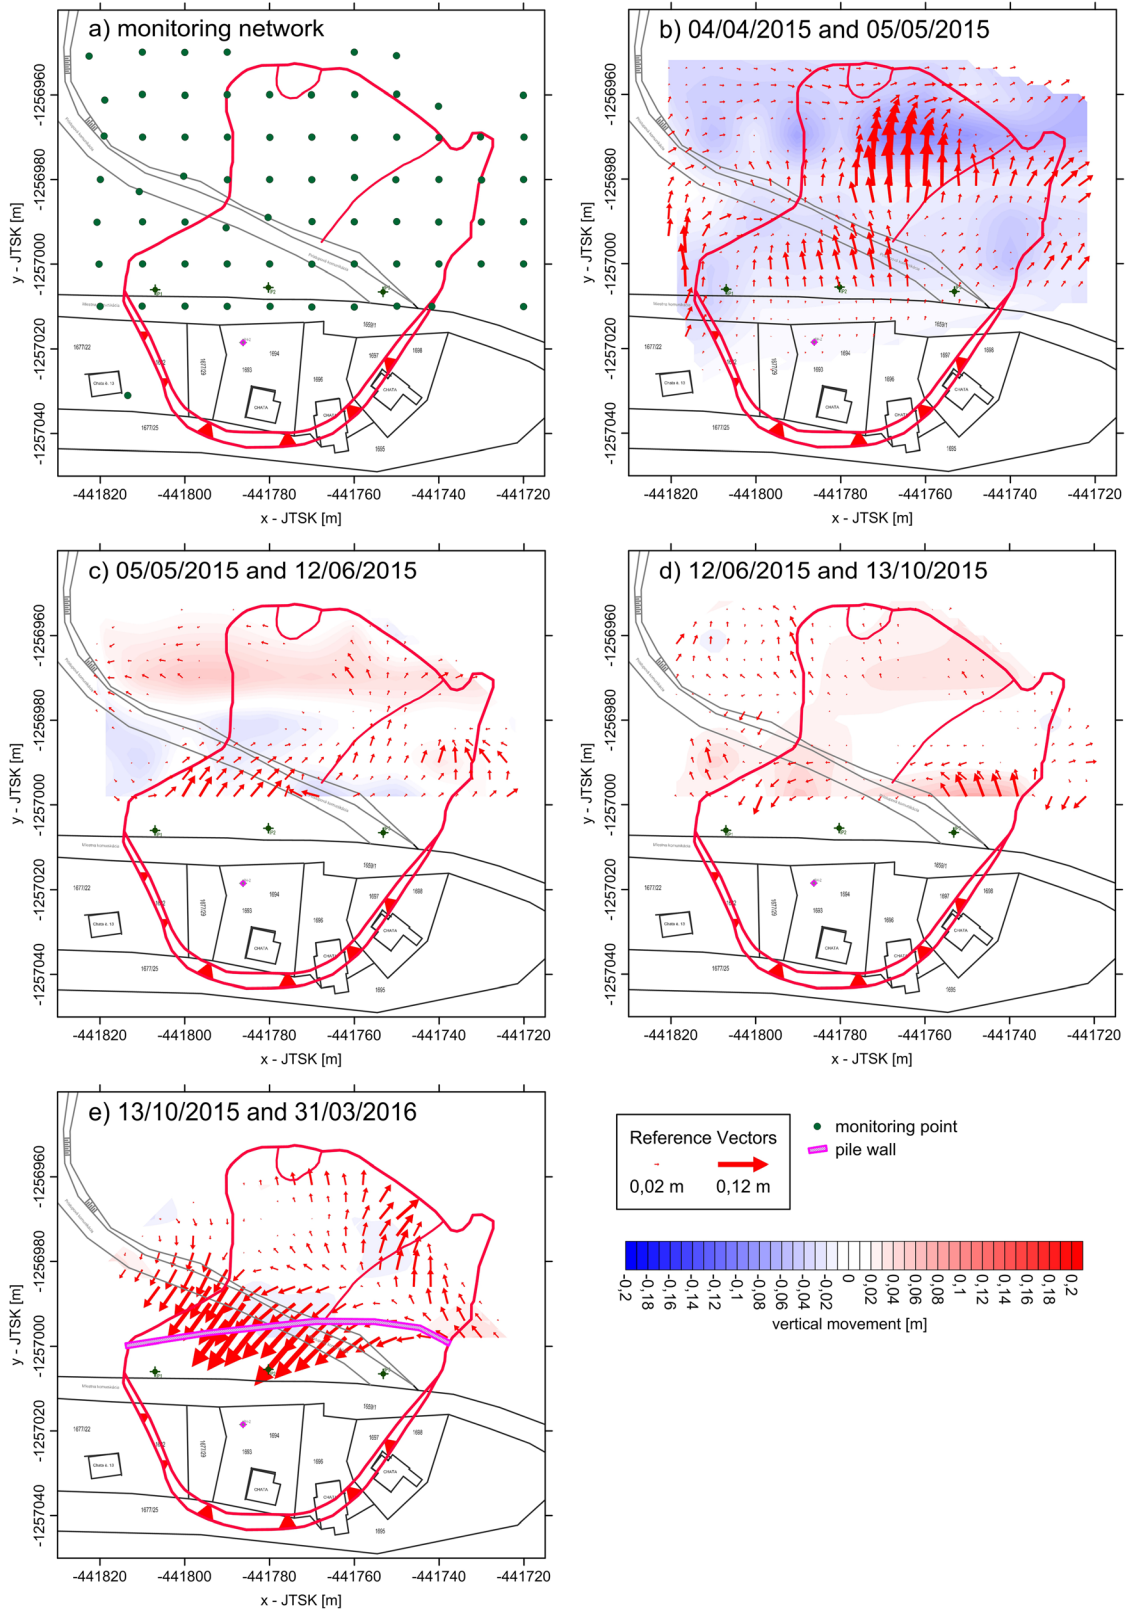
Fig. 11 Movement vectors of geodetic network points. **a** Measurement network. **b** Course of horizontal and vertical movements before construction of the pile wall. Horizontal movement to the north and subsidence of the whole area (emptying of the mining water reservoir). **c** Course of horizontal and vertical movements during construction of the pile wall, the wall was built from east to west. Uplift of the toe and right side of the landslide (by the landslide process). **d** The pile wall is finished but not anchored and the wall and its surrounding area are being rotated anticlockwise. **e** Backwards horizontal movement (to the southwest) in the vicinity of the pile wall and the area on the left flank of the landslide (could be caused by the anchoring of the wall to the slope or the refilling of the reservoir). Minimal vertical movements

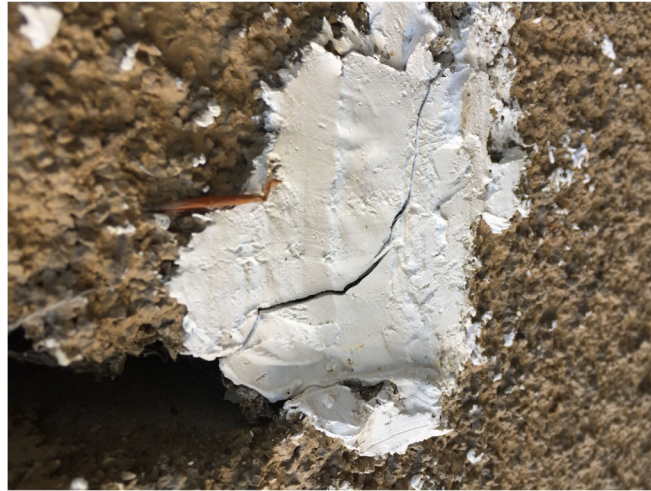
Fig. 12 Deformation of target PG-2, 3 March 2017

The first deformation affected target PG-1 between April and October 2016, which was 10 months after completion of the remedial works. Between December 2016 and March 2017, the first

deformation was observed on target PG-2 at the same chalet. The other targets remained without deformation throughout observation. After May 2016, it was no longer possible to monitor deformation of targets G-1 to G-5 because they were removed when the chalet was reconstructed during the summer. Figure 12 shows the deformation of target PG-2 in March 2017, which is nearly identical with the deformation in December 2016. The deformations are very small, not exceeding 1–2 mm. It is evident that movement on such a small scale cannot be attributed to active slope deformation. It may have been caused by the subsequent consolidation of the slope deformation. Compared with the deformations that occurred before remediation of the landslide, these are negligible.

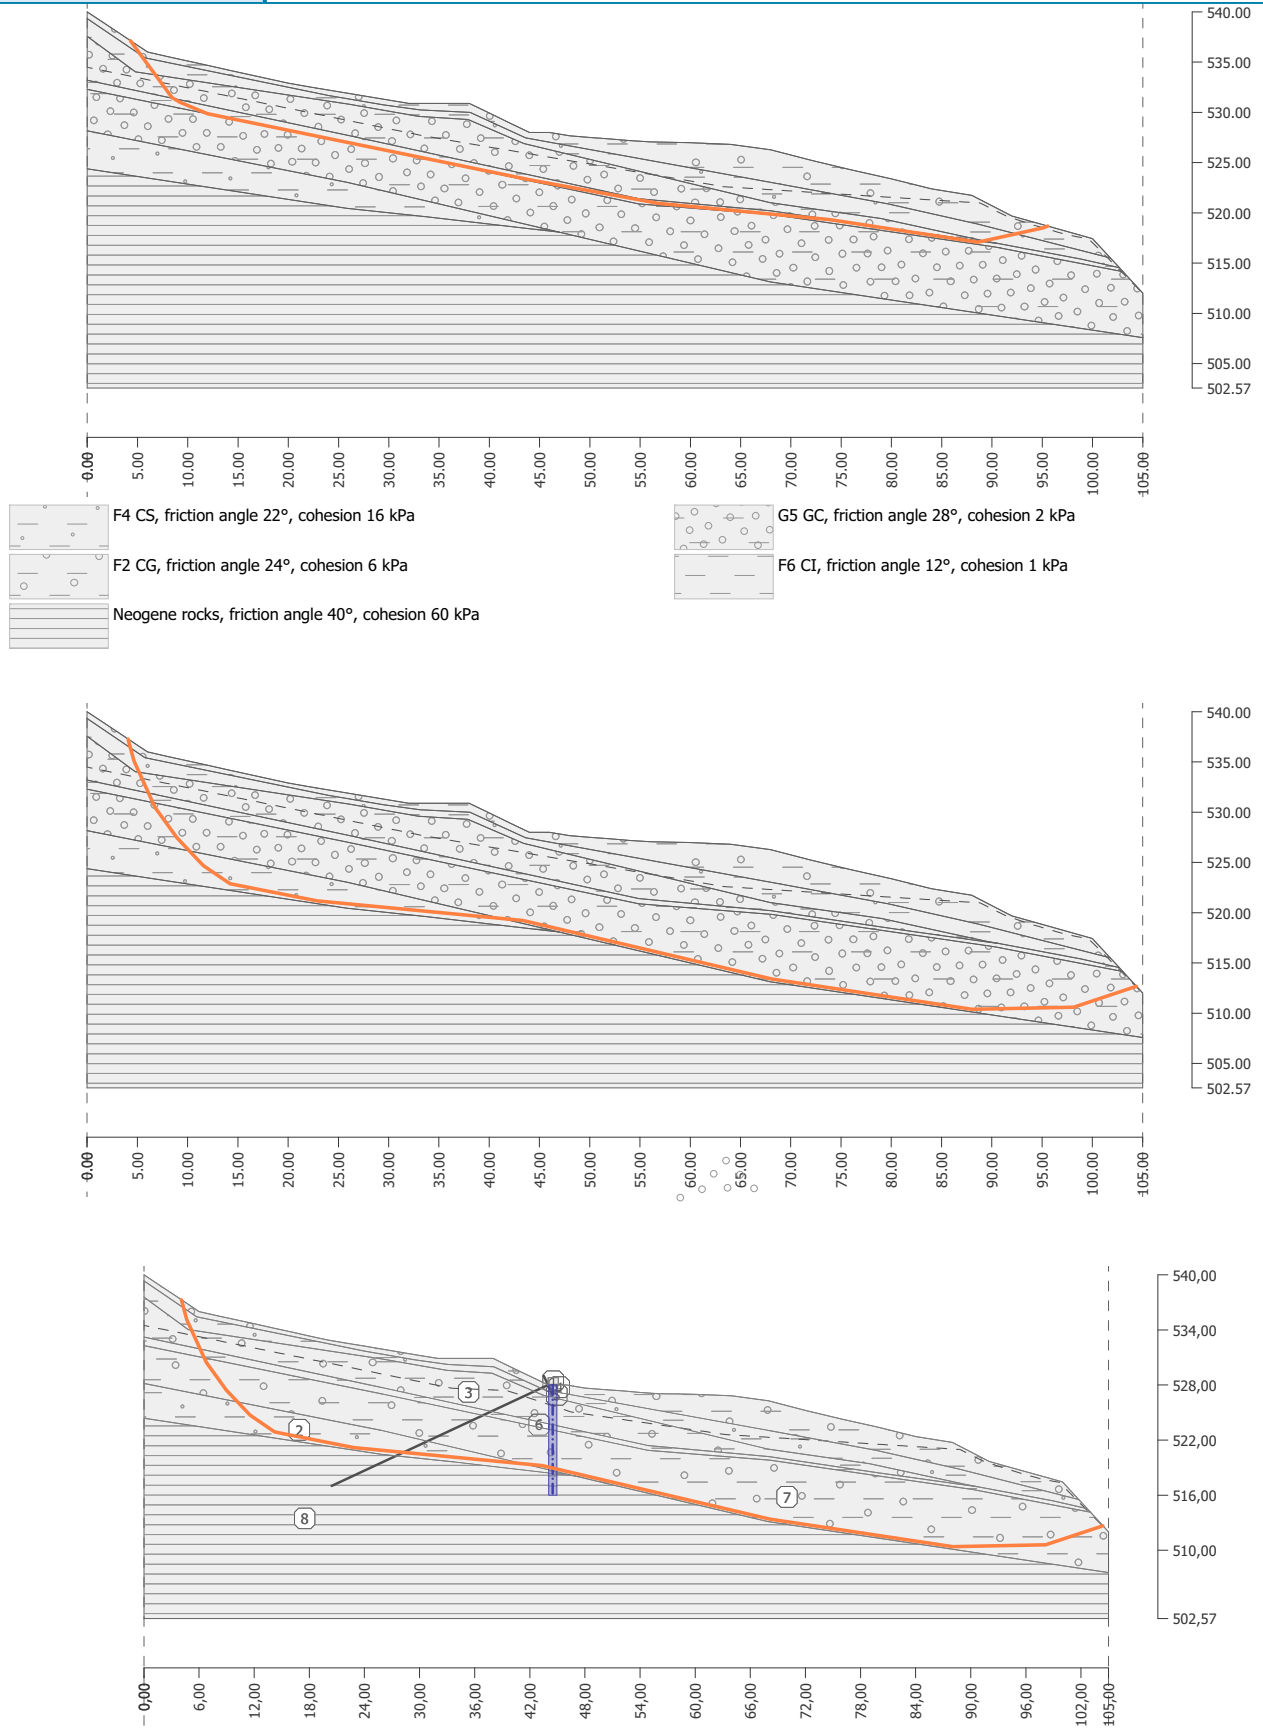
Fig. 13 Stability calculations. a Verified shear plane. b Basal shear plane. c Stability calculation with remediation elements

Conventional threshold of Fs for permanent constructions has a value of 1.5, which presents satisfactory safety level. For special constructions, like this one is, the value of Fs is set by structural engineer also taking into account other plans with future land use. In our case, the road will be enlarged in near future, so also dynamical loads will increase.

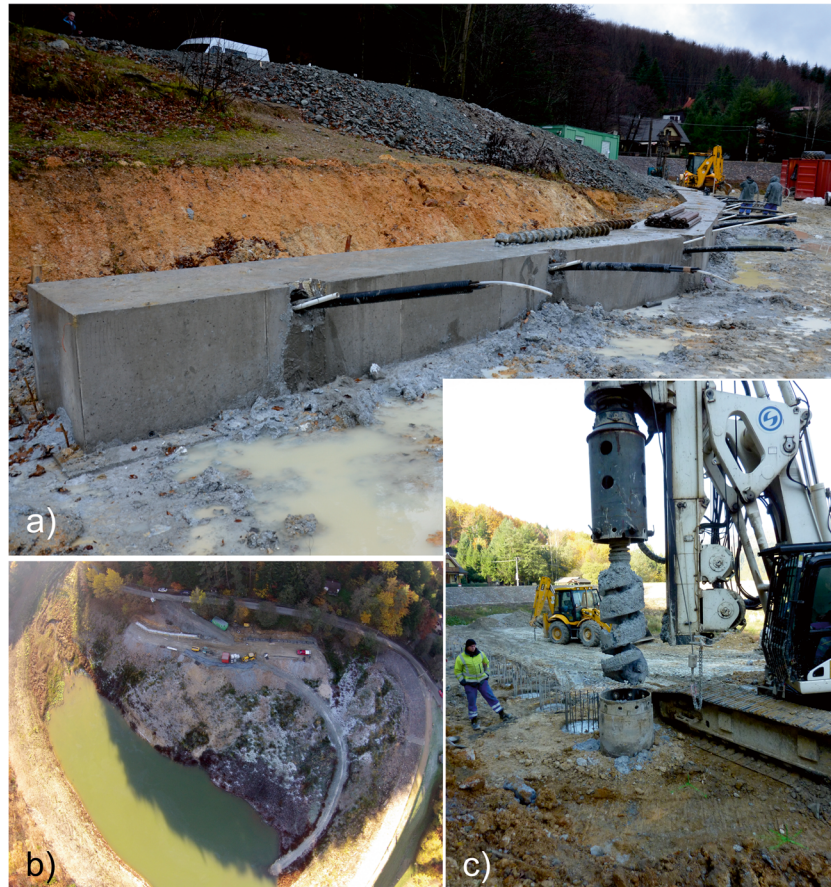
Fig. 14 a View of the anchored reinforced concrete wall. b Aerial view of remedial works in progress. c Drilling the piles

The remediation of the landslide (Fig. 14) using an anchored pile wall was carried out in accordance with the design documentation between 21 October and 30 November 2015. To facilitate the construction of the anchored pile wall and make it easier for heavy plant to access the site, a work platform reinforced with a layer of aggregate was built before work commenced. The wall consists of 52 reinforced concrete piles 12.0 m in length, 900 mm in diameter, with a total length of 624 m. The piles were drilled by a SOILMEC drill rig. The concrete used for the piles is grade C25/30 reinforced with B500b concrete steel basket. The heads of the piles were fastened by anchoring reinforced concrete beams with dimensions 800 × 1100 mm and a length of 78.0 m. The concrete

in the beam is grade C25/30 with B500B concrete steel. The pile wall is further secured by 26 cable anchors at intervals of 3.0 m. The anchors are mounted to the beam through a steel pipe with a diameter of 219/7 mm ending with a 300 × 300-mm steel plate. The length of the anchors is 26 m with a root length of 10 m. The total length of the anchors is 676.0 m. The tilt of the anchors from the horizontal is 25°. The anchors are preloaded with a force $P_k = 300$ kN, which represents 50% of the maximum characteristic force when fully burdened by a landslide in its definitive stage $P_k = 600$ kN (Gomolčák 2015).
