Landslides (2019) 16:1003–1020
 DOI 10.1007/s10346-019-01159-x
 Received: 3 January 2019
 Accepted: 20 February 2019
 Published online: 5 March 2019
 © Springer-Verlag GmbH Germany
 part of Springer Nature 2019

Successive landsliding and damming of the Jinsha River in eastern Tibet, China: prime investigation, early warning, and emergency response

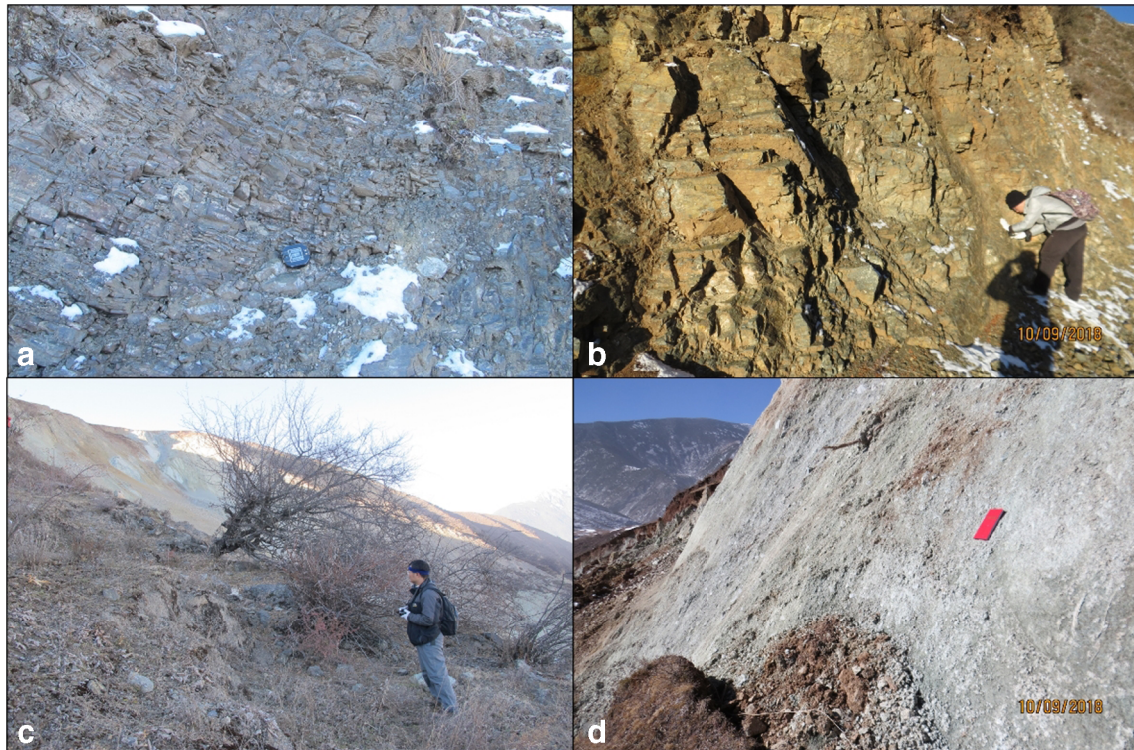
The exposed rock outcrops near the source area are shown in Fig. 2. The main source rock of the landslide was found to be serpentinite. On the southern side of the landslide body, gneiss rock was exposed around 3450 m (Fig. 2a) and behind the landslide scarp along the road (Fig. 2b). Further, gray gneiss outcrops were found adjacent to the landslide body on southern side (Fig. 2c). On the northern side of the landslide body, at the back scarp, green-white colored crushed serpentinite outcropped as shown in Fig. 2d.

Fig. 2 Exposed rock outcrops around the main landslide area. **a** Gneiss outcropped near 3450 m southern side. **b** Gneiss outcropped along the road at the top of the landslide. **c** Gray gneiss outcropped adjacent to the landslide on southern side. **d** Green-white crushed serpentinite outcropped on the back scarp of the landslide

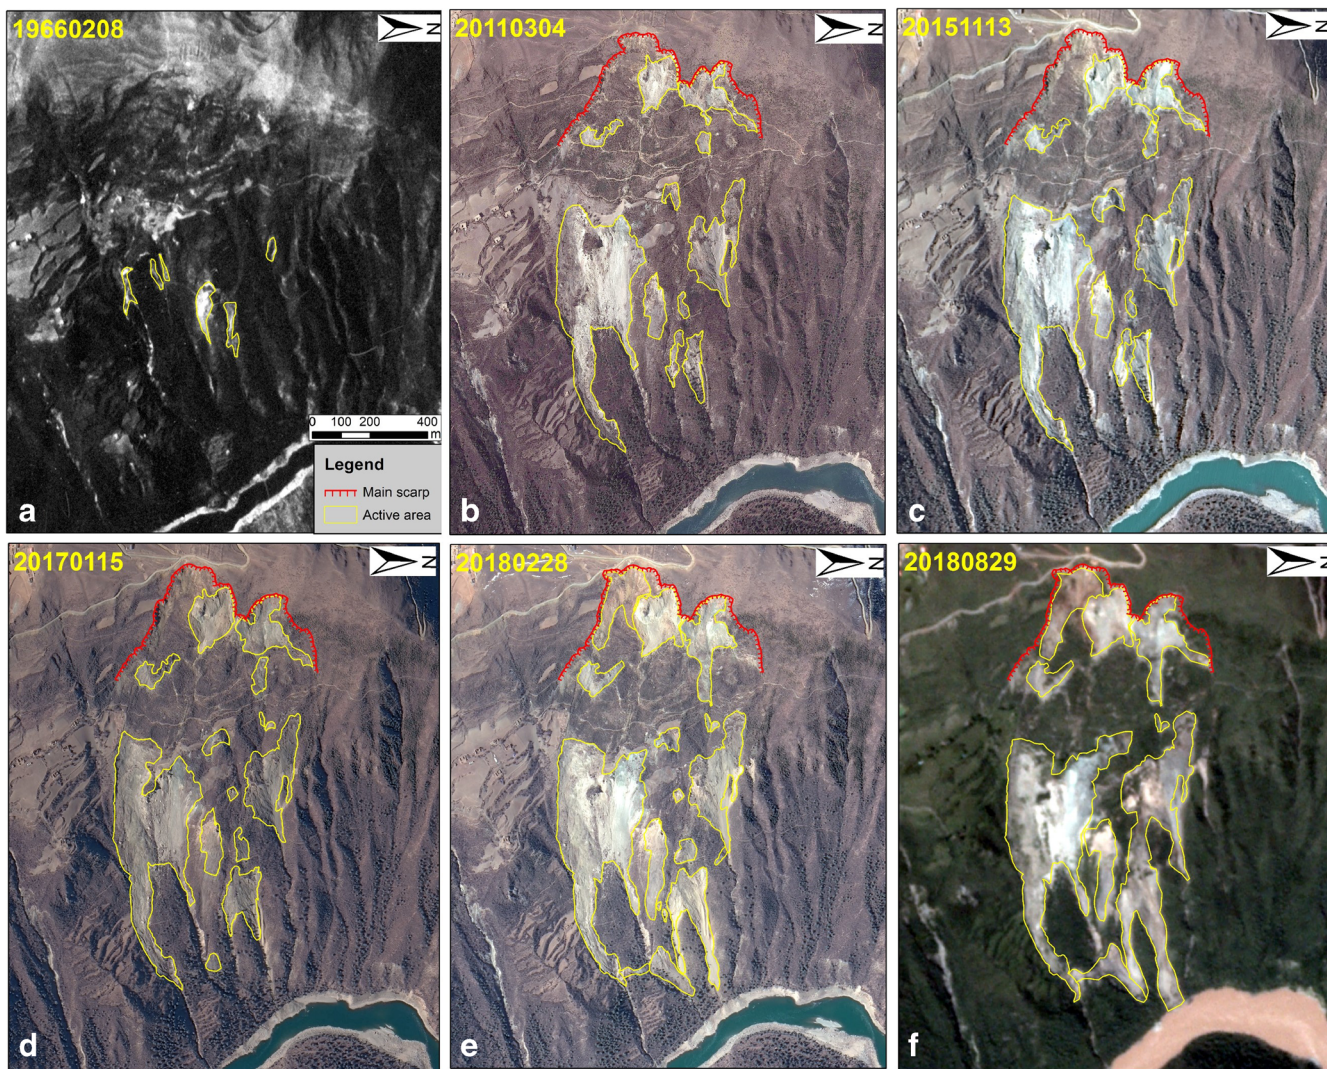
disruption as shown in Fig. 5a. The slope might have been already gravitationally deforming and prone to failure. In 2011, a continuous tensile crack had formed at the back scarp while surface disruption increased as shown in Fig. 5b. Overall deformation of the slope might have begun in 2011. Satellite images taken in March 2011 and in November 2015 (Fig. 5c) reveal how extensive cracking at the scarp had led to a dislocation. The deformation over the body of the creeping mass continued increasing during 2017 and 2018 (see Fig. 5d, e). Images taken in 2018 reveal how these trends accelerated, leading to a formation of a shear zone at the lower and middle sections of the moving mass. Finally, the image taken on August 2018 (in Fig. 5f) shows extensive disruption and signs of further deformation, indicating that the landslide was in an equilibrium state close to instability. Therefore, catastrophic failure of the slope was imminent.

Thus, the historical deformation observed by remote sensing data shows how the slope was deformed through a process of steady movement for decades, prior to the first failure on October 11, 2018. Also, it demonstrates how rock fracturing and acceleration of displacements were developed on the whole creeping body a year before collapse. Our analysis also shows how it is possible to employ remote sensing techniques directly to monitor deformation of unstable slopes. If continuous monitoring of the canyon of the Jinsha River had been in place, it would have been possible to utilize detailed numerical models, adopt system response protocols, and even perform mitigation works that could have reduced economic fallout further.

Fig. 5 Visual interpretation of historical deformation of the landslide. a KeyHole. b GeoEye-1 image. c Ziyuan ZY-3 image. d Gaofen-2 GF-2 image. e Gaofen-2 GF-2 image. f PlanetScope image. The time these images taken are shown using yyyy-mm-dd format in each figure

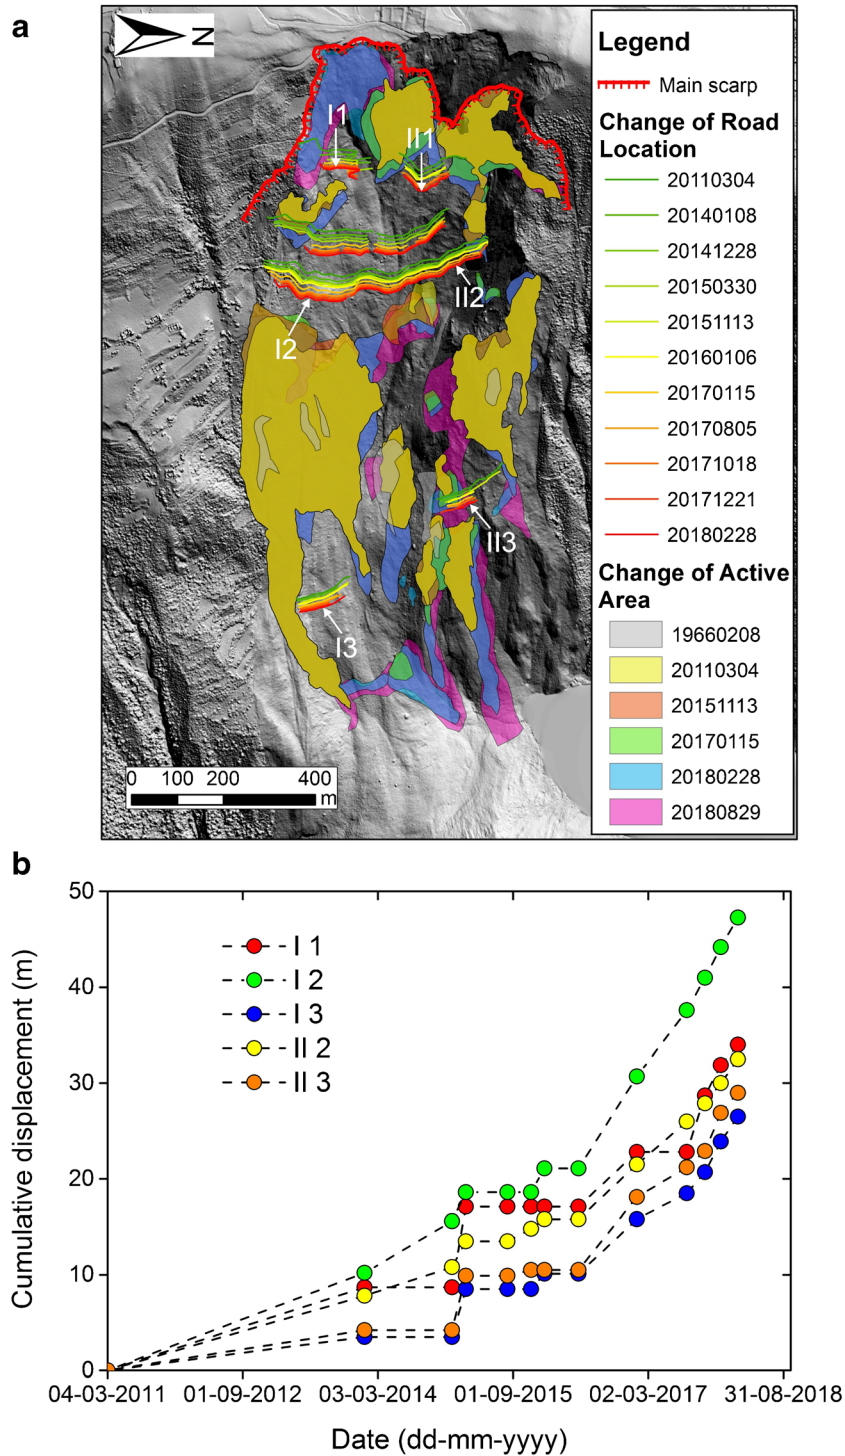
Fig. 6 a Deformation map of different zones and b their back-calculated displacement over years. Increasing displacement can be seen from the increasing size of polygons and the back-calculated displacements

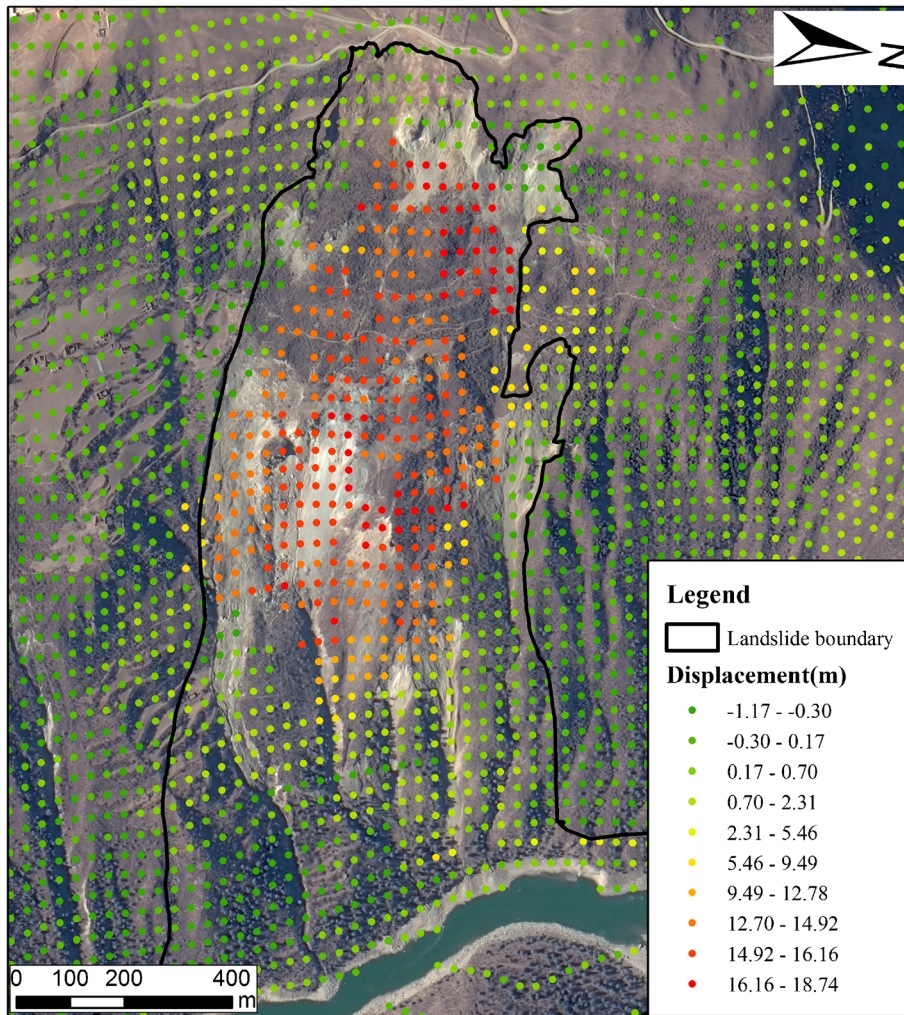
Fig. 7 Estimated landslide deformation results showing satellite line of sight (LOS) direction displacements based on pixel-offset tracking (data source provided by the Oriental Zhiyuan Technology Co., Ltd)

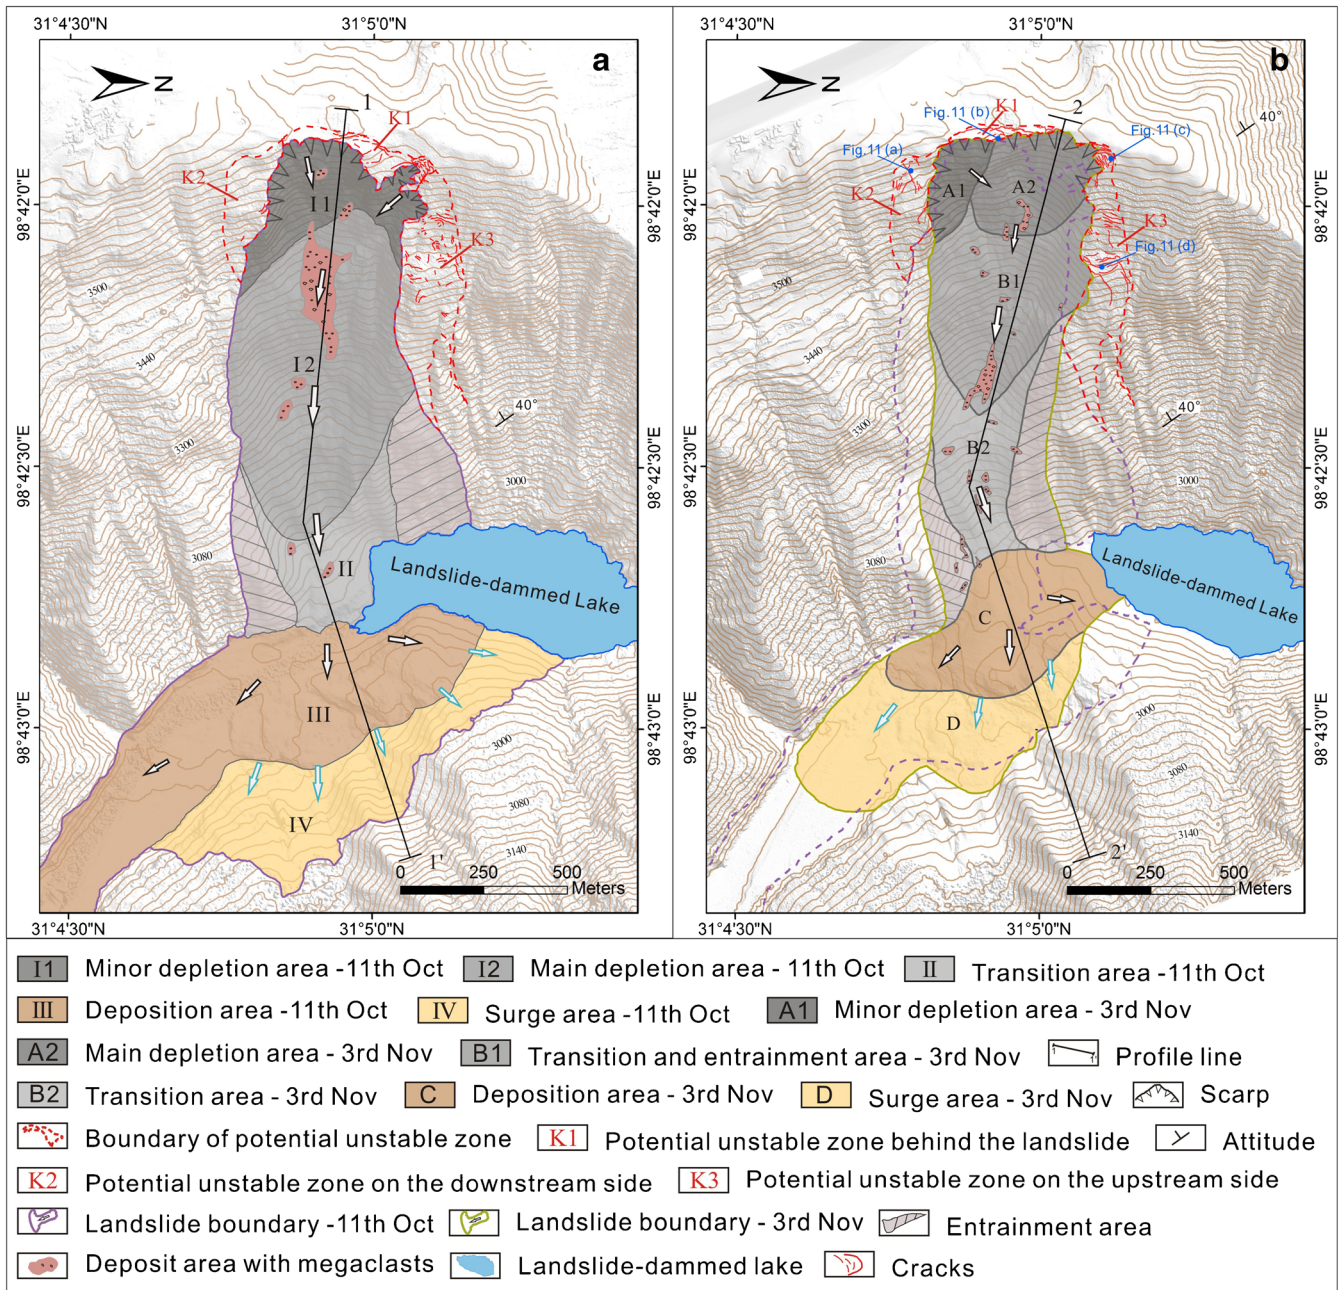
By comparing the pre- and post-sliding DEMs, it can be seen that the first failure started between 3000 and 3500 m a.s.l. This material loss carved a depression of 90 m in the scarp of the source area (I) as shown in Fig. 8. Material moved downslope until reaching 2800 m a.s.l. at the bottom of the canyon, confirming a clear transportation (II) and deposition area (III) that dammed the river. Furthermore, a portion of it surged uphill on the other bank (IV). Disruption induced by the landslide led to instability at the rear and lateral margins of the landslide source area (K₁, K₂, and K₃ as indicated in Fig. 8).

(Fig. 8b). The A1 area is located on the south side of the trailing part of the zone I, and the A2 area is located on the north side. The rock mass in zone A was exposed after the occurrence of October 11, 2018, landslide. Thus, tensile cracks on the rock masses widened gradually leading to failure. Comparison of DEMs before and after the landslide show that 60 m of previously exposed rock from the first landslide was carved within zone A, removing a volume of 3.6 million m³. Failure of A1 led to loss of additional shear resistance in A2, which in turn caused the rock mass to collapse and further removal of more than 1 million m³ of rock mass had occurred. The main scrap has a green-white color, indicating presence of chlorite. Rock mass above the headscarp is still unstable; thus, rock falls continue to occur as a result of large cracks and fractures. However, large-scale collapses are unlikely as the whole structure is supported on structurally competent hard gneiss.

Fig. 8 Geomorphic maps for both the events. **a** First landslide event on October 11, 2018. **b** Second landslide event on November 3, 2018

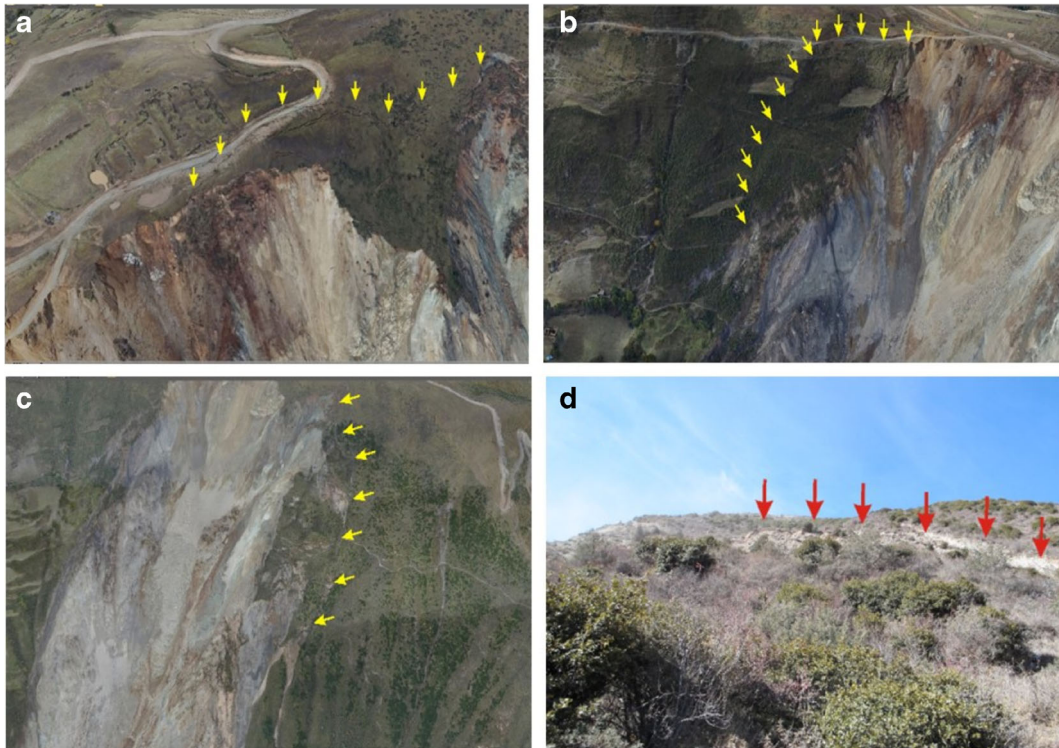
A series of tensile cracks with strikes of $320^\circ\sim 350^\circ$ were induced by fracturing around the source area. They are 150 m long and show a downward displacement between 30 and 50 cm (Fig. 10a). Ten to 40 cm opening of fissures is observed. Particularly, a subset extends to the right rear side of the source area with strikes between 0° and 10° . Fractures spread over an area of $3.6 \times 10^6 \text{ m}^2$ with assumed volume of $4 \times 10^6 \text{ m}^3$. Another group of cracks with a strike of 40° reached the free face, leading to a triangular unstable wedge on the left edge of the source area. This wedge became the source of the second landslide occurred on November 3.

Between 3300 and 3500 m a.s.l., rock mass with 2 to 3 m benches are found predominant (Fig. 10b). They span for 400 m, following a strike of 110° and exhibit the largest deformation at the southern edge. The overall dimensions of this compromised area are $400 \text{ m} \times 120 \text{ m}$ spanning over a 200-m elevation, leading to a total disturbed volume of roughly 1 million m^3 .

Grinded green serpentinite along with fractured and strongly weathered rocks were exposed at this edge (Fig. 10c). The top of this edge follows a fracture with a strike of 200° while its middle section shows a fracture zone with a strike of 140° . Small rock collapses are found at its base. The unstable block at this edge is a prismatic body having 550 m long, 160 m wide, and 120 m thick dimensions.

Fig. 10 a Crack distribution in K1 area above the headscarp (the arrow in the figure refers to the crack zone). b Crack distribution in K2 area on the true right side (the arrow in the figure refers to the crack zone). c Panorama of lateral shear fractures in upper reaches of K3 area on the true left side. d Shear crack on the upstream side of the K3 zone (the arrow in the figure refers to the crack zone)

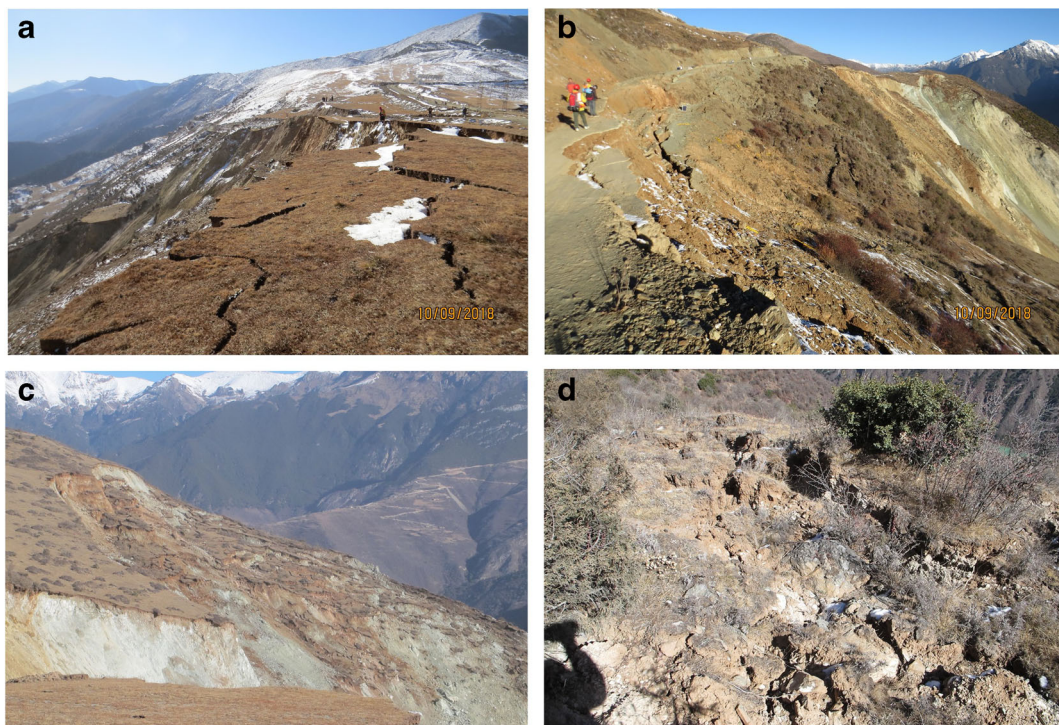
After the second landslide, the large scarp of the October 11 landslide became even more exposed and wider cracks are observed as shown in Fig. 11. Contrarily, areas immediately below the source of November 3 failure looked overall stable. Small rock collapses were observed in the aftermath of the previous landslides (October 11 and November 3), but no pervasive large deformations or instabilities are expected. Extensive cracking (with 17° strike and 20 to 50 cm thick) are observed at the base of the first landslide at heights between 3500 and 3600 m a.s.l. Serpentinite at this location is green and white colored, highly fractured, with high content of chlorite and can be broken even by hand (Fig. 11).

Fig. 11 Location of tension cracks and potential failure paths after the first event. a Tension cracks in the trailing part of K1 area. b Platform of slope dislocation in K2. c Fracture zone of serpentinite in the upper part of K3. d Intense tensile fractures in the middle of K3. Locations of K1, K2, and K3 are shown in Fig. 8b

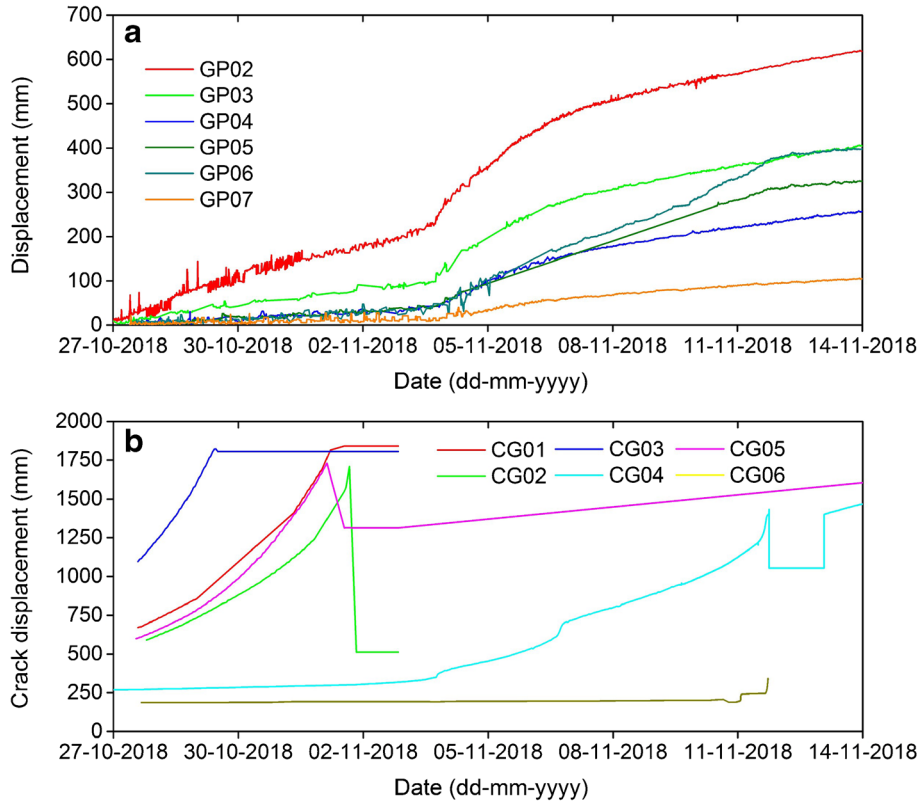
GNSS satellite displacement monitoring points were placed surrounding the headscarp of the October 11 landslide. Until November 3, a steady, almost linear-trending displacement had been observed, until a sudden initial increase was noticed just before the second landslide. After the initial increase, displacement accelerated compared to what had been observed earlier in October (Fig. 13a).

The crack gauges were placed on tensile cracks behind the source area (I) of October 11 landslide. Measured time histories are presented in Fig. 13b. Gauges CGo1, CGo2, CGo3, and CGo5 broke before the November 3 event. CGo4 is located 20 m behind the A1 area and spans along a crack oriented in the north-south direction. Sudden increases were observed three times, and they are consistent with the increase in recorded displacement time histories. First increase occurred at 18:00 local time on November 3, 2018, during the slope failure. The other two were observed at 8:00 on November 11 and at 11:00 on November 21. On both occasions small rockfalls were observed around the exposed scarp. Agreement between GNSS logs and crack gauge monitoring show how they reflect the deformation process of the whole slope, making GNSS data and CG data particularly well suited for compiling landslide early warning models.

Fig. 13 Continuous monitoring of displacement through a GNSS and b crack gauges from October 27, 2018

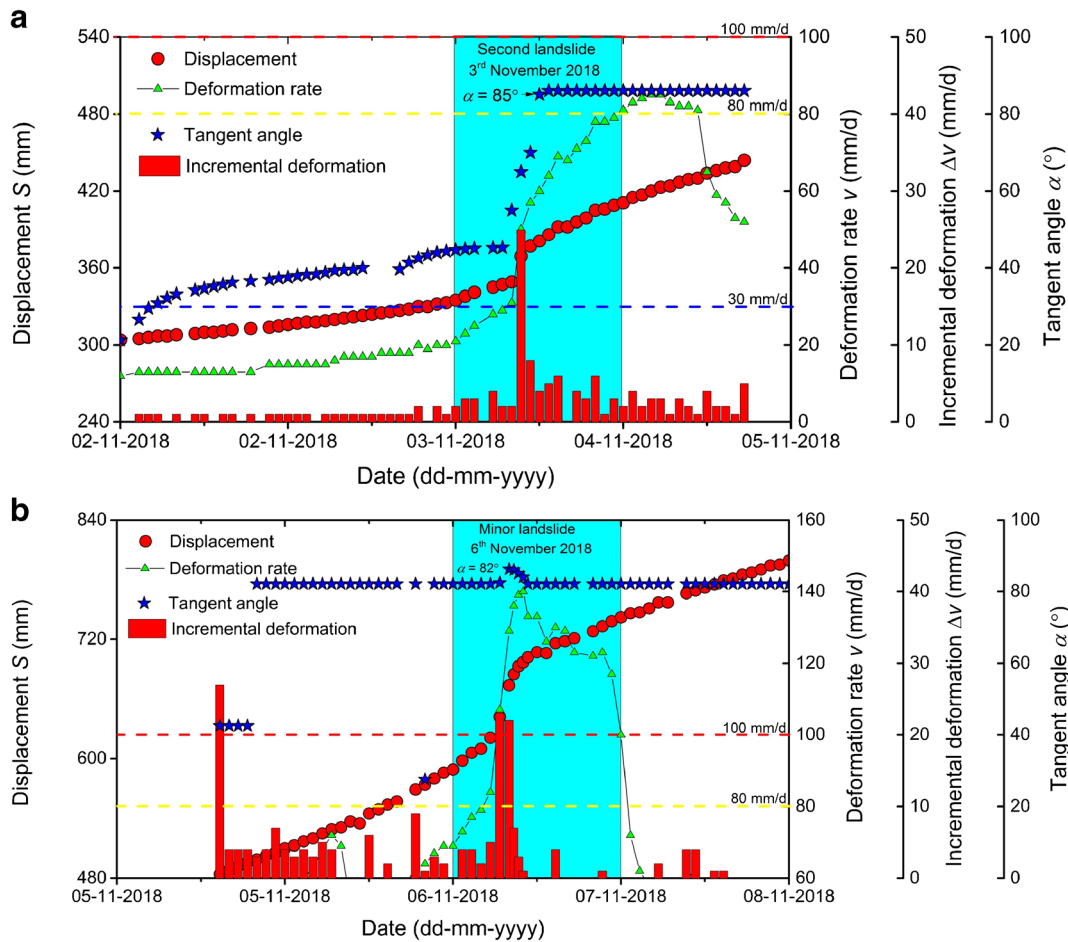
The early warning system performed remarkably well as predictor of the slope failure on November 3. Assessment of recorded displacement collected since October 26 allowed for a definition of a clear baseline for ν_o , issuing a clear imminent landslide early warning 24 h before the disaster. Data from crack gauge CGo4 is shown in Fig. 15a. Likewise, on November 6, a milder warning was issued (vigilance level), as a sudden deformation buildup was observed (Fig. 15b) and a minor landslide occurred. However, the deformation was not sustained in time.

Fig. 15 Early warning charts using displacements and crack gauges. **a** Second landslide event on November 3, 2018. **b** Third landslide event on November 6, 2018 (using crack gauge CG04)
