Lianheng Zhao · Dejian Li · Hanhua Tan · Xiao Cheng · Shi Zuo

Characteristics of failure area and failure mechanism of a bedding rockslide in Libo County, Guizhou, China

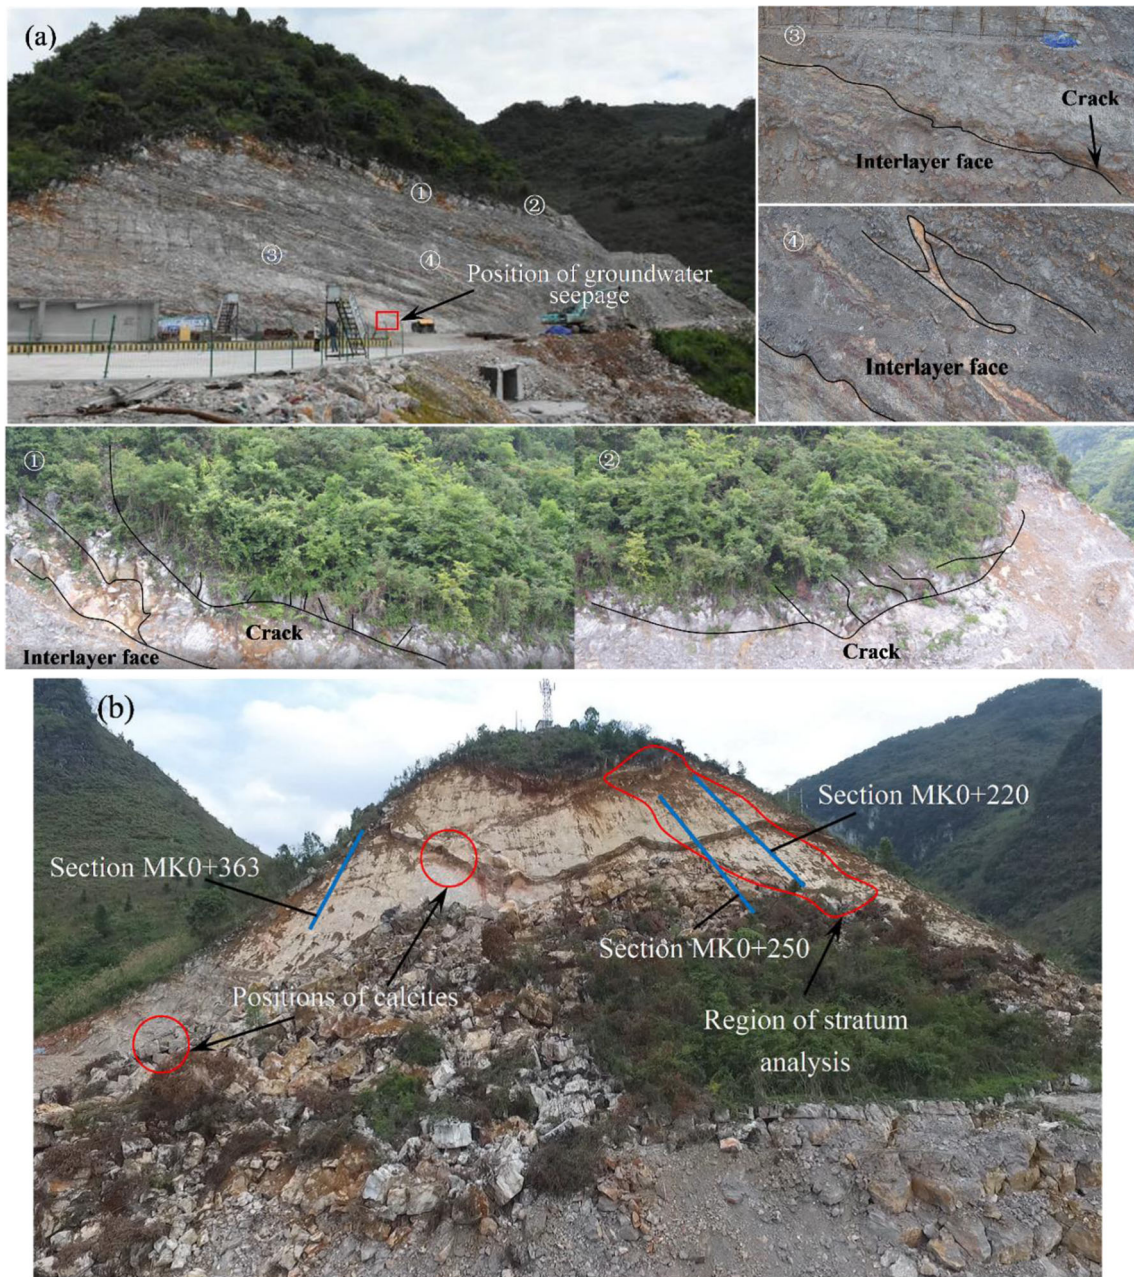
A bedding rockslide accident occurred at 18:05 (UTC+8) on September 23, 2017, at a construction site on the San-Li highway, in Libo County, Guizhou Province, China (Figs. 1 and 2). This rockslide caused three deaths, six injuries, and an accumulation zone of medium weathered limestone that blocked the main line of the M ramp (MKo+165 ~ MKo+400). The distance from the front edge of the upper unstable and dangerous rock masses area to the

Fig. 2 Slope conditions. **a** Before the landslide; **b** after the landslide

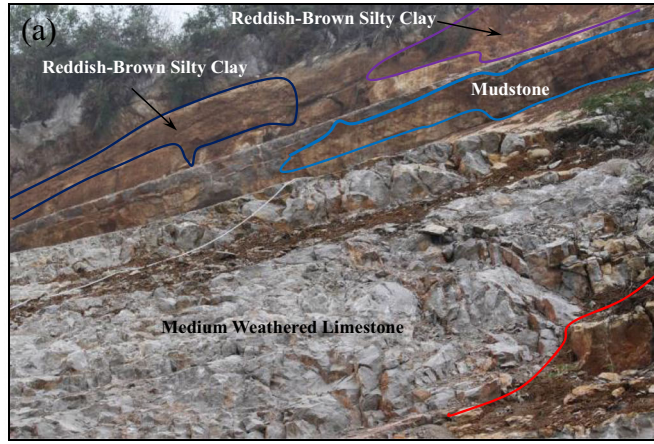
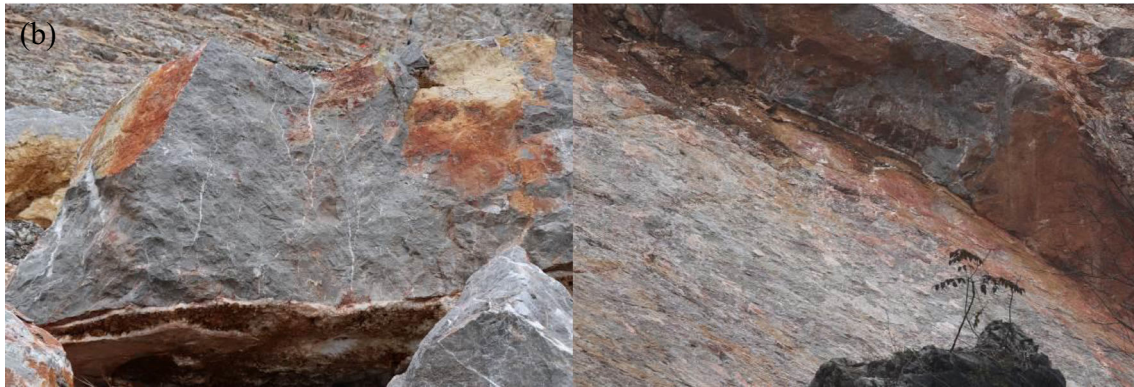
characteristics of the rock formation. A weak interlayer was identified by investigating the sliding bed (Fig. 3a), along which a potential sliding surface could be easily developed under these geological conditions. The joints provided room for the development of calcites (Fig. 3b). Through the above analyses, these geological characteristics contributed to high risk of a landslide.

Fig. 3 The geological conditions of the bedding rockslide. a The situations of stratum; b the calcites filled in the joints surface

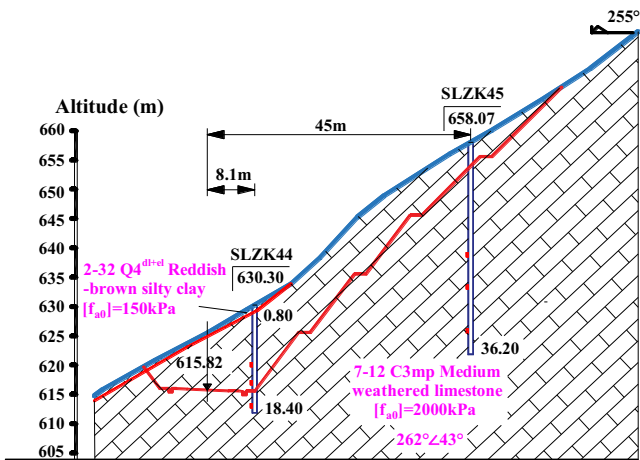
The surface soil mass was a reddish-brown silty clay (Q_4^{dl+el} , the number of strata is 2–32) with low water content ($\omega = 28.6\%$) and high plasticity (the liquid limit “ ω_L ” is 51%, and the plasticity index “ I_p ” is 29.8). In addition, it contained a small amount of limestone breccia (the particle size ranging from 2 to 16 mm) and had a certain degree of contamination in the underlying bedrock. The maximum depth of the reddish-brown silty clay was 0.80 m (Fig. 4).

Fig. 4 Cross-section of MK0+220 before the landslide (Q₄^{dl+el} is Quaternary system clinosol and residual. C_{3mp} is Carboniferous system Ma'ping group. The depth of reddish-brown silty clay is 0.8 m. The depths of the drill holes SLZK44 and SLZK45 are 18.40 m and 36.20 m, respectively)

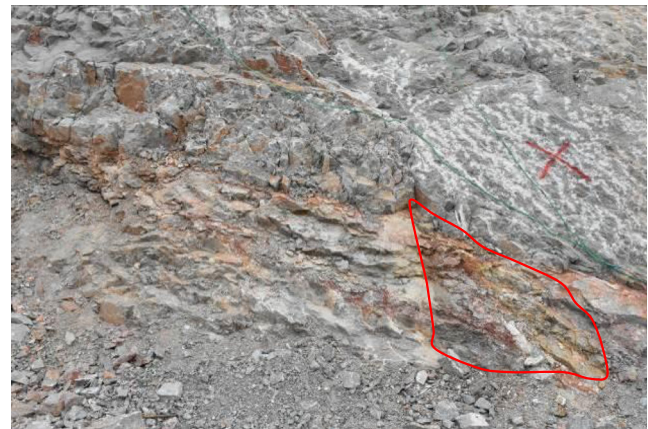
The types of groundwater in the landslide area are primarily Quaternary pore water and bedrock fissure water. The Quaternary pore water mainly existed in the residual soil layer and the aquifer is thin. The bedrock fissure water was presented in the fissure. The aqueous characteristics of groundwater were generally weak owing to the limitation of recharge conditions. Before the rockslide, there was a mark of groundwater seepage at the foot of the slope (Fig. 5).

Fig. 5 Groundwater seepage at the foot of the slope

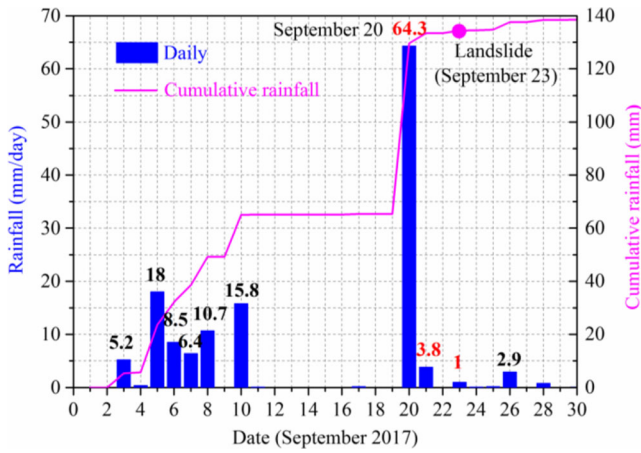
By querying the local climate resources (monitoring station ID is 57,936, in Libo County, Guizhou Province, China), the cumulative rainfall in Libo County in September 2017 was 138.5 mm, and rainfall was relatively frequent (Fig. 6). In September 2017, there were 10 days during which the rainfall exceeded 1 mm, and 7 days during which the rainfall ranged between 0 and 1 mm. In particular, the daily rainfall on September 20 reached 64.3 mm (Fig. 6). The rainfall not only increases the unit weight of the rock masses but also decreases the shear strength of the rock masses and sliding band. In addition, a large amount of rainwater infiltrated into the rock masses of the slope body through preexisting cracks, resulting in a loss in strength of rock masses. Thus, under the action of rainwater, the rock masses were further softened and its shear strength reduced.

Fig. 6 Rainfall intensity and cumulative rainfall in Libo County in September 2017

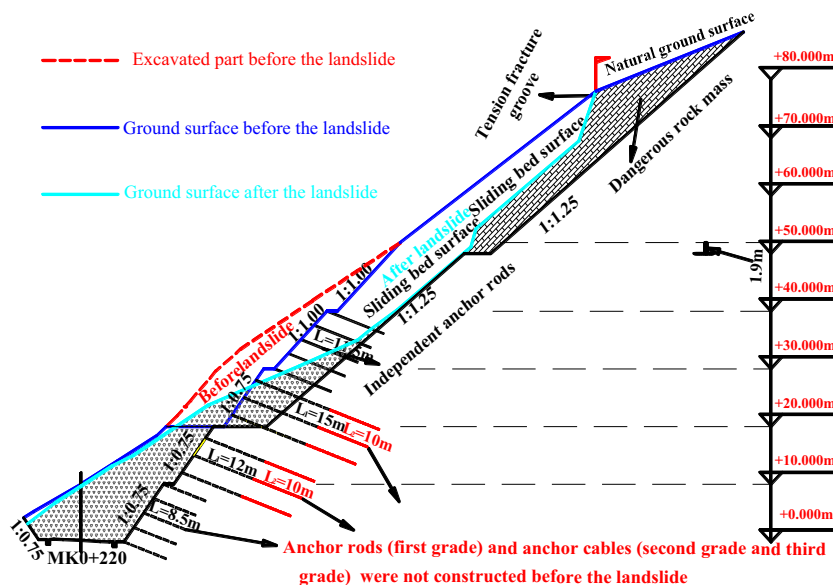
According to the design plan, the slope was to be excavated dividing into five slope grades, and the maximum excavation height is 51.9 m. The stepped-slope excavated mode was adopted: based on Fig. 7, the slope ratios (height: width) corresponding to the first grade to the fifth grade were respectively 1:0.75, 1:0.75, 1:0.75, 1:1, and 1:1. The platform width was 2 m. The

former four slope grade heights were all equal to 10 m and the fifth one was 11.9 m. The first grade and fourth grade were reinforced by 8.5-m- and 11.5-m-long anchor rods. In addition, the second grade and third grade were reinforced by 22-m- and 25-m-long anchor cables. In the fifth grade, the shrubs were used for the slope protection. Before the landslide, the anchor rods were constructed in the fourth slope grade. The third slope grade was excavated; however, the anchor cables were not constructed.

3. Based on field investigations, all the exposed anchor rods on the sliding bed were cut off by the landslide body. As shown in Fig. 7, only a small part of the anchor rods still embedded in the rock masses. Therefore, their reinforcing effects on the fourth slope grade were limited. Under the erosion action of rainwater and tensile stress of the overlying rock masses of the area II-1 and area II-2, the tension fracture groove at the back edge of the slope continued to develop and eventually cut through. Then, the creeping slip of the overlying rock masses of the area II-1 occurred, and the sliding groove line appeared on the left and right sides. Finally, the tension cracks of the fracture platform between area II-1 and area II-2 cut through (Fig. 8a). Therefore, the slipping surfaces of the area II-1 and area II-2 were connected (Fig. 8b).

Fig. 7 Slope excavation situation before and after the landslide

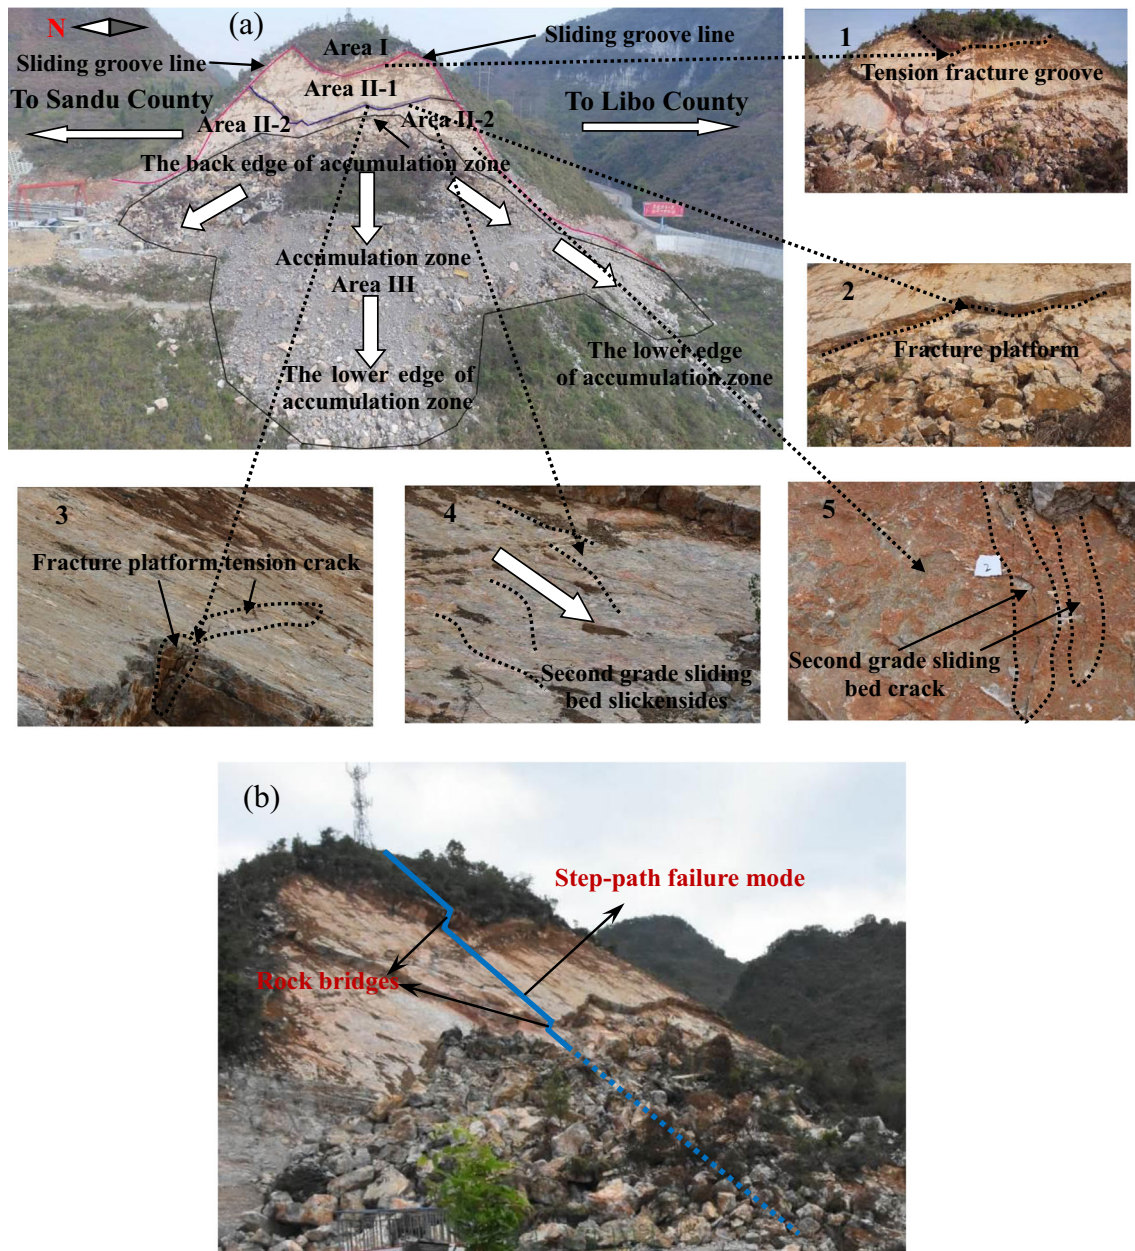
According to field investigations, the failure area is divided into three parts: the upper unstable and dangerous rock masses area (area I), the middle stable sliding bed area (area II), and the lower accumulation zone area (area III) (Fig. 8a). The middle stable sliding bed area (area II) is divided into two sub-regions by a fracture platform with an average thickness of approximately 2 m (Fig. 8a): first-grade sliding bed area (area II-1) and second-grade sliding bed area (area II-2). The shape of the sliding bed indicates that the landslide follows the step-path failure mode (Fig. 8b).

This part is located at the top of the slope with a circular tension fracture groove at the lower part. The maximum longitudinal (sliding direction) length is approximately 25 m, and the average thickness is approximately 6 m. The volume of this part is approximately 8000 m³. Most of this area is covered by plants (Fig. 8a).

joint surfaces but tensile failure of the rock bridge between adjacent joint surfaces (Fig. 8b). In addition, based on Fig. 8a, before and after the landslide, the red line represented an interface between the sliding surface and the original slope surface on the left and right sides of the sliding bed.

There were sliding groove lines on the left and right sides of area II-1. The sliding bed surface was relatively smooth with several evident slickensides (Fig. 8a). There were also many cracks on the sliding bed surface and a tension crack in the fracture platform (Fig. 8a).

The sliding bed surface had several evident slickensides and many cracks (Fig. 8a). Small soils and small stones could be seen in part position on the slipping surface. The tension crack cut through under the action of rainfall softening and sliding forces. Finally, the overlying rock masses of the area II-2 slid directly along the joint surface.

This part is located on the roadbed slope and embankment slope (Fig. 8a). The thickness and volume of the accumulation

2. The free face formed by the slope excavation was always in an unloading state. Before the landslide, the slope had been accumulating elastic strain energy before the cracks appear. According to the dip angle of the slipping surface (39°) and the mechanical analysis of the Libo bedding rockslide, the maximum shear strain concentrated along the cracks at the front of the slope. As shear strain accumulated, it showed an increase in deformation resulting in the appearance of the lower shear outlet (Fig. 2a). In addition, joint surfaces continued to develop under the shear deformations of the sliding surface and the erosion action of rainwater. The mudstone interlayer in the limestone and the tensile failure of the fracture platform provided convenient conditions for the connection of adjacent sliding surfaces (the step-path failure mode in Fig. 8b). These characteristics provided the potential sliding surface for the landslide.

Fig. 8 The division and characteristics of the bedding rockslide. **a** 1 Tension fracture groove (area I); 2 fracture platform (area II); 3 fracture platform tension crack (area II-1); 4 second-grade sliding bed slickensides (area II-2); 5 second-grade sliding bed crack (area II-2). **b** Step-path failure mode

energy accumulated in the slope released rapidly along the direction of crack development and the step-path sliding surface was finally formed. The landslide body slipped in the lower part of the slope. The back edge of the landslide body accumulated in a curved shape at the bottom of the area II-2. The lower edge of the landslide body continued to slip in two directions along the embankment slope (Fig. 8a). Finally, the entire landslide process was completed.>

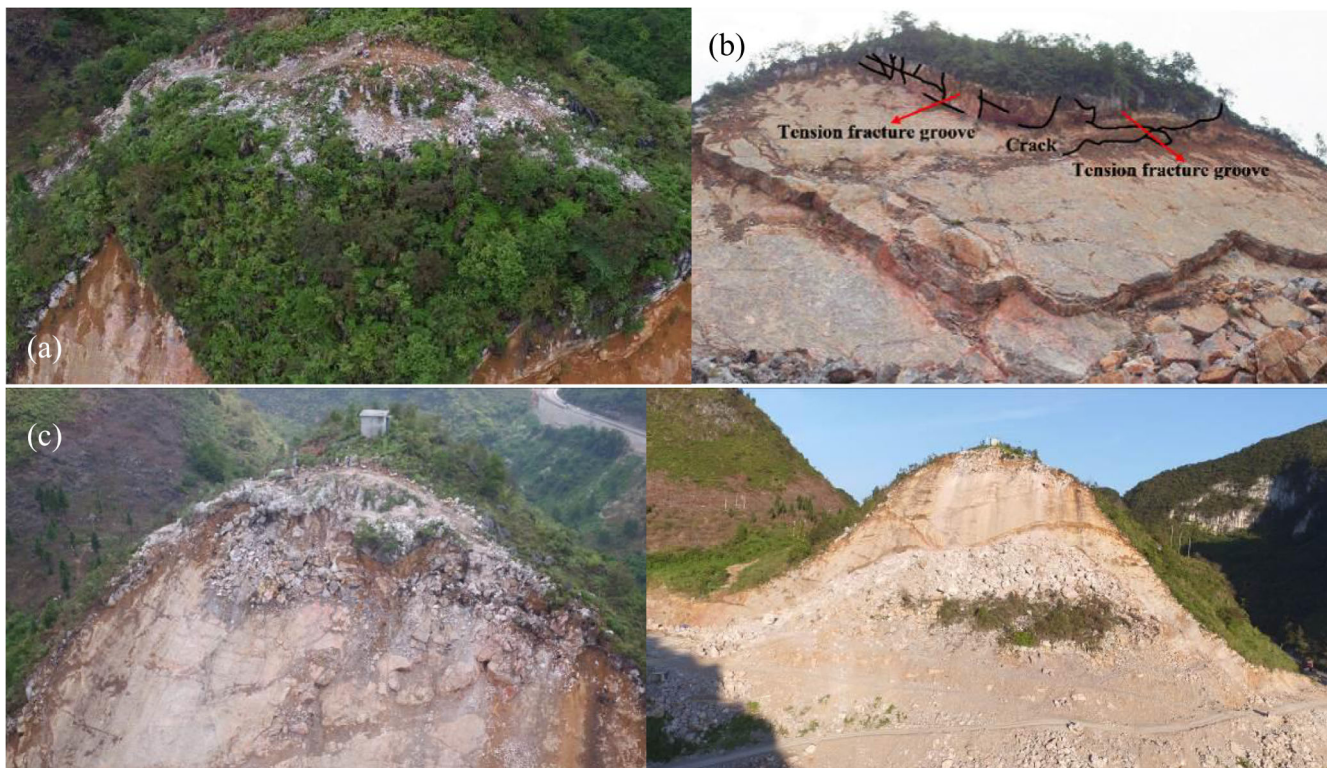
After the landslide, it was found that the upper rock masses (Fig. 9a) was about to slide easily for the following reasons: (1) The integrity of

the rock masses was poor; (2) the slope was steep with a dip angle of approximately 39° and had bedding characteristics; (3) a free face was formed after the landslide (Fig. 9b); and (4) evident cracks appeared on the tension fracture groove (Fig. 9b).

Fig. 9 a The upper unstable and dangerous rock masses. b The tension fracture groove. c The slope after the blasting

For safety, a blasting treatment was carried out on this part of rock masses. The total weight of explosives used in this blasting was 1.72×10^3 kg. There were a total of 15 blasting holes with apertures ranging from 111 to 115 mm. The depth of the blasting holes in the middle position was 18 m, and the depth on both sides was 15 m. The distance from the blasting holes to the free face was approximately 7 m.
