Deying Li · Liangxuan Yan · Li Wu · Kunlong Yin · Chin Leo

The Hejiapingzi landslide in Weining County, Guizhou Province, Southwest China: a recent slow-moving landslide triggered by reservoir drawdown

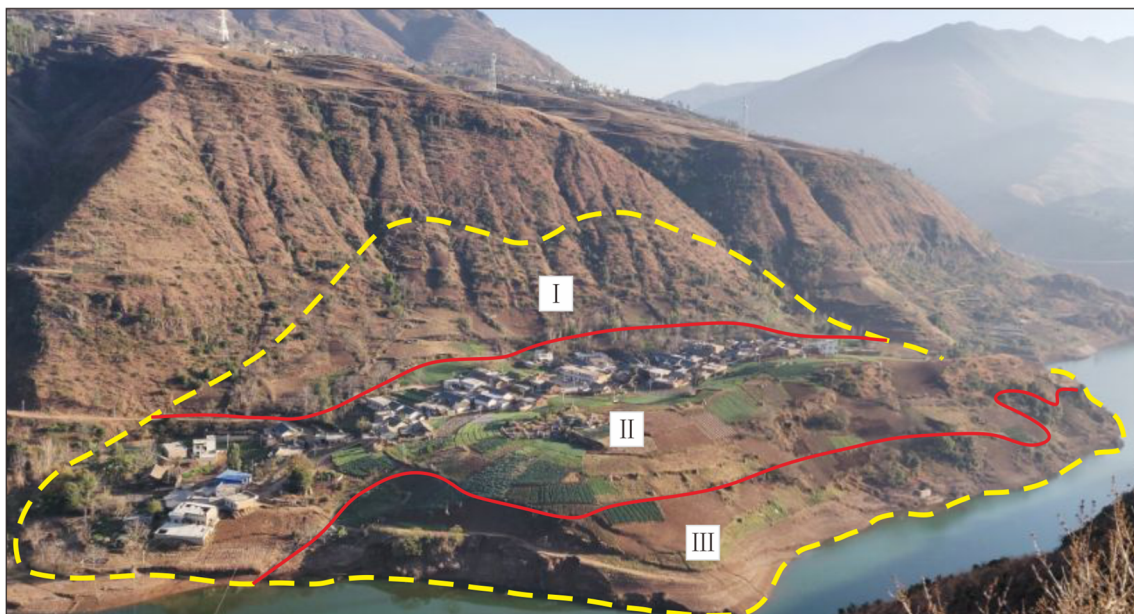
- (1) **Region I:** The rear region is a steep slope of 40 to 60° and it is characterized by gravel soil. The elevation of the rear boundary varies between 1508 and 1550 m.

- (2) **Region II:** A flat platform is located in the middle of the landslide and it has a length of 650 m roughly aligned with the Yulong River and a width of 180 to 220 m. The topography of the platform near Yulong River is a raised, with its highest elevation at 1452 m. The elevation of the platform near NO.1 Gully ranges from 1400 to 1420 m and the elevation near NO.2 Gully ranges from 1430 to 1440 m. The platform slopes in a north-east direction in general. The soil on the surface is characterized by clay with gravel. Most of the Heping village houses are concentrated here.

- (3) **Region III:** The landslide toe was approximately 14 to 17 m below the water level of 1370 m. There is a road along the landslide front which ranges in elevation from 1360 to 1411 m. The slope of the Yulong River bank below the road ranges from 50 to 70°. The slope above the road near the NO.1 Gully ranges from 10 to 25°, and near the NO.2 Gully ranges from 30 to 50°. Most of the surface is covered by gravel soil.

Fig. 4 Photo of the landslide, showing three sub-regions based on their varying terrain

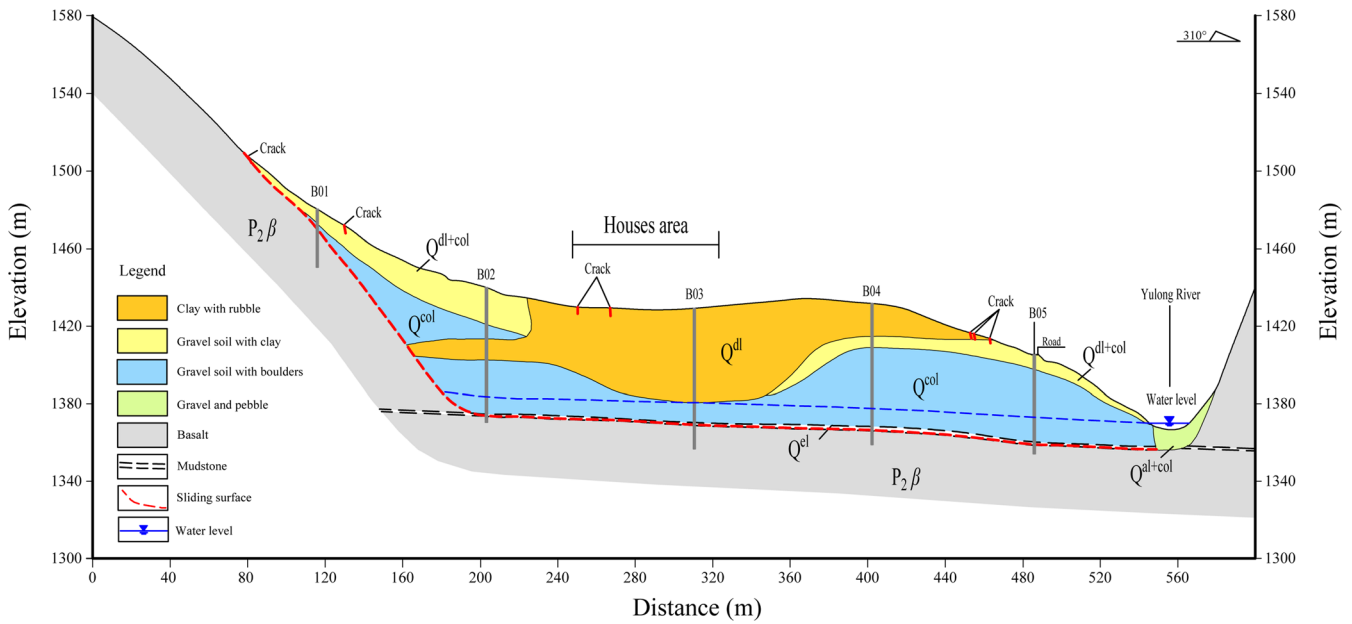
Quaternary deposits. The mobilized material was composed of Quaternary deposits over tuffaceous mudstone with a lower shear strength. Figures 6, 7, and 8 show the landslide structure and the distribution of landslide material. The groundwater level in the landslide body was observed during the drilling boreholes. The dashed blue line of groundwater level was estimated based on the measured data during the drilling investigation. From the top to the

Fig. 6 Geological longitudinal section of the landslide (I–I') (see Fig. 5)

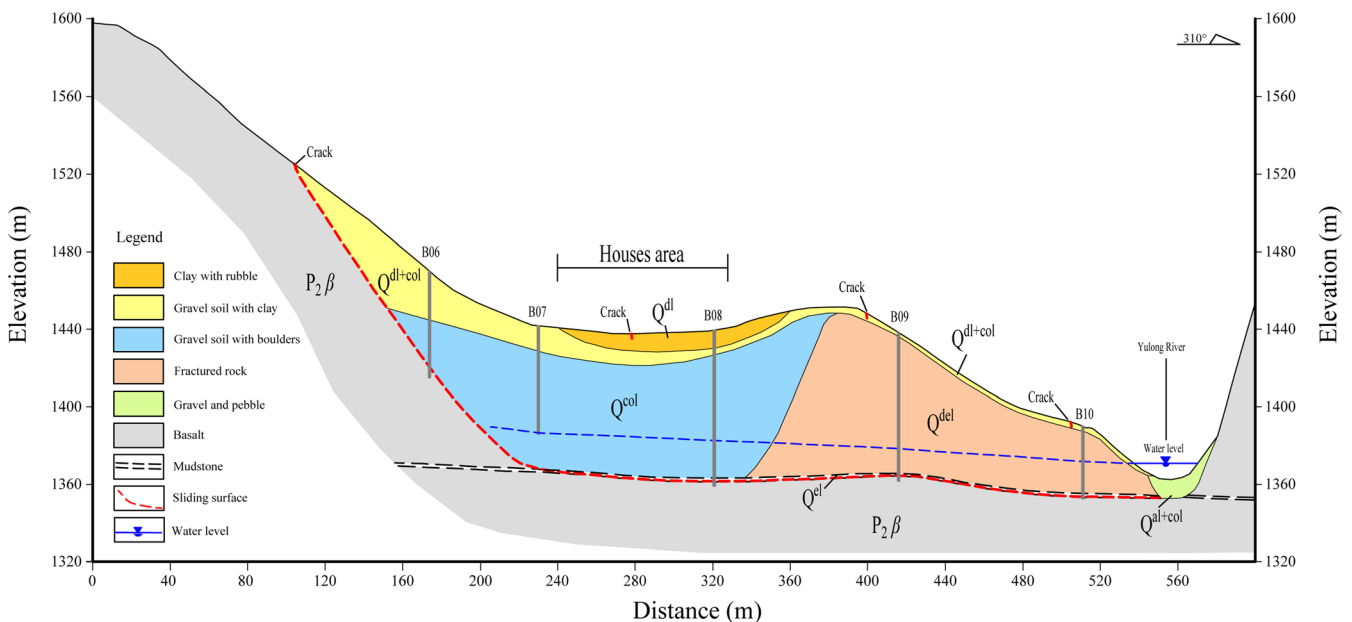
Fig. 7 Geological longitudinal section of the landslide (II–II') (see Fig. 5)

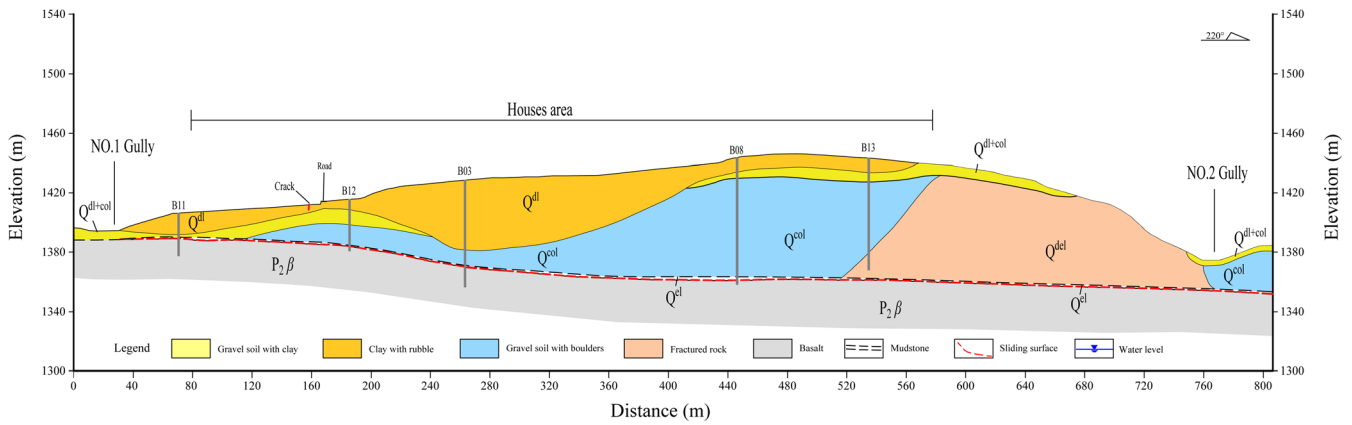
Fig. 8 Geological longitudinal section of the landslide (III-III') (see Fig. 5)

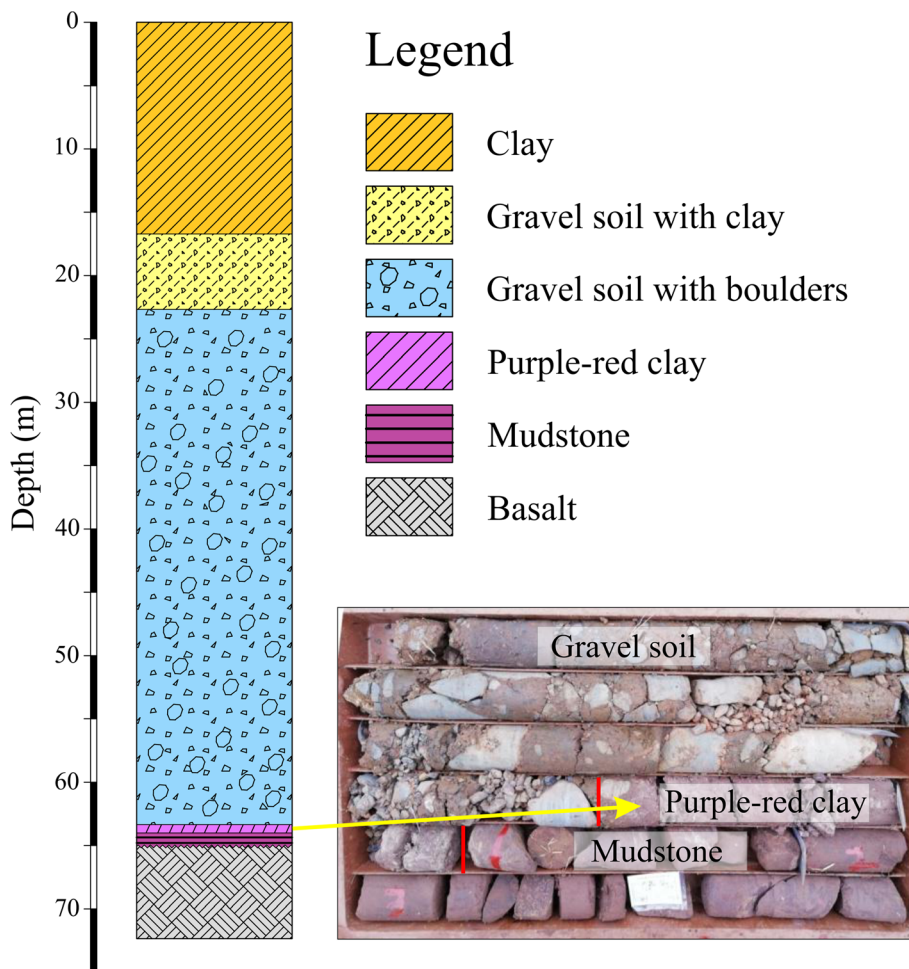
bottom, the landslide profile includes the following: (1) yellow and brown clay with 10–30% gravel, consisting of basalt, 2–50 m thick; (2) yellow gravel soil with 20–30% clay, 0–30 m thick; (3) brown gravel soil with some boulders, 18–40 m thick in general; (4) fractured rock from an old rock slide, 30–50 m thick in general, but locally up to 80 m thick, occurring mainly near NO.2 Gully; (5) purple-red clay from weathered mudstone, located on the top of tuffaceous mudstone, 0–2 m thick. The sliding zone is in the weathered mudstone layer. It is shown in the dashed line due to the thinner thickness. The shear strength parameters of potential slide zone soil were measured by direct shear test. The cohesion and friction angle of saturated sample were 8.9–13.8 kPa and 5.4–7.6° respectively. The typical landslide structure, including clay, gravel soil, mudstone, and basalt, illustrated by Borehole B04, is shown in detail in Fig. 9, which also shows the core samples of gravel soil, purple-red clay, and mudstone.

There may be two kinds of landslide soils located in the contact zone between the Quaternary deposits and the bedrock: (1) gravel soil with clay—an unsaturated soil, which is located in the rear region with a steep slope of 40 to 60°; (2) purple-red clay located mainly in regions II and III—its slope of 2 to 8° is very gentle and would have been saturated after the reservoir impoundment.

Fig. 9 Borehole log of B04 and a photo of the core samples showing the potential sliding soil

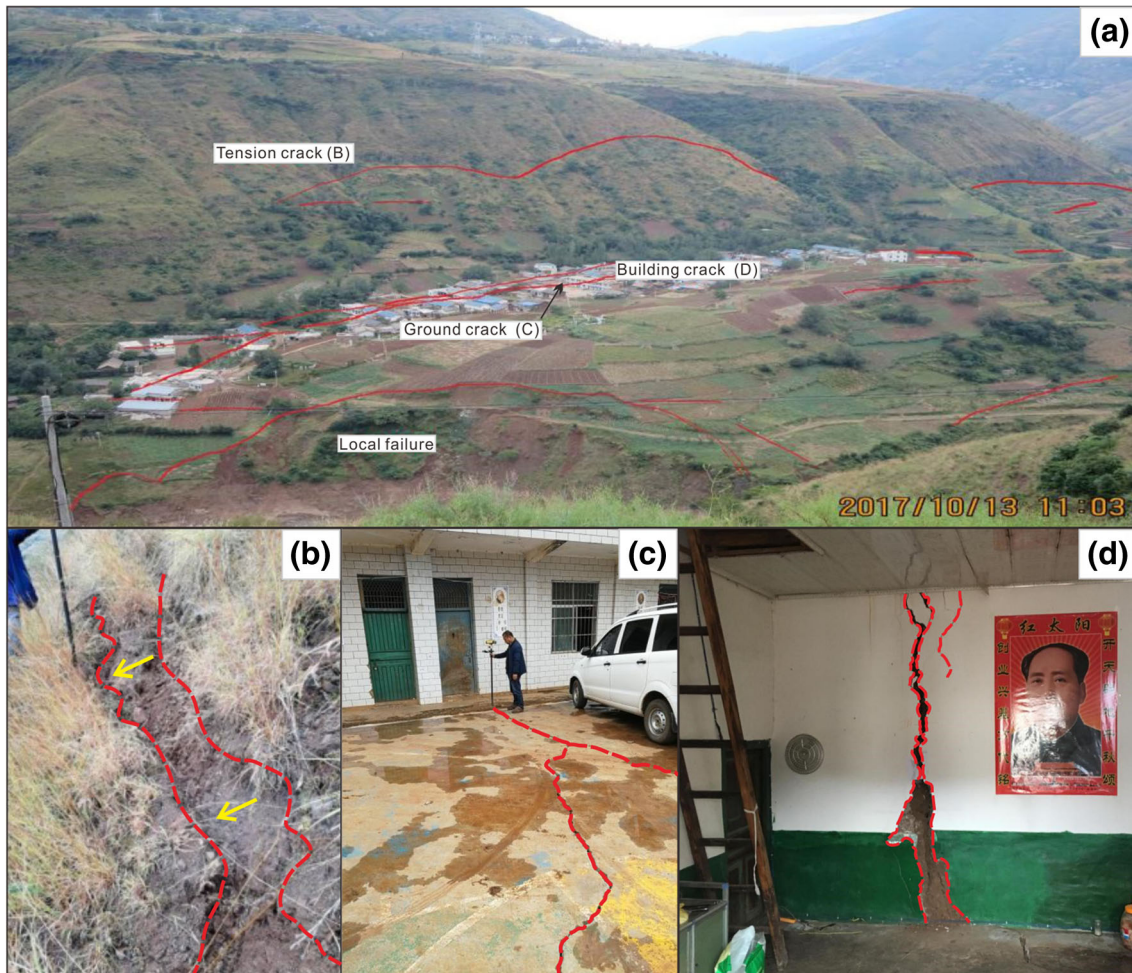
Field investigation on 20 August 2017 revealed more than 20 ground cracks with slow growth along the length of the landslide surface and several local failures in the landslide front, as shown in Fig. 10. Four tension cracks occurred at the top of I region at approximate elevations of 1490 m and 1510 m. These cracks were about 12–208 m long and had a maximum width of 0.44 m. The majority of the landslide cracks were mainly distributed on the platform of the II region and their extension direction was parallel to the direction of the river valley. These cracks have a length of 21–140 m and a width of 0.02–0.1 m, and they caused damage to several houses. The mainly local failure near NO.1 Gully covers an area of $1.8 \times 10^4 \text{ m}^2$ and is toe-erosion collapse along the river bank. It occurred on about 20 August 2017, following the draw-down of the reservoir water level, and caused damage to the village road.

Fig. 10 Characteristics of landslide cracks: (A) distribution of landslide cracks; (B) tension crack in the rear region; (C) damage to a paved area in the platform region; (D) damage to a house interior in the platform region

1. Plastic sheets should be used to cover the landslide cracks. This would prevent surface water from seeping into the cracks and limit the increase of pore water pressure in the landslide.
2. Subsurface monitoring of the landslide should be adopted in the future. This should include monitoring of groundwater levels and measurement of underground displacement using inclinometers. The main aims are to identify the relationship between the groundwater level and reservoir water level and determine the possible sliding hazard zone. The locations of these measures installed proportionally in the landslide are proposed, as shown in Fig. 17.

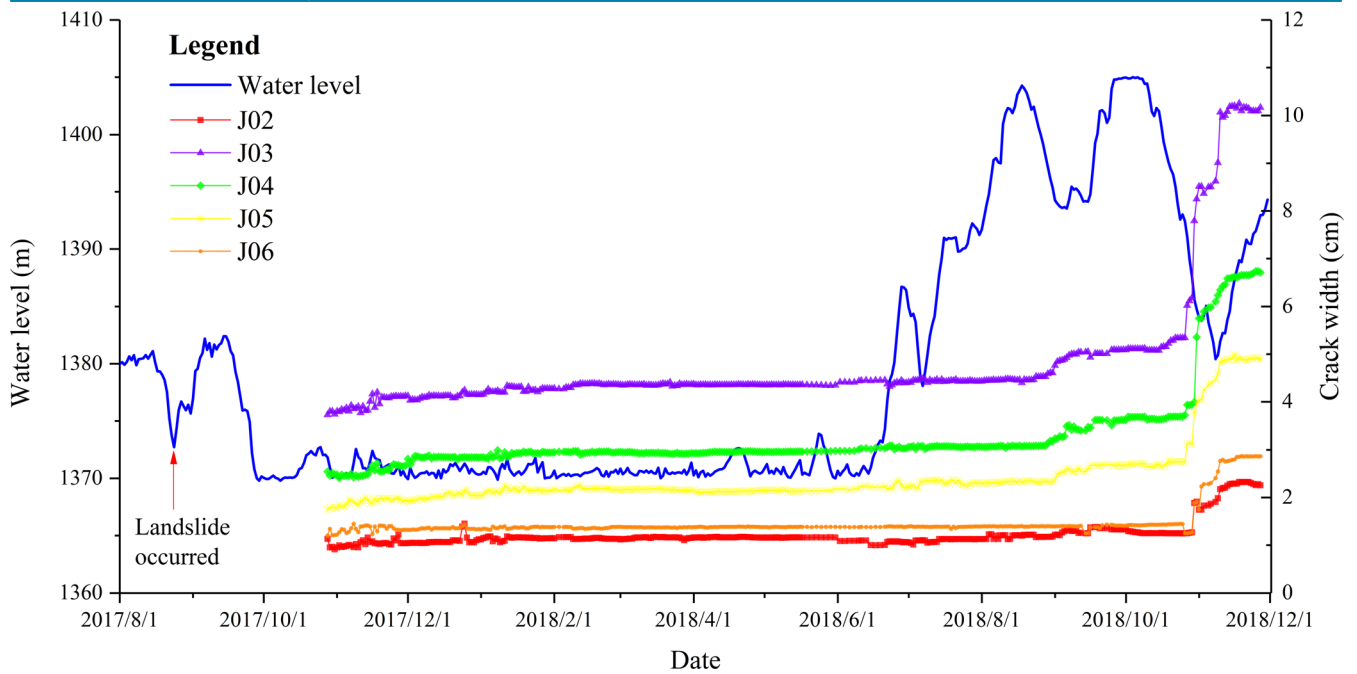
Figures 12 and 13 show the evolution over time of cumulative changes in crack width based on the simple crack measurements. Total station monitoring points To2, To8, and T12 could not be observed, because trees hid the monitoring points from view, so there is no observed data for these three points. Cumulative

1. The deformation varied spatially. The maximum crack width change of J11 was 44.15 cm. The maximum crack deformation observed created a long continuous crack of the boundary at the rear of the landslide—it was 208 m long. The change in crack width was larger than the changes at other monitoring points of 2.26 to 10.17 cm in the platform. This indicated that the deformation in the rear region was greater than that in the

2. The deformation fluctuated with time and reservoir level changes. The monitoring data shows that the landslide was stable from December 2017 to July 2018. The rate of crack width change registered 0-0.08 mm/day in this period, but increased to 6.1-16.2 mm/day from mid-August to mid-

Fig. 12 Cumulative change in crack width at the crack monitoring points

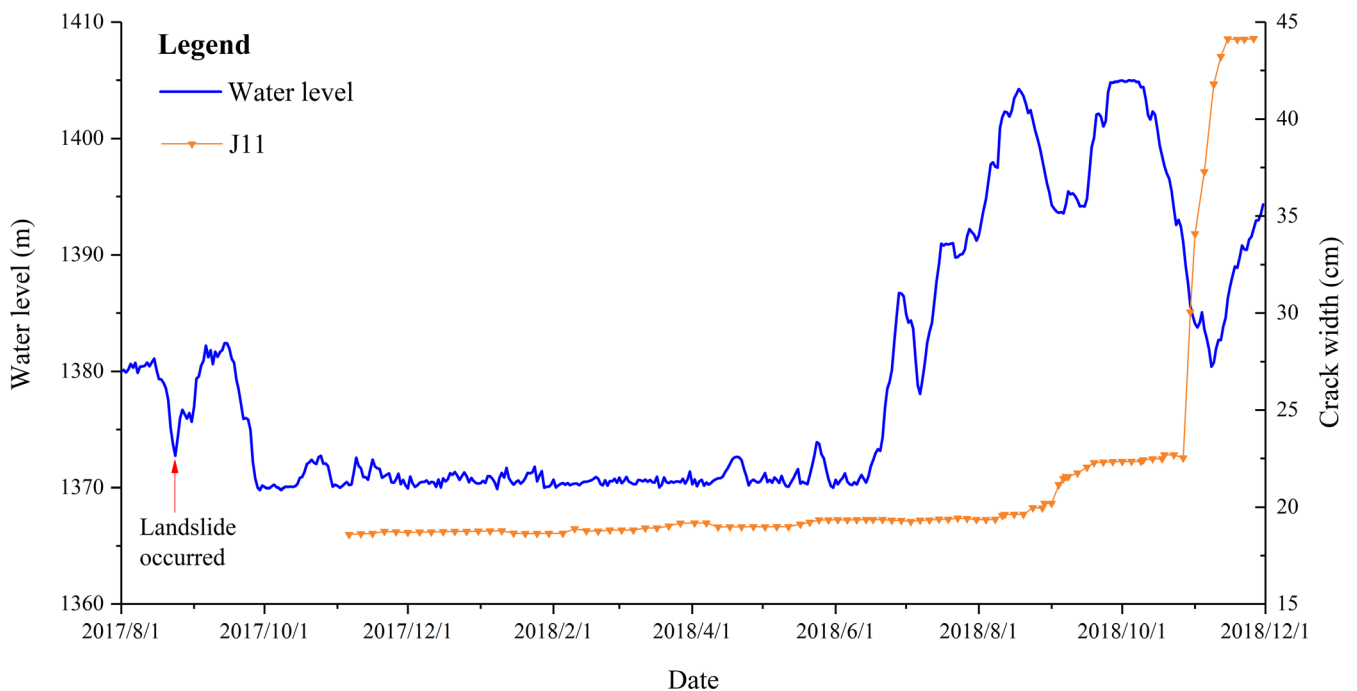
Fig. 13 Cumulative change in crack width at the J11 monitoring point

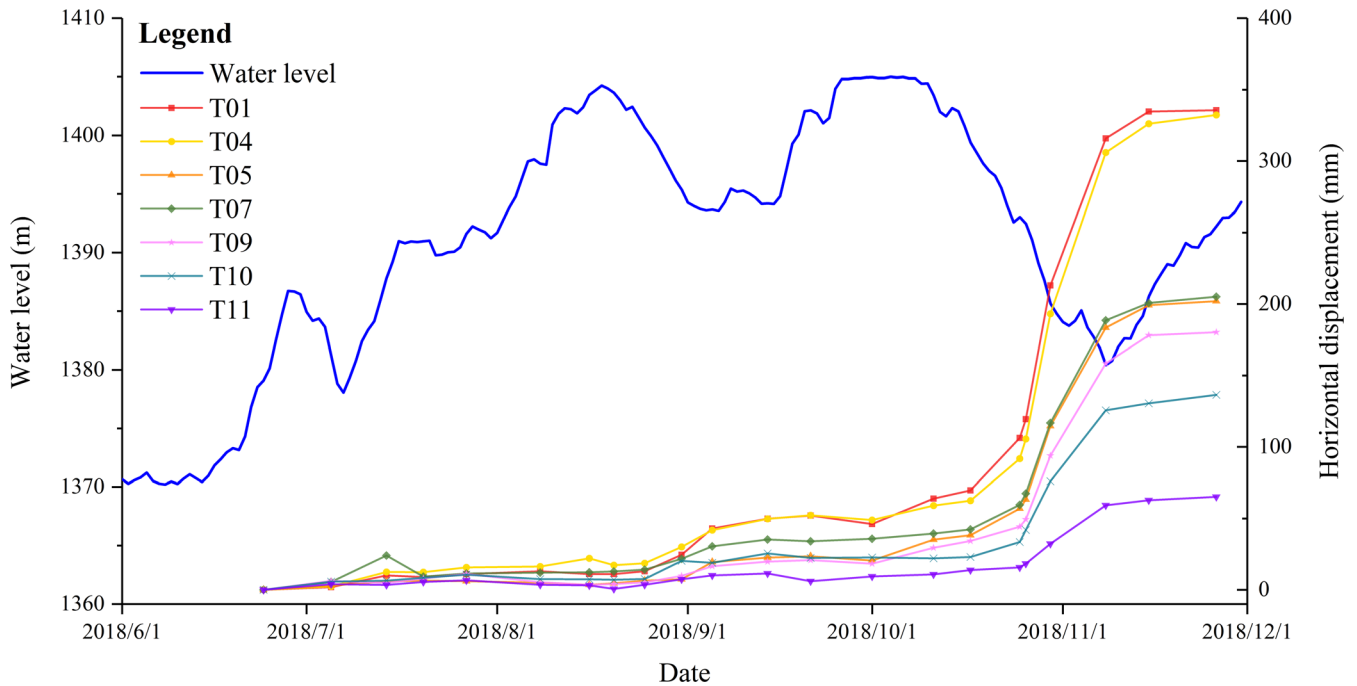
displacements of To3 and To6 beyond the landslide boundary were respectively 5.1 mm and 3.3 mm. Figure 14 shows the cumulative displacement versus time data for other total station points. Based on the observed results, the main features are as follow:

flat platform. In addition, the cumulative displacements of To1 and To4 were respectively 335.7 mm and 332.3 mm. The cumulative displacement of other total stations was smaller than 205.1 mm. This shows that the landslide toe near NO.1 Gully moved quickly by comparison.

November of 2018. The same phenomena occurred in the monitoring results for the total station. The landslide decreased or became stable when the reservoir water level was raised from June to mid-August 2018. During the drawdown period from mid-October to mid-November 2018, however, the displacement occurred at a rate of 12.3–21.8 mm/day and the landslide became very active. The displacement curve shows power law acceleration phases during the drawdown period. The temporal variability is shown by the increase in the slope of the displacement curves corresponding to this period.>

displacement and variations in the reservoir water level is shown in Figs. 12, 13, and 14. These graphs show that the landslide was evidently affected by the drawdown of the water level from 10 October to 8 November 2018, but not by the earlier sharp rise in water level from 14 June to 18 August 2018. For example, the water level rose rapidly from 1370.0 to 1386.7 m in June 2018, but the change in crack width was virtually negligible. Another period of rise of the reservoir water from 23 July to 18 August 2018 also produced a negligible change in landslide deformation. One reason was that the rise of the reservoir water increased normal stress on the landslide front located below the reservoir and consequently increased the resistance force against sliding (Li et al. 2010).

Fig. 14 Cumulative displacement measured by total station

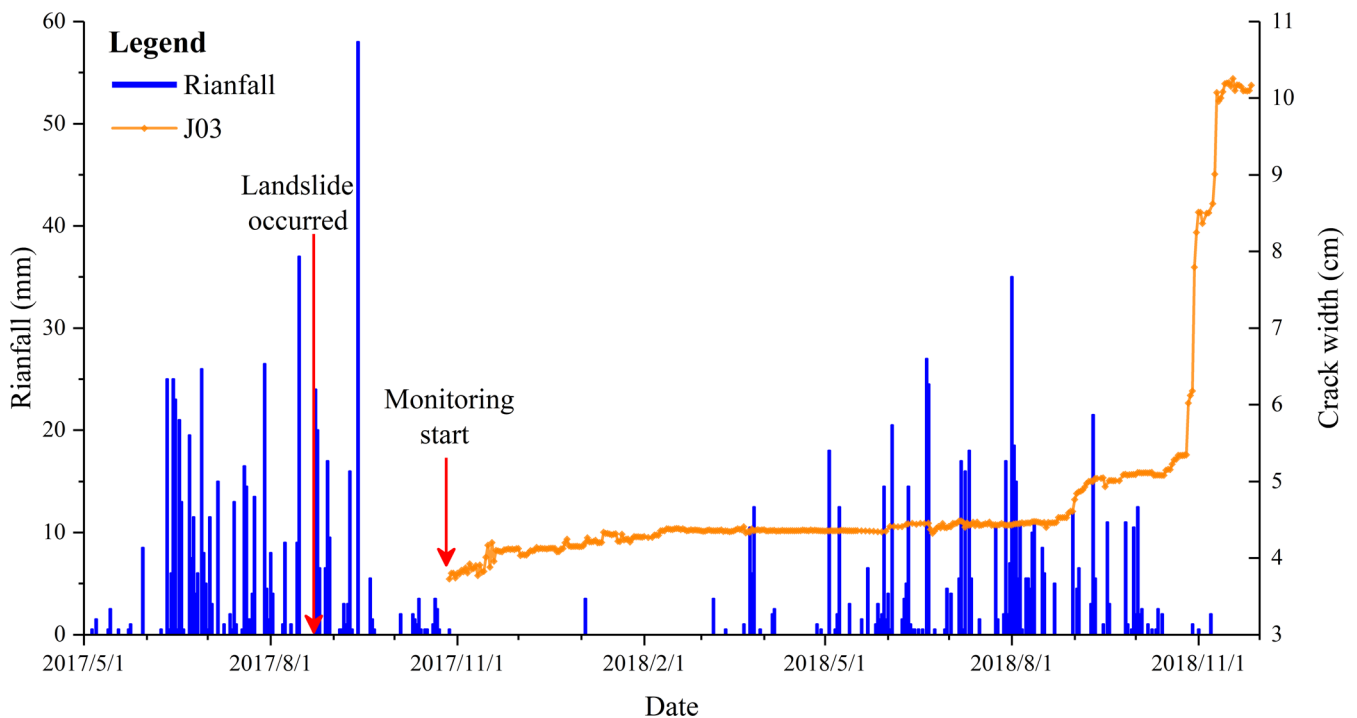
The nearest rain gauge to the landslide is at the dam site and rainfall data from that station was used. Figure 15 shows the daily rainfall from May 2017 to November 2018 and the cumulative change in crack width from October 2017 to November 2018. Although the cumulative 2-day rainfall totaled 46 mm from 14 August to 15 August 2017, there was no rainfall from 16 August to 20 August 2017. There was thus a period of about 5 days without rainfall prior to the landslide occurrence. From 29 July to 5 August 2018, it rained every day and the cumulative 8-day rainfall totaled 111 mm. However, the crack width at the J3 monitoring point increased by just 0.2 mm during this period. Based on the field investigation and the analysis of monitoring data, there was no obvious evidence that the landslide was triggered by rainfall.

Fig. 15 The relationship between daily rainfall and cumulative change in crack width
