Landslides (2019) 16:2247–2258
 DOI 10.1007/s10346-019-01254-z
 Received: 20 December 2018
 Accepted: 7 August 2019
 Published online: 16 August 2019
 © Springer-Verlag GmbH Germany
 part of Springer Nature 2019

Mass movement and formation process analysis of the two sequential landslide dam events in Jinsha River, Southwest China

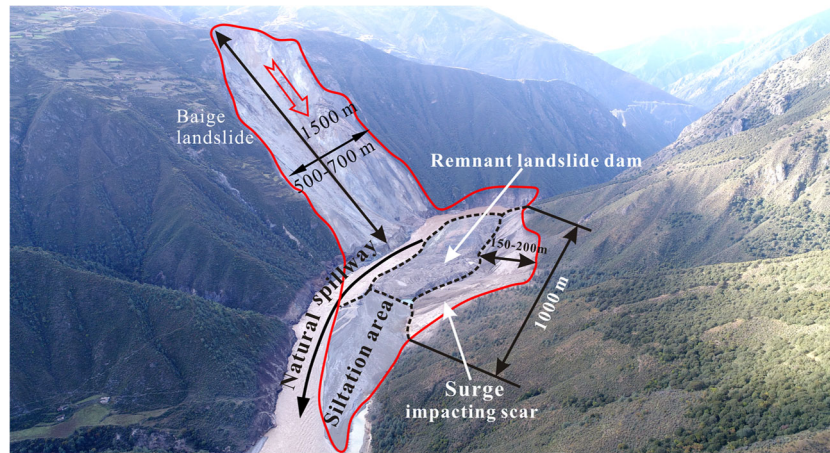
As shown in Fig. 4, the field investigation indicated that the Baige landslide was a typical slope failure with a high-speed sliding mass, and the source mass slid down from the top of the mountain

ridge at an average elevation of more than 3720 m. The relative elevation difference exceeds 840 m, and the run-out distance was approximately 1500 m. Approximately $1.0 \times 10^7 \text{ m}^3$ of sliding mass rushed into the Jinsha River and caused a high surge of more than 150 m. The surge hit the river bank on the other side and swept away the trees and other vegetation, leaving a large scar with a height of 150–200 m and a length of more than 1000 m. The ensuing accumulation body from both banks blocked the river channel and formed the Baige landslide dam. The large landslide dam was estimated to have a volume of more than $1.5 \times 10^7 \text{ m}^3$ with an average height of 80 m and a length of 1100 m. The volume of the resulting landslide dammed lake was estimated to be more than $2.7 \times 10^8 \text{ m}^3$. The lake started overflowing 34 h later, and the water level dropped to a safe level of 2894.6 m 5 days later.

Fig. 4 Main geometric information of the Baige landslide

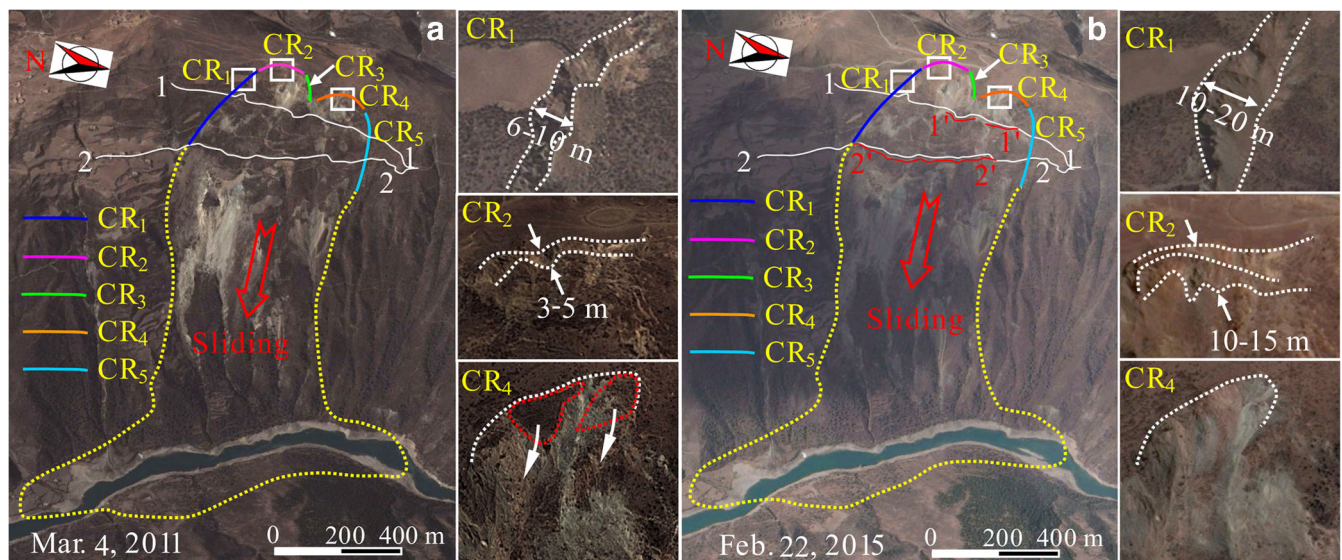
To investigate the deformation history of the Baige landslide, two scenes of remote-sensing images from Google Earth prior to the landslide (Fig. 5) were acquired and analyzed through visual interpretation (Fan et al. 2017). As shown in Fig. 5a, significant deformation can be observed since Mar. 4, 2011. Several small-scale collapses took place at the middle and back of the landslide area. Two tension cracks along the mountain ridge (CR_2 and CR_4) and three along the sliding direction (CR_1 , CR_4 , CR_4) could be identified at the back of the landslide area. Among these cracks,

the longest crack (CR₁) zigzagged for 150–200 m with a visible staggered step of 6–10 m. The other cracks stretched to various sizes, and most were opened. Figure 5b shows an image of the potential landslide area on Feb. 22, 2015. It can be seen that the deformation and failure phenomenon intensified because of gravity, rainfall, or ice/snow melting. Small-scale sliding and collapses occurred more intensively with the cracks being deepened and widened. The stretch length and opening width of CR₁ were significantly enlarged, and its visible deformation dislocation increased to 10–15 m. Small-scale collapse was densely developed at the back of the landslide along CR₂ and CR₄. A remarkable deformation can be identified by comparing the positions of the paths (1–1 and 2–2) across the upper part of the landslide area. The increasing development of the cracks, small-scale collapses, and deformation phenomenon suggested that the potential failure mass had already been substantially deformed and was prone to massive failure.

Fig. 5 Two scenes of remote-sensing images of the Baige landslide from Google Earth: a on Mar. 4, 2011, and b on Feb. 22, 2015

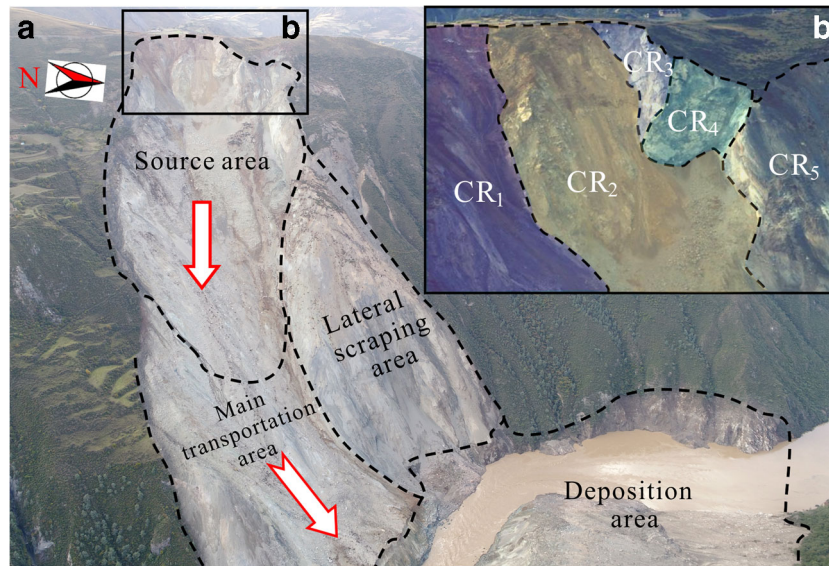
Fig. 6 High-resolution image of the landslide scar taken by the UAV: **a** a view of the landslide scar and **b** source area of the Baige landslide

As shown in Figs. 6 and 8a, the source area was bounded by preexisting cracks, over which a remnant slope was formed with a steep angle ranging from 50° to 70° and a width of 200–400 m after the landslide. The rock mass was mechanically characterized by relatively low strength and structural fragmentation due to long-term weathering and unloading. The source mass detached from the top of the mountain ridge at an average elevation of more than 3720 m and extended to the middle lower part of the slope at an elevation of approximately 3000 m. Then, the landslide mass slid along the slip surface with a high kinetic energy, eroding the preexisting loose deposits by scraping. A wide (500–700 m) but short (200–600 m) scrape area was observed below the source area. According to the morphological characteristics, the scraped area can be divided into a U-shaped main transportation area and a triangle-shaped lateral scraped area. The main transportation area was extended along the main sliding direction, where the

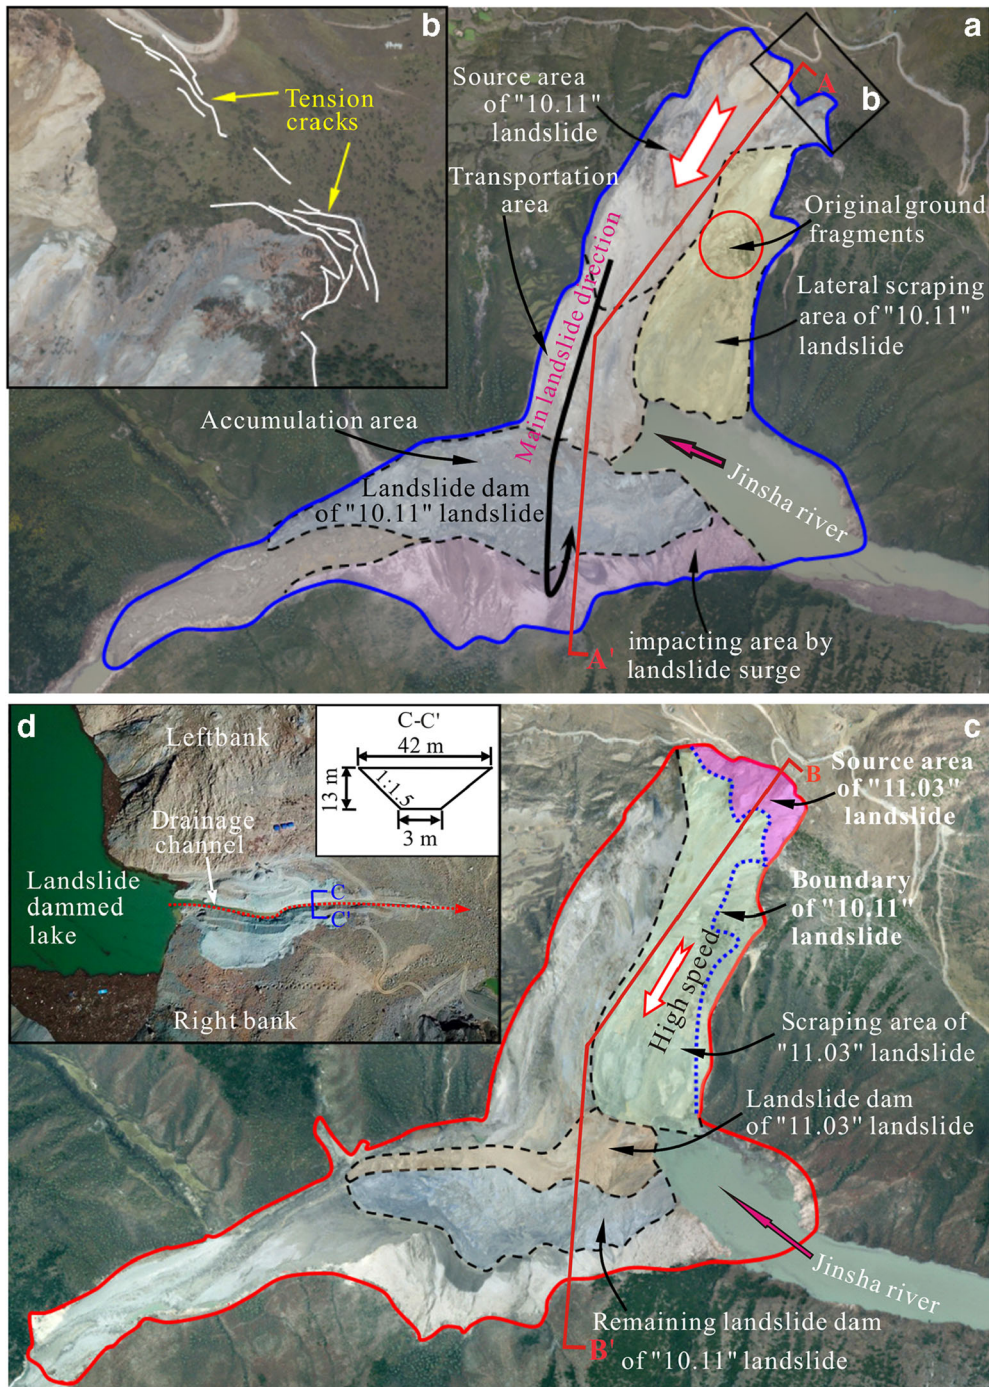
To investigate the landslide in detail, UAV technology was used to acquire high-resolution 3D image models of the Baige landslide (Fig. 8). According to the topography and geomorphology characteristics, the area influenced by the landslide can be generally divided into four major zones: the source area, the transportation area, the lateral scraping area, and the deposition area.

As shown in Figs. 8a and 9a, the large sliding mass with entrained loose deposits was pushed down by the high gravitational energy towards the bank on the other side of the river (left bank), where a landslide dam with a sloping surface was formed quickly after the initiation of the landslide. The highest part of the landslide dam was approximately 115 m (elevation of 2985 m) on the left bank side, while the lowest elevation was approximately 2931 m (height of 61 m) on the right bank side (Fig. 9a). The landslide dam on the left side was mainly composed of rock blocks and was relatively stable, while the landslide dam on the right side was mainly composed of detritus and loose soil and was therefore in a less stable state.

Fig. 8 High-resolution 3D image model of the “10.11” and “11.03” landslides taken by the UAV: **a** mass movement of the “10.11” landslide, **b** tension cracks at the back edge of the remnant slope after the “10.11” landslide, **c** mass movement of the “11.03” landslide, and **d** top view of the drainage channel of the “11.03” landslide dam during excavation

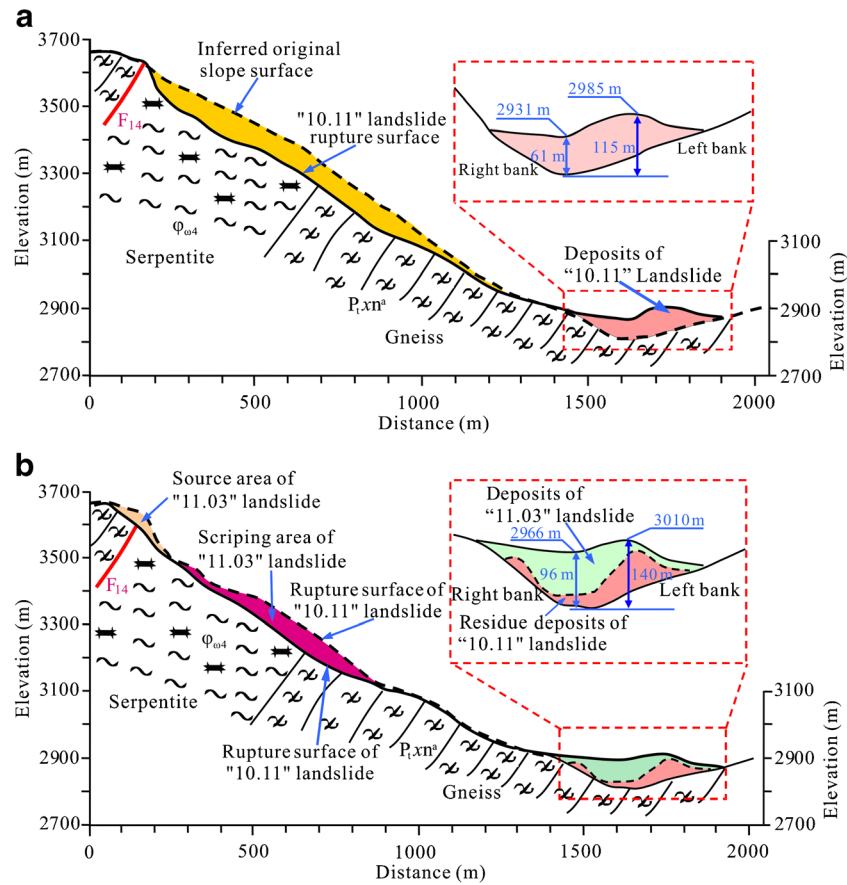
Fig. 9 Cross sections along the main sliding profile: **a** for the first landslide along location A-A' and **b** for the second landslide along location B-B'

As shown in Fig. 9, for a detailed analysis of the scraping and entraining effects of the Baige landslides, two cross sections for the first and second landslides are made along the main sliding profile A-A' and B-B', respectively (Fig. 8 a and c). Due to the short sliding distance, the entrainment and sliding volume amplification effects are unobvious in the "10.11" landslide (Figs. 8a and 9a). However, notable scraping and entraining were observed during the mass movement for the second landslide on November 3, 2018, as a result of high-speed failure. As shown in Figs. 8c and 9b, the source mass detached from the top of the mountain ridge at a high elevation and slid down along the steep terrain at a high speed. The avalanche mass hit with very high kinetic energy on the original sliding bed, where massive loose deposits were accumulated by the "10.11" landslide. The sliding mass was fragmented and

transformed into a rock avalanche because of crashing and collision loading. During the high-speed mass movement process, the interaction with underlying materials was notable. Much of the bed deposit was impacted and scraped by the high-speed sliding mass. The original scraped area was substantially widened and deepened (Fig. 8c), and the original ground fragments on the lateral scraping area (Fig. 8a) were totally removed. The heavy rainfall in early October 2018 resulted in high water content or saturation of bed deposits and caused the entrainment to be more serious. When the high-speed sliding mass impacted the bed deposits, the pore water pressure rose rapidly, and the excess pore water pressure reduced the shear strength of the bed material and facilitated failure. The existence of water played a key role during the mass movement process of landslides, especially for the entrainment of landslides (Zhou et al. 2016). The scraping, eroding, and entraining on preexisting loose deposits greatly increased the sliding volume and expanded the scrape zone (Fig. 8c). The total volume of the resulting landslide deposition was estimated to be more than $6.0 \times 10^6 \text{ m}^3$, approximately three times that of the source mass volume.

The speed, topography, and sliding volume have significant effects on the accumulation and shape of the landslide dam. Due to the high speed of the first landslide, the deposits rushed towards the opposite bank, mainly accumulated at the left bank and formed a sloping-shaped landslide dam (the height of the dam at the right bank is much lower than that at the left bank, as shown in Fig. 9a). However, the rock mass of the second landslide on November 3, 2018, mainly accumulated at the toe of the slope (on the right bank side) because of the topography and

obstruction from the remnant landslide dam body (Fig. 9b). The volume of the "11.03" landslide, which was initially estimated to be much lower than $2.0 \times 10^6 \text{ m}^3$ and considered to have little influence on the drainage of the landslide dammed lake, was significantly enlarged to more than $6.0 \times 10^6 \text{ m}^3$ from the entrainment and sliding volume amplification effects. Due to the volume and deposition status of the "11.03" landslide, the original sloping shape of the landslide dam has changed. The lowest height of the landslide dam was increased to more than 96 m with the corresponding volume of the landslide dammed lake estimated to be more than $7.7 \times 10^8 \text{ m}^3$ (Fig. 10a). As a result, the dam break risk was high, and a swift and aggressive treatment had to be taken to drain the water.

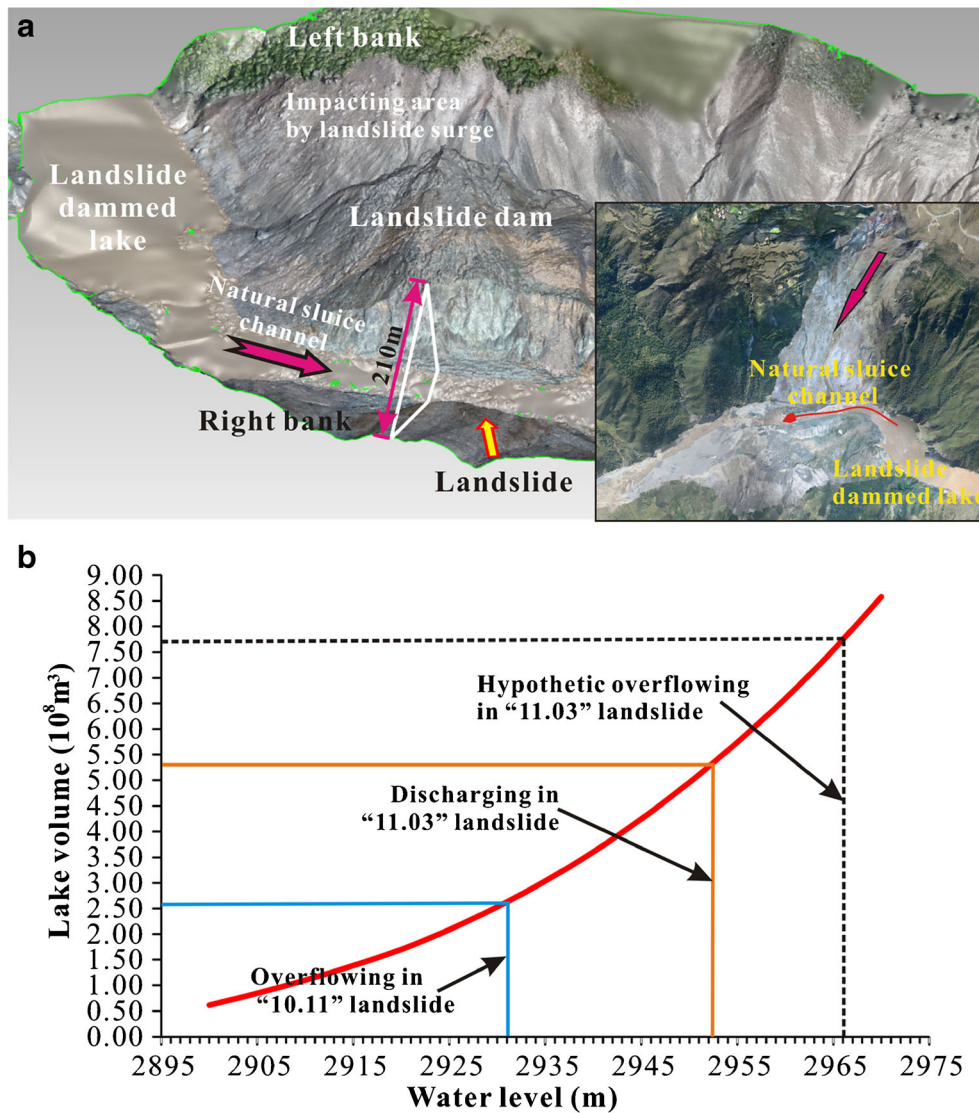
As shown in Fig. 10a, the volume of the landslide dammed lake was estimated to be more than $2.7 \times 10^8 \text{ m}^3$, and the water level rose quickly after the landslide. Approximately $5.04 \times 10^6 \text{ m}^3$ of water flowed into the landslide dammed lake per hour, and the rate of rise in the water level is estimated to be 0.5–0.6 m per h. Fortunately, the sloping shape of the landslide dam provided a favorable condition for natural overflowing. More importantly, the dam break risk was estimated to be low, and no manual intervention was required because of the significant long length and gentle

As shown in Fig. 10a, although the inflow decreased to approximately $2.92 \times 10^6 \text{ m}^3$ per hour and the water level rose by 0.22 m

per hour, the total volume of the landslide dammed lake was greatly enlarged and was estimated to be more than $7.7 \times 10^8 \text{ m}^3$ (water level of 2966 m). The probability of dam failure was particularly high if the water level rose to 2966 m and started overflowing without human intervention. In addition, the submerged range and the economic losses at the upstream and downstream areas would be extremely large. Therefore, a timely and appropriate manual intervention, such as excavating drainage channels to decrease the water level, was necessary and feasible.

Fig. 10 Overflowing characteristics of the Baige landslide dams: a water level-lake capacity curve for the first and second landslide dammed lakes and b geometric information of the spillway

A drainage channel was designed to discharge the lake water at the left bank side of the landslide dam. Until November 10, 2018, a trapezoidal drainage channel was excavated with a length of approximately 200–240 m, a bottom width of 3 m, and an average depth of 13 m (Fig. 8d). The water from the landslide dammed lake started to flow at approximately 10:00 on November 12, 2018. After 55 h of discharge, the water level dropped from the highest elevation of 2956.4 m down to 2898.4 m, and the dam break risk was totally removed.

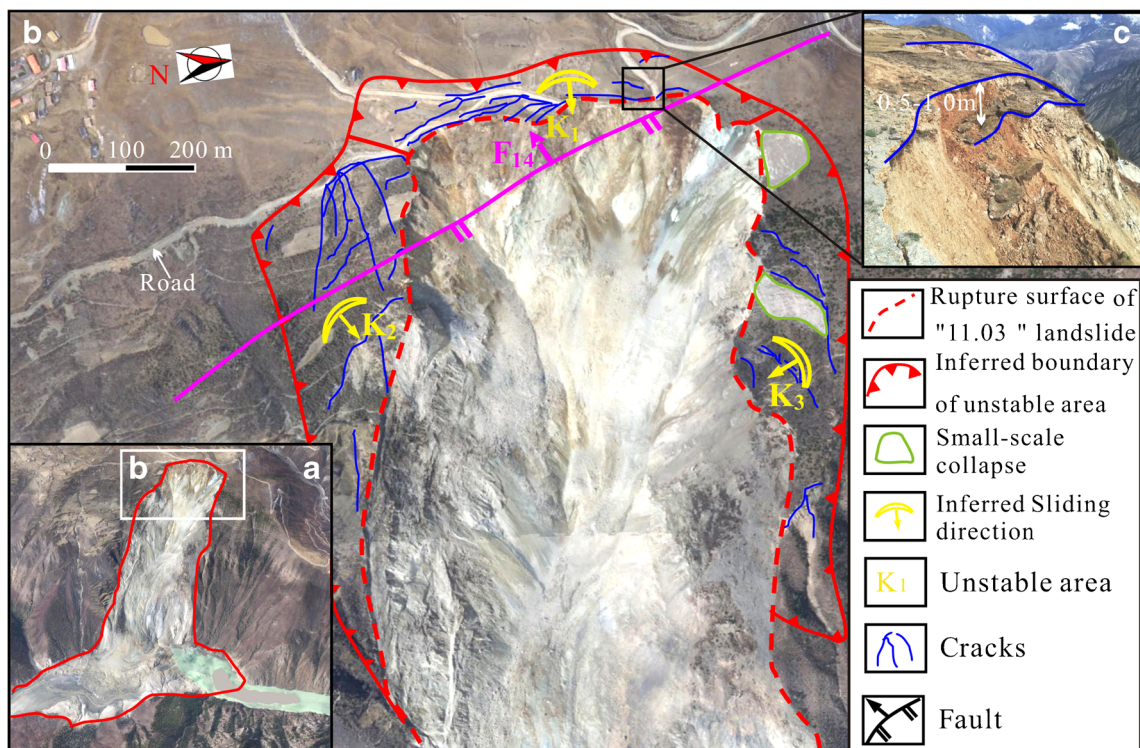
After the second landslide, myriad deep-seated cracks still existed along the back edge of the remnant slope. Due to terrain features and crack distribution characteristics, three potential unstable areas can be identified through the high-resolution 3D image model and field investigation: the K_1 zone, K_2 zone, and K_3 zone (Fig. 11).

The K_1 zone is along the back edge of the remnant slope. This zone has a length of approximately 400 m, a width between 30 and 60 m and a height of approximately 80–100 m, and its volume is estimated to be $1.5 \times 10^6 \text{ m}^3$. The strongly weathered rock mass in this area is broken with poor strength (Fig. 11c). Numerous large cracks can be observed through the high-resolution UAV images, and the majority of them are distributed in nearly south-north directions with steep dip angles. Most of the cracks are open with a

Fig. 11 Potential unstable area distributions on the remnant slope

width of 20–50 cm, a visible depth of 1.0–2.0 m, and a length of 10–100 m. Staggered steps can be obviously observed near the back edge of the remnant slope with a staggered distance of 0.5–1.0 m (Fig. 11c). The K_2 zone is triangle shaped at the south flank of the remnant slope. This zone has an estimated volume of $1.0 \times 10^6 \text{ m}^3$ with a length, width, and thickness of approximately 800 m, 50–200 m, and 50–100 m, respectively. Tens of large open cracks are developed along the lateral edge or along the road at the top of the slope. The K_3 zone lies at the north flank of the remnant slope with an estimated volume of $1.2 \times 10^6 \text{ m}^3$. Several small-scale collapses occurred in this area, and the outcrop rock mass was mainly composed of highly weathered serpentine.

After the first and second landslides, the stress state of the slope changed. During the unloading and stress adjustment process, new cracks emerged and expanded as a result of the shear stress concentration. Due to the gravitational effect, potential unstable areas gradually deformed towards the free surface and, in turn, promoted propagation and opening of the cracks. The continuous development of cracks and fractures at the back edge of the remnant slope had an extremely adverse impact on the stability of potentially unstable areas. Open cracks provided preferential paths for infiltration of water and thus increased the pore water pressure, softened the rock mass, and reduced rock mass mechanical indicators. The risk of potential unstable areas is prominent under unfavorable conditions, such as ice/snow melting, rainstorms, and earthquakes. These conditions pose a significant threat to the spillway of the landslide dam and may block the Jinsha River again. Hence, deformation monitoring and comprehensive treatment measures must be taken to reduce potential secondary disasters.

Thus, the devastating consequences from multiple landslides can be unexpected; timely measures should be carried out to reduce the associate risks, particularly, when the remnant slope is likely to fail again for this case (Fig. 11). For example, manually excavating the dam body and taking advantage of the erosion and transportation features of the flow to carry away the remnant

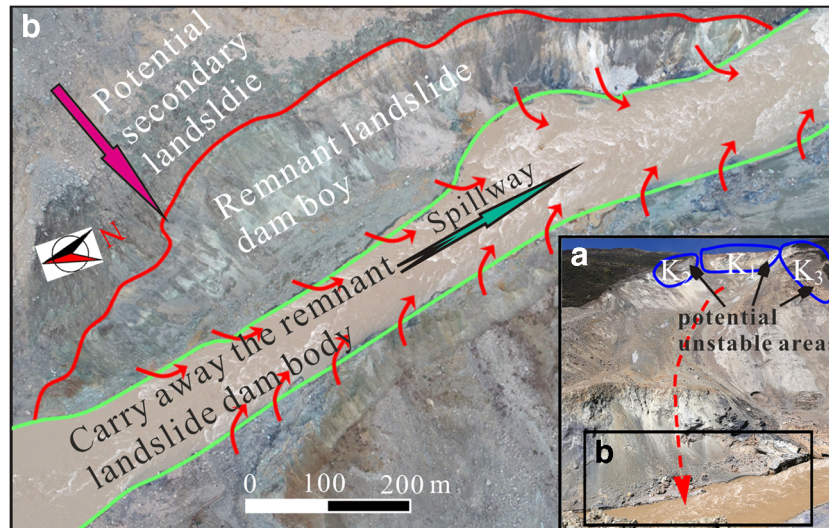
Fig. 12 Method for taking advantage of the erosion and transportation features of the flow to carry away the remnant landslide dam body

landslide dam body should be performed. This can make sufficient space for the mass of a possible third secondary landslide (Fig. 12).
