## Deformation characteristics and failure mechanisms of a rainfall-induced complex landslide in Wanzhou County, Three Gorges Reservoir, China

**Abstract** A rainfall-induced complex landslide occurred on April 4, 2013, in Wanzhou County, Three Gorges Reservoir, China. Approximately  $1.5 \times 10^6$  m<sup>3</sup> of earth and rock mass slid over a distance of ~ 30 m, destroying residential buildings and rural roads. We perform a comprehensive assessment of the cause of this landslide using field surveys, borehole drillings, and interpretations of aerial photographs. This landslide exhibited a complex failure mode in which the upper part of the earth slope first deformed and slid along geotechnical interfaces. This then triggered the slide of the lower part of the flysch bedding rock. In this study, the landslide mass was divided into nine separate blocks considering their internal geological features and movements. The study also shows that antecedent rainfall, in association with the geological and morphological features of the steep slope, the presence of weak interlayers, and human interventions such as slope excavations, jointly caused this disaster. This well-observed even

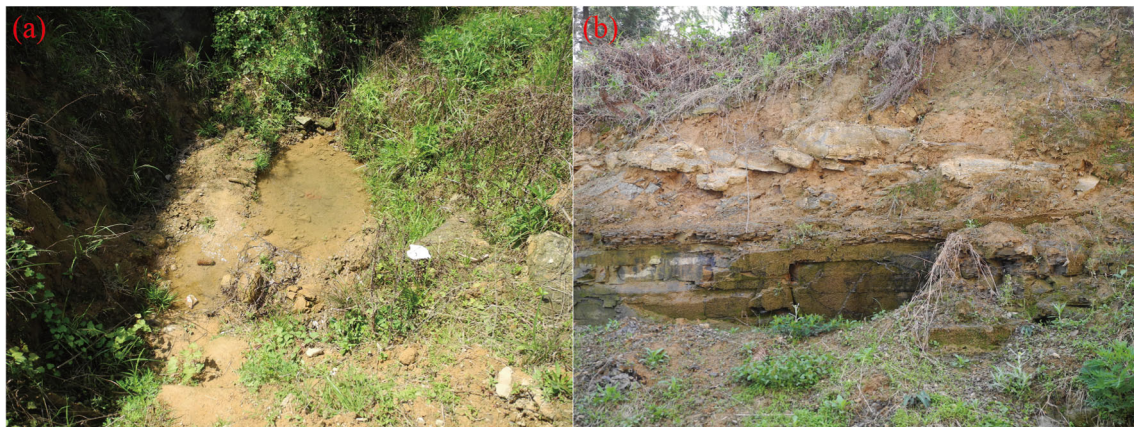
back margin of the landslide and other seeps at the foot of the steep slope at the front edge of the landslide (Fig. 4). Figure 2 shows the locations of the water springs and water seepage.

**Fig. 4** Photographs taken by the authors showing. a Water spring at the back margin of the landslide. b Water seepage at the slope toe (see Fig. 2 for the locations of the photo taken)

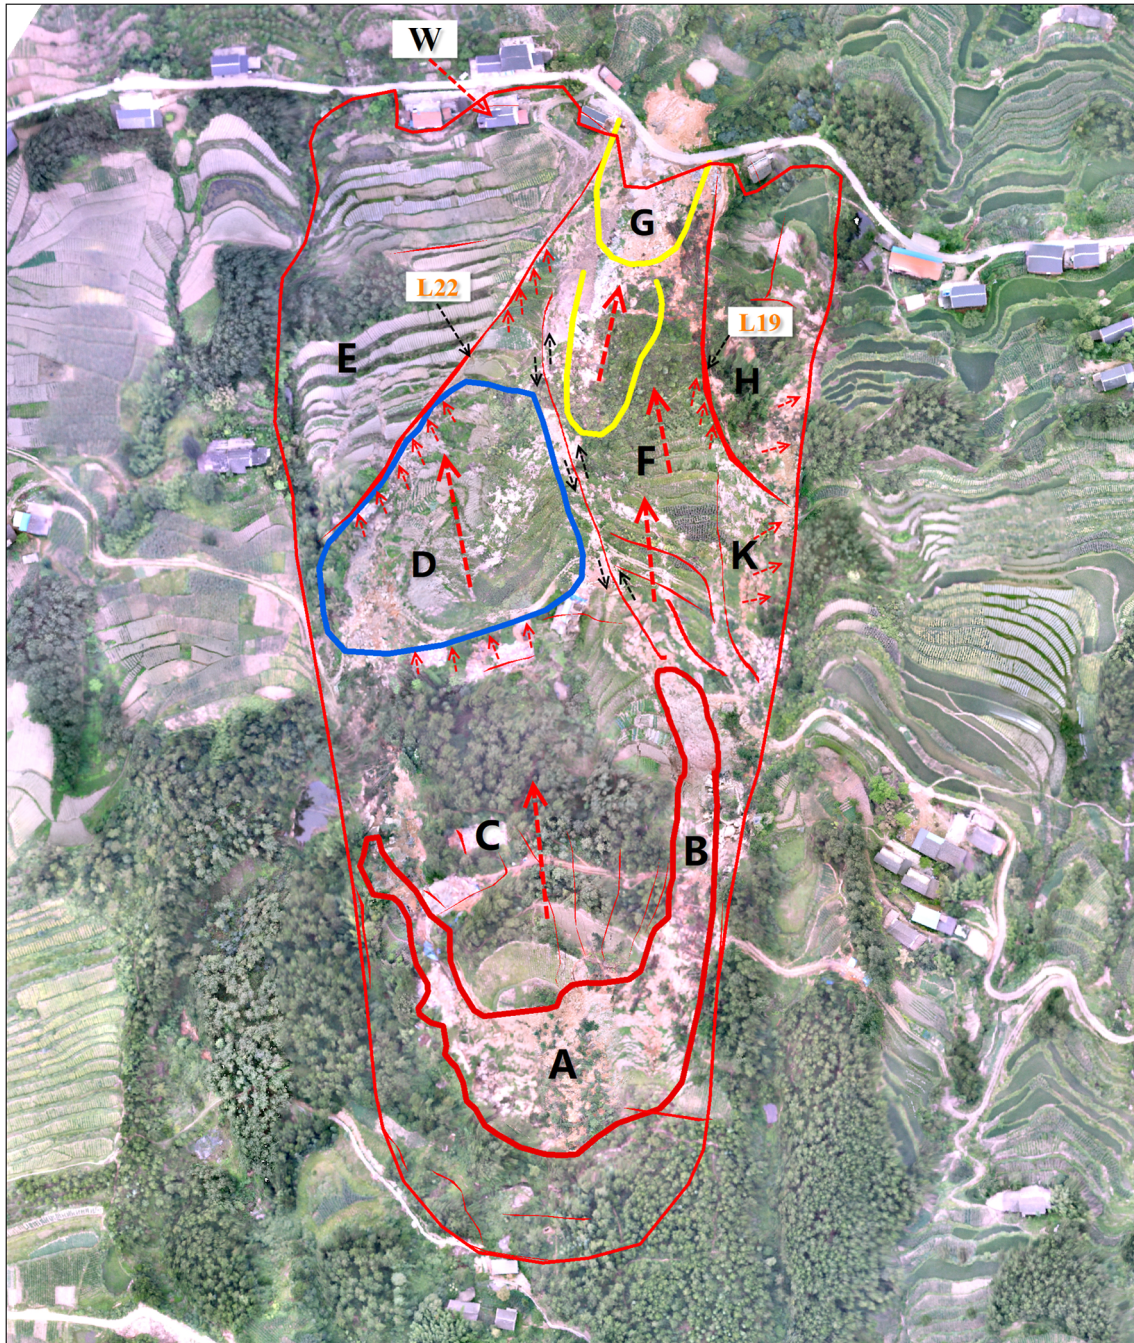
**Fig. 6** Interpretation of the landslide deformation extent based on aerial images. Note the lettering indicates different regions where photographs presented in this paper have been taken (see Figs. 7 and 8)

The ground in the middle of the landslide was blocked by the bedrock at the boundary of fracture L22 (Fig. 6, L22). The landslide

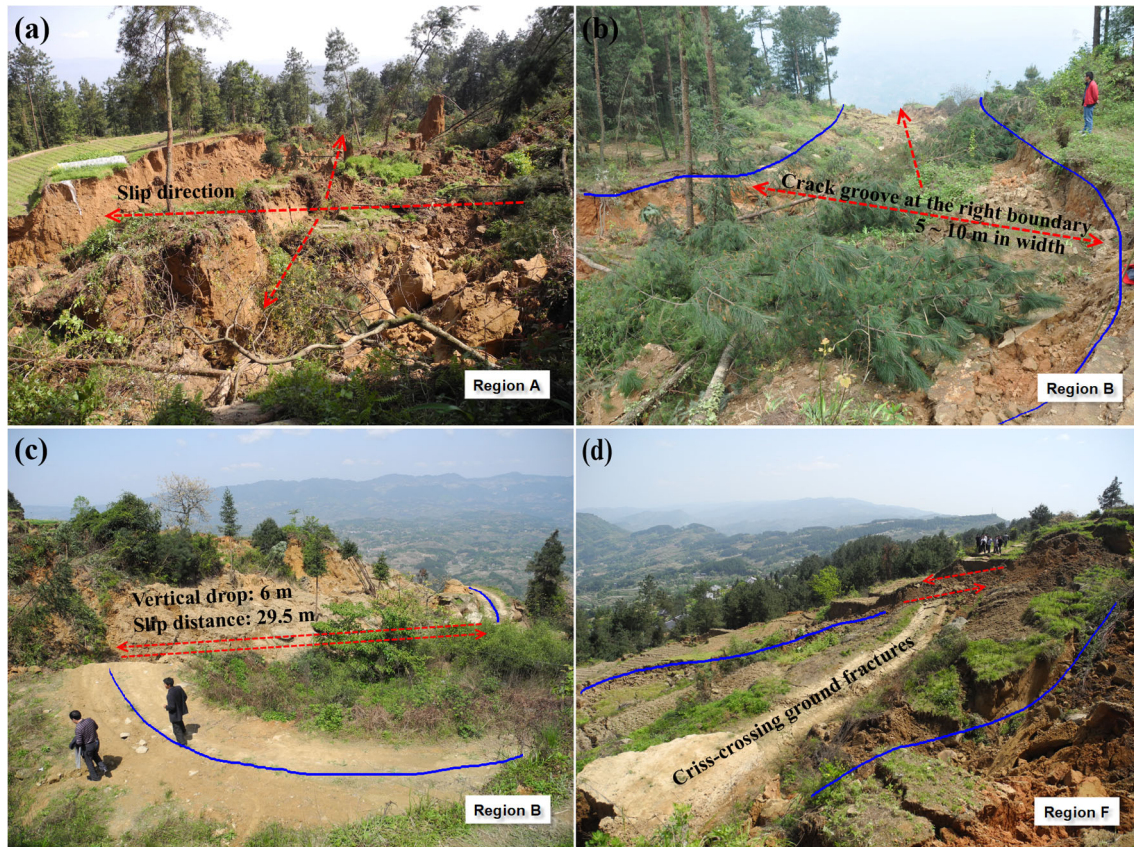
in width, ~ 220 m in longitudinal length, and ~ 5 m in depth (Fig. 7b). Influenced by the two tensile cracks, a rural road along the rear part of the landslide was dislocated downward by a vertical height of approximately 6 m and a distance of about 29.5 m (Fig. 7c). In addition to the large cracking grooves, other ground cracks were generated in the middle part of the landslide, reaching a maximum length of ~ 50 m, a width of ~ 3 m, and a depth of ~ 5 m (Figs. 6, red lines and 7d).

**Fig. 7** Photographs taken by the authors showing the landslide's deformation characteristics. **a** The tensile crack at the back margin of the landslide in region A. **b** The tensile crack at the right-hand side boundary of the landslide in region B. **c** The dislocation downwards of the rural road in region B. **d** Criss-crossing ground fractures that developed in region F. The locations of the photos taken are marked in Fig. 9

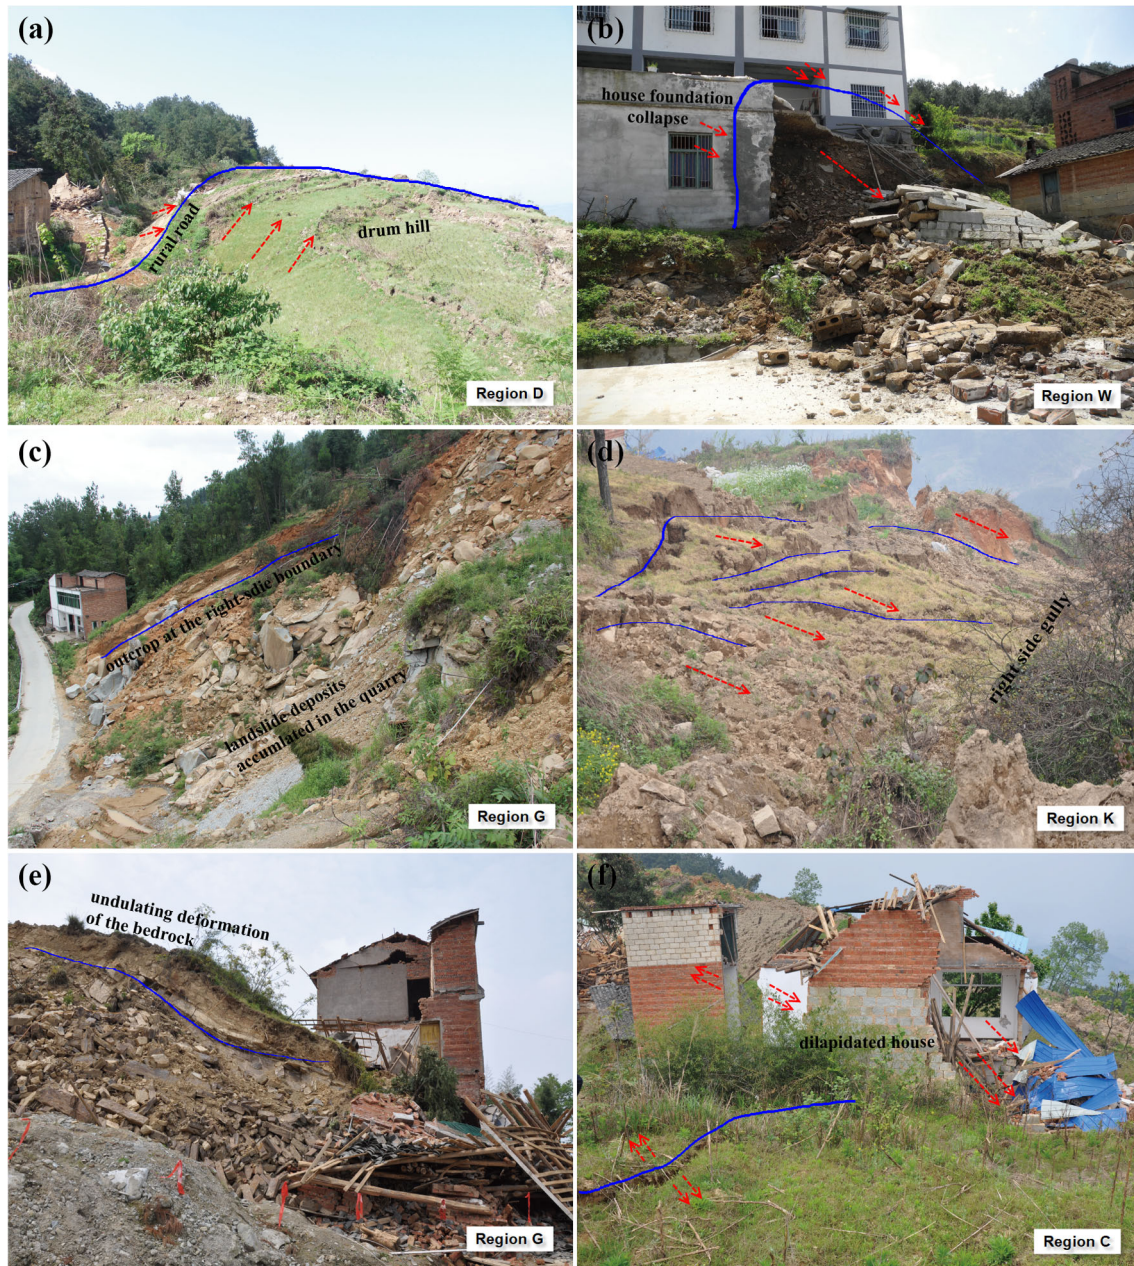
Pushed by the upper-earth slope failure in the back margin, the lower part rock mass (Fig. 6, region F) slid forward along the weak interlayer between the sandstone and the shale located by the borehole data. Controlled and blocked by the structural fracture L19 (Fig. 6), the rock mass with overlaying soil on the middle-right side of region F and K slid towards the quarry and deposited most of its material there (Figs. 6, region G and 8c). The differential movements of the slide in regions D and F produced a long shearing crack between the two regions (Fig. 6). Some of the overlaying soil disintegrated and crashed into the right-side gully (Figs. 6, region K and 8d). With respect to topographic conditions, a small part of the slide overshot the boundary of fracture L19 and accumulated in the weak deformation region H (Fig. 6). The extruding mass movement generated bulging cracks at the landslide toe and squeezed a thin layer of shale at the front, forming an undulating shape (Fig. 8e). The residential buildings on the landslide suffered the most serious damage and some collapsed (Fig. 8f). After the event, the main slope still continuously creeps and

**Fig. 8** Photographs taken by the authors showing the landslide deformation characteristics. **a** The drum mound formed by the landslide's extrusion in region D. **b** The house foundation that collapsed due to the bedrock collision in region W. **c** Landslide deposits in the quarry. **d** Slope deformation in region K. **e** Undulating deformation of the shale rock at the left-side of the landslide toe in region G. **f** Dilapidated houses in the upper part of the slide in region C. The locations of the photos taken are marked in Fig. 9

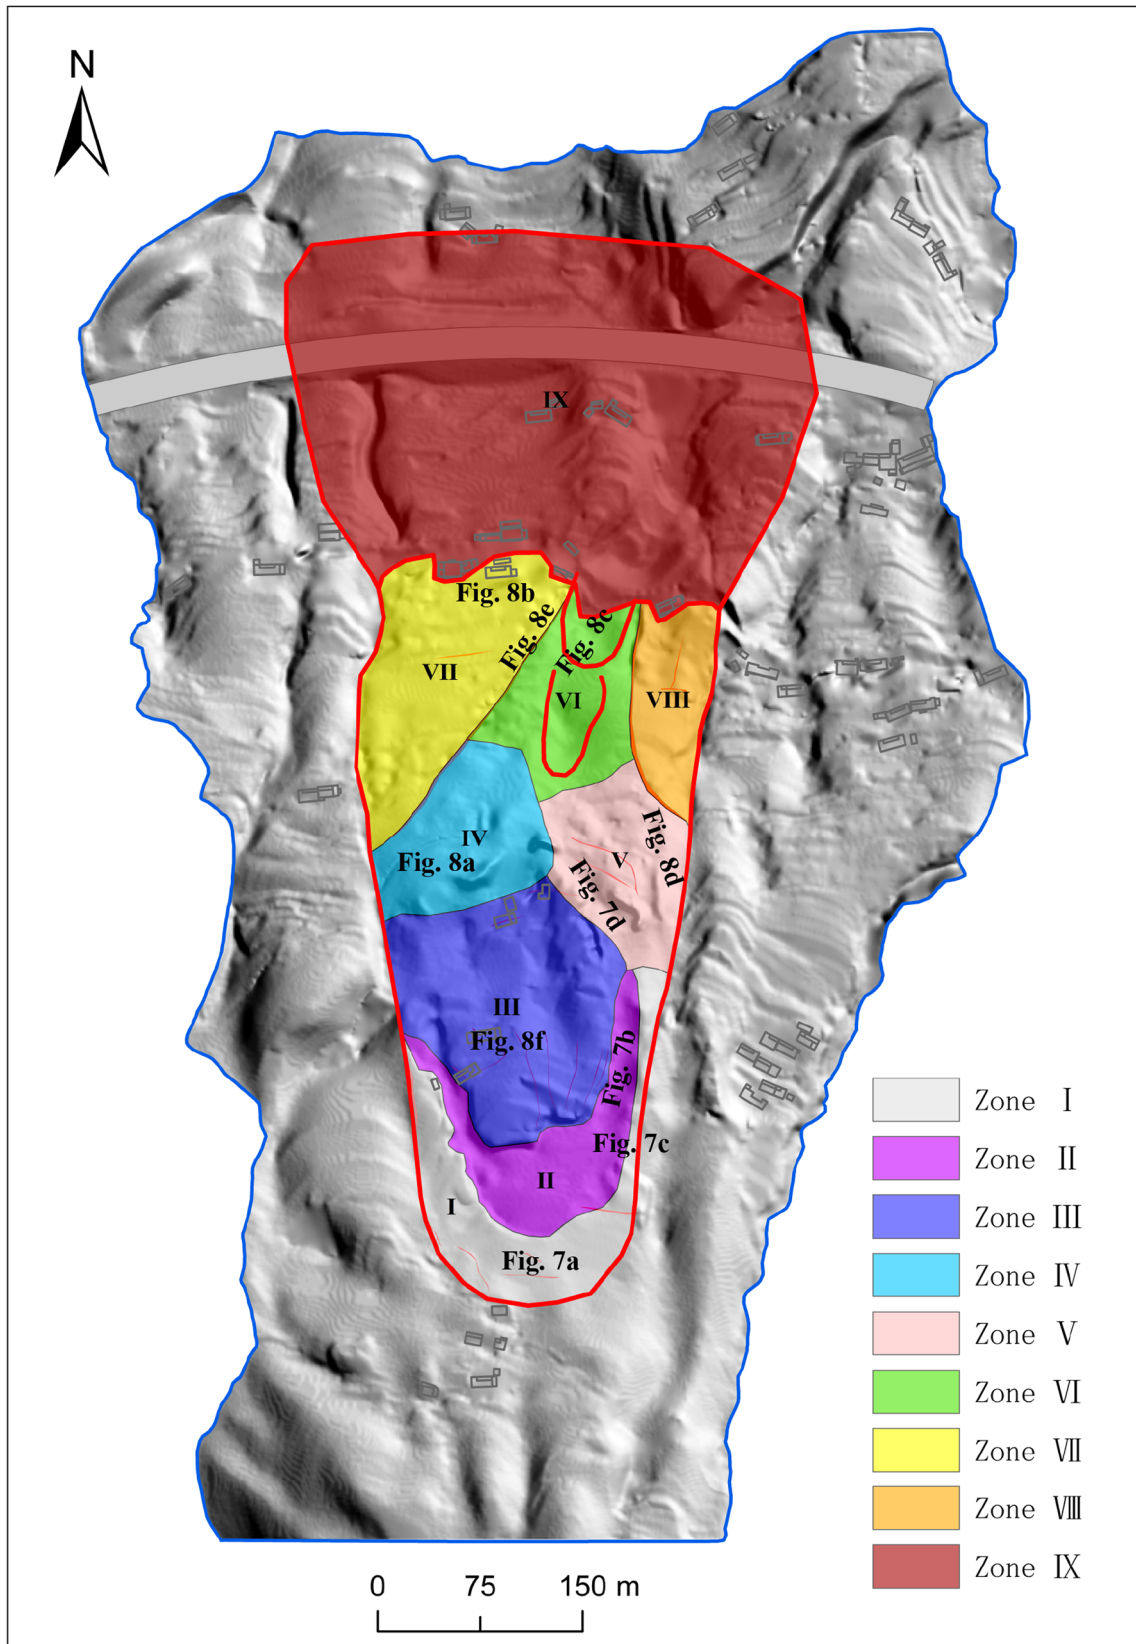
Restricted by the topographic conditions, structural planes, and thickness changes of the weathering layer, the landslide displayed significant disintegration during the sliding. Based on the deformation characteristics described previously and the geological profiles derived from borehole data, the post-landslide area was divided into nine deformation zones (Fig. 9).

The zone of the tensile grooves at the back margin of the landslide (zone I): This area was strongly affected by the deformation of the tensile grooves in zone II and developed a number of cracks due to large displacement earth-slope failure (Fig. 7a). The elevation of this zone at the back margin of the landslide is about 950 m a.s.l. Zone I narrows gradually from the main axis of the landslide towards both sides. The width of the central area is about 30 m. The main cracks strike perpendicular to the main slide direction and parallel to the back scarp of the landslide. Based on the characteristics of the crack width, extension direction, and cutting relation, we believe that this area is still in an unstable state and is likely to develop local collapse.

**Fig. 9** The subdivision of the deformation of the Sunjia landslide. The annotations mark the locations of the photos presented in Figs. 7 and 8

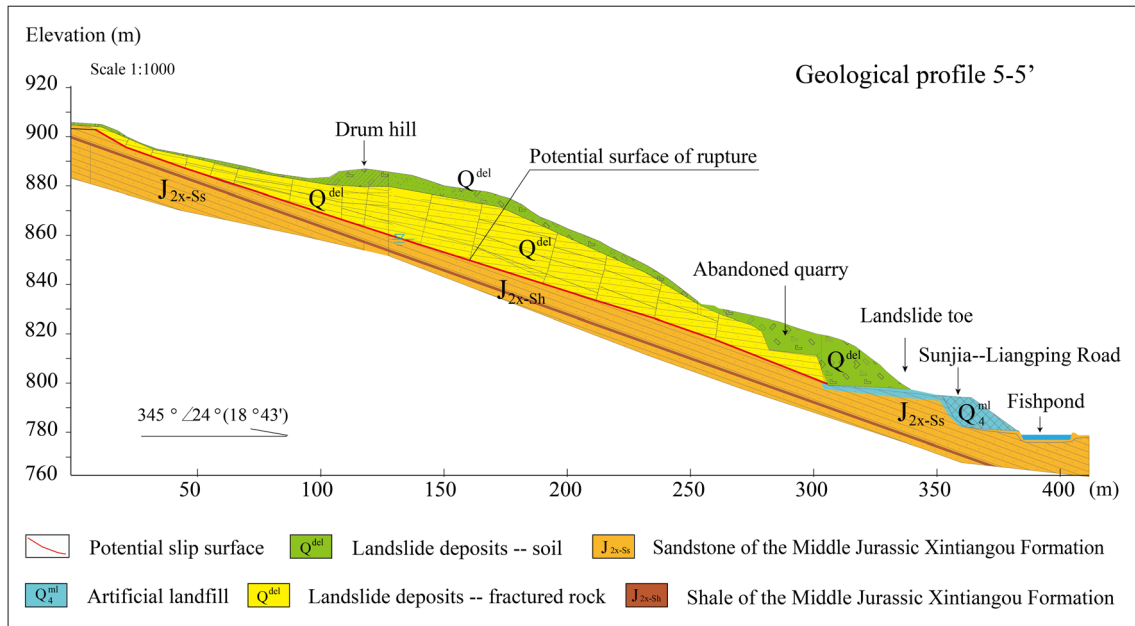
Fig. 10 Geological profile 5-5' (see Fig. 2 for the location of the profile)

Frontal accumulation zone (zone VI): The accumulation area is mainly located in the quarry at the landslide toe (Fig. 10, geological profile 5-5'). A large amount of fractured sandstone and shale mixed with argillaceous siltstone and weathered Quaternary soil were deposited in this area (Fig. 8c). The elevation of the accumulation area is relatively lower than the stable area on both sides, with a stacking thickness of about 20 m (Fig. 11, geological profile 4-4').

Landslide potential threat area (zone IX): We find no evidence of mass deformation and destruction in this area after the slope failure in 2013. According to the borehole data and post-event monitoring, the post-slide deposits with a large volume of broken Quaternary debris show an unstable state. An extreme rainfall event would potentially induce the landslide to slip again, threatening the communities downslope (Fig. 10).

in decreasing the retaining force and driving the slope towards a disequilibrium/unstable state. Pushed by the upper-earth slide, the lower bedding rock slope formed a penetrating shear slip plane at the weak interlayer surface of shale, and quickly transformed into a rock slide (Figs. 10; 11, geological profiles 4-4' and 12b). However, the two well-connected fractures, L19 and L22 (Fig. 6), that developed on each side of the quarry blocked the main rockslide body and resulted in fragmentation of the bedding rock and limited slipping distance (< 10 m) downslope (Fig. 10, geological profiles 5-5').

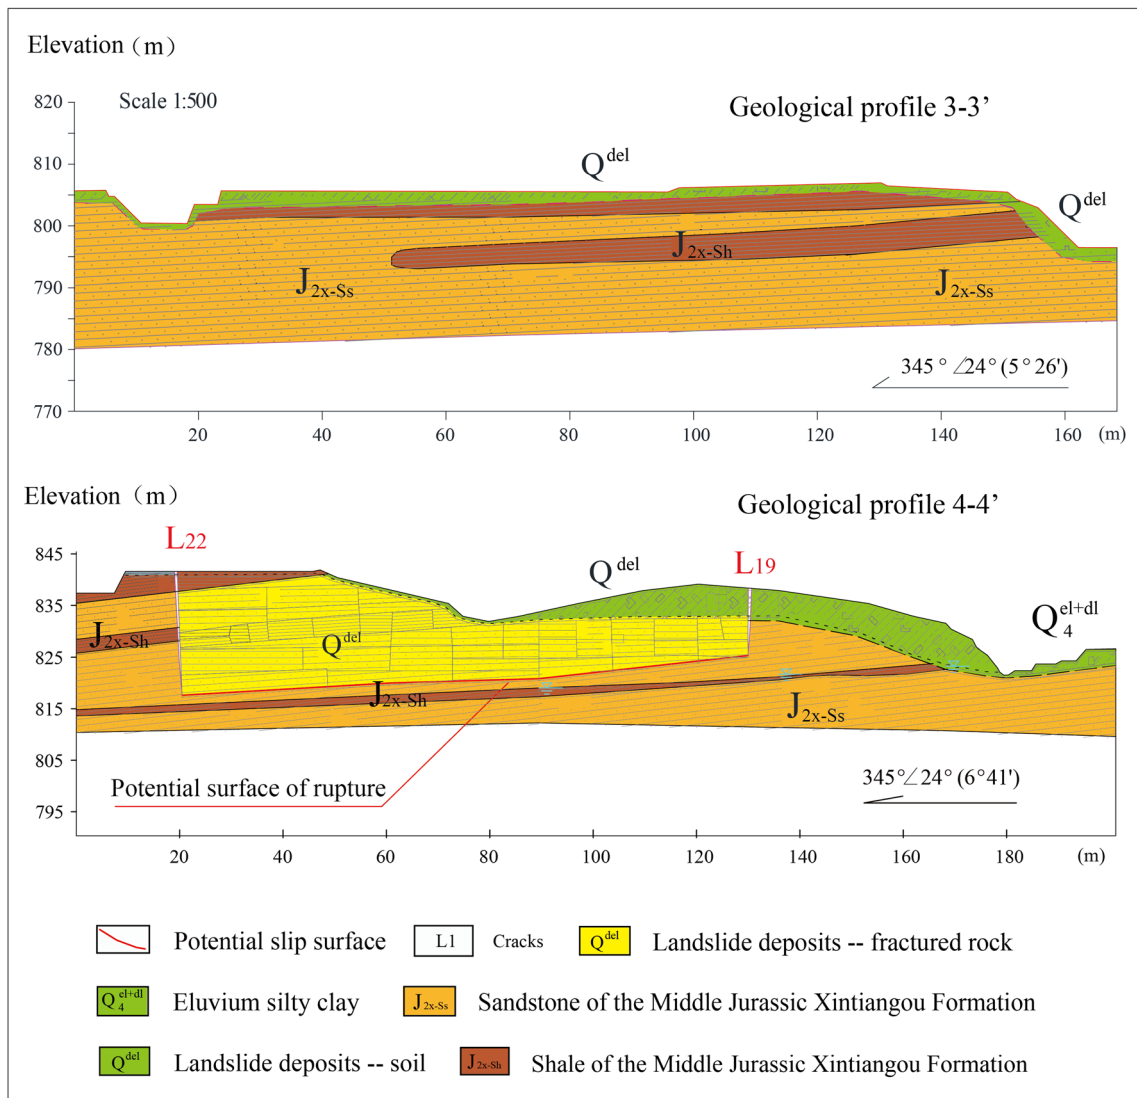
Weak deformation zone (zones VII and VIII): The bedrock in this region is relatively intact (Fig. 11, geological profile 3-3'). Impacted by the thrust nappe area (zones IV and V), the overlaying soil in this zone suffered deformation with sporadic fractures. Due to the steep terrain and intense strike at the thrust nappe zones, some of the Quaternary soil on the surface directly crossed the boundary of fractures L19 and L22 and accumulated on the weak deformation zones (Fig. 6).

**Fig. 11** Geological profiles 3-3' and 4-4' (see Fig. 2 for the profiles' locations)

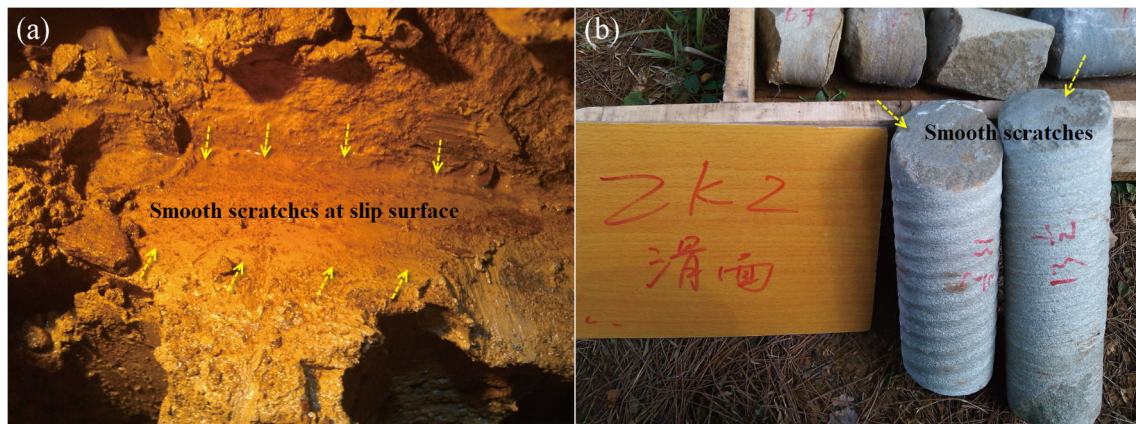
**Fig. 12** Slip surfaces exposed by borehole drilling. a Slip surface of the earth slope. b Slip surface of the bedding rock slope
