Landslides (2020) 17:1935–1949
 DOI 10.1007/s10346-020-01394-7
 Received: 21 January 2020
 Accepted: 11 March 2020
 Published online: 8 April 2020
 © Springer-Verlag GmbH Germany
 part of Springer Nature 2020

Yueping Yin · Bolin Huang · Quan Zhang · Guoqiang Yan · Zhenwei Dai

Research on recently occurred reservoir-induced Kamenziwan rockslide in Three Gorges Reservoir, China

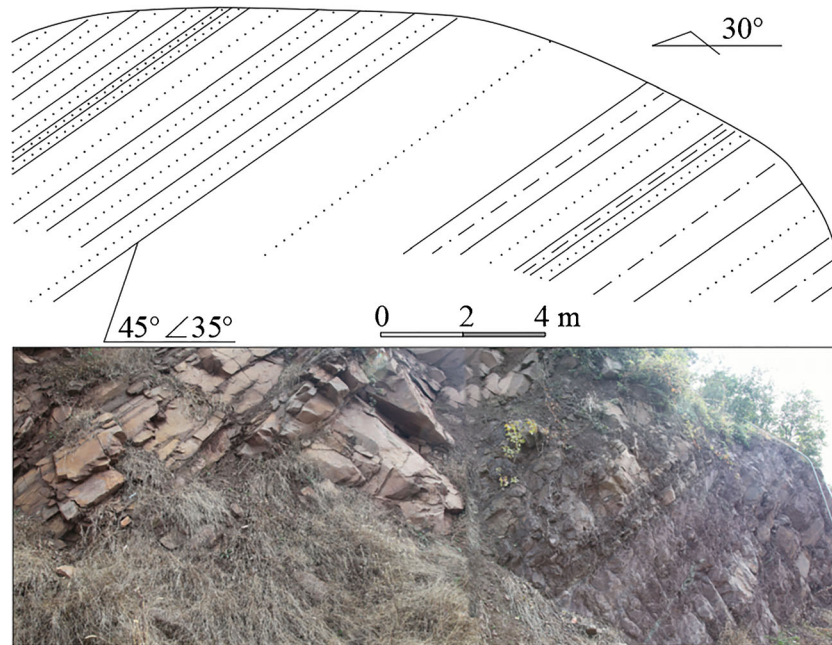
Fig. 3 The outcrop and sketch of sandstone-mudstone of unequal thickness in the same strata as the slide mass. See Fig. 2 for a specific location

mass. The structural planes in group A with an attitude of $270\text{--}290^\circ \angle 50\text{--}70^\circ$ are the major large structural planes. Occasionally, scratches with calcium crystal deposition are presented on this set of structural surfaces, suggesting possible movement occurrence in the slope history. The attitudes of the other two groups of small structural surfaces (group B and group C) were $230\text{--}250^\circ \angle 45\text{--}55^\circ$ and $325\text{--}340^\circ \angle 60\text{--}70^\circ$. Combination of these three groups of structural planes and beddings forms triangular prisms and rectangular columns. On the south of the outcrop, silty mudstone with

unequal thickness is observed; the middle layer of silty mudstone is indistinguishable, which can be crushed by hand and intensively weathered. Additionally, the structural planes of A and B groups are also developed in silty mudstone.

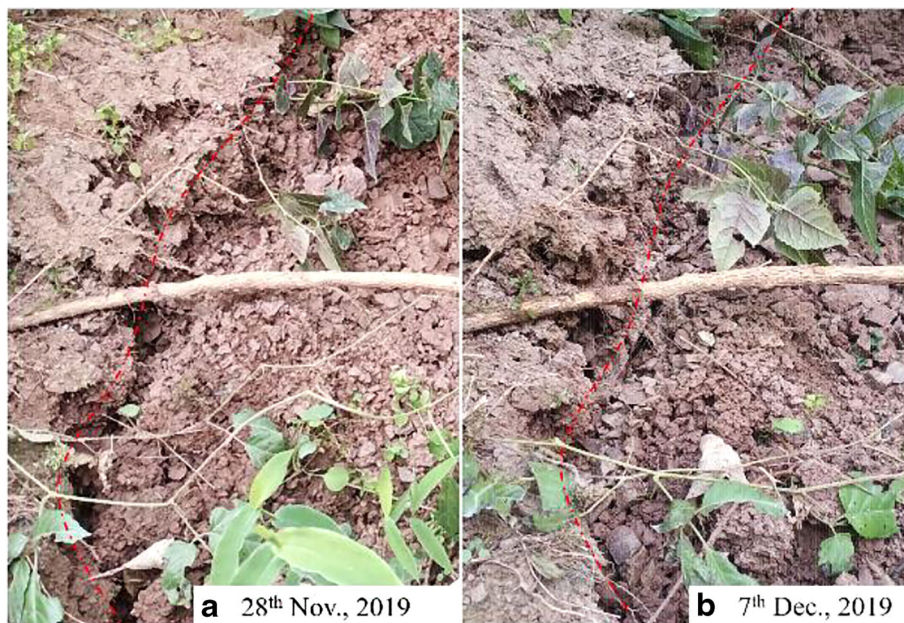
Fig. 4 The crack change in point E on November 28 (a) and December 7 (b). The crack was partially lowered by 5 cm on December 7

On November 28, inspectors found new cracks in another area (i.e. at point E in Fig. 4 a), and on November 29, the slope began to show significant deformation. The slide mass slipped slowly along the silty mudstone (weak plane) for about 20 cm after measured siltstone (Fig. 5), and the sliding direction was nearly consistent

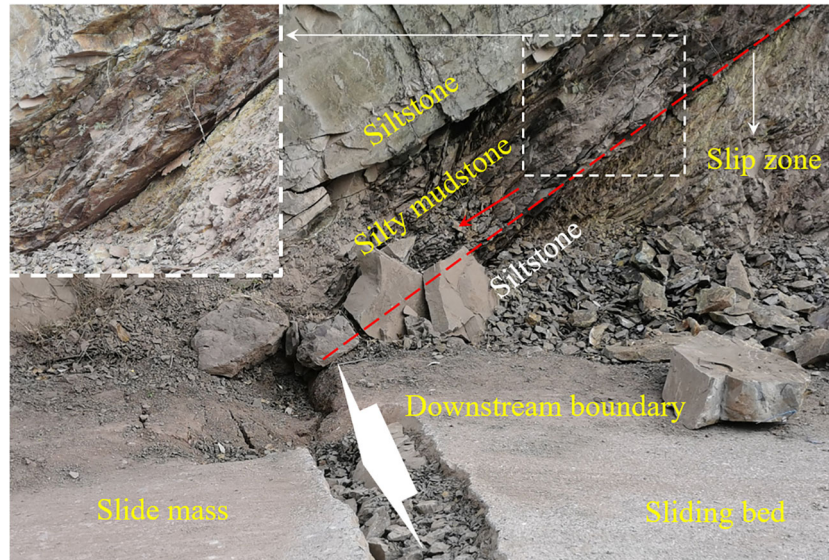
Fig. 5 Photos of the slip phenomenon and boundary cracks caused on November 29, clearly showing the lithology and rock mass structure of some slide mass, slip zone, and sliding bed

with the slope direction (about 340°). After this slip, the leading edge was partially lowered by 5–30 cm, with a crack depth of 1.2 m. A tensile crack appeared at the downstream of the slope, with a strike of 315° and a width of 10–25 cm, and the downstream boundary of the landslide began to form. A near arc tensile crack appeared at the trailing edge of the landslide, with a trend of $150\text{--}225\text{--}275^\circ$ and a width of 5–25 cm, hence, forming the boundary at the trailing edge of the landslide.

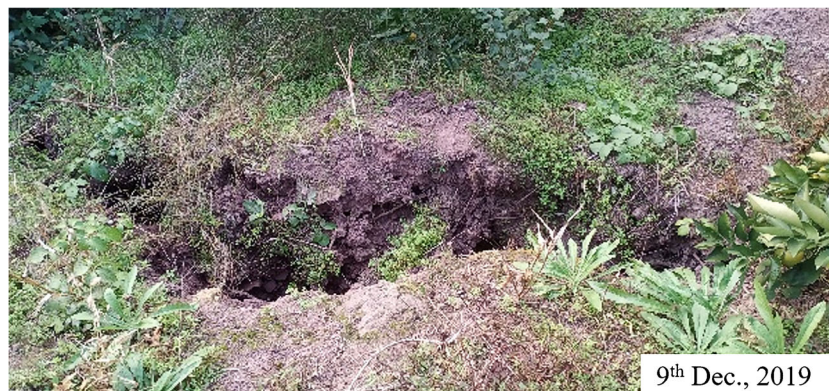
Fig. 6 Photos of transverse cracks in the middle of the slide mass, taken on December 9

On December 9, accelerated deformation of the landslide was observed, where the falling deformation of the trailing edge cracks reached 20 cm, followed by the formation of many transverse cracks in the middle of the slide mass (Fig. 6). The leading edge of the landslide along the river showed swelling, and the crack of downstream boundary increased by about 12 cm. A connection existed between the cracks in the downstream side and the trailing edge of the landslide.

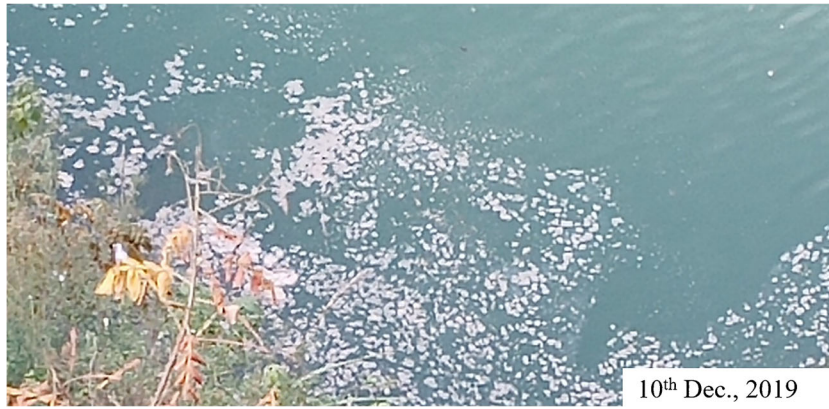
Fig. 7 The water in the river has a lot of foams before sliding on December 10

In the morning of December 10, the upstream boundary of the landslide formed and connected with the crack in the trailing edge. At this stage, the landslide boundary was fully connected. The sandstone cliff re-slipped briefly at a speed of about 0.8 cm/h. At the downstream boundary, the rock mass above the highway kept falling, generating the rock mass friction and fracture sound. The water in the river had a lot of foams, due to the inflow of rocks and the possible inflow of groundwater from the slide mass (Fig. 7). At 16:18, the Kamenziwan landslide began to show overall sliding.

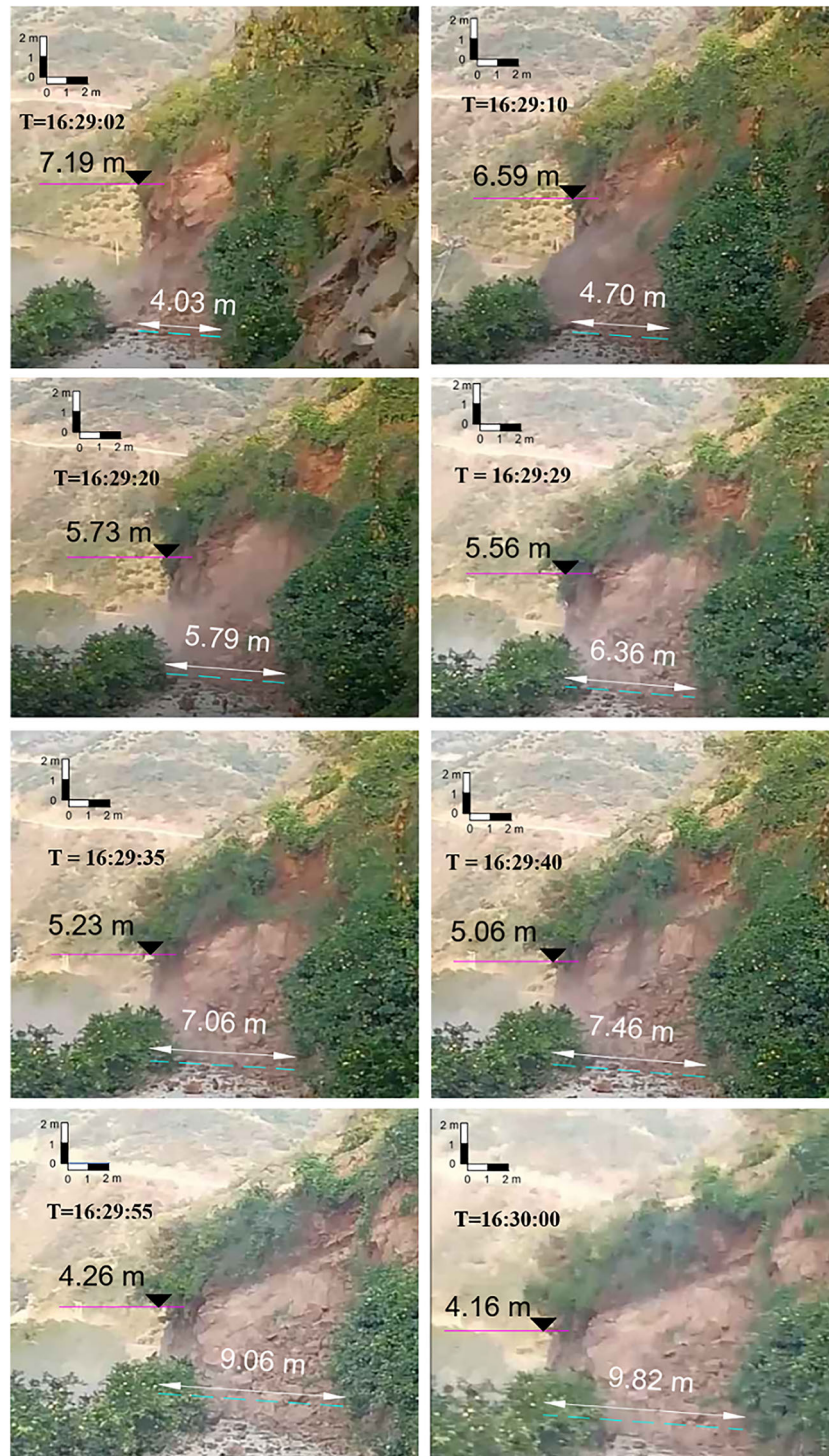
A close monitoring of the process was backed by multiple witnesses and monitors to provide multi-angle and multi-period video shooting of the sliding process. Figure 8 shows the slip moment at the most violent moment of the landslide. In the moving process, the sidewall of the landslide continued to collapse, accompanied by loud rock fractures, collisions, and friction sounds. The surface of the slide mass was constantly pulled apart, drifting dust from the pulled cracks. The leading-edge slide mass pushed the water slowly, and the local rock mass disintegrated into the water, producing waves and shock waves, which turned into the turbid, at a later stage.

Based on Fig. 8, considering the road and sandstone cliff as the reference, the velocity and acceleration of the landslide in the overall sliding can be roughly obtained, using the relation of displacement, velocity, and time in Newton's law (Huang et al. 2012). At about 20 s, the sliding velocity reached its maximum, i.e. about 0.15 m/s (Figs. 9 and 10). During the 58 s, the average velocity of the landslide reached about 0.1 m/s. At about 60 s, the acceleration of landslide reached the maximum, i.e. about 0.1 m/s². From 16:18, the landslide began to move, and the landslide did not slow down until 16:31. Therefore, it can be estimated

that the whole movement time of the landslide was more than 15 min, with the average sliding speed of about 0.02 m/s. According to the Varnes classification, the landslide speed is classified as very rapid (Hungr et al. 2014). Since the movement speed did not exceed 1 m/s, the amount of water, flowing into the landslide, was limited, with no solid impulse wave, consistent with the conclusions of previous studies (Heller et al. 2009).

Fig. 8 Instantaneous photos of lateral motion of the Kamenziwan landslide. The video was filmed at 16:29 (photo taken by local patroller Chen YJ on date)

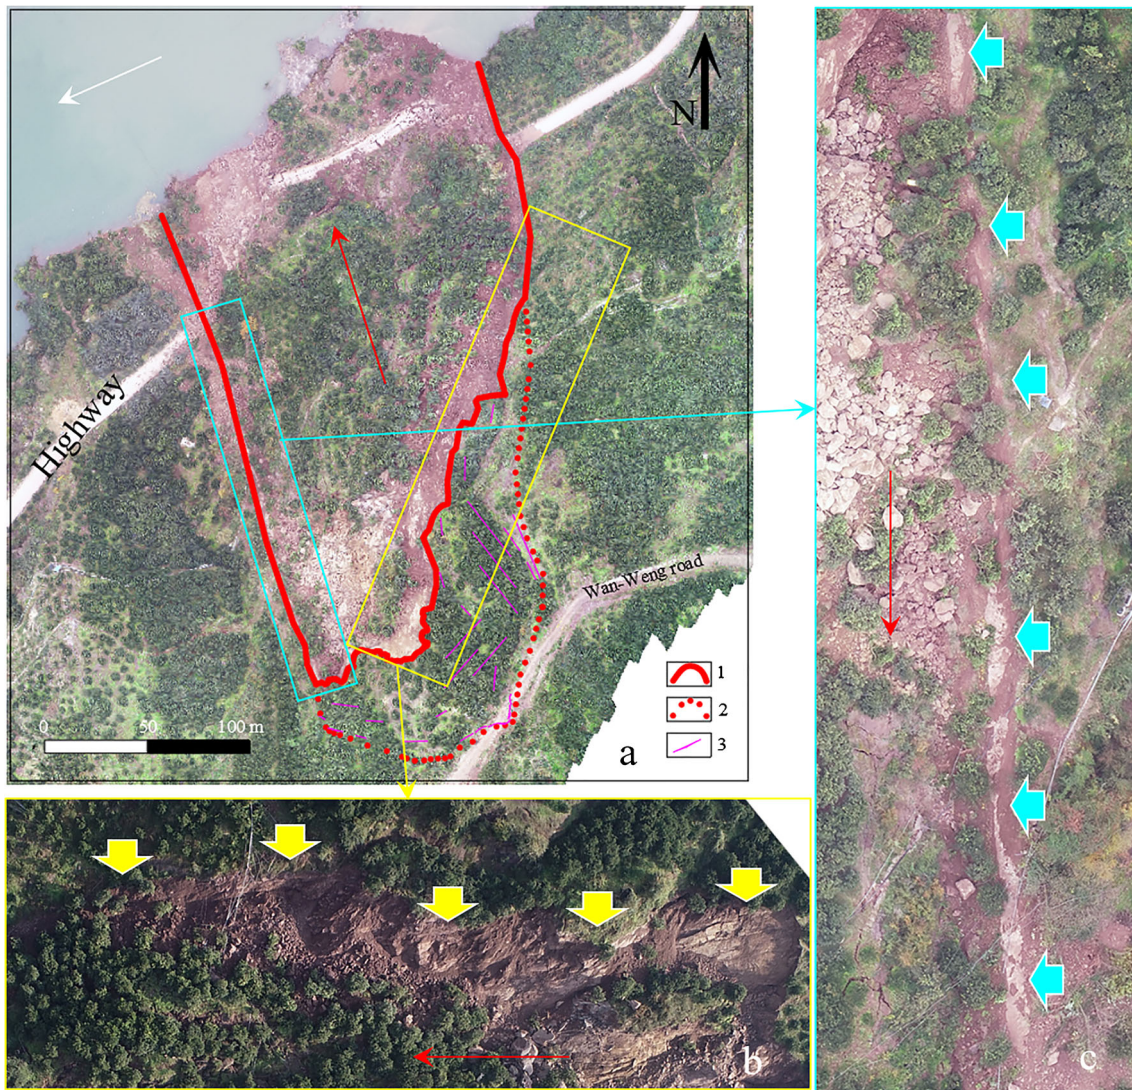
Since the Kamenziwan landslide occurred, a full range of ground surveys and unmanned aerial vehicle (UAV) topographical surveys have been conducted (Fig. 12). A series of structural planes of group A constitute the main rear wall of the landslide and the upstream boundary of the landslide (Fig. 12b). The downstream boundary of the landslide is the sliding bed consisting of sandstone, most of which is exposed after sliding (Fig. 12c). The maximum elevation of the trailing edge of the landslide is 280 m. The

In terms of the landslide images (Fig. 12), in the local area of the trailing edge, the local area of the leading edge, and the shear boundary of both sides, there are loose and overhead stone accumulation, with the internal cracks of the slide mass. However, the overall form of the slide mass remains unchanged, maintaining the roads, trees, and orange trees on the slide mass in their original conditions. This indicates that there is no collision, covering, and

Fig. 12 The UAV images of the Kamenziwan landslide. Red solid line represents the landslide borderline, red dashed line demonstrates the border of retrogressive region, and the magenta lines represent cracks. **a** Shows the crack layout of the whole region and retrogressive region after the landslide. **b** Shows the landslide trailing edge and upstream boundary, and yellow arrows indicate the exposed area of group A structure surface. **c** Shows the sliding bed on the downstream side, and the cyan arrows indicate the exposed area of the same siltstone bedding

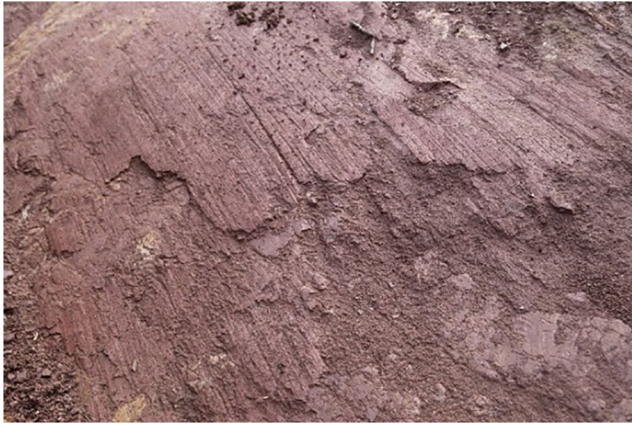
Fig. 13 The remaining fuchsia slip zone on the sliding bed-yellow sandstone surface, with a large area of polished surface and striated scratches on the slip zone (photo taken by Bolin Huang after failed)

The slip zone is considered an important key factor for landslide. The slip zone in Kamenziwan landslide consists of fuchsia clay. Based on the scanning electron microscopy (SEM) images (Fig. 24) and X-ray diffraction (XRD) analyses, the slip zone mainly consists of quartz and montmorillonite. Montmorillonite has strong swelling and water absorption capability, which resulted in the characteristics of easy sludge and softening. The presence of these types of minerals in the slip zone makes it more susceptible to landslide.

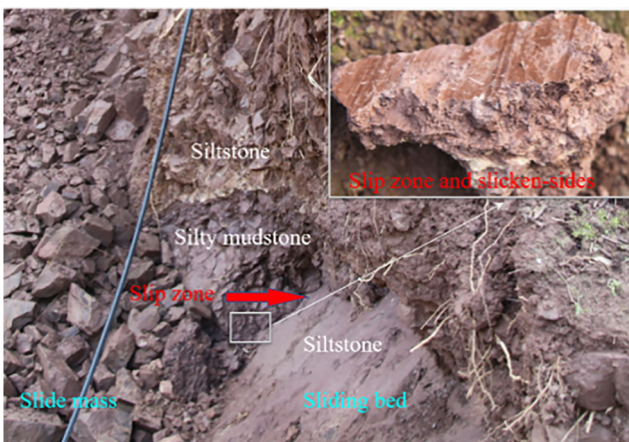
Fig. 14 Photos of slide mass, slip zone, and sliding bed in the trailing edge. Right-upper map is the photo of slip zone, with a large area of polished surface and striated scratches (photo taken by Bolin Huang after failed)

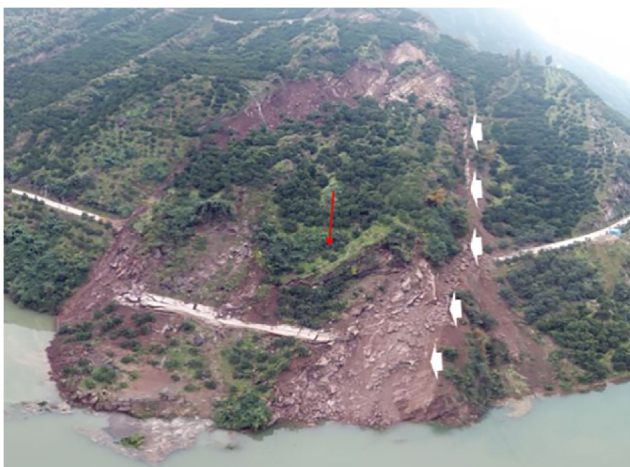
Fig. 17 The full-face photo of the Kamenziwan landslide. The white arrows indicate the position of the slide bed, suggesting that the landslide shear outlet is near 174 m

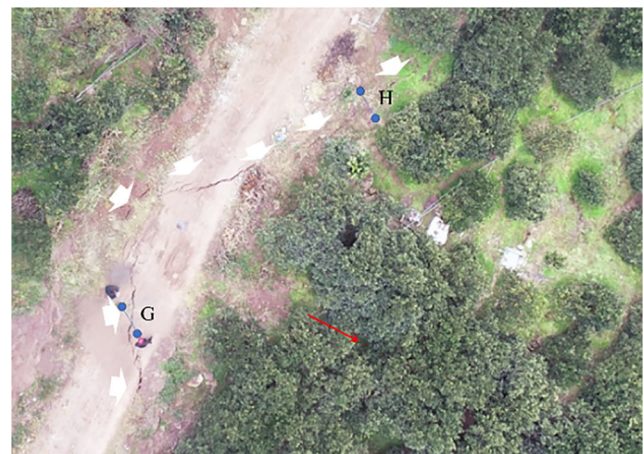
After the overall sliding, the retrogressive zone is formed, where a large number of cracks are developed (Fig. 11). The highest crack is located on the Wan-Weng road, extending in a series of en echelon (Fig. 18). After the landslide, the retrogressive zone has experienced deformation. Until 1 p.m. on December 20, the crack has a maximum width of about 15 cm and a subsidence of about 18 cm. The retrogressive zone is determined by the boundary of the crack development zone (detailed region seen in Figs. 2 and 12). The area of the retrogressive zone is $0.6 \times 10^4 \text{ m}^2$, and the corresponding volume is about $12 \times 10^4 \text{ m}^3$, when calculated at an average thickness of 20 m.

Fig. 18 Retrogressive zone photo. The crack on the left side extends very long, about 15 m, and the crack on the right side is only visible on the road surface. G and H are the measuring points of crack relative displacement

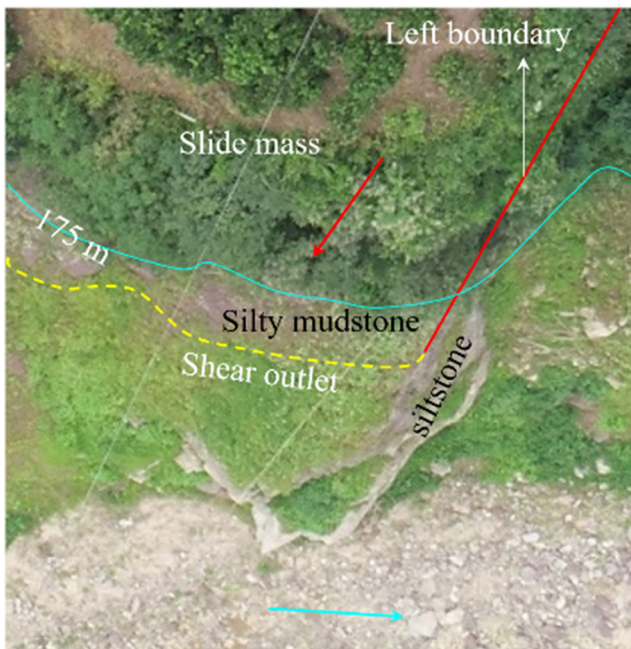
It is significant to explore the damage mechanism of the leading edge in Kamenziwan landslide. Figure 23 shows the leading-edge photo of the landslide in July 2019, suggesting that siltstone and mudstone (slip zone) are exposed below 175 m asl. In terms of micro-geomorphology, a small “sea cliff” is formed above 175 m. Below the elevation of 175 m, the strata above the sandstone in sliding bed are eroded, completely. The erosion of rock mass causes the landslide to lose a key anti-slide section, exposing the slip zone to form shear outlet. The elevation of 145 to 175 m corresponds to the water level fluctuation zone of the Three Gorges Reservoir, where periodic changes in the surface water level cause periodic changes in the groundwater level. Generally speaking, the groundwater fluctuation zone, caused by reservoir water fluctuation, is mainly concentrated in the middle-lower part of the slide mass (Tang et al. 2019; Yin et al. 2016; Xia et al. 2013; He et al. 2010).

Fig. 23 Photo of the water level fluctuation zone before the Kamenziwan landslide (July 10, 2019)

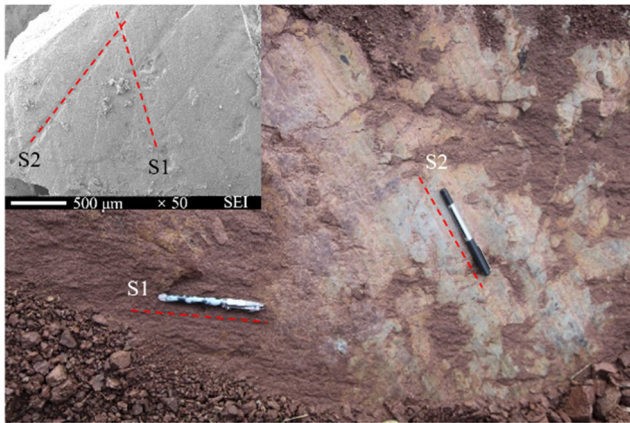
Field investigation shows that multiple movements have occurred along the slip zone. After a careful cleaning of the downstream part of the slip zone, two different sets of scratches were observed on the sliding bed (Fig. 25). Group S1 corresponds to the direction of the landslide movement, with a strike of about 340°, and the strike of group S2 is about the true tendency of rock strata,

which is 40°. This means that the slope has been creeping along this “slip zone”, towards the true tendency in the early stages. In other words, the formation of the slip zone can be related to the early movement. The movement is probably tectonic movement, causing the weak layer to form an interlayer shear zone (Wang et al. 2004), which then evolves into the slip zone (Li et al. 2007). After 175-m impoundment, the degradation of rock mass in water level fluctuation zone accelerates the evolution of weak layer to the slip zone.

Fig. 25 Two sets of scratches on the yellow slide bed. The direction of the pen indicates the direction of the two groups of scratches
