Emergency response to the reactivated Aniangzhai landslide resulting from a rainstorm-triggered debris flow, Sichuan Province, China

Keywords Reactivated Aniangzhai landslide · Rainstorm · Debris flow · Emergency monitoring

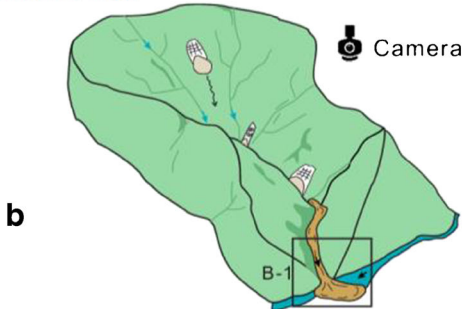
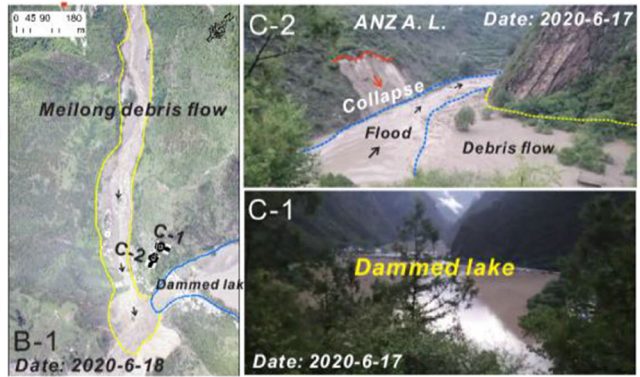
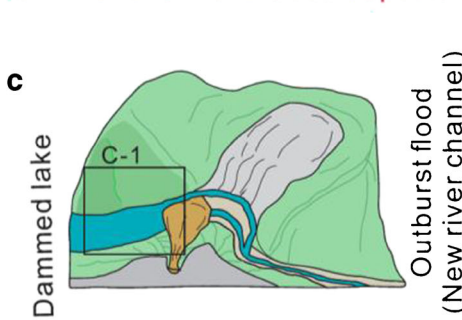
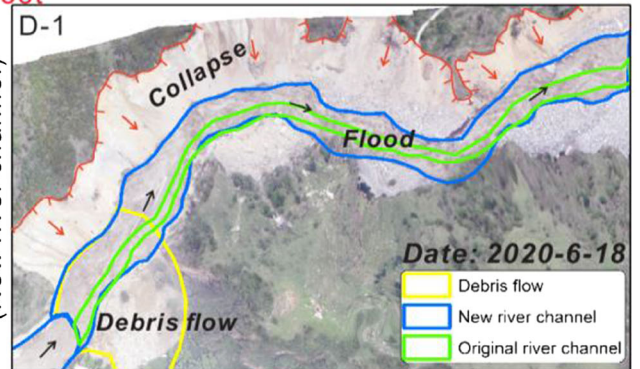
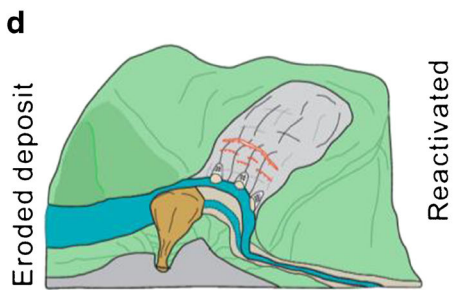
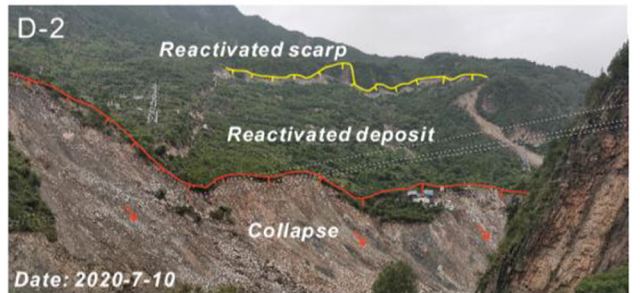
Fig. 5 The evolution process of the reactivated ANZ landslide. (A–D) Sketches of the evolution process along with field and UAV images. (A) The unexpected rainstorm; (B, B-1) the typical characteristics of the Meilong debris flow; (C, C-1 and C-2) the dammed lake and the new river channel; (D, D-1 and D-2) the front collapses of the ancient ANZ landslide (D-1) and the overall area of reactivated landslide (D, D-2). The photos in (C-1) and (C-2) were taken on June 17, 2020 by local residents

The short, intense rainstorm (Fig. 5(A)) activated the deposits accumulated in the gully (Fig. 5(B)). At approximately 3:00 am on June 17, the Meilong debris flow occurred. The debris flow lasted approximately 3–4 h. The debris flow rushed out of the Meilong valley into the XJC River and partially blocked the river (Fig. 5(B-1)), and a dammed lake was formed (Fig. 5(C and C-1)). The images pre- and post-Meilong debris flow indicate that the deposits covered the

The fast-moving debris flow rushed into the XJC River (Fig. 5(C and C-2)), raised the riverbed by approximately 8–12 m, and formed a dammed lake (Fig. 5(C-1)). On the morning of June 17, the river overflowed the front section of the deposit and formed a new river channel (Fig. 5(C-2)), and this new channel lay at the foot of the ancient ANZ landslide (Fig. 5(D and D-1)). The new river channel intensely eroded the foot of the ancient ANZ landslide, and some collapses occurred on the morning of June 17th (Fig. 5(C-2)). On June 18, the whole front collapsed (Fig. 5(D-1)), and the ancient ANZ landslide was reactivated (Fig. 5(D and D-2)). The images of ancient ANZ landslide before and after the Meilong debris flow indicate that obvious deformation began to appear throughout the reactivated area covering an area of 0.62 km² (Fig. 7).

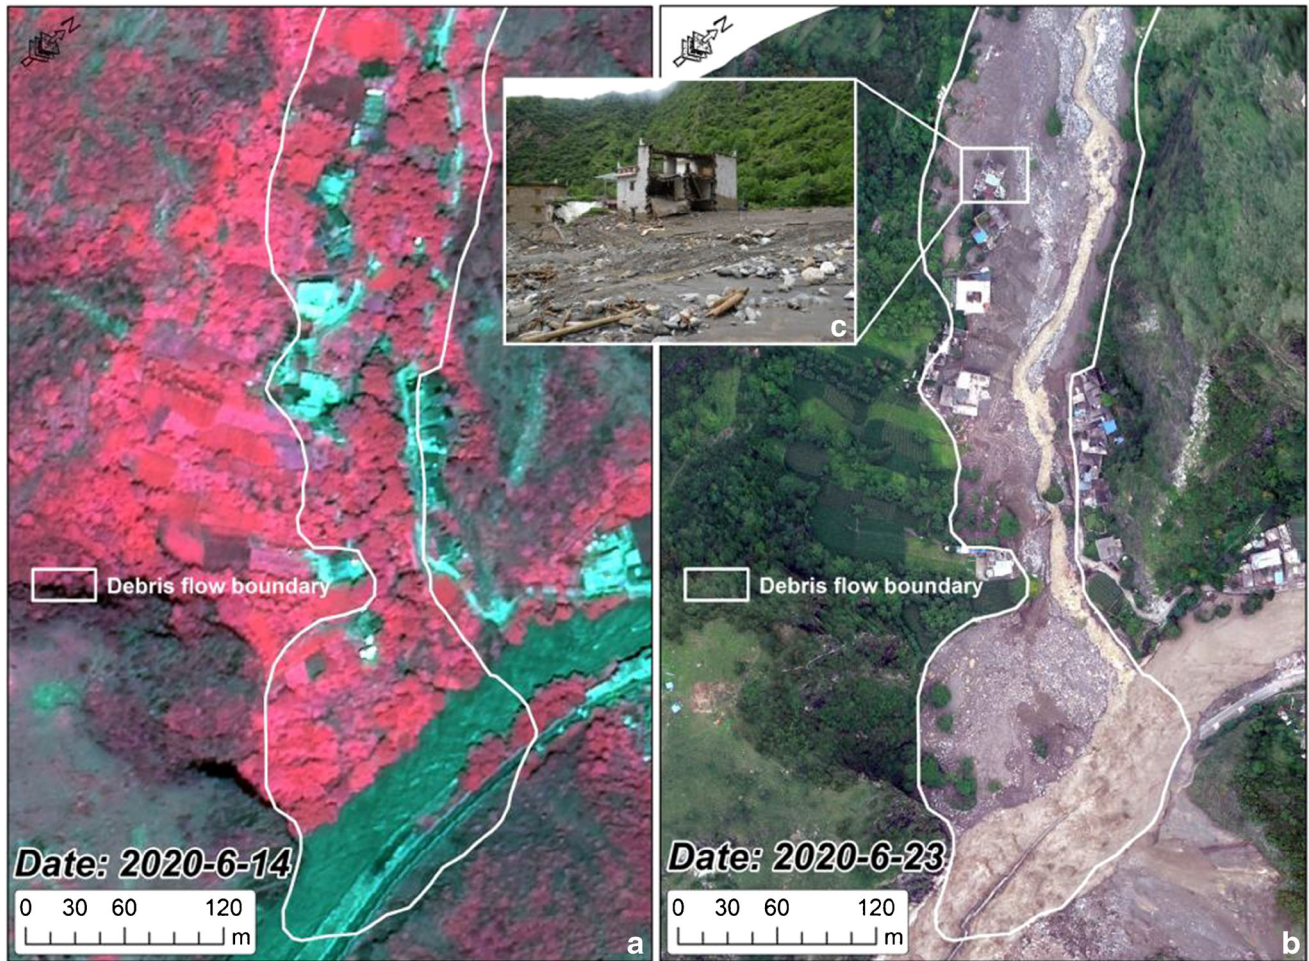
Fig. 6 Typical characteristics of the Meilong debris flow. (A and B) Images before (satellite image) and after (UAV image) the Meilong debris flow. (C) Buildings were damaged by debris flow

whole gully bottom, with widths ranging from 20 to 80 m, and that some buildings were damaged (Fig. 6). The depth and volume of the Meilong debris flow were 6–12 m and 0.4 Mm³, respectively, according to field investigations.

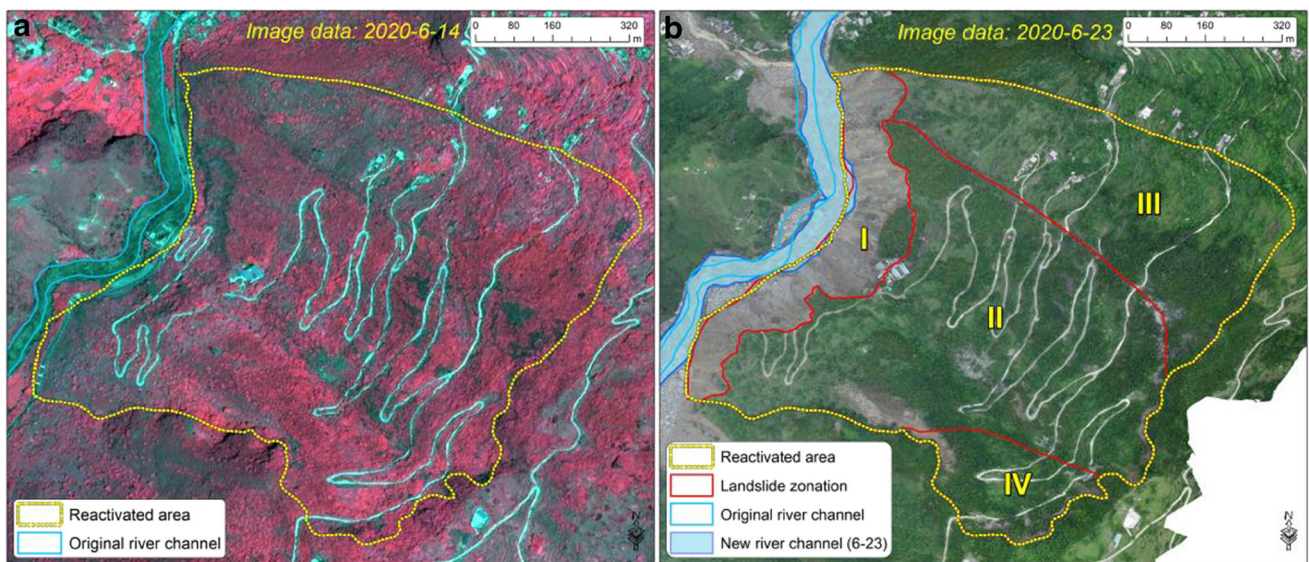
Fig. 7 Images of the ancient ANZ landslide before and after the Meilong debris flow indicate that the ancient ANZ landslide was reactivated. a Satellite image before the Meilong debris flow. b UAV image after the Meilong debris flow. The satellite image is from Gaofen-2

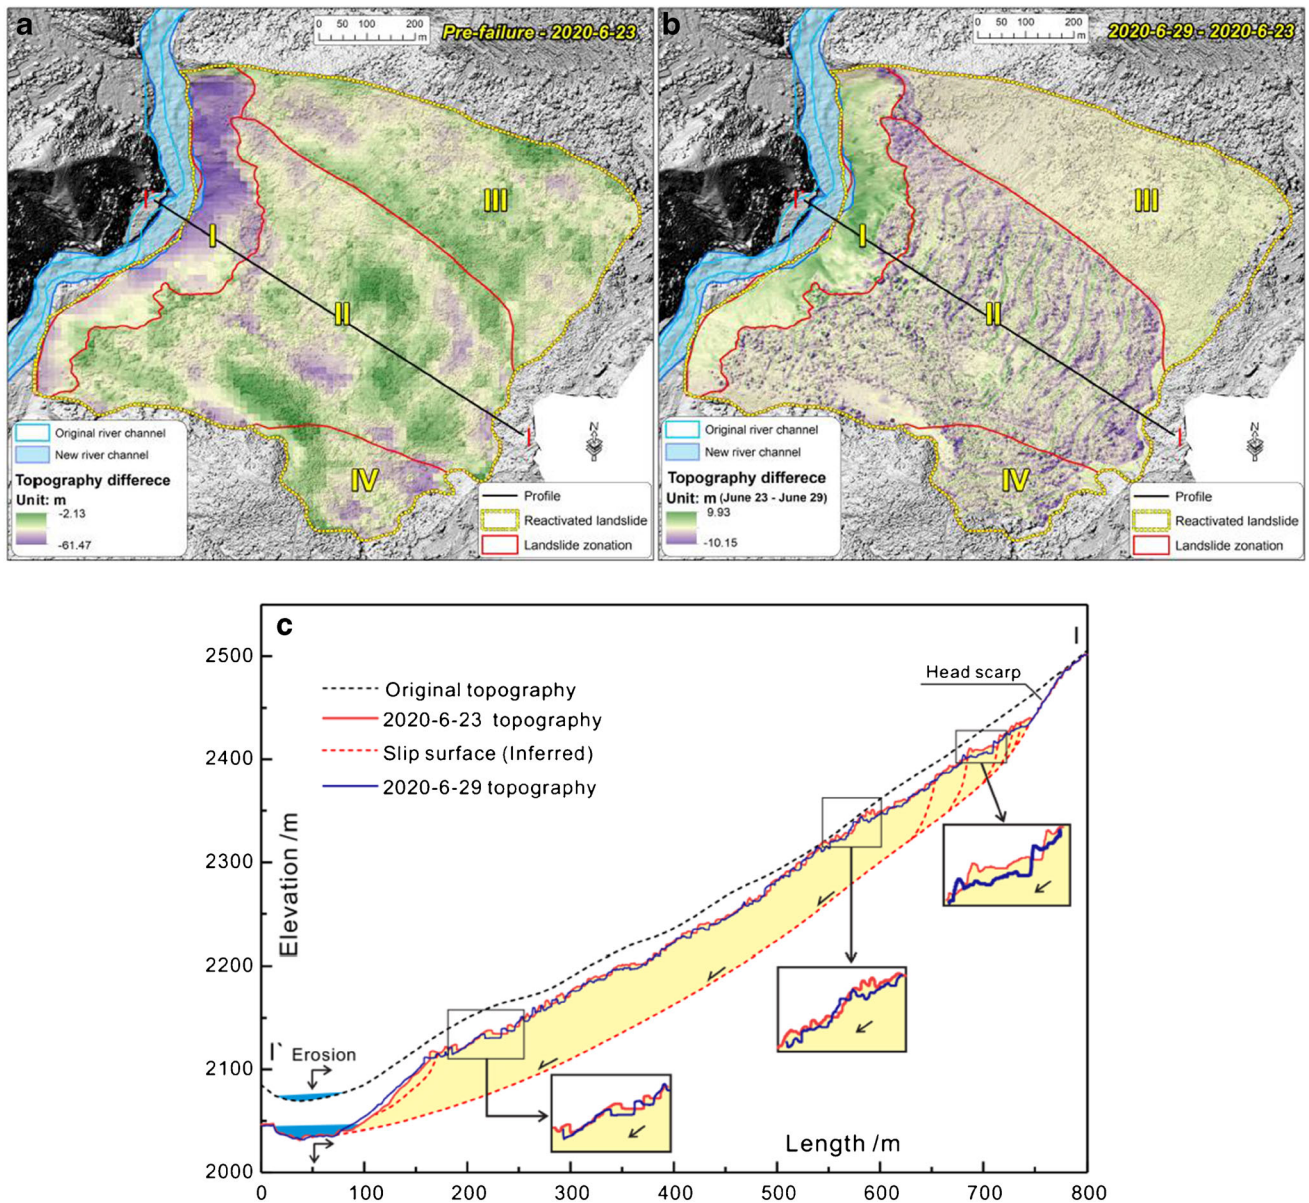
Fig. 8 The topographic variations between different periods. **a** The topographic difference between the June 29, 2020 topography and the original topography. **b** The topographic difference between June 29, 2020 and June 23, 2020. **c** The profile variations of different periods. The slip surface was inferred from microtopography variation, outcrops of existed slipping surface and potential surface rupture

To detect the basic deformation of the reactivated area, two topographic difference maps before and after reactivation and in different periods after reactivation are depicted (Fig. 8a, b), and the profile variations of different periods were also obtained (Fig. 8c). From the topographic difference map before and after reactivation (Fig. 8a), the whole reactivated area underwent obvious deformation, especially in the front section where maximum elevation change reached approximately 61.5 m.

From the topographic difference of different periods after reactivation (June 23, 2020–June 29, 2020), topographic growth appears in the front section, while topographic reduction mainly

appears in the middle and rear sections (Fig. 8b). The reactivated landslide slipped downward as a whole because the movement did not change the microtopography but, rather, the relative positions of the points (Fig. 8c).

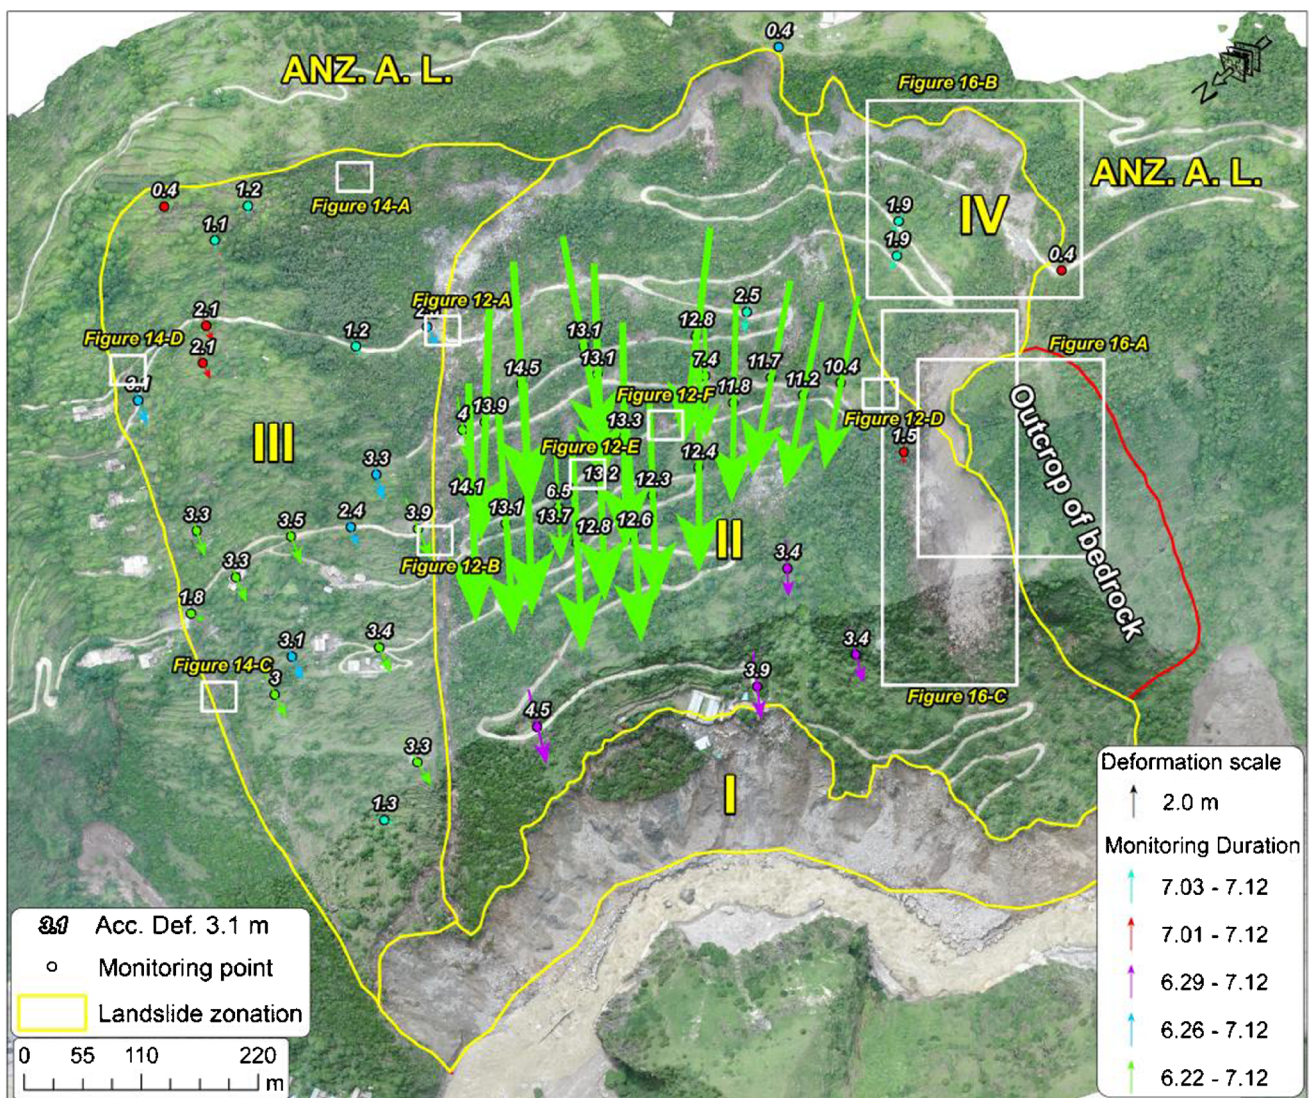
Fig. 9 The deformation vector distribution of reactivated deposits according to the emergency monitoring scheme. Acc. Def., accumulative deformation. The locations of the monitoring points are listed in Fig. 2(D)

Figure 9 shows the distribution of deformation vectors of monitoring points. From Fig. 9, the middle section of the reactivated part is approximately perpendicular to the river channel, which is the normal direction. The deformation

scales of middle section were the largest. The movement directions of the two lateral sections are mainly related to that of the middle section, especially the downstream section (Fig. 9).

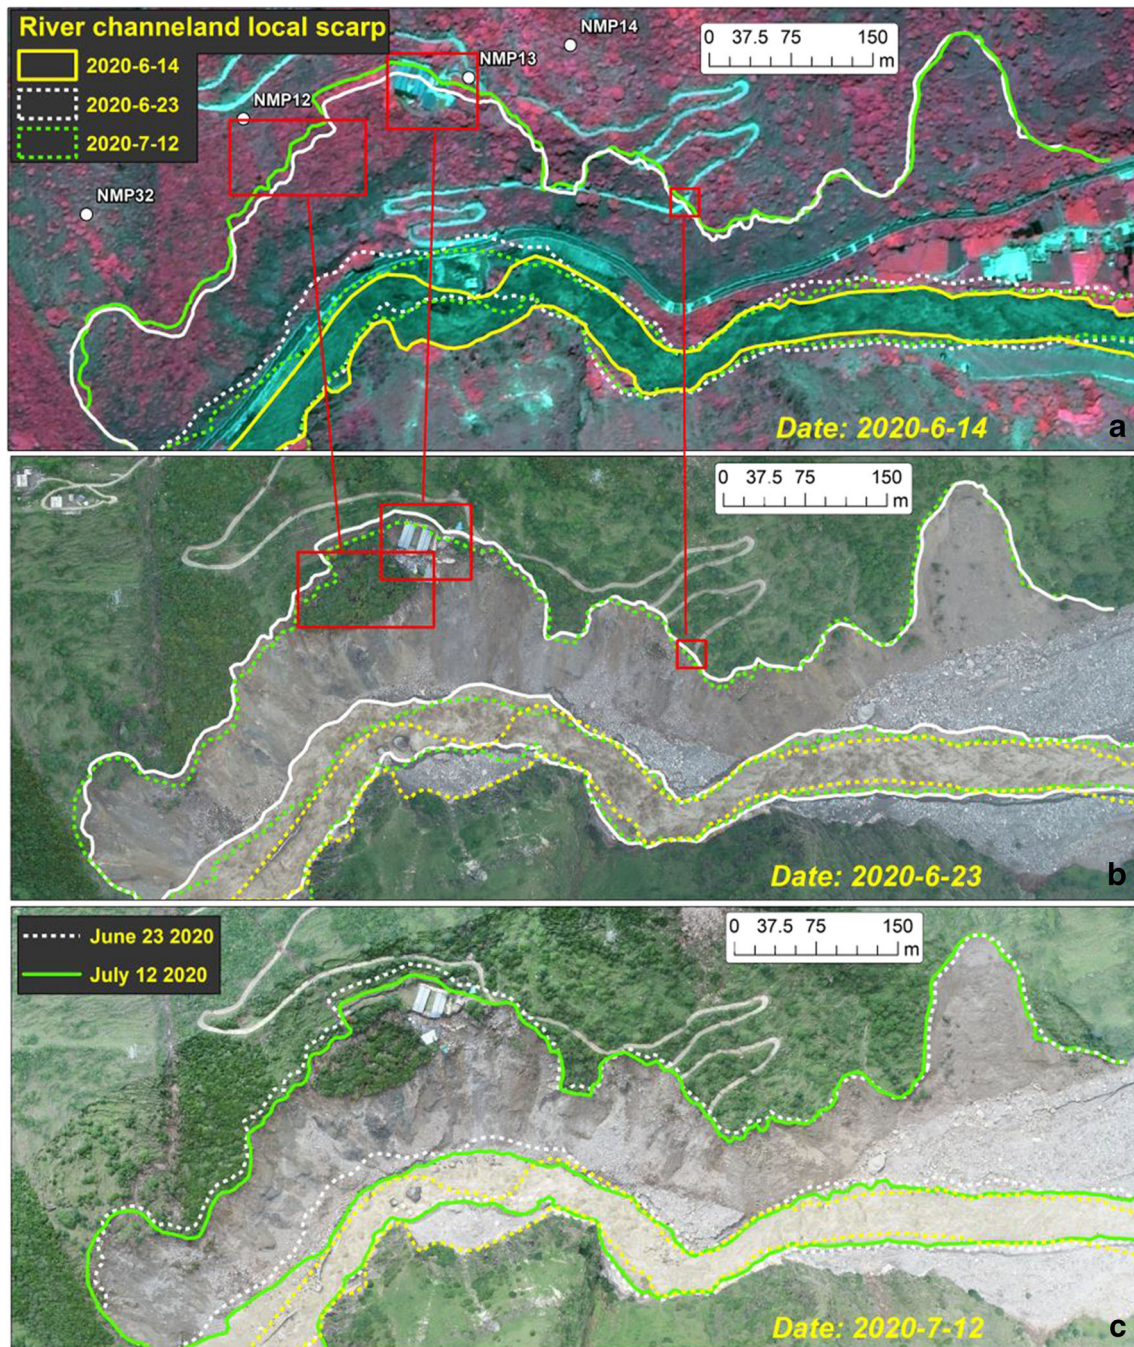
Fig. 10 The different periods of satellite (A) and UAV (B and C) images show the collapse characteristics of the front collapse zone (I). Image A is from Gaofen-2; the red boxes in (A) and (B) show the obvious deformation that occurred in these places

Front collapse zone I is located in the front section of the reactivated area and covers an area of $4.68 \times 10^4 \text{ m}^2$ (Figs. 9 and 10). The satellite and UAV images indicate that the new river channel flows along the foot of reactivated deposit and the current river is slightly wider than pre-event channel (Fig. 10). The UAV image from June 23 indicates all collapses appeared in this zone (Fig. 10(B)). The UAV images from June 23 to July 12 indicate no further obvious collapses occurred in this zone, but the overall movement was forward, with displacements reaching 6–11 m (Fig. 10). The intense erosion caused a mass loss of more than 2.8 Mm^3 in zone I according to the calculation of topographic difference.

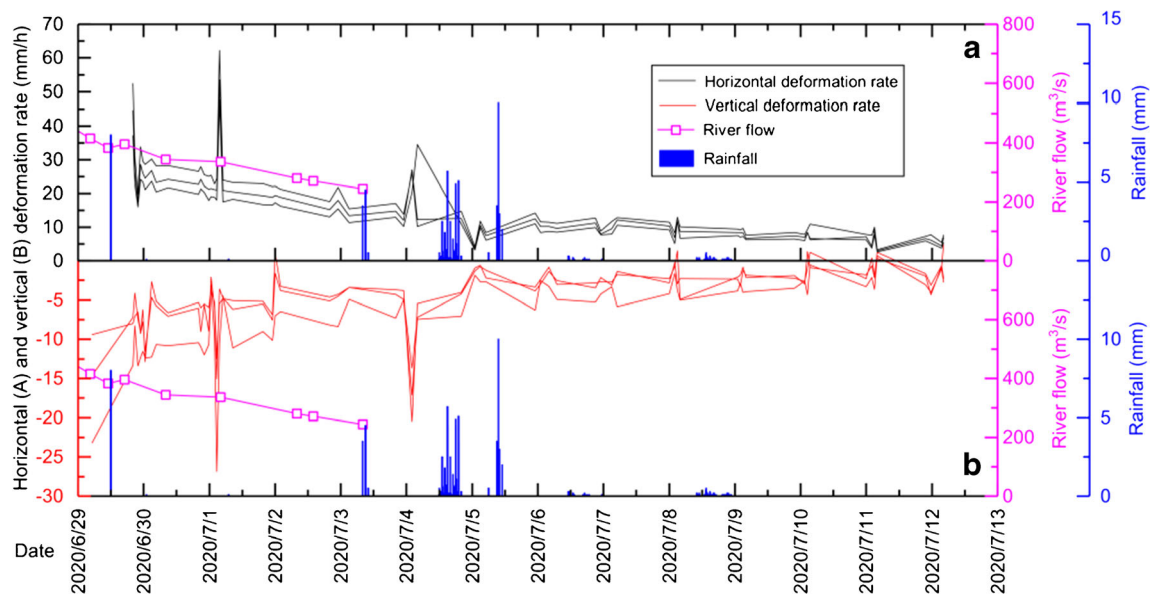
Figure 11 shows the deformation rate of monitoring points in zone I. All monitoring points present similar distribution patterns in a similar direction despite some differences in values (Figs. 9 and 11). The initial deformation rates in the horizontal direction and vertical direction reached 20–40 mm/h and 10–20 mm/h, respectively (Fig. 11), and the cumulative deformation increased rapidly. Then, the deformation rate decreased slowly. By July 12, 2020, the deformation rates in the two directions were both less than 5 mm/h (Fig. 11).

Fig. 11 The deformation rate of monitoring points in front collapse zone I. (A) Horizontal deformation rate. (B) Vertical deformation rate. The rainfall data is from self-built rainfall station whose location is listed in Fig. 2(D), the river flow data is from Guanzhou power station whose location is listed in Fig. 2(A). The rainfall data and river flow data in Figs. 13, 15, and 17 are the same with Fig. 11

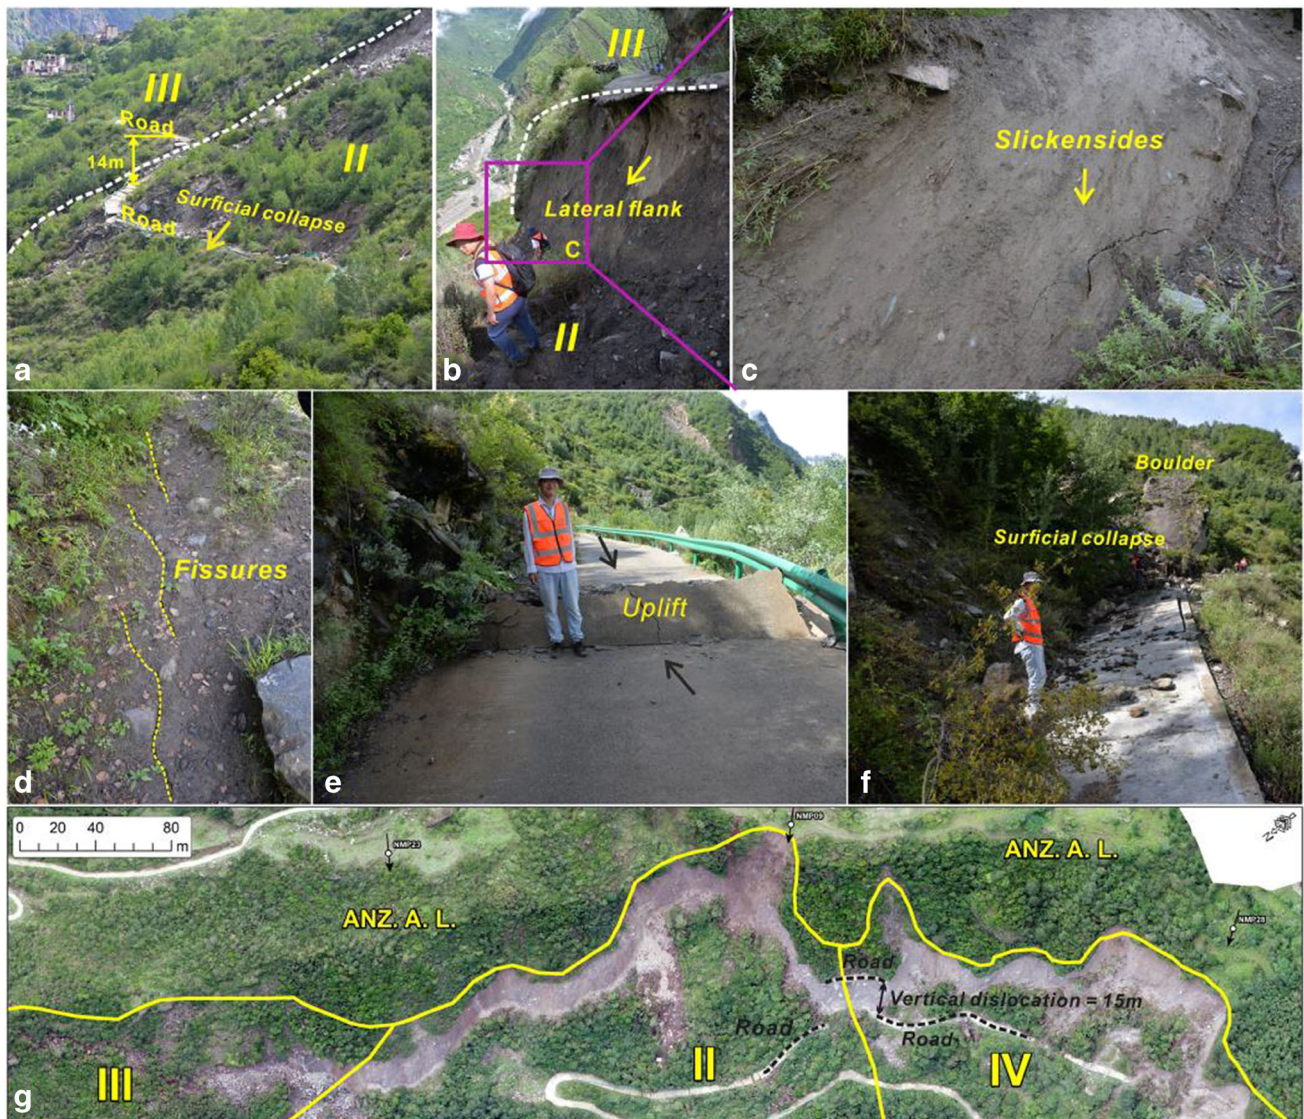
Zone II is the area with the most intense deformation, and obvious local head scarps and lateral flanks are present (Figs. 9 and 12).

The roads were destroyed at the boundary of zone II and zone III, where the vertical dislocation reached 5–14 m (Fig. 12(A and B)). Slickensides are obvious on the lateral flanks (Fig. 12(C)). A similar phenomenon also appears in the local head scarp area (Fig. 12(O)), and the dislocations of the local head scarps reach 15–20 m in the horizontal direction and 15–25 m in the vertical direction. Numerous fissures have formed near the downstream boundary (Fig. 12(D)).

The deformation directions in both zone III and IV can be decomposed with a deformation component toward zone II (Fig. 9). Therefore, the zone II features superimposed latitudinal compression, producing some instances of road uplift (parallel to the deformation direction) in zone II (Fig. 12(E)). Numerous surficial collapses are also concentrated in this zone (Fig. 12(F)).

Fig. 12 Typical characteristics of main deformation zone II. (O) obvious dislocation in the local scarp area, (A and B) dislocation of a road and a lateral flank at the upstream boundary, (C) slickensides on the upstream flank, (D) numerous fissures at the downstream boundary, (E) uplift of a road in the middle section of zone II, and (F) a surficial collapse in zone II. The locations of (A), (B), (D), (E), and (F) are listed in Fig. 9

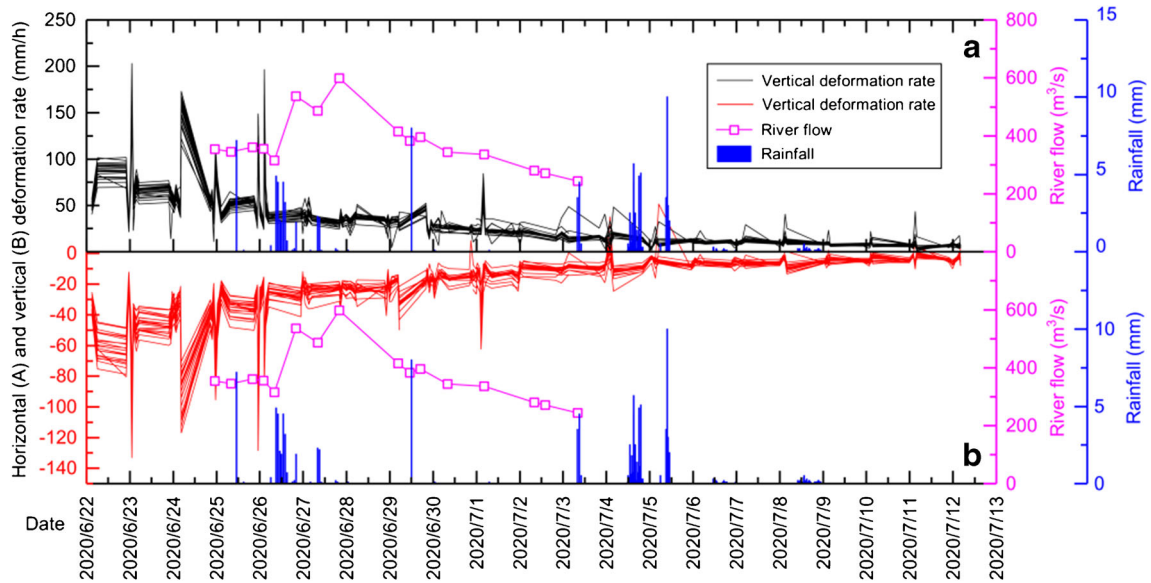
Figure 13 shows the deformation rate of monitoring points in zone II. Similar to the distribution patterns of the monitoring points in zone I, all monitoring points present similar distributions in the same direction despite some differences in values (Figs. 9, 11, and 13). The initial deformation rates in the horizontal direction and vertical direction reached 50–200 mm/h and 20–120 mm/h, respectively (Fig. 13), and the cumulative deformation increased rapidly. With time, the deformation rate decreased obviously; by July 12th, 2020, the deformation rates in the two directions were both approximately 5 mm/h (Fig. 13). The cumulative deformation values were also stable and reached 10.4–14.5 m in the horizontal direction and 7.1–11.4 m in the vertical direction.

Fig. 13 The deformation rates of monitoring points in main deformation zone II. (A) Horizontal deformation rate. (B) Vertical deformation rate

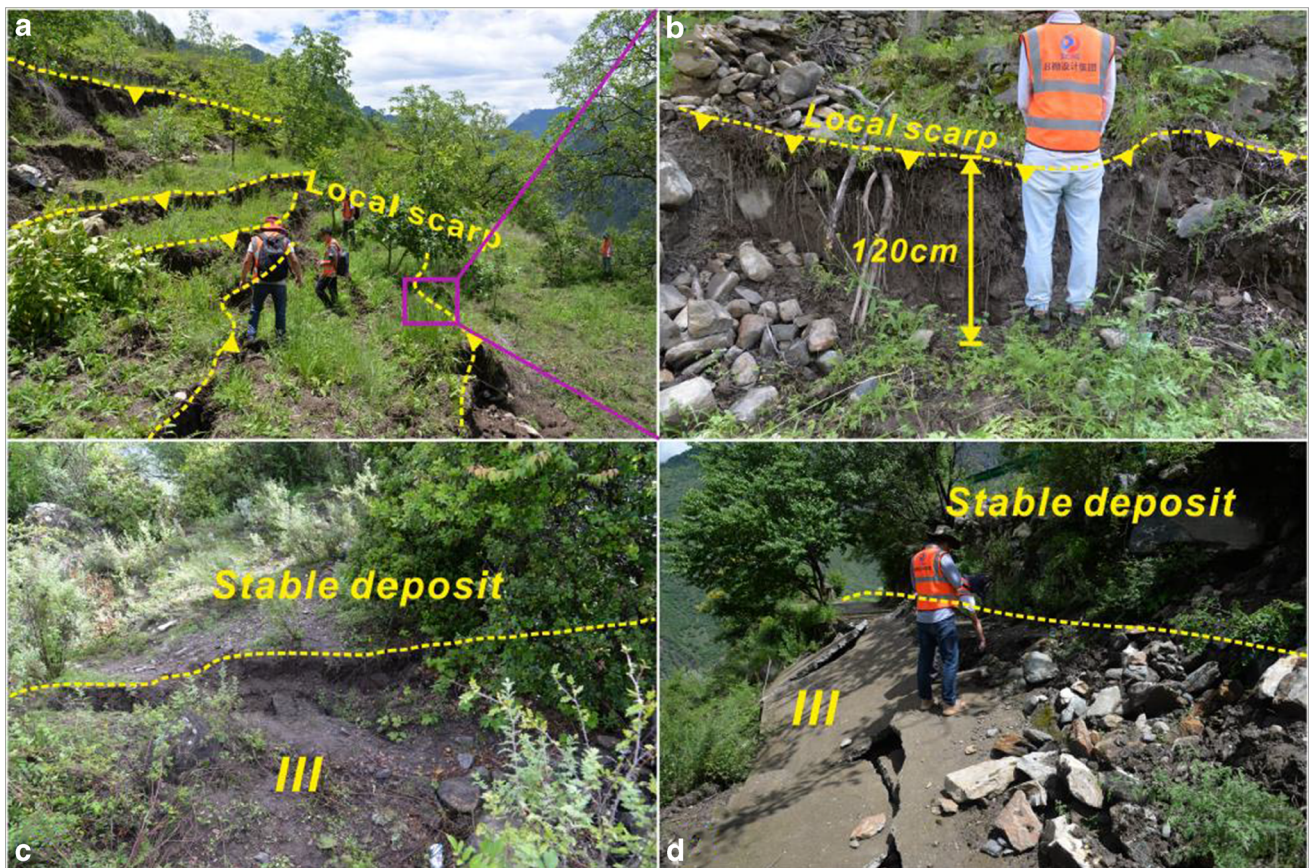
phenomena in terms of topographic differences (Fig. 8), while the field investigations indicate that multistage local head scarps with dislocations ranging from 0.5 to 2.2 m formed (Fig. 14a and b). The upstream boundary mainly consists of fissures with widths less than 15 cm (Fig. 14c), and some roads were damaged (Fig. 14d). The characteristics of the downstream boundary can be found in Fig. 12(A and B). The shape of this zone is an inverted trapezoid, and increasingly narrow deformation space caused the deposits in zone III to expand in the latitudinal direction. Therefore, zone III presents a composite deformation direction oriented downward toward zone II.

Fig. 14 The boundary characteristics of upstream deformation zone III. a, b Local multistage scarps in zone III. c, d Characteristics of the upstream boundary. The locations of a, c, and d are listed in Fig. 9

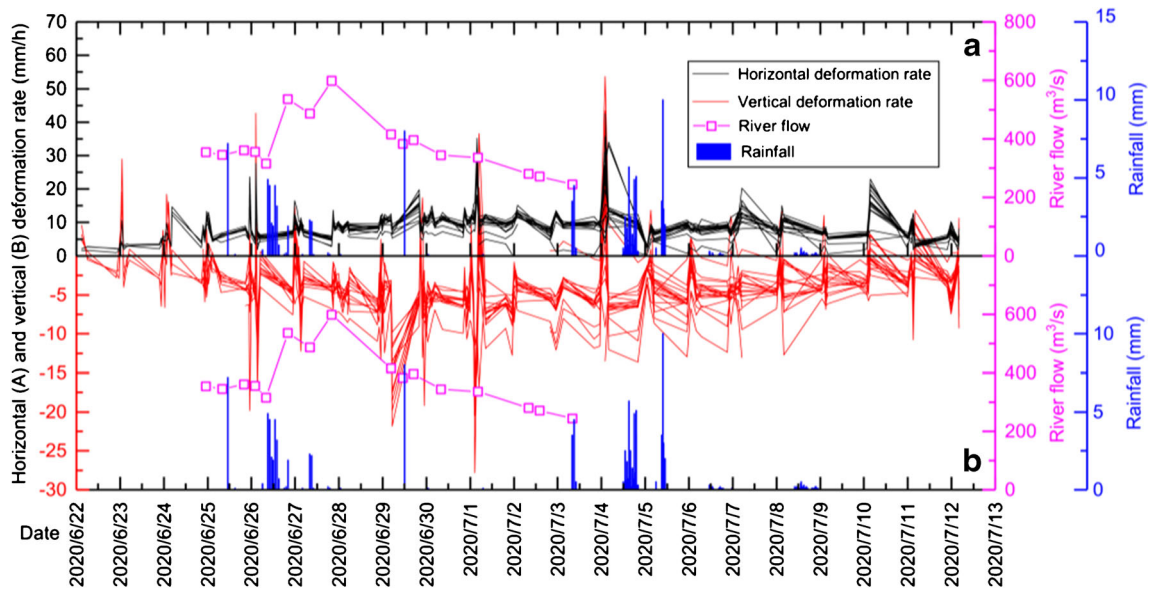
Figure 15 shows the deformation rate of monitoring points in zone III. All monitoring points present similar distribution patterns in the same direction despite some differences in values (Figs. 9 and 15). However, unlike the distribution patterns in zones I and II, the pattern in this zone shows a deformation rate that first

increased and then decreased very slowly, and the current deformation rate is approximately 5 mm/h (Fig. 15). The cumulative displacement of zone III presented an approximately uniform increase and reached approximately 3.0 m in the horizontal direction and approximately 1.7 m in the vertical direction. From Figs. 11, 13, and 15, the fluctuations of rainfall and river flow have no obvious influences on the deformation rate of reactivated deposits.

Fig. 15 The deformation rate of monitoring points in upstream deformation zone III. (A) Horizontal deformation rate. (B) Vertical deformation rate

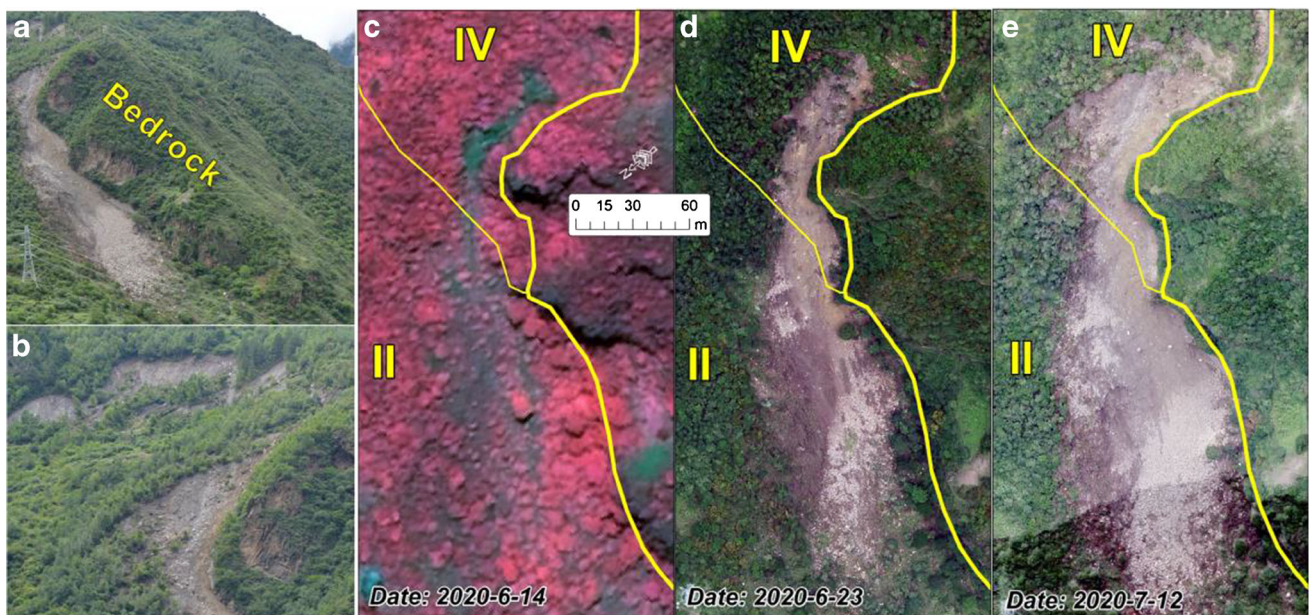
direction were formed (Figs. 9; 12(O); and 16(B)). An obvious local collapse appeared along its lower boundary, and the collapse area

expanded over time (Fig. 16(C, D, and E)). The deformation phenomena in zone IV are similar to those in zone III and display

Fig. 16 The field images show the outcrop of bedrock (A) and the local head scarp (B), and the satellite and UAV images show the evolution process of the local collapse on different dates (C, D, E). Image (B) is from Gaofen-2. The locations of (A), (B), and (C) are listed in Fig. 9

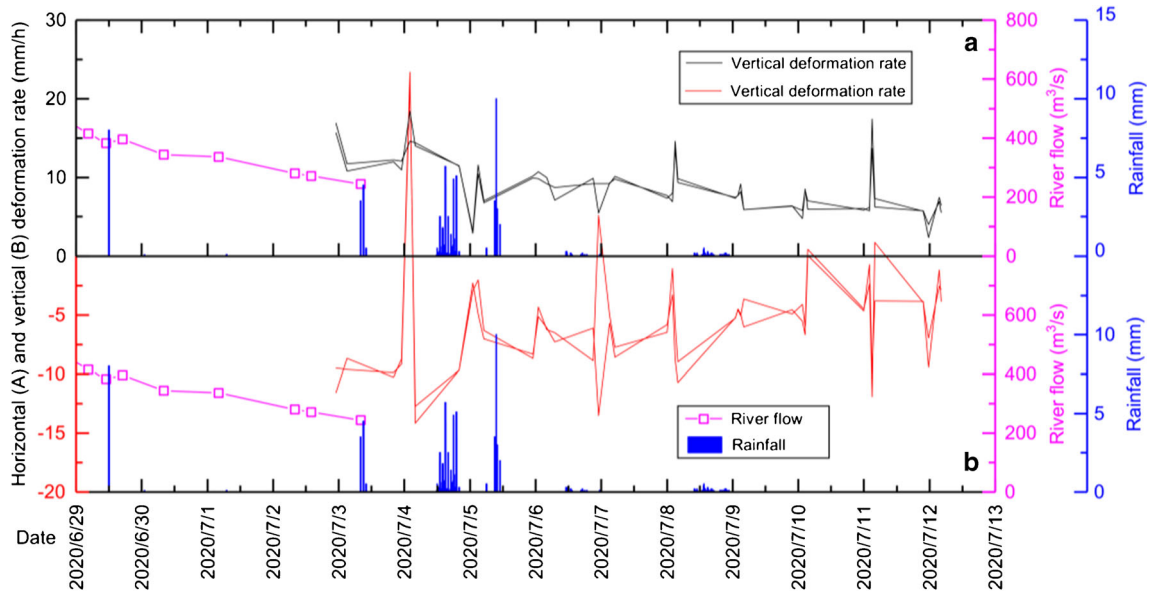
approximately uniform deformation at present, as shown in Fig. 17; the current deformation rate is approximately 5 mm/h.

Fig. 17 The deformation rate of monitoring points in downstream deformation zone IV. (A) Horizontal deformation rate. (B) Vertical deformation rate

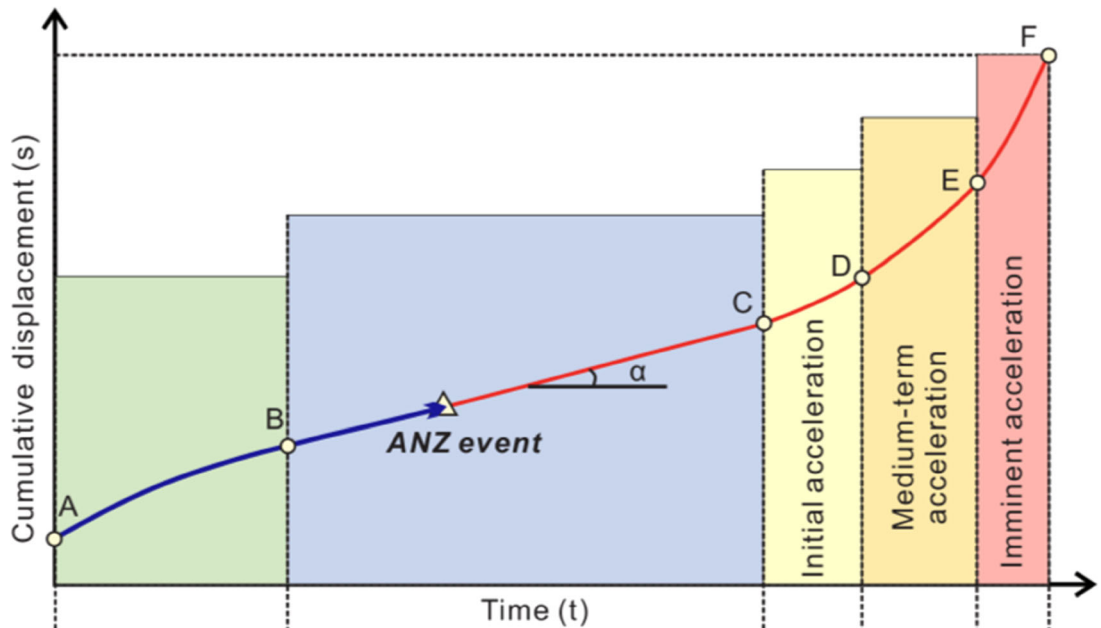
Fig. 18 The warning criteria of the landslide early warning system and the potential current state of the reactivated ANZ landslide. v_1 —attention deformation rate, v_2 —caution deformation rate, v_3 —vigilance deformation rate, the detailed information of this early warning system is listed in Fan et al. (2019) and Xu et al. (2020)

maintains a consistent deformation rate (approximately 5 mm/h, $\Delta v = 0$), which indicates that the ancient ANZ landslide is in the constant deformation state (Fig. 18). The constant deformation state requires special attention, as indicated by the early warning system, and some emergency measures should be taken into consideration to prevent it from entering the next phase with catastrophic consequences.
