Landslides (2021)18:3577–3597
 DOI 10.1007/s10346-021-01741-2
 Received: 31 December 2020
 Accepted: 12 July 2021
 Published online: 5 September 2021
 © Springer-Verlag GmbH Germany,
 part of Springer Nature 2021

Geo-structures and deformation-failure characteristics of rockslide areas near the Baige landslide scar in the Jinsha River tectonic suture zone

Abstract After two successive Baige landslides in the Jinsha River tectonic suture zone, a landslide scar with three steep free surfaces has been exposed in the source area, where three concomitant sliding blocks (K₁, K₂, and K₃) have been identified as continuously moving at high rates, suggesting further potential failures within these areas. This study focused on structural geology and conducted a comprehensive multidisciplinary analysis to understand the active features and geological evolution models for these sliding blocks. Results showed that the three rockslides can be further subdivided into eleven subdomains. The revealed rock masses are likely to be affected by faults, fracture zones, and folds, and are featured by widely distributed and variable interbedded lithology with heterogeneous qualities combined with fragme

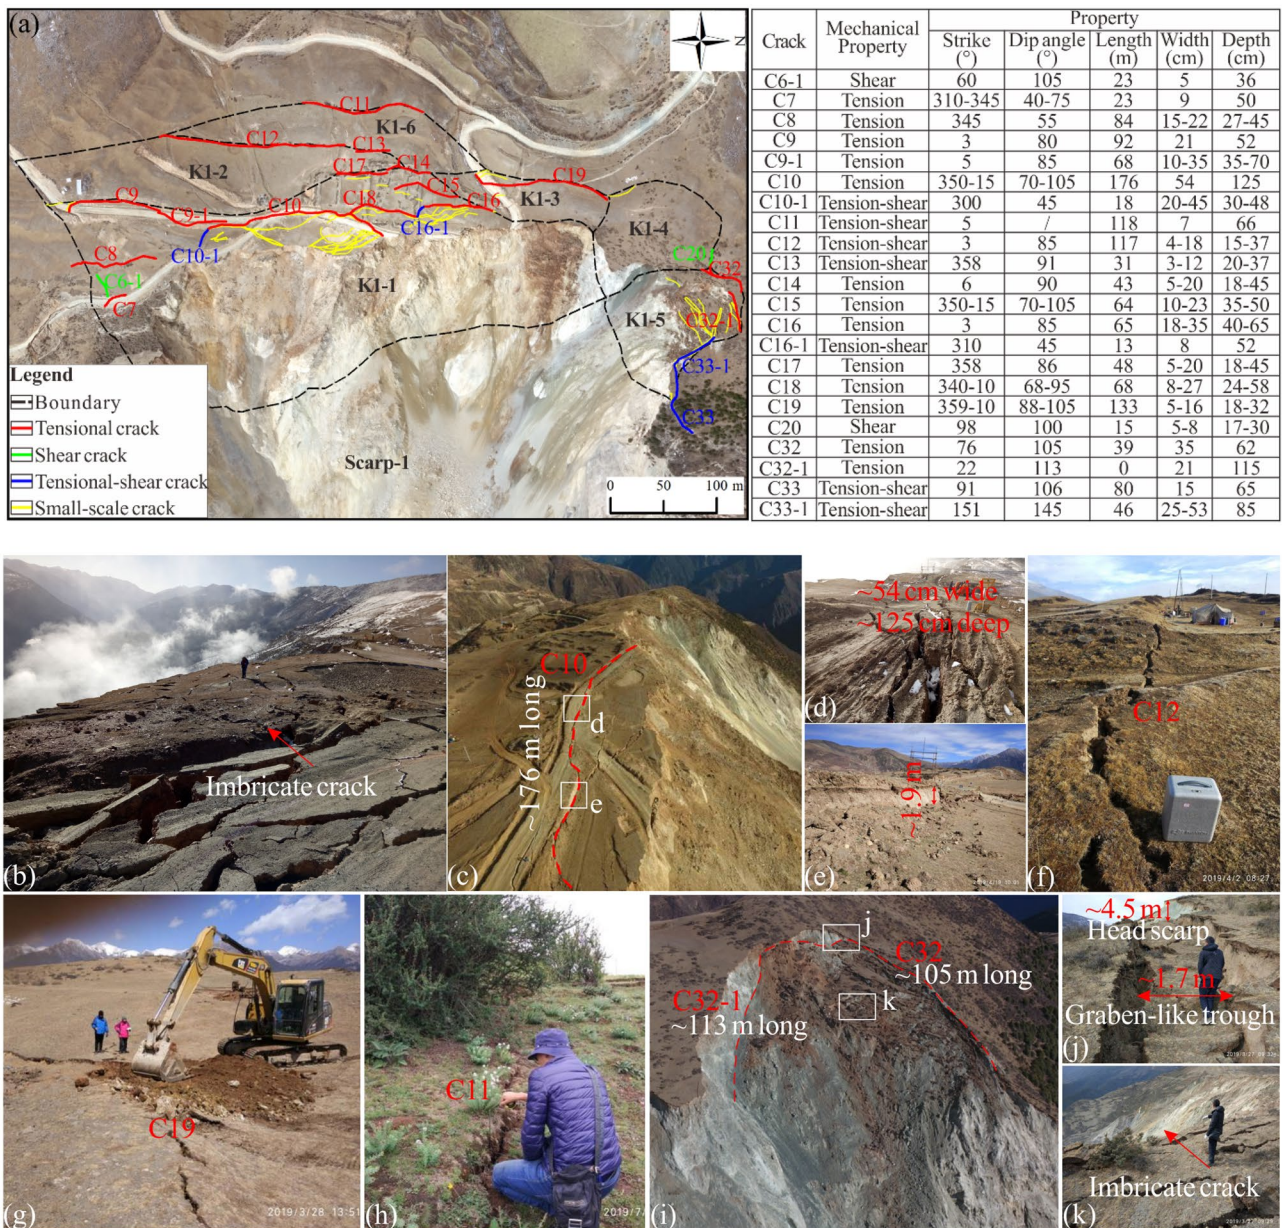
The mapping results of surface cracks at K1, K2, and K3 as of October 2019 are presented in Figs. 4-6, respectively. As shown in Fig. 4, many different-scale arc-shaped cracks are distributed across K1, and almost all of them are tension-induced. Tensional cracks in this area which are sub-parallel to Scarp-1 are very common, striking either approximately NS or EW, which would be favorable for kinematic release toward the free space. Multiple small-scale and dense imbricate cracks are distributed near the free surface, followed by several large-scale transverse cracks showing ongoing extension. The cracks in K2 are shown in Fig. 5. They have disparate strikes corresponding to different mechanical properties, which are the approximately NS-striking tensile cracks, the NW-SE-striking tensile-shear cracks, and the approximately EW-striking shear cracks (Fig. 5a). Several dense arc-shaped NS-striking cracks are well-developed on the middle (Fig. 5b) and north side (Fig. 5c) of K2. For both the lower and upper parts of K2, cracks are relatively scattered without centralized distribution. The distribution characteristics of cracks in K3

Fig. 4 Surface crack mapping results for K1: **a** characteristics of cracks on K1, **b** and **k** multiple small-scale and dense imbricate cracks distributed near the free surface, followed by several larger-scale

transverse cracks, such as **c–e** C10, **f** C12, **g** C19, **h** C11, and **i** C32 and C32-1, and **j** a graben-like trough with maximum width of ~1.7 m, and a head scarp up to ~4.5 m high on the west side of this graben

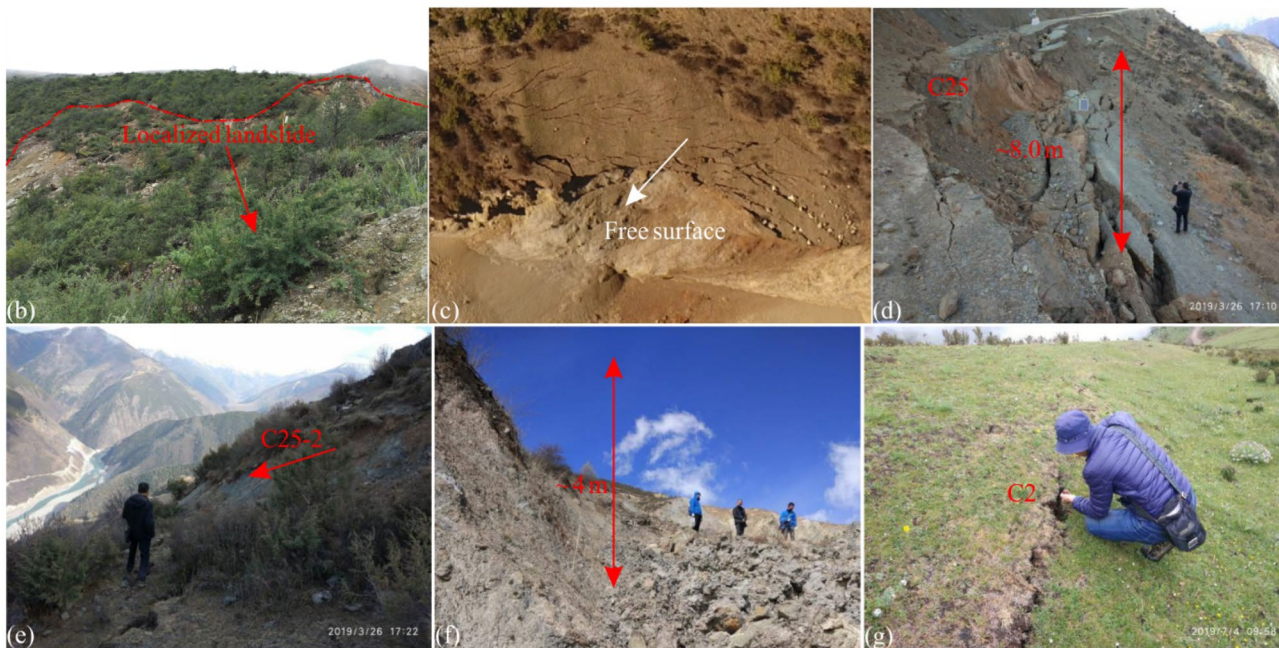
Fig. 5 Surface crack mapping results for K2: **a** characteristics of cracks on K1, **b** a localized landslide developed in the middle of K2 induced by several dense arc-shaped NS-striking cracks, **c** dense arc-shaped cracks on the north side of K2 that fracture the rock masses and result in the unstable blocks of K2 gradually deforming and dis-

integrating toward the free surface, **d** larger-scale crack C25 forming a scarp, **e** a derivative crack of C25 (named C25-2) along the EW strike, **f** a scarp with a maximum dislocation height of ~4 m, and **g** a tensile crack C2 distributed on the upper part of K2

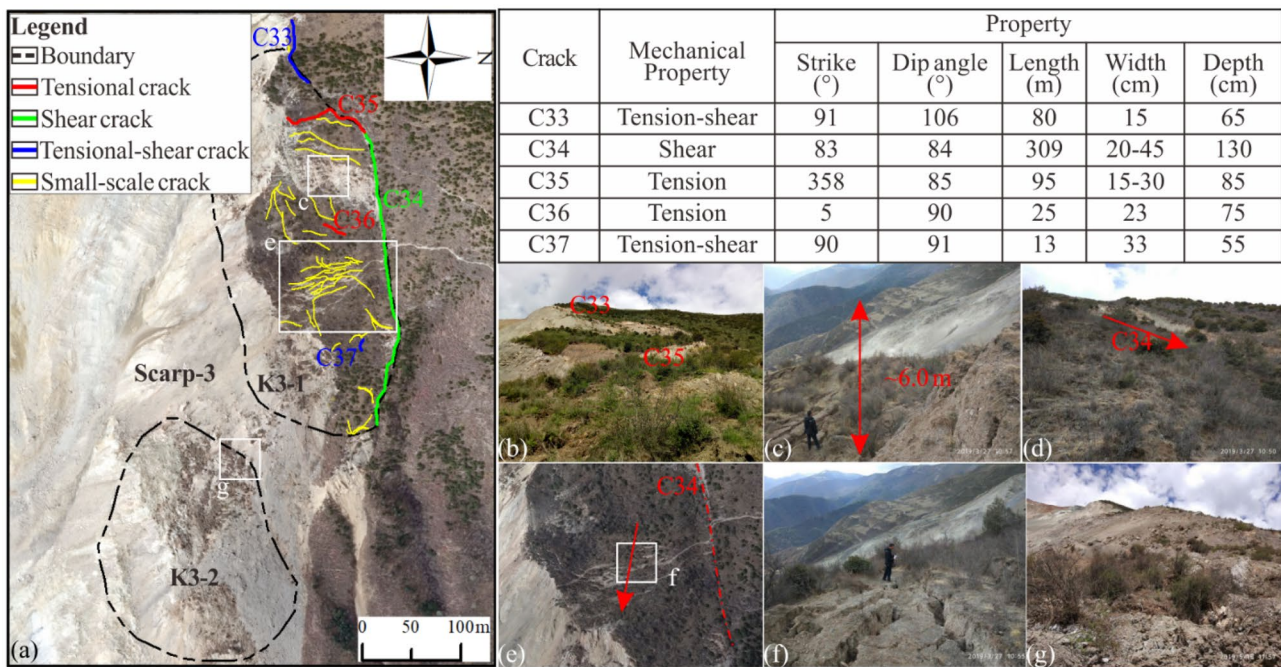
are relatively clear, consisting of NS-striking tensile cracks and EW-striking tensional-shear and shear cracks (Fig. 6).

Fig. 6 Surface crack mapping results for K3: **a** characteristics of cracks on K3, **b** and **c** many arc-shaped tensile cracks distributed at the upper part of K3, causing the rock mass to be pulled apart and thus resulting in the formation of visible scarp, **d** a remarkable shear

crack C34 on the left side of K3 defined the boundary of K3, **e** and **f** bulging cracks distributed in the middle of K3 due to the continuous eastward expansion of the sliding block under impeded by the front rock masses, and **g** a back scarp of K3

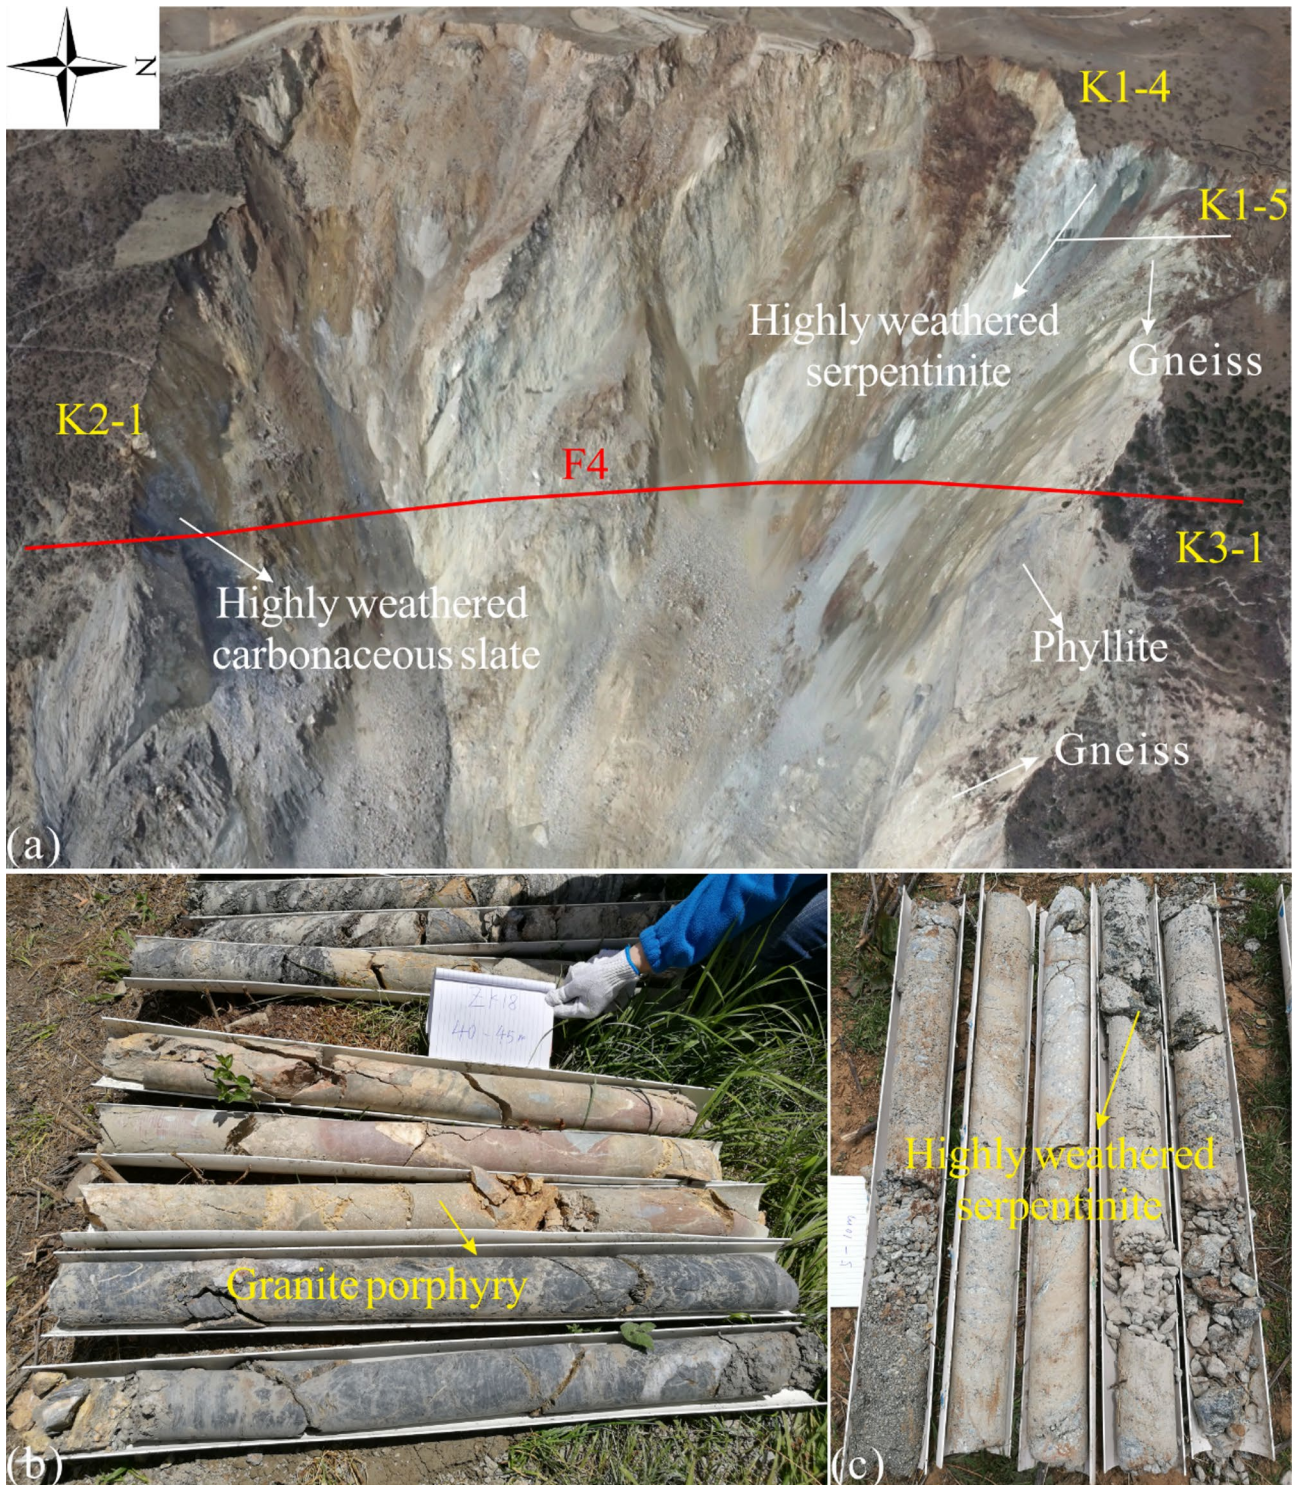
Fig. 8 Exposed special geo-structures near the landslide scar: **a** daylighting special rock masses and interpreted F4, **b** exposed granite porphyry in ZK18, and **c** exposed serpentinite in ZK16

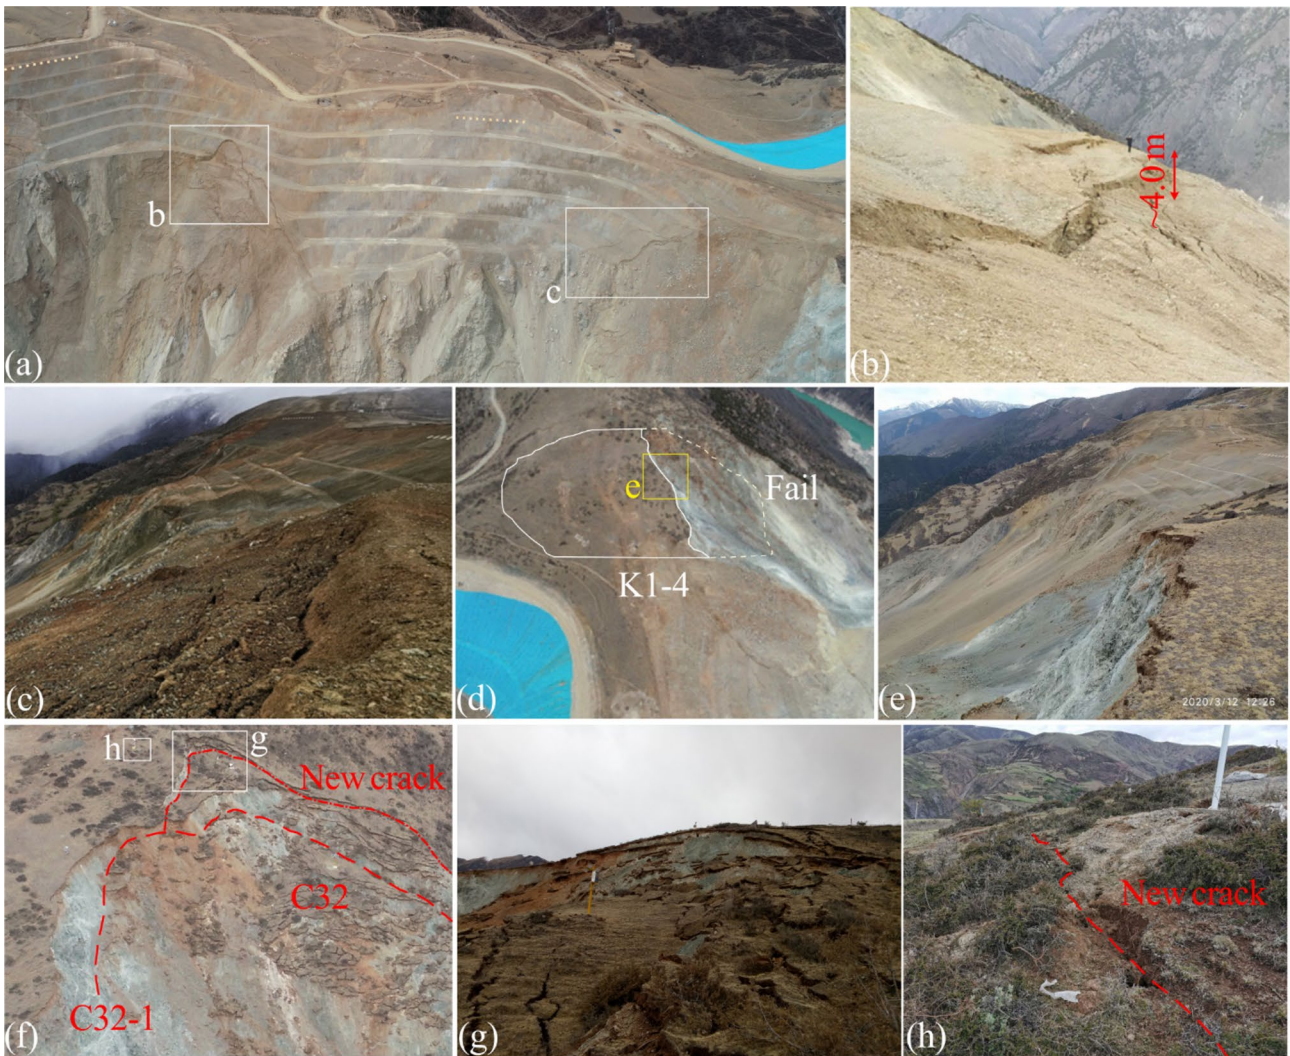
First, in K1-4 and K1-5, where serpentinite is widely distributed, the deformation–failure range generally continues to expand

backward, which is manifested in the continuous initiation, propagation, and coalescence of new cracks at the top of both areas (Fig. 15d–h). However, because K1-4 and K1-5 have different internal structures, their geological evolution models vary. As shown in Fig. 8a, the rock mass in K1-4 primarily consists of serpentinite. Thus, cracks propagate more easily due to brittle fracturing of the serpentinite. However, the middle and upper parts of K1-5 are mainly composed of serpentinite with concave vein-like distribution, while the lower part of K1-5 is mingled with relatively intact gneiss (Fig. 8a). Thus, deformation toward the free surface caused by the strength degradation of serpentinite in K1-5 is effectively impeded by the gneiss, which thereby leads to only the shallow layers descending progressively from the middle part to the upper part of K1-5 (Fig. 15g).

Fig. 15 Deformation-failure characteristics of K1: **a–c** deformation observed in the two spoil landfills at the front part of K1-1, **d** and **e** failure occurred in the front part of K1-4, **f** and **g** continuous expansion

of deformation-failure range in K1-5, and **h** newly formed crack observed at the upper part of K1-5

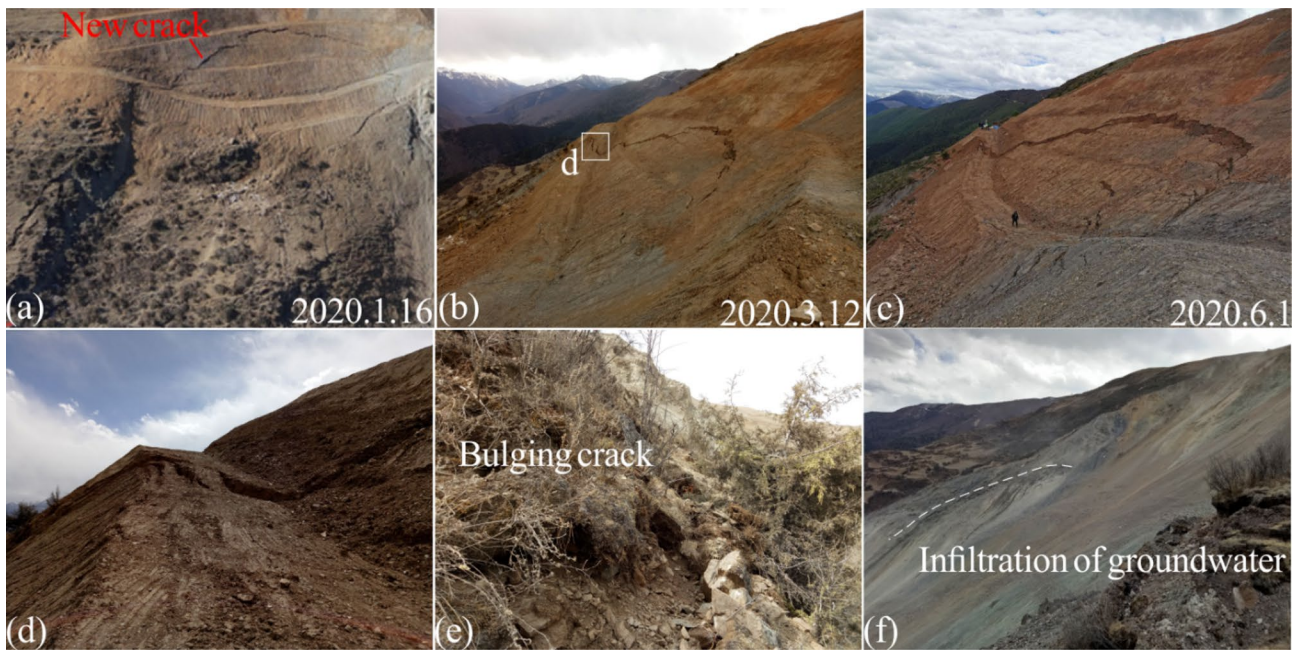
has been excavated, but the investigation results show that a new arc-shaped crack is generated at the original position of C25 (Fig. 16a). This newly formed crack is in a state of continuous propagation as indicated by Figs. 16a–c. Based on our investigation in March 2020 (Figs. 16b, d–f), this newly formed crack has extended to a width of 0.2–0.3 m, with a depth of 0.7 m, and connected with the pre-existing shear crack (C25-2). Additionally, at the lower part of K2-1, a bulging crack is visible (Fig. 16e). These features imply that the boundary of K2-1 has been formed as defined by the aforementioned cracks. Moreover, as shown in Fig. 16f, there is a band of groundwater seepage in the highly

weathered carbonaceous slate near the toe of K2-1. Concurrently, due to the saturation and softening caused by the continuous infiltration of groundwater, the highly weathered carbonaceous slate more likely serves as the main failure surface of K2-1 (Fig. 18a), which is confirmed by the severe hole sticking and slurry leakage occurring at a depth of 15 m in ZK17 during drilling.

Fig. 16 Deformation-failure characteristics of K2: **a–d** a new arc-shaped crack and continuous propagation processes in K2-1, **e** a bulging crack observed at the front part of K2-1, and **f** a band of groundwater seepage in the front part of K2-1

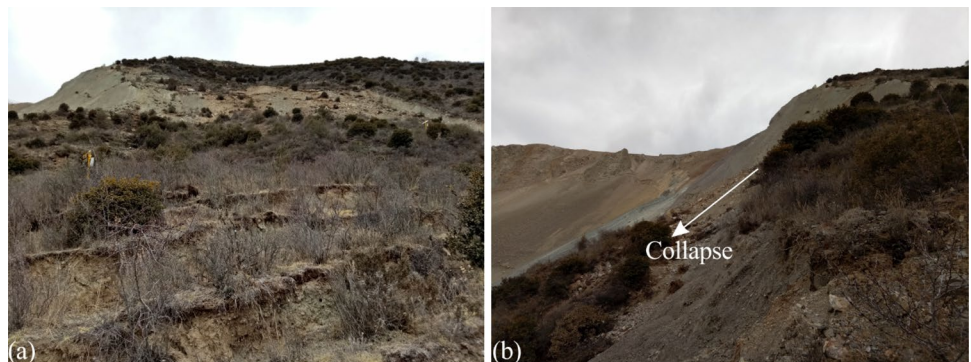
(Fig. 17a) and local collapse at the toe of the highly weathered gneiss (Fig. 17b). According to the borehole core of ZK17, the rock undergoes tectogenesis and is brecciated at the depth of 19–21 m (Fig. 18b), which is inferred as the potential failure surface of K3-1.

Fig. 18 Inferred failure surface for K2-1 and K3-1: **a** highly weathered carbonaceous slate at depth of 15 m in ZK 17 and **b** brecciated sandstone at depth of 19–21 m in ZK 18
