Peculiar earthquake damage on a reinforced concrete building in San Gregorio (L'Aquila, Italy): site effects or building defects?

Abstract In San Gregorio (L'Aquila, Italy) a three-story, reinforced concrete (RC) building had the first floor collapsed following the earthquake of April 6, 2009. The remaining two stories fell with a displacement in the horizontal projection of about 70 cm. This unusual behaviour is made more puzzling by the fact that buildings located at a short distance and with similar features had little or no damage reported. To understand the causes of the collapse we performed strong motion recordings, microtremor measurements, a detailed geological survey, a high-resolution geo-electrical tomography, a borehole with a down-hole test. On the building we performed a geometrical survey and laboratory tests on concrete cores. The acceleration and noise recordings have shown a high amplification with uphill-downhill direction. The geological survey has revealed the presence of co-seismic fractures on stiff soils. Geo-electrical tomography has shown an unexpected, strong discontinuity just below the building. Taking advantage of excavations in adjacent lots, we hav

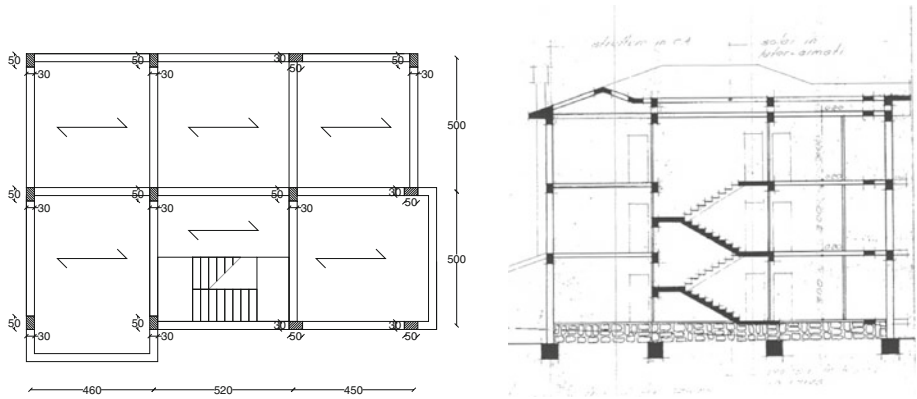
Fig. 3 In plan (units are cm) and transversal sections of the studied building

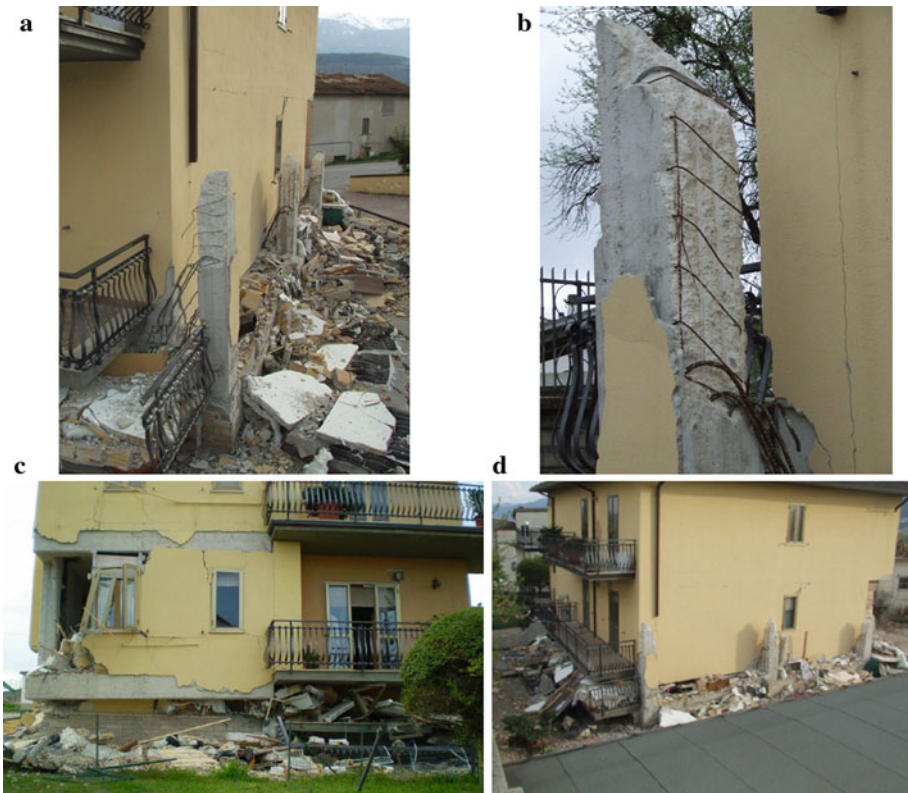
Fig. 4 Storey mechanism: details of the columns on back view (a); structural column details (b); lateral view (East) (c); back view (North) (d)

With regard to the damage mechanism of the studied building, it was possible to observe a storey mechanism. In Fig. 4c, d some significant images of the collapse are reported. It can be seen that only the first floor has been affected by the structural damage, but probably this fact does not implies a significant difference of stiffness with the other floors (all the floors had infills and the height was equal). The collapse was due to a significant shift (estimated at about 40 cm) on the first floor. As consequence, the columns of the first floor were cut at the top section (close to the beams). This mechanism may have been facilitated by both the poor anchoring of the bars and the fact that the beam-column joint that was not cast monolithically.

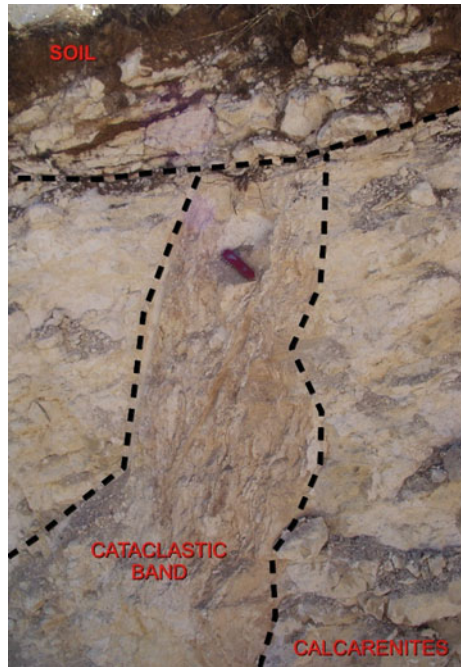
On the contrary, several decimetric cataclastic bands that cross-cut the Miocene calcarenites (Fig. 7) are characterized by a NE-SW direction that mimics the trend of the other normal fault.

Fig. 7 Photograph of the outcropping calcarenites with decimetric cataclastic band. See Fig. 6 for location

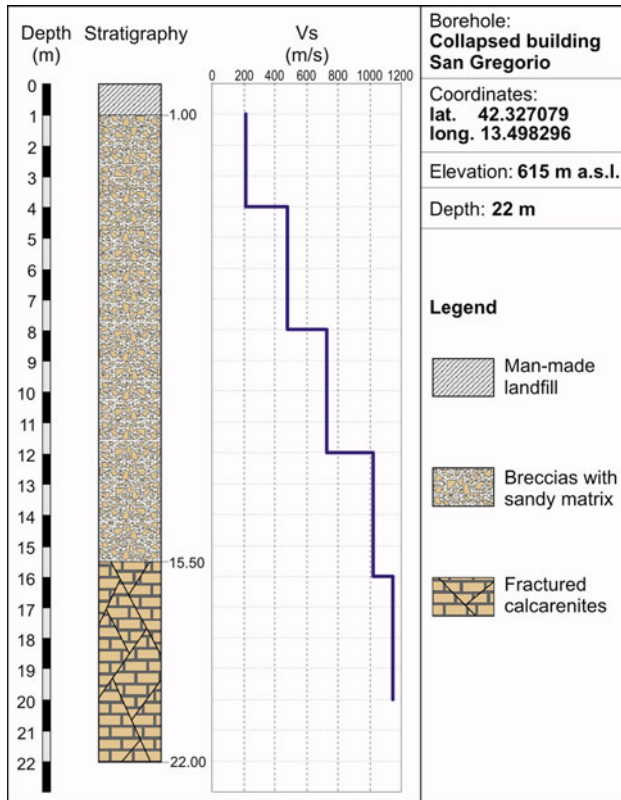
succession is made up of about 15 m of scarcely cemented breccias with sandy matrix, overlying the Miocene calcarenites which show a moderate degree of fracturation. The velocities of the shear waves obtained through the down-hole test gradually increase with depth across the breccias, with an abrupt step from about 200 m/s to about 1,000 m/s between the depth of 4–12 m.

Fig. 8 Geognostic borehole performed in the foundation soil of the collapsed building. See Fig. 6 for location

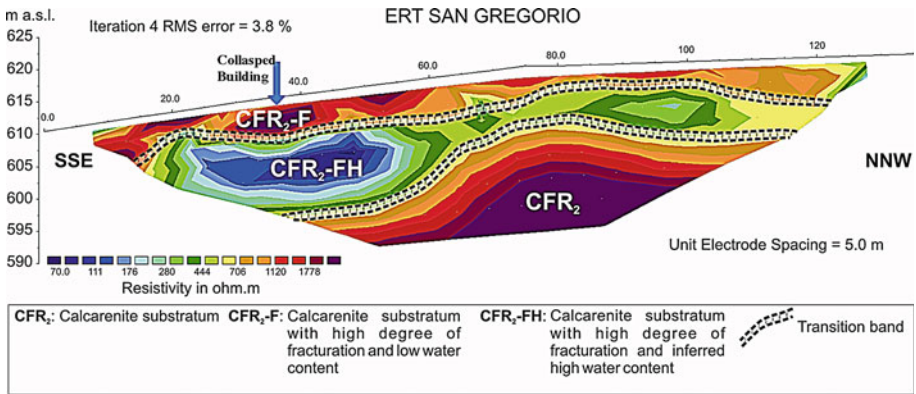
The electrical image shows, in the whole, a resistivity pattern characterized by three electrical layers, the central one relatively conductive. The most outstanding feature is certainly the relatively low resistivity zone ($\rho < 200 \Omega\text{m}$) just below the collapsed building.

On the basis of both geological and borehole data, this configuration could be due to different physical (electrical) properties of the same lithotype (calcarenite), rather than to the presence of different lithological horizons. In particular, the deep high resistivity zone ($\rho > 650 \Omega\text{m}$) could be associated with massive calcarenitic bedrock (CFR2), as found in the borehole at a depth of about 15–16m from ground level. The relatively conductive central layer, which presents resistivity values down to 70 Ωm in the left-hand zone, and the thin resistive surface layer could be associated with the same calcarenitic bedrock, but intensely fractured and with the likely presence (CFR2-FH) or absence (CFR2-F) of water. Furthermore, in the central part of the electrical image, the occurrence of a strong step in the lateral resistivity distribution could be due to the presence of a fault plane.

Fig. 9 Electric resistivity tomography carried out on a section passing close to the collapsed building located at about 40m from origin. See Fig. 6 for location details

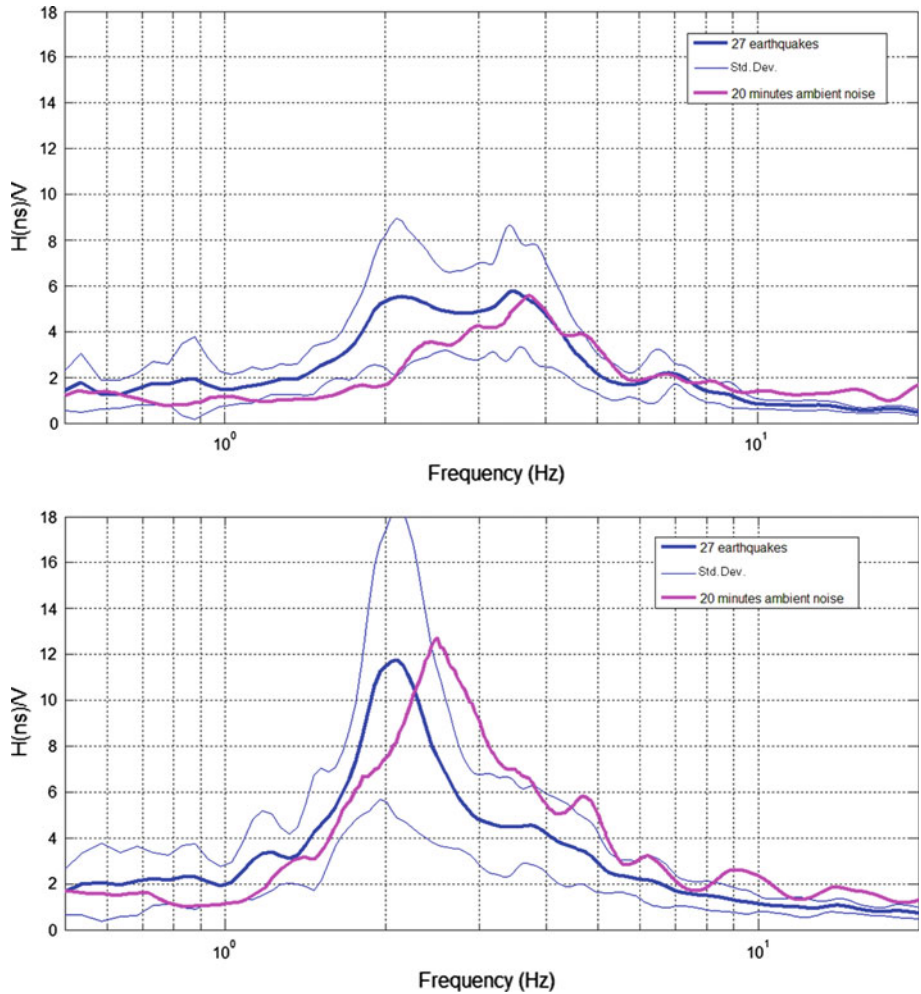
Fig. 11 HVSR curves for the two components (NS on the *top* and WE on the *bottom*) by 27 earthquakes and 20 min of ambient noise recordings

a clear resonance peak at about 2.6 Hz. This ambient noise HVSR has been validated by HVSR calculated on the 27 earthquakes of Table 1, according with the technique proposed by Lermo and Chávez-García (1993) and Castro et al. (1997).

It is interesting to note the satisfactory agreement between the two HVSR curves not only in detection of frequency and amplitude of resonance peak but also in the shape. The H/V obtained from earthquakes shows a slight decrease in the frequency and amplitude of the main peak respect to the H/V from noise recordings probably due to a non-linear effect.

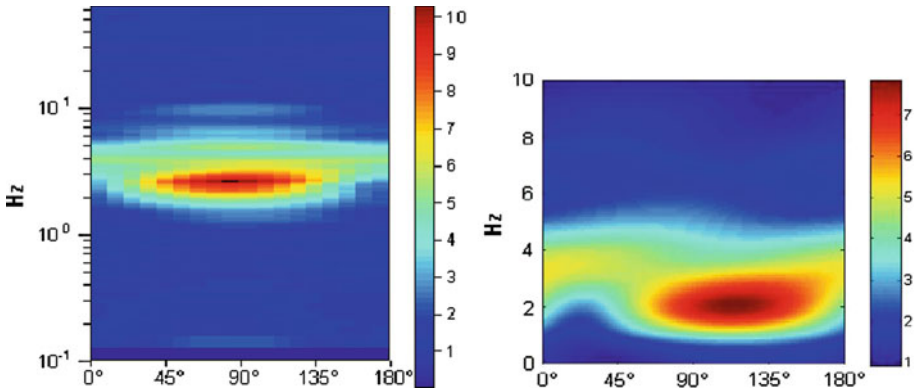
Moreover, even the ambient noise HVSR curves show a clear directional effect as highlighted by earthquake HVSRs. Figure 12 shows a strong directionality revealed with earthquakes and ambient noise HVSR at about 2 Hz. The slight difference in angle is due to the

Fig. 12 Horizontal to vertical moving angle ratio by ambient noise recordings (*left*) and by 27 earthquakes (*right*)

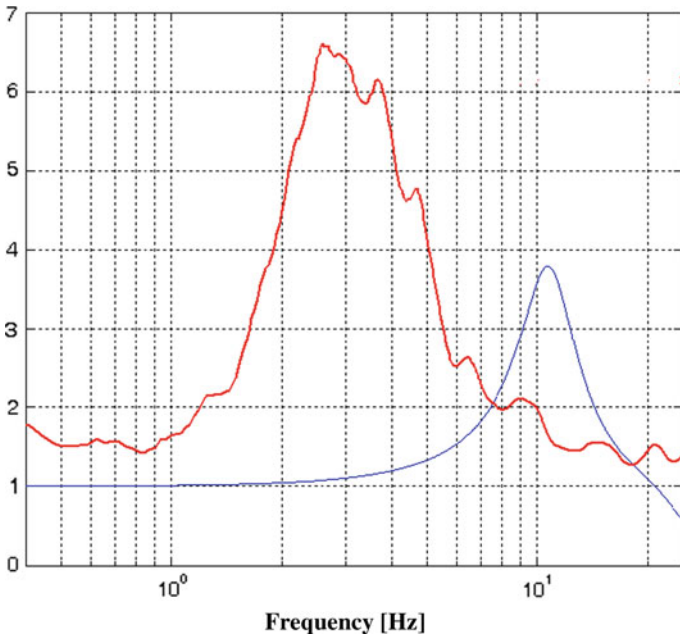
Fig. 13 Comparison between ambient noise HVSr (*red*) and 1-D model (*blue*)

This peculiar and strong directionality might suggest a 2D effect. In fact, a 1D model has been performed considering the values of the velocity taken from the down-hole and the stratigraphy of the geognostic borehole carried out close to the collapsed building (see Figs. 6, 8). The model curve highlights a resonance peak at a frequency much higher than the one estimated by earthquake and ambient noise HVSr (10Hz vs. 2.5Hz, Fig. 13).
