Damage assessment of churches after L'Aquila earthquake (2009)

Sergio Lagomarsino

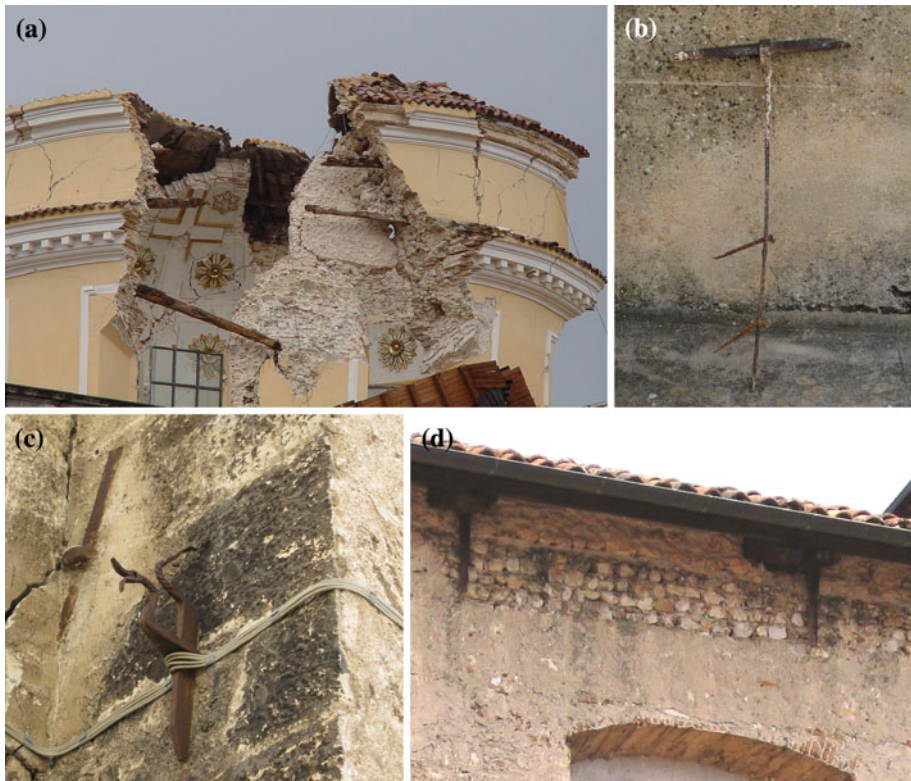
Fig. 6 Some examples of “wooden ties” and connections: **a** “wooden ties” at different levels of the dome of Santa Maria del Suffragio church in L’Aquila; **b** the terminal connection elements, taken from the debris: the key and the steel plate (with two nails); **c** the external key; **d** and external wooden key for the connection of the trusses in Santa Maria del Carmine church in L’Aquila

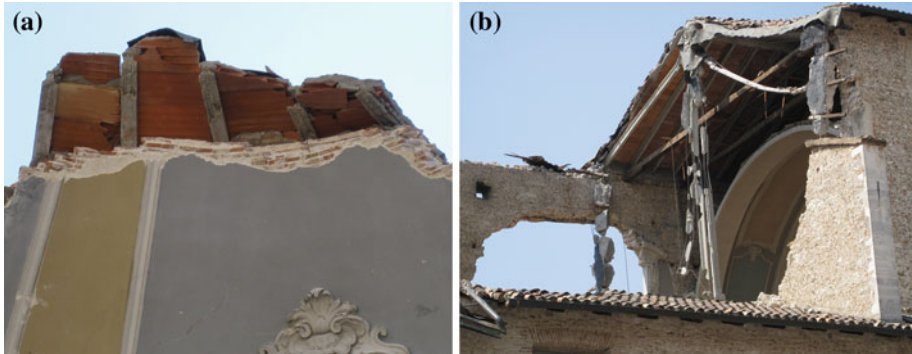
Finally, also the Aquilan churches were found vulnerable due to the bad behaviour of modern interventions of structural strengthening. The term “modern” means building techniques used during the last century and particularly reinforced concrete and steel. Wooden roofs which are relatively light and flexible were often substituted with heavy and rigid reinforced concrete slabs, which almost always resulted in having a negative effect on the structure as well as its preservation (Fig. 7).

Fig. 7 The modern roof made by r.c. precast elements and unreinforced concrete slab in Santa Maria Paganica church in L'Aquila: **a** the small portion of the dome which did not collapse; **b** trusses with pre-cast r.c. joists

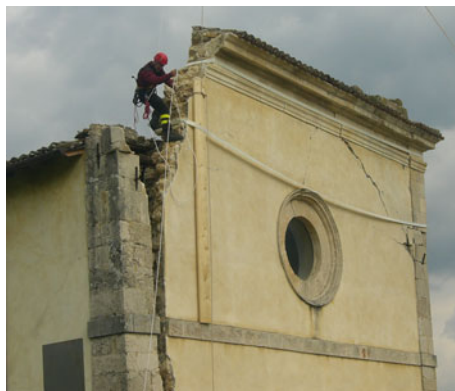
Fig. 8 Santa Maria degli Angeli church, in Civita di Bagno, L'Aquila

One of the emblematic examples is S. Maria degli Angeli, located in Civita di Bagno (Fig. 8), which shows out-of-plane overturning in the upper part of the left side and marked cracking proving an analogous mechanism on the right side, which did not evolve to the point of complete collapse.

The case is interesting because it highlights certain types of construction solutions. The corners were made of squared stones while the façade walls and lateral walls were made of irregular stones. This solution dictated by aesthetic reason but perhaps also by the desire for better connection, represents instead a point of weakness because the connection between the two types of masonry created discontinuity. In this case, an overturning mechanism was definitely activated with a fracture line throughout the plane of the façade rather than in correspondence with the connection to the lateral walls (as usually occurs). One can note the presence of anchoring keys of “wooden ties” which however did not hold in the façade probably due to decay at the extremities of the wooden log.

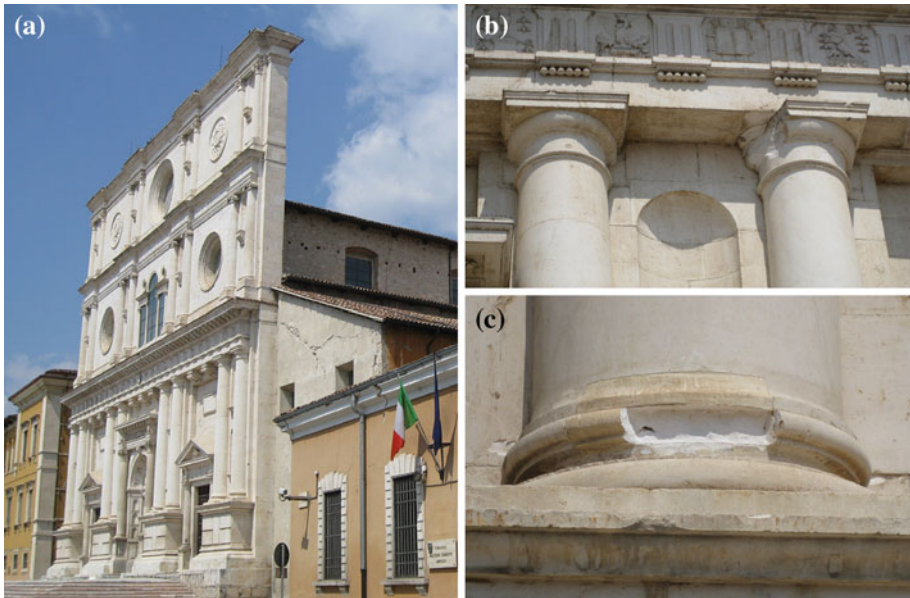
An interesting case is the façade of the Cathedral of S. Bernardino in L'Aquila (Fig. 9), which did not overturn despite the large and slender raised portion. Rocking of slender

masonry elements is a very complex problem, which depends on various factors: characteristics of seismic motion; monolithic nature of the masonry structures; slenderness; size of the element (particularly its thickness). The seismic activation of the oscillation depends on wall slenderness but overturning is strongly related to the thickness. Moreover, in the presence of irregular masonry, a wall cannot oscillate on sharp edges, but localized crushing occurs, with a lesser capacity to withstand repetitive cycles (due to progressive decay). The façade of S. Bernardino was made of excellently hewn marble ashlar and had been reinforced in the 1960's with a reinforced concrete covering to the rear face of the wall. This intervention certainly increased resistance and stability to horizontal actions, but also increased its stiffness; as a consequence, the horizontal equivalent seismic actions were increased, compared with the one that would have occurred in the case of unreinforced walls, with notable compressive stresses at the edges. This was demonstrated by widespread localized crushing at the base of the semi-columns and capitals (Fig. 9). In the absence of r.c. reinforcement, the wall would surely be subjected to wider oscillation but fewer compressive stresses in the edges (and therefore less localized damage).

Fig. 9 S. Bernardino basilica in L'Aquila: **a** the façade; **b–c** details of some local crushing of marble elements due to out-of-plane overturning mechanism

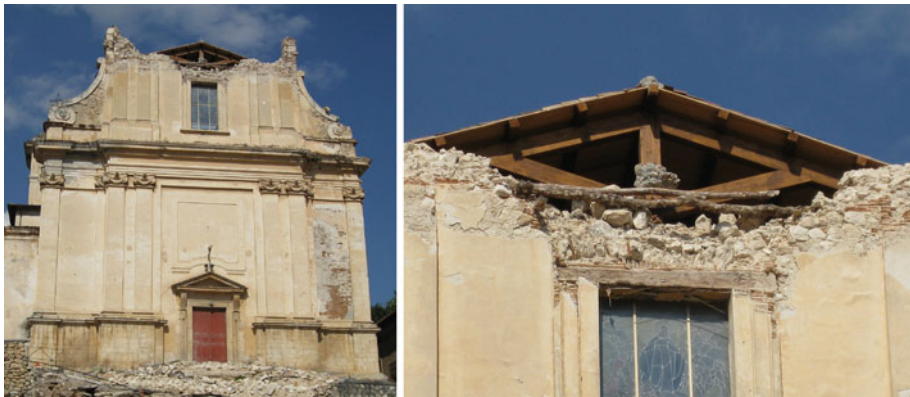
Fig. 10 Madonna dei Raccomandati church in San Demetrio né Vestini

Another interesting case is the church of the Madonna dei Raccomandati in San Demetrio ne' Vestini (Fig. 10). Here, the façade was erected in Baroque style after the earthquake of 1703 and the gable collapsed in the recent earthquake. It can be observed how the new roof, recently rebuilt with a wooden trussed structure, did not lean on the tympanum, and therefore resulted in a total lack of connection. Within the masonry, a “wooden tie” element was present, made of irregular logs which were too short (in other words, the builder believed that the length of overlapping was sufficient for adherence, which instead proved to be insufficient).

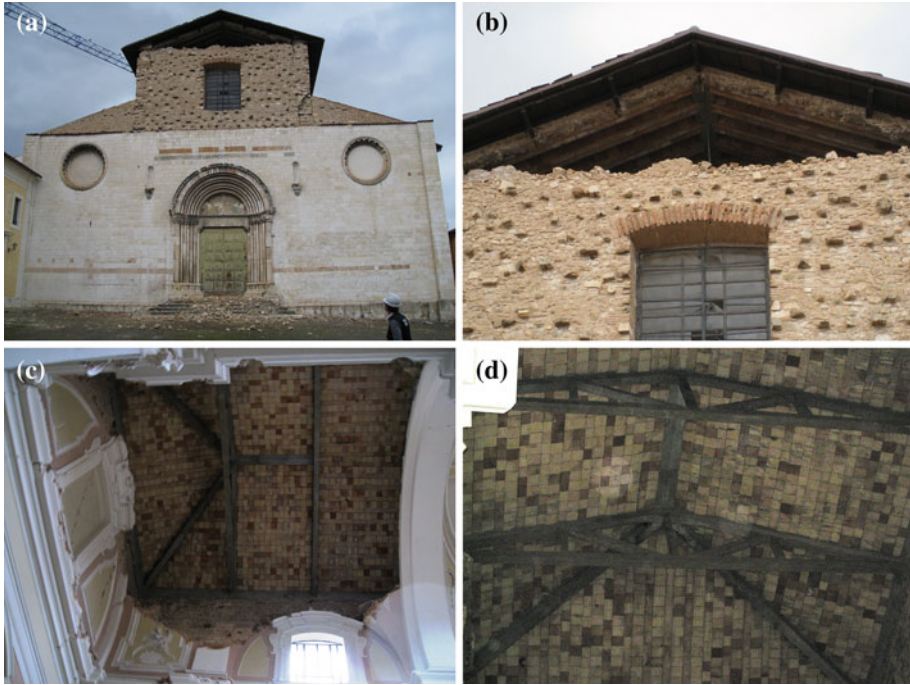
Fig. 11 San Domenico church in L'Aquila: **a** the façade; **b** the collapsed gable of the façade; **c–d** collapse of the transept vault due to substitution of the roof, made by r.c. trusses

Another negative effect of stiff r.c. roofs is what they do to the gable of the façade. An example is the church of S. Domenico in L'Aquila (Fig. 11), which can be considered representative of many analogous situations. At first glance, the collapse of the gable seems to be caused by an overturning mechanism, but the stringcourse did not allow that mechanism by creating a connection at the summit. In the presence of a flexible wooden roof, the overturning mechanism is associated with a rise in the gable due to the opening of the hinge

at its base; the ridgepole and the purlins lean on the gable, if they are well-connected, and can contrast overturning. Instead in a roof with a r.c. slab, the flexural stiffness opposes the uplift of the gable with a subsequent increase in vertical compression stresses; this compression provokes collapse due to wall crushing. In fact, this was found and caused the masonry wall to crumble rather than overturn as a rigid block. Figure 11d shows that also king trusses are made from r.c.; this is an emblematic case of the faith in this material during the last century for the static restoration of historic constructions (it is important to consider the difficulty of utilizing a material which must be cast on site, necessitates lengthy drying and hardening times, and is subject to “fluage” phenomena; wood or steel are for sure the proper materials for a king truss).

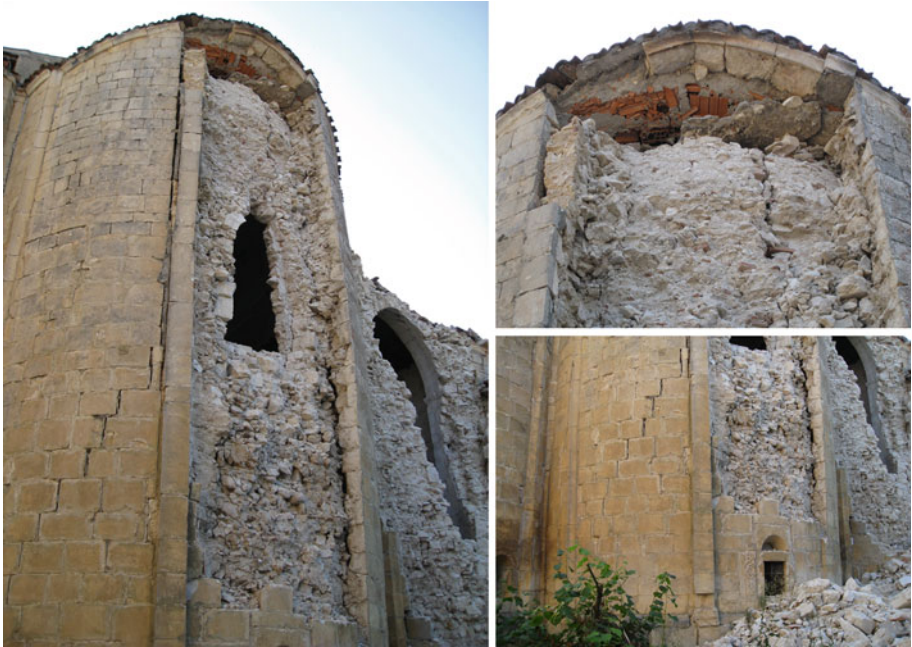
Fig. 12 The apse of S. Eusanio Martyr church in Sant'Eusanio Forconese

An interesting example of damage in the apse was found in the church of S. Eusanio Martire in Sant'Eusanio Forconese (Fig. 12). There is a very tall semi-circular apse with well-hewn stone masonry walls divided into three parts by two small pilasters. The earthquake provoked the collapse in the external leaf of the masonry in the central portion, which occurred for various reasons:

- (1) the external leaf, though apparently in good condition, was very thin and badly connected to the internal masonry nucleus (this is typical in many hewn ashlar walls);
- (2) the pilasters did not have a static function (due to their reduced thickness) and created discontinuity in the external masonry leaf, favouring its detachment in the central portion (note the detachment of the pilaster in the first photograph even when the external leaf did not collapse; certainly, in the absence of the pilasters, the wall would have behaved better);
- (3) the roof of the church had recently been replaced (note the stringcourses and concrete elements) and this certainly could have increased the local stresses at the interface between masonry and r.c. elements.

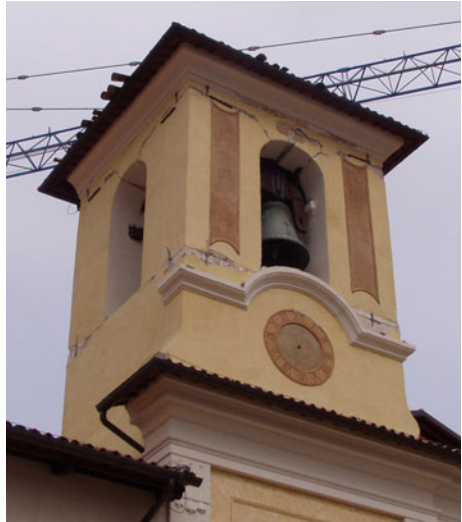
Fig. 13 Bell cell in the ex-convent of S. Domenico in L'Aquila

In the first case, there are “wooden ties” at the base and at the top of the cell; the piers developed an overturning mechanism, which in the upper portions involved the arches; in the absence of tie rods, there were openings of the hinges and sliding in the central ashlar, though limited by the upper wooden tie rod. The possibility of developing this overturning mechanism limited shearing damage to the piers.

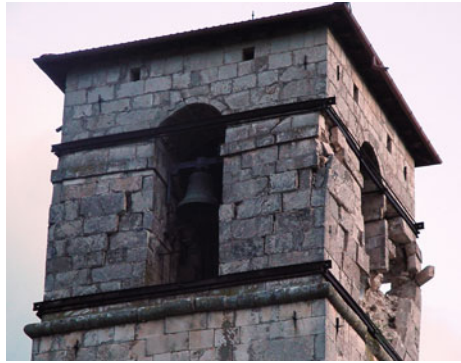
Fig. 14 Bell cell of S. Felice Martire church in Poggio Picenze

On the contrary, in the case of the church in Poggio Picenze, an intervention, debatable even on a formal level, had been carried out, which was aimed at creating better connection but added exaggerated rigidity to the structure. Instead of classic tie rods, small metallic bars connected in pairs had been inserted at the base of the piers and at the base of the arches. The result was that the possibility of deformation was localized only in the piers (due to the fact that the upper section was completely rigid), with subsequent serious damage due to shearing. The photograph clearly demonstrates how complete collapse did not occur only by luck, and nevertheless, the problem of restoring the tower must be dealt with considering the extent of the damage.

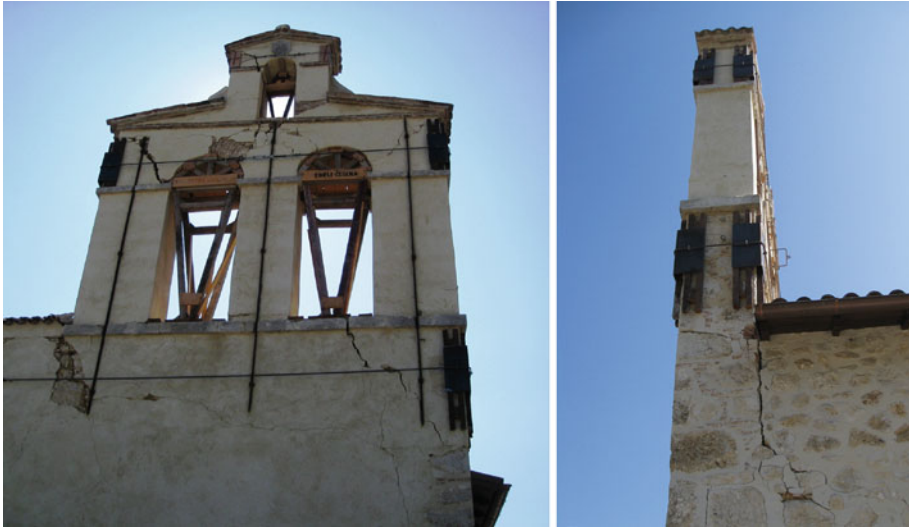
Fig. 15 Plane belfry of S. Michele Arcangelo church in Villa Sant' Angelo

The Case of the church of S. Michele Arcangelo in Villa Sant’Angelo is interesting (Fig. 15). The first image shows severe in-plane damage to the three piers and two arches. The belfry was equipped with three external vertical tie rods, axial to the piers and connected to the wall at the extremities and in the centre (please do not confuse them with the horizontal bars put in place after the earthquake for safety measures).

The vertical bars limited the formation of hinges at the base of the piers, but shifted the damage under the anchoring point of the bars themselves. In the upper portion the mechanism formed along the arches with a strong concentration of damage near the connections between the bars and the walls. One can also note the troubling diagonal cracking with displacement under the external pier which was a consequence of the strong shearing action at the base due to the bars which increased stiffness.

Figure 15b is also interesting and shows an out-of-plane oscillation mechanism with horizontal cracking on the side of the façade (directly below the connection of the vertical tie rods) and vertical cracking of detachment to the lateral walls of the church.
