Rapid seismic evaluation of historic brick-masonry buildings in Vienna (Austria) based on visual screening

Günther Achs · Christoph Adam

Abstract The present paper addresses seismic assessment of historic brick-masonry buildings located in the city of Vienna based on rapid-visual-screening (RVS). The RVS methodology has been adopted for this specific type of buildings considering their consistent typology and consequently enhancing the validity and quality of the seismic assessment. In this context, structure-relevant parameters such as regularity of the inspected building, its state of preservation and geometry are evaluated. Additionally, the human and economic impact of earthquake-induced damage on the object is integrated assessing damage relevant factors such as the number of exposed persons and the importance of the object for the public. Based on the derived score of each of these two sets of parameters the inspected building is classified into one of four vulnerability classes. Furthermore, the damage potential of a seismic event comparable with the L'Aquila 2009 earthquake is predicted correlating the results of the RVS methodology and damage grades according to EMS-98.

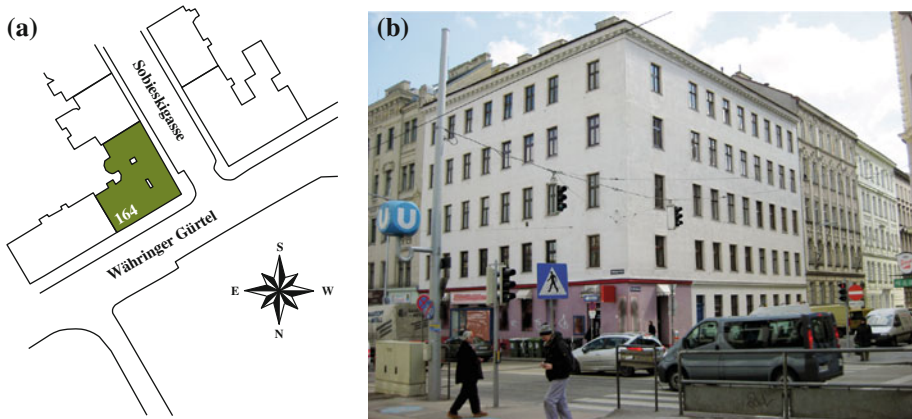
Fig. 4 **a** Overview of the investigated object “Währinger Gürtel 164”, **b** photograph of the test object

district of Vienna at the intersection of two streets named “Währinger Gürtel” and “Sobieskigasse”, as shown in Fig. 4a. It was constructed in 1891 as a residential building, and had two perpendicularly arranged wings resting on a basement. Figure 4b shows a photograph of the test object facing both street fronts. A vaulted brick-slab separated horizontally the basement and the first floor. The brick-masonry load-bearing walls had a thickness up to 75 cm, the thickness of the partition walls was 15 cm.

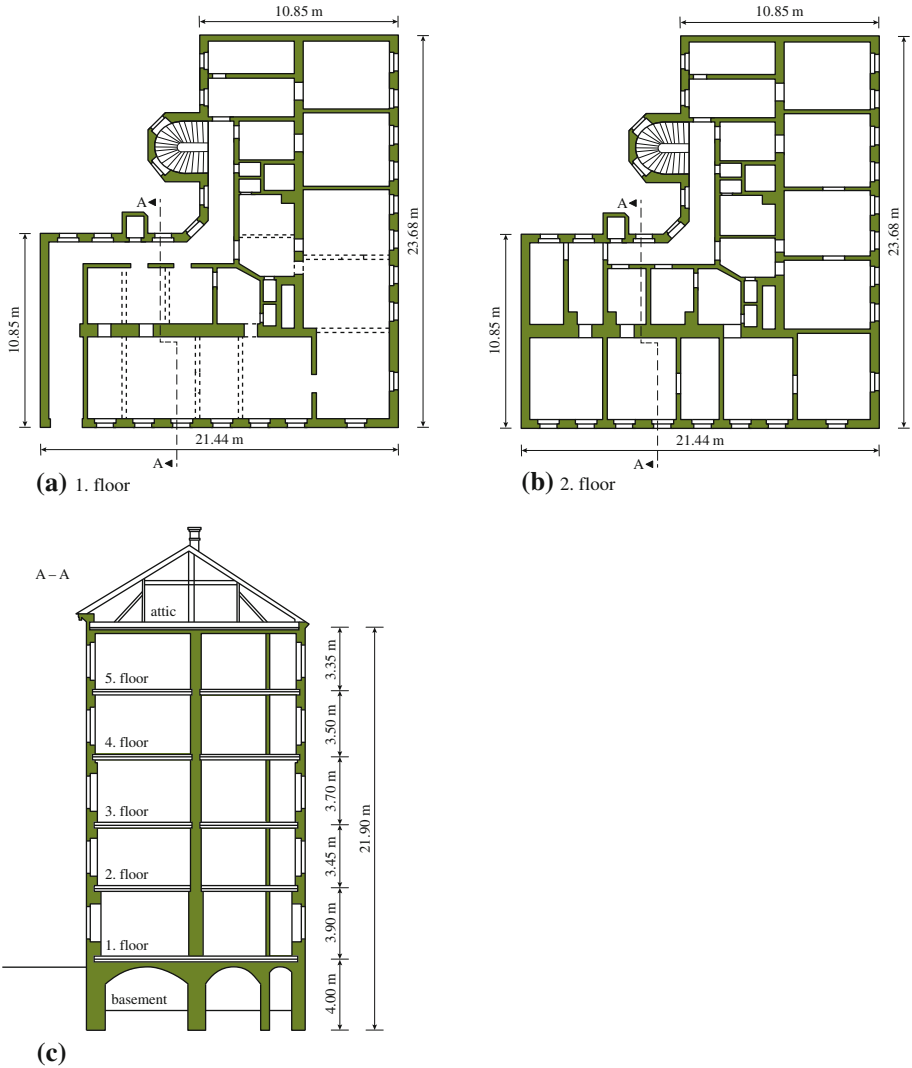
In the past, the first floor was converted into a store removing most of the partition walls. Furthermore, the internal load-bearing walls were weakened by at least two openings. In Fig. 5a the floor plan of the first floor in its condition during the vulnerability assessment is shown. The removed internal lateral walls are depicted with dashed lines. The almost identical upper stories have been used for housing purposes only. Figure 5b shows the floor plan of the second floor, representing exemplarily the upper floors. A section of this object is depicted in Fig. 5c. After the subsequently described assessment in 2009 the building was demolished.

- Parameter S_{01} describing the seismic hazard is 2.0, because the building was located southwest of the river Danube, Table 1.
- The building was L-shaped, and thus its plane was irregular. Since the length to width ratio ($23.68/21.44 = 1.10$) is smaller than 4, according to Table 1 parameter S_{02} is 5.
- In the first floor almost all lateral partition walls have been removed, however, load bearing shear elements have been preserved. Thus, the regularity in elevation parameter S_{03} is 50, see Table 1.
- The steel ties connecting the timber ceilings and the walls were in bad condition throughout the building, thus leaving sub-parameter $S_{04,1} = 5.0$. Furthermore, the brick faults above the basement were also in bad condition, i.e. $S_{04,2} = 5.0$. According to Table 1 multiplication of $S_{04,1}$ and $S_{04,2}$ yields the horizontal stiffness parameter $S_{04} = 25.0$.

Fig. 5 **a** Floor plan of the 1st floor, **b** floor plan of the 2nd floor, and **c** section of the object “Währinger Gürtel 164”

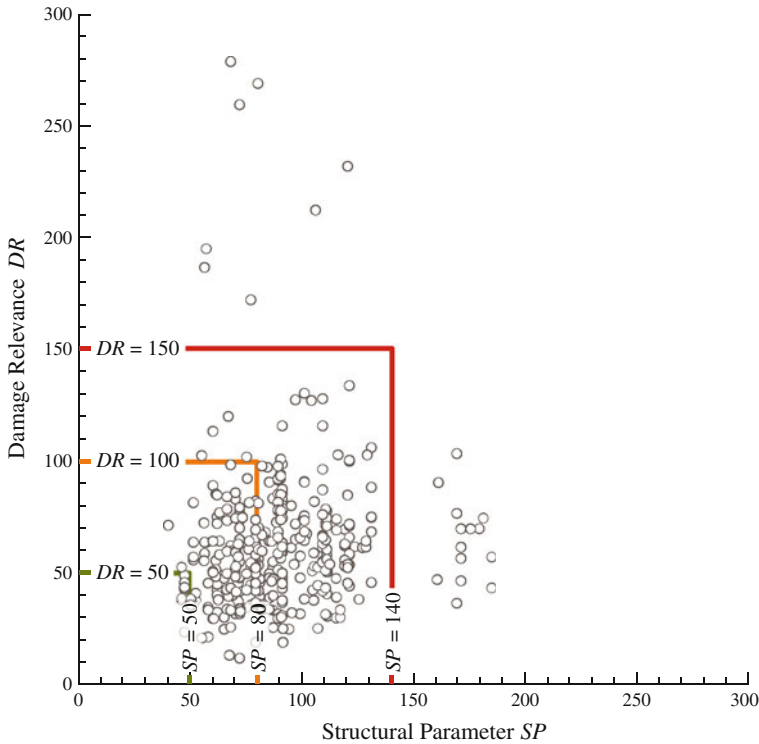
In Fig. 7 the Damage Relevance DR is plotted against the Structural Parameter SP for each inspected building of this large-scale application. This figure reveals that the outcomes of the experiment show a precise separation of Vulnerability Classes $VCIII$ and $VCIV$ either in

Fig. 7 Damage Relevance DR of various buildings plotted against the corresponding Structural Parameter SP . Pilot area in the 20th district of Vienna

terms of the Damage Relevance DR or the Structural Parameter SP . Hence, inspected objects classified into Vulnerability Class $VCIV$ either have a comparatively high Damage Relevance DR , predominantly caused by the high number of exposed persons within the building, or have a very high Structural Parameter SP , which can be only generated by an irregularity in elevation. According to Fig. 7 most of the inspected objects were classified into Vulnerability Classes $VCII$ or $VCIII$ without any precise separation between those classes. The main reason for that is the relatively large number of different individual parameters, which enter DR and SP , and hence, the benchmarks of a single parameter at a specific building may vary significantly.

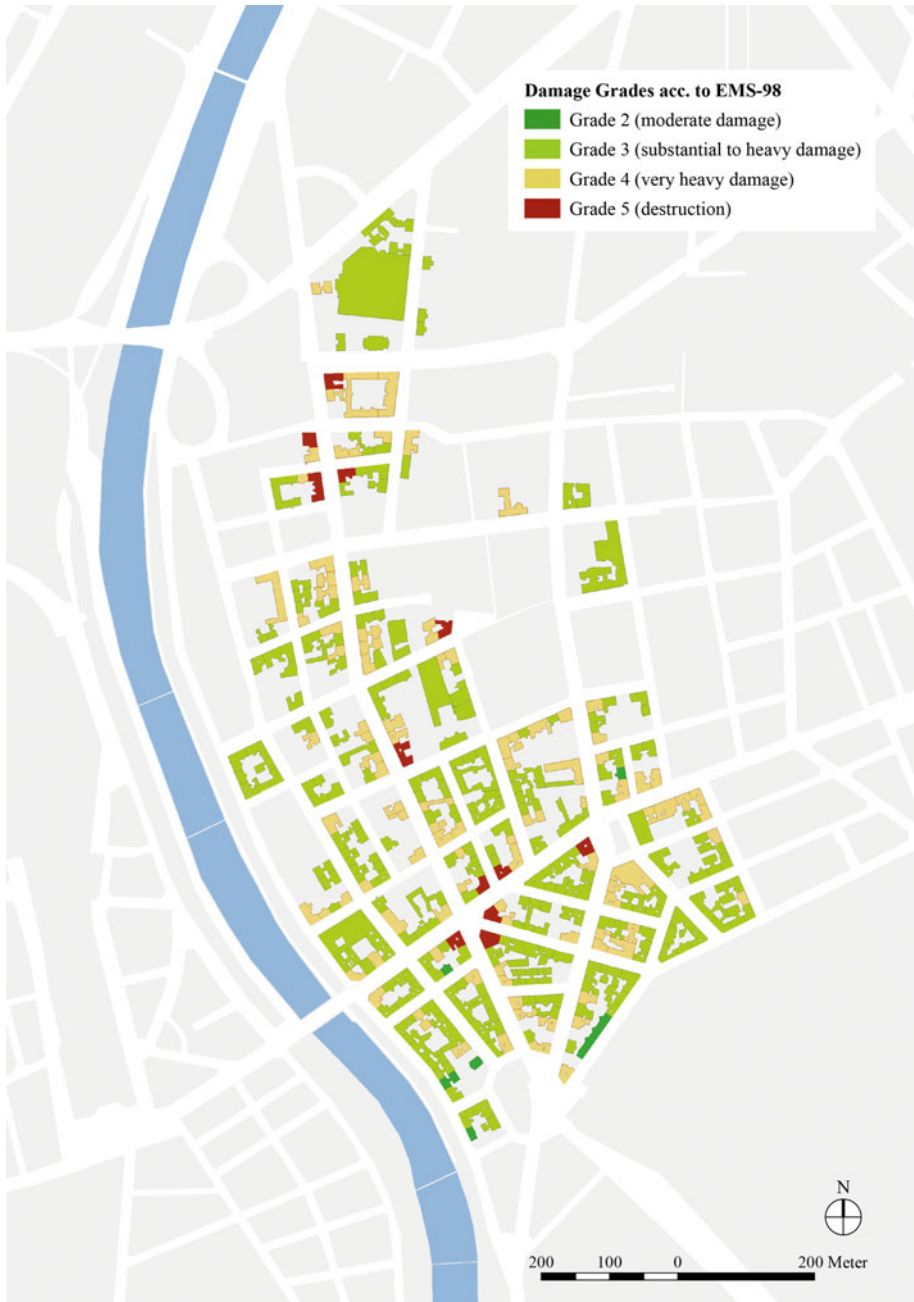
Fig. 11 Assessed damage grades according to EMS-98 of the inspected objects in the pilot area

and rapid prediction of the possible impact of a certain earthquake with moment magnitude $M_w = 6.3$ on the inspected buildings. An illustrative presentation of the results from the investigated pilot area leads to the map of the predicted damage scenario shown in Fig. 11.
