Performance of the L'Aquila (central Italy) gas distribution network in the 2009 (M_w 6.3) earthquake

Simona Esposito · Sonia Giovinazzi ·
Ludovica Elefante · Iunio Iervolino

Received: 28 December 2012 / Accepted: 23 June 2013 / Published online: 2 July 2013
© Springer Science+Business Media Dordrecht 2013

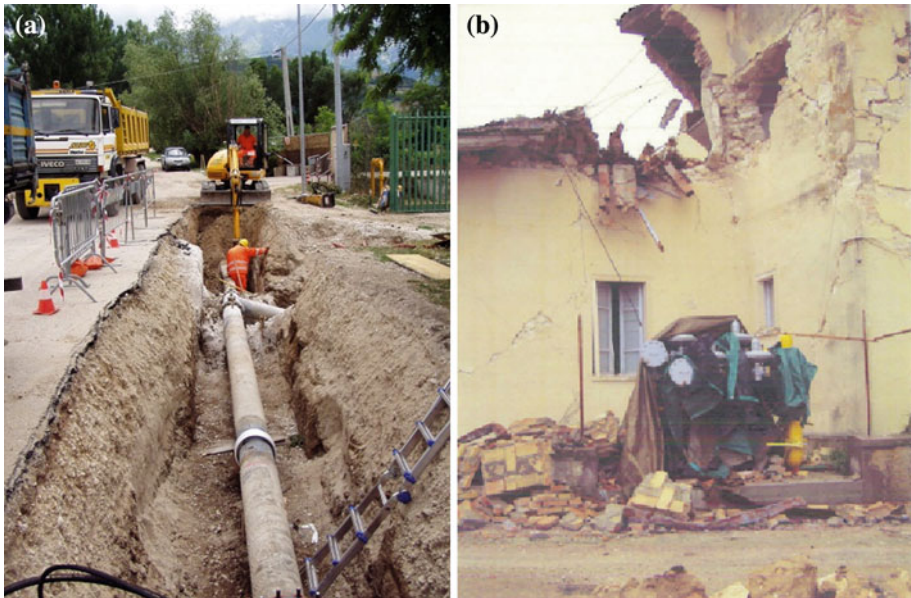
Fig. 4 Damage to stations: **a** repairs to the input/output network of Onna M/R and inclusion of stop-system; **b** RG housed in a masonry kiosk closed to building and damaged following the 6 April 2009 earthquake (photos courtesy of ENEL Rete Gas)

- M/R station in Onna: gas leak reparations including excavations, welding joints with special pieces like dielectric joints, welding pipes and recovery steel/polyethylene piping connections (Fig. 4a).
- M/R station in Centi Colella: valve replacements and input/output substation network repair.
- M/R station in Sassa: no post-earthquake interventions according to *EIE* reports analysed.

Few RGs in L’Aquila and Onna had to be replaced concurrently with the laying of new pipe. One of the principal causes of earthquake-induced damage to different typologies of RG stations was the collapse of rubble from adjacent buildings (Fig. 4b).

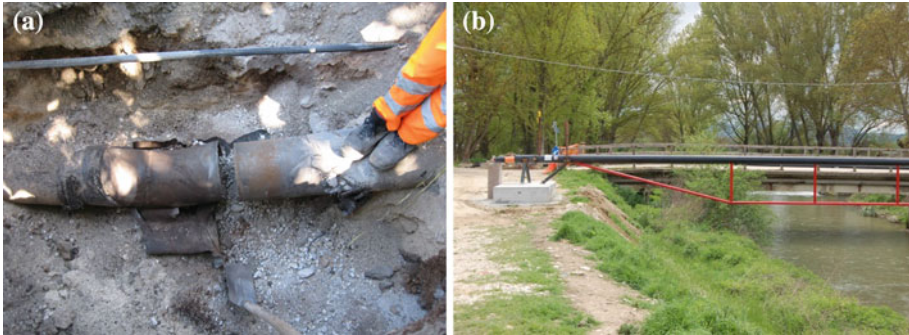
Fig. 6 Damage to gas pipes following the L’Aquila earthquake: **a** gas welded joint of a LP steel pipe pulled apart in Paganica (AQ); **b** gas pipe connected to a damaged bridge in Onna (AQ) replaced with a stand-alone pipe (photos courtesy of ENEL Rete Gas)

dence of the gas welded joints (Fig. 6a). One of the pipe of the MP distribution network, connected to a damaged bridge in Onna, was replaced with a new stand-alone supported on either side of the crossing by two new concrete abutments. The pipe was rigidly connected to the abutment with no flexible connection between the pipe and the bridge foundations (Tang and Crooper 2009). A flexible join for the river crossing pipe would have been preferable solution (Fig. 6b).

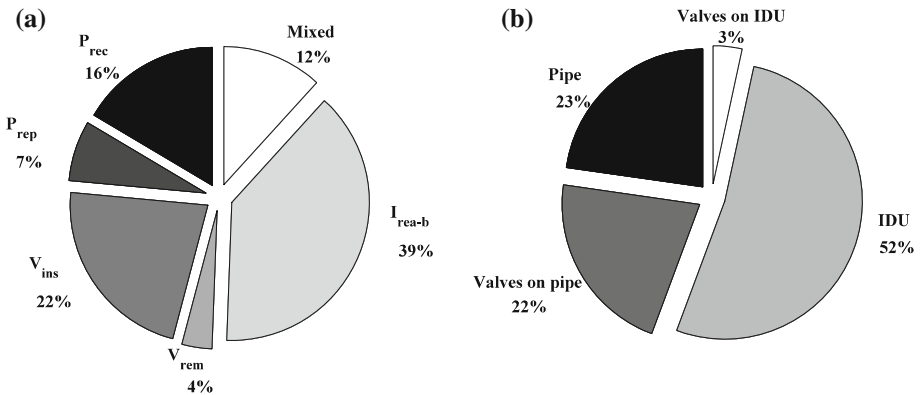
Fig. 7 Repair operations addressing damage to buried components for the portion of the gas network located in Zone 1: **a** number of repairs for six intervention categories; **b** number of repairs for different buried components

Figure 7a shows the percentages for the six macro categories associated with the repair operations to buried components (Table 1, excluding first row) for the portion of gas network

located within the selected area (Fig. 8). Figure 7b groups the same percentages for the four buried system components considered in this analysis, namely: pipe; service laterals (IDU system); valves along pipes; and valves along IDU systems.

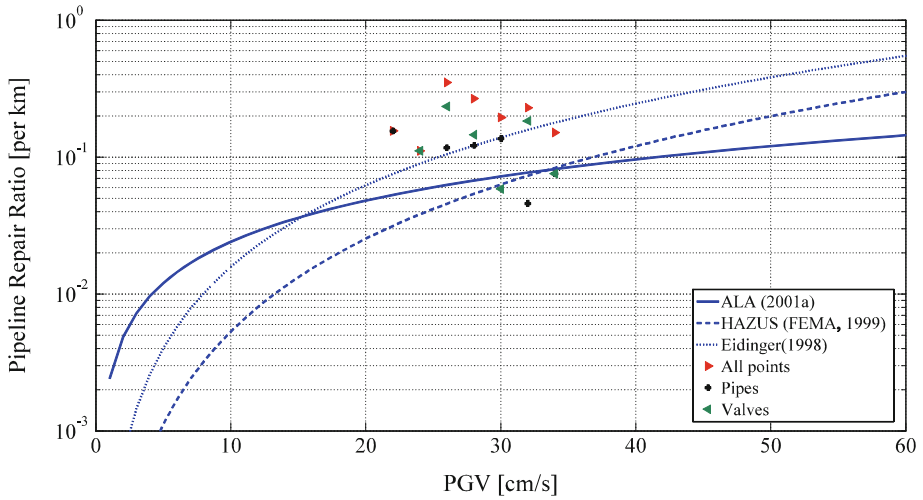
Figure 9 shows that the repair rates trend estimated for L'Aquila seems somewhat underestimated by existing fragility curves; however, it must be highlighted that the considered fragilities relations have been obtained combining data from different kinds of pipes (e.g., ALA 2001b). Moreover, the different sources of uncertainties related to PGV values and repairs may have influenced the results obtained. The estimates of repair rates were in fact based on *Shakemap*TM to retrieve local ground motion intensity; these are large-scale emergency management tools affected by large uncertainty. Finally, repair reports analyzed for the damage assessment are not post-earthquake standardized forms, and the processing could be affected by missing data or inaccuracy of the maintenance technicians.

Fig. 9 R_R -PGV points compared with some existing fragility curves

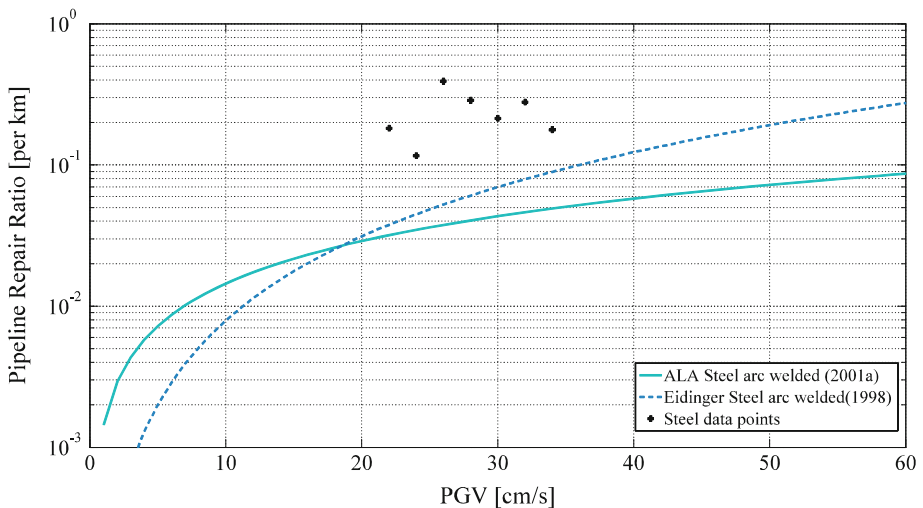
Regarding the comparison as a function of pipe material, Fig. 10, the repair rate trend observed in L'Aquila is larger with respect to existing fragility curves. A reason may be that selected fragility relationships were derived for arc-welded joints steel pipes. L'Aquila network, in the selected area, is instead characterized by gas welded steel pipes (for which fragilities are unavailable in literature) that, according to Ballantyne (1995), are more vulnerable to earthquakes with respect to arc-welded joint. Moreover, also in this case, the different sources of uncertainties related to PGV values and repairs may have influenced the results obtained.

Fig. 10 R_R -PGV with respect to pipe material
