Performance of buildings with masonry infill walls during the 2011 Lorca earthquake

Lutz Hermanns · Alberto Fraile ·
Enrique Alarcón · Ramón Álvarez

Received: 24 February 2012 / Accepted: 29 July 2013 / Published online: 9 August 2013
© Springer Science+Business Media Dordrecht 2013

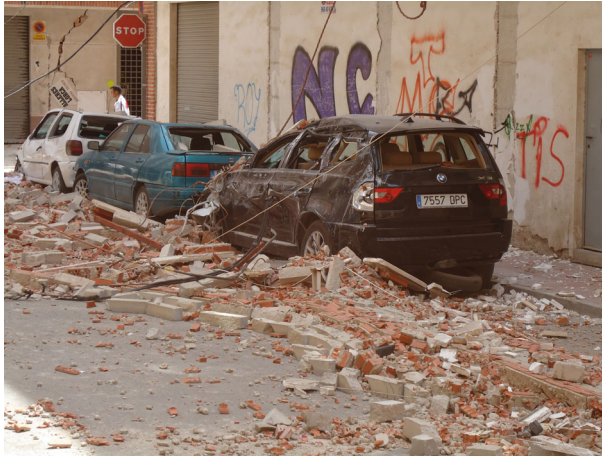
Fig. 1 Street covered with rubble of damaged buildings

As can be seen in Fig. 1 rubble was strewn across the streets from damaged buildings. Actually pieces of the facades that fell down during the earthquake injured a lot of persons. In some occasions façade infill panels located at upper floors and roof parapets collapsed and fell onto the ground. Two different failure mechanisms are thought to be responsible for their collapse.

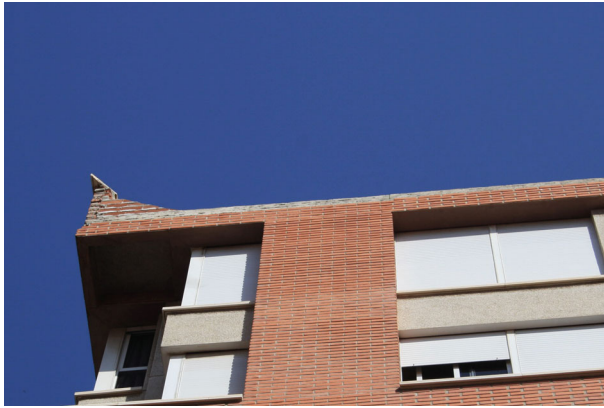
Fig. 2 Building with a partially collapsed parapet wall

The structure of this particular building did not suffer significant damage whereas the roof parapet almost completely collapsed. This type of incoherence in terms of the seismic behavior of different components of the same building is unacceptable.

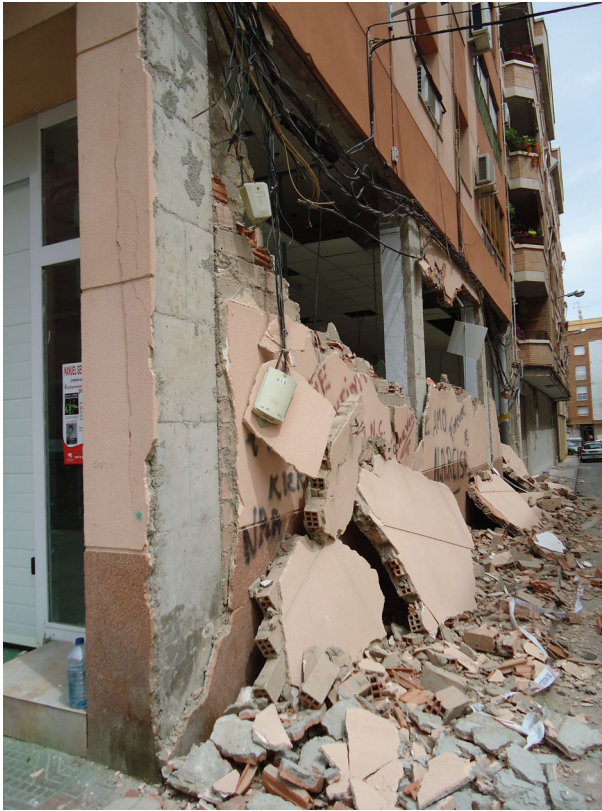
On lower floors the failure of masonry infill panels was caused by excessive in plane loads, displacements of the frame structure (see Fig. 3) and in some cases by pounding of adjacent buildings.

Fig. 3 Damaged masonry infill walls at ground floor

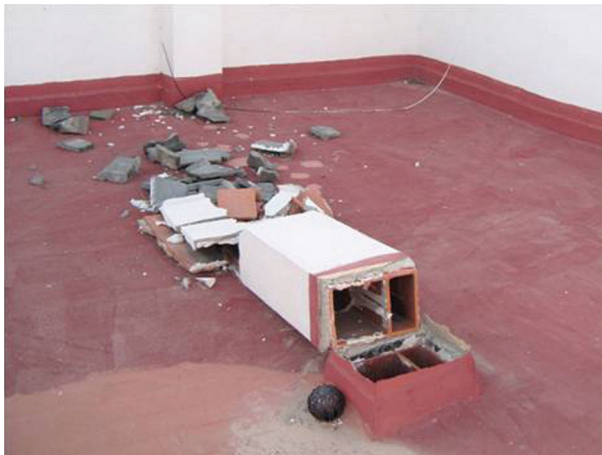
Fig. 6 Collapsed chimney on a flat roof

Not only parapet walls failed at this load level but also chimneys as can be seen in Fig. 6.

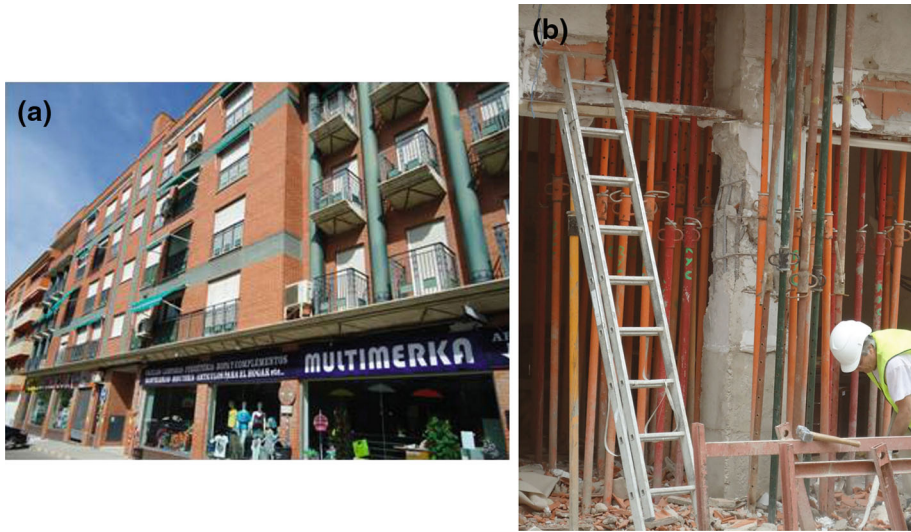
Fig. 7 a Buildings with a soft-storey, b severely damaged column

- Soft storey mechanisms due to infill panels with lower stiffness at the ground floor level and panels with higher stiffness at upper floors (see Fig. 7a).

- Masonry infilling effect on frame columns (see Fig. 7b). The horizontal displacements of the frame columns are restricted due to the presence of the infill wall. The reduced height of the column increases the forces the column experiences during a seismic event.

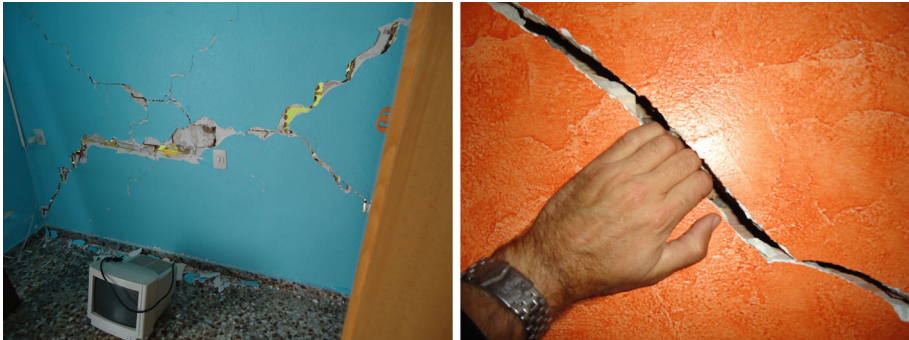
This simple example may explain the high number of damages observed in infill and partition walls (see Fig. 11).

Fig. 11 Examples of damaged partition walls during the Lorca earthquake

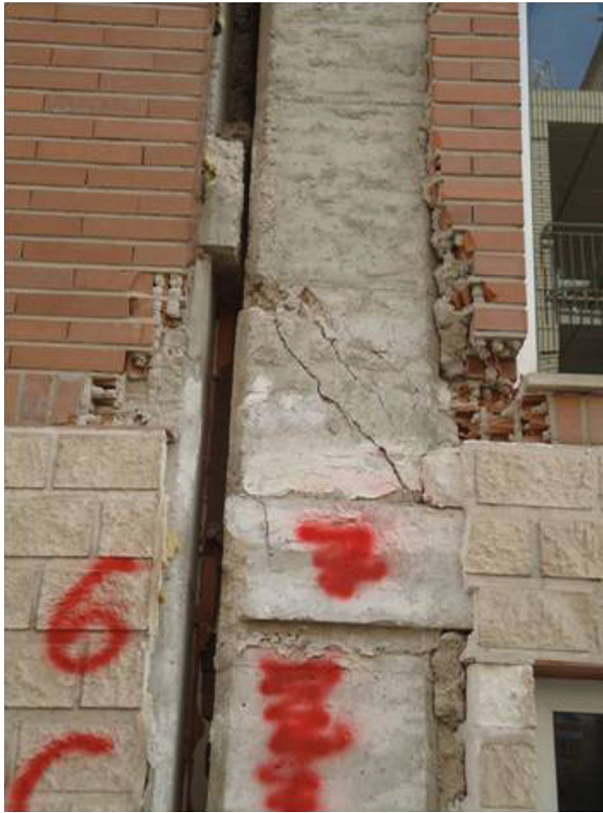
In Fig. 12a the mode shape corresponding to the model with intact infill panel at ground level is shown and in Fig. 12b the one corresponding to the model with the damaged infill panel at ground level. In Fig. 13 an example is presented where two buildings pounded resulting in damaged façade elements. Pounding occurred at the floor level of the first floor as a consequence of the reduced lateral stiffness of the ground floor of one of the buildings. The reduction in stiffness was due to a cracked infill panel at ground level.

Fig. 13 Example of buildings that suffered damage due to pounding effects

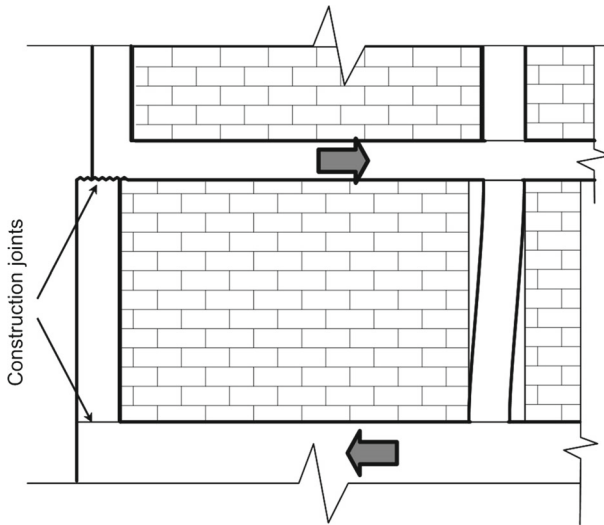
Fig. 16 Failure at the construction joint of beam–column connection

Construction joints in columns are usually located at the undersides of the slabs and beams as shown in Fig. 16.

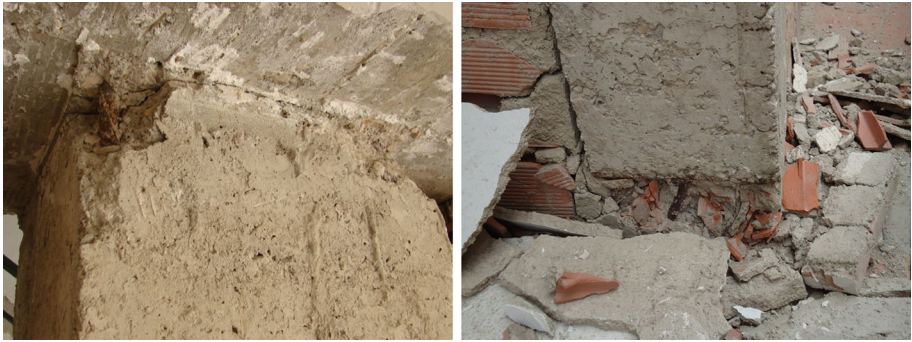
Failures of the contact surface were observed in several occasions (see Fig. 17).

This type of failure was observed particularly often in end bays of the exterior RC frames.

Fig. 17 Examples of failure at the construction joint of a beam–column connections

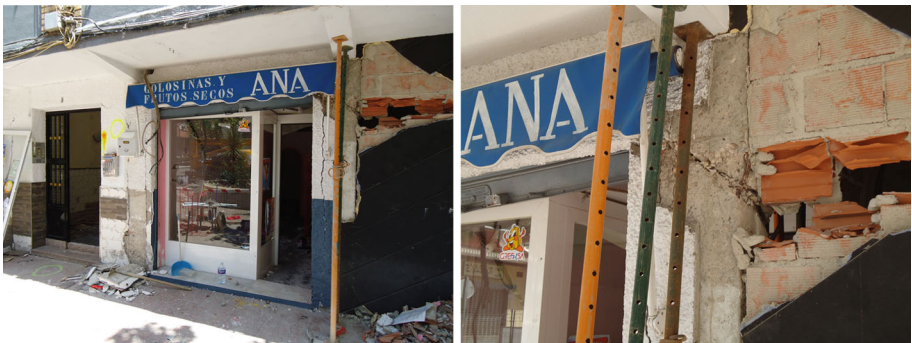
Fig. 19 Example of a shear-damaged column due to the failure of the adjacent infill panel

The formation of two struts may be favored by the existence of conduits, openings or other discontinuities in the infill panel (see Fig. 19).

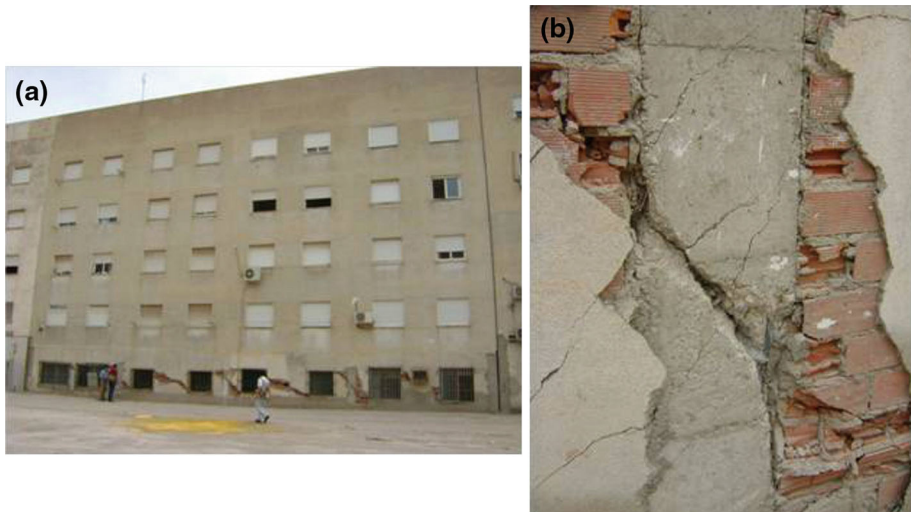
Fig. 20 Example of cracks crossing a column at mid-floor height. **a** Building, **b** detail

In general crack propagation in the infill panels indicates the position of the traction diagonal that connects two beam–column connections however, in some cases the cracks in the infill panels developed laterally displaced crossing the column at mid height like in Fig. 20b.
