Seismic performance of masonry residential buildings in Lorca's city centre, after the 11th May 2011 earthquake

Luisa Basset-Salom · Arianna Guardiola-Víllora

Received: 21 December 2012 / Accepted: 19 November 2013 / Published online: 1 December 2013
© Springer Science+Business Media Dordrecht 2013

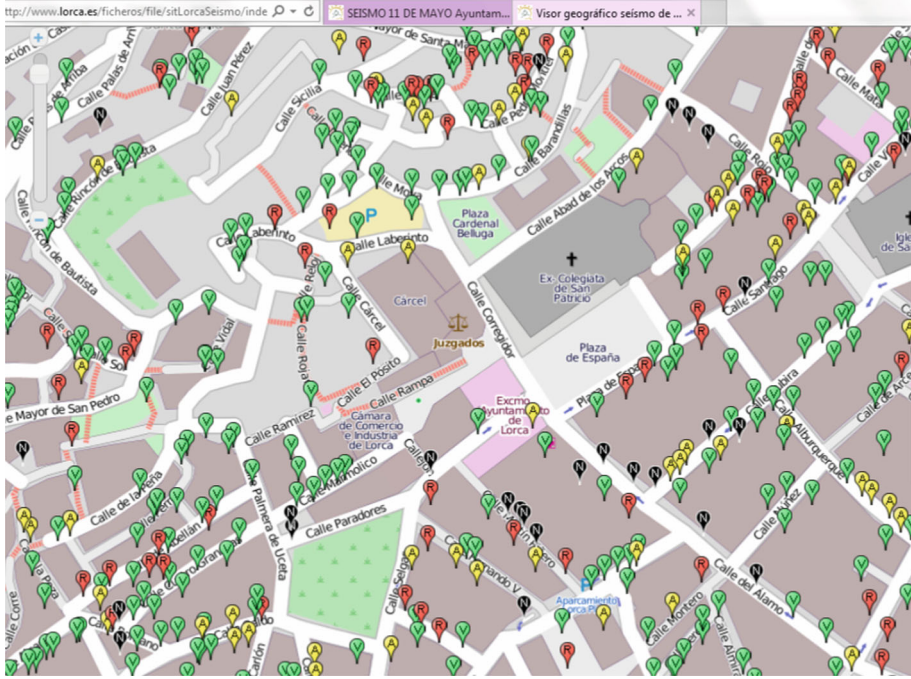
Fig. 1 Damage building location and classification: *Black*, N (collapsed or to be demolished, 4.2%), *red*, R (significant structural damage, 8.85%), *yellow*, A (low to moderate structural damage, significant to moderate non-structural damage, 17.08%) and *green*, V (without structural damage, low to moderate non-structural damage, safe for normal use, 69.87%). Source: Lorca’s City Council 2011

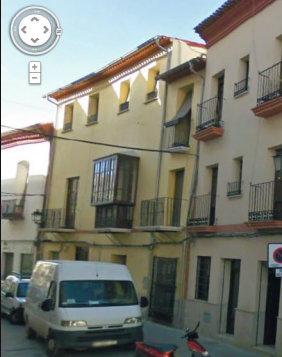
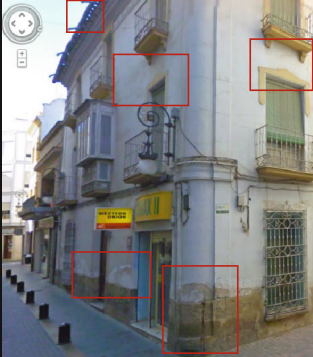
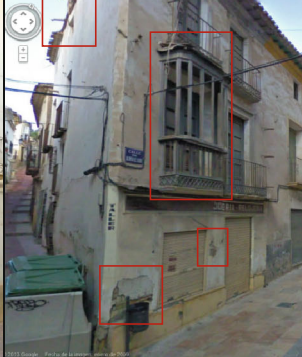
Table 2 Maintenance level of the surveyed traditional residential buildings, before the earthquake (Google Street View)

<p>Good maintenance level: Neither cracks nor moisture</p>	<p>Medium maintenance level: Slight cracks in the plaster, a few roof tiles are broken or have fallen off</p>	<p>Bad maintenance level: Cracks in walls, mortar loss, partial failure of roof overhang, moisture and efflorescence in walls, water infiltration.</p>

Traditional masonry residential buildings showed big differences in their maintenance level (see description in Table 2). This aspect is a determinant factor in their seismic response, not only for the building itself, but also due to the lack of the stabilizing contribution of neighbouring cells (Carocci and Lagomarsino 2009; Basset-Salom and Guardiola-Villora 2013). The majority of the observed masonry façades, 58 %, have a good maintenance level, 30 % medium and only 12 % bad, corresponding to abandoned buildings.

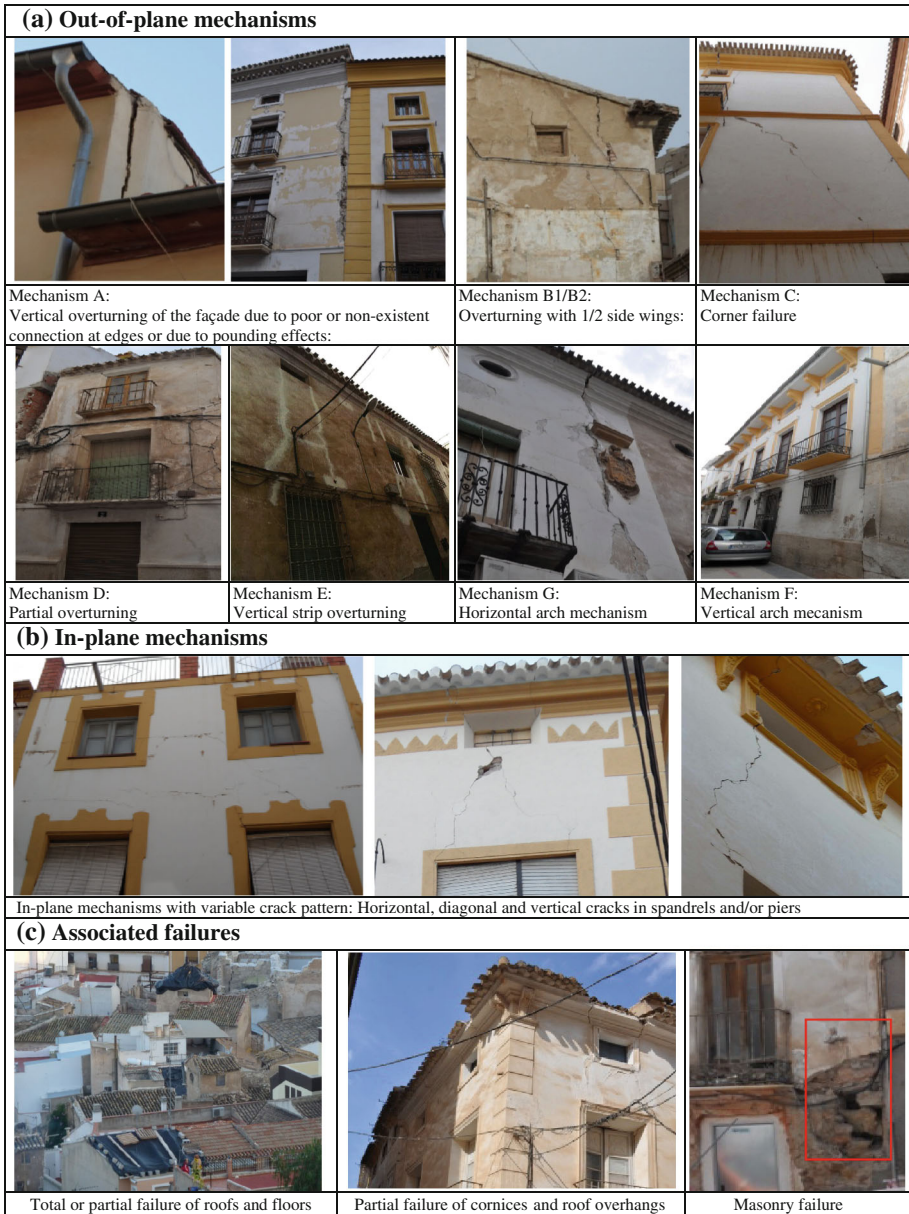
In addition to out-of-plane and in-plane collapse mechanisms, other associate failures have been documented (Fig. 12c): total or partial failure of roofs and floors, partial failure of cornices and roof overhangs and, finally, masonry failure.

Out-of-plane collapse mechanisms involve, sometimes, roofs and floors, causing their total or partial failure, due to the out of plane movement of the façades. This effect is increased when horizontal structures and walls are poorly connected or when the wooden elements are badly preserved. One of the most extended damage in the area is the partial failure of cornices and roof overhangs, showing their inadequacy in seismic regions and the poor effectiveness of the stone corbels or iron brackets designed to improve their behaviour. The occurrence of localized masonry failure in some buildings is due mainly to the poor quality and irregularity

Fig. 12 Collapse mechanisms observed in the surveyed area: **a** out-of-plane mechanisms, **b** in-plane mechanisms and **c** associated failures

of the rubble stones, the insufficient bond between stones and mortar, the lack of transversal compactness and the deficient connections between the different wall leaves.

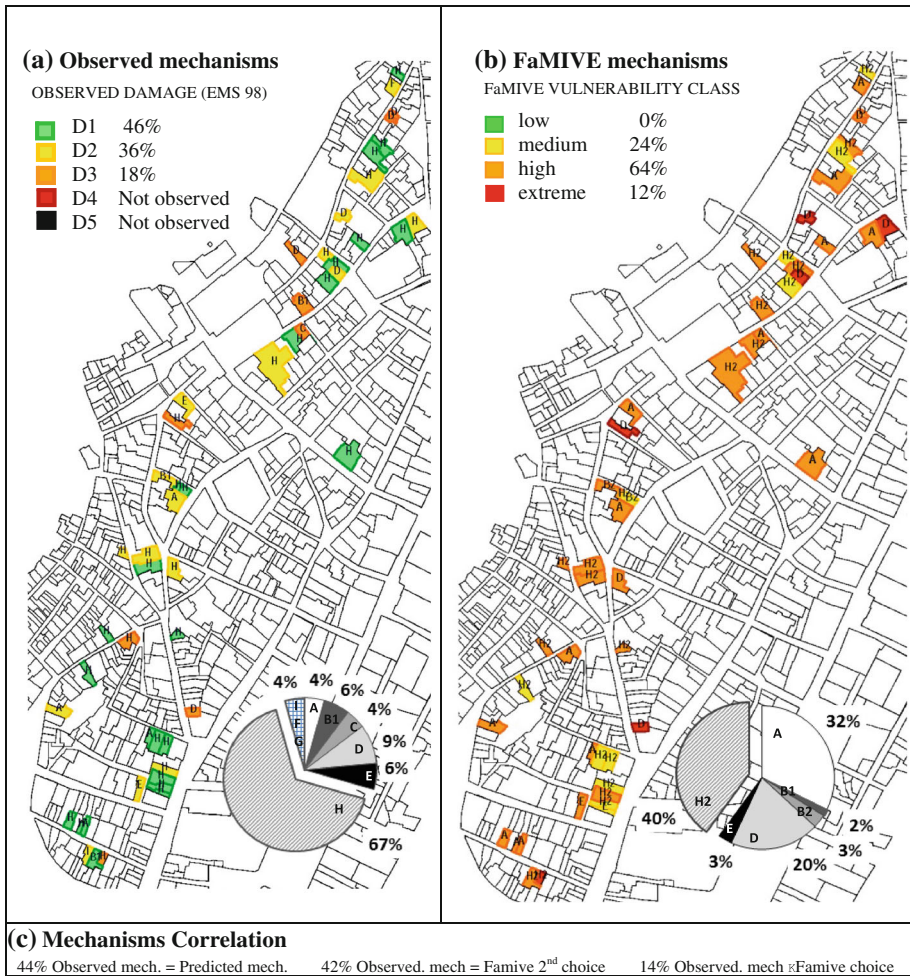
The correlation has been established not only between the observed mechanism and the first FaMIVE proposed mechanism but also with the second FaMIVE choice: 44 % of the observed mechanisms are predicted as the prevalent ones, while 42 % correspond to the second choice. Not matching prediction represents only 14 % (Fig. 16c).

The main difference is that the percentage for observed out-of-plane mechanisms (33 %) is lower than the corresponding percentage for the predicted ones (60 %). As has been proved in previous studies about the seismic performance of similar masonry buildings, when façades are prevented from overturning by efficient connections between orthogonal walls, the most probable collapse mechanisms would be the in-plane ones, however, the façade will fail with an out-of-plane mechanism when there is lack of connection. During the survey, it has been very difficult to establish in some buildings the presence of internal strengthening devices and their efficiency. In absence of accurate information, this uncertainty has been taking into account considering that the walls were poorly connected and assigning a low level of reliability in FaMIVE inspection form. Therefore, differences in the collapse mechanism prediction can be explained by the unnoticed presence of restraining elements that are preventing the occurrence of out-of-plane mechanisms.

Fig. 16 a Observed collapse mechanisms and damage levels, b FaMIVE predicted collapse mechanisms and vulnerability classes and c mechanisms correlation

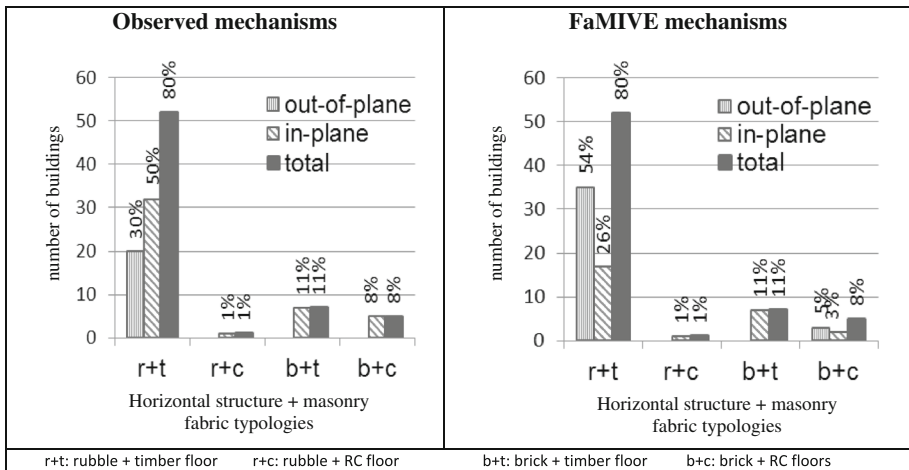
To explain better the differences between FaMIVE predictions and surveyed damage, a comparison has been made depending on the horizontal structure and the masonry fabric typologies (Fig. 17), showing that differences correspond to rubble masonry walls with timber floors (out-of-plane mechanisms: 30% observed, 54% predicted and in-plane mechanisms: 50% observed, 26% predicted).

Quality, dimensions and construction characteristics of masonry fabric are relevant factors in seismic performance, being rubble masonry walls the most difficult to characterize. The average size of rubble walls units and overlap data have been obtained directly from open cracks in the façades or from demolished nearby buildings or party walls. On the other hand, despite the fact that observed walls were neither uniform nor homogeneous, the same unit sizes and overlap have been considered for all rubble façades.

Fig. 17 Observed and calculated mechanisms depending on horizontal structure and masonry fabric typologies

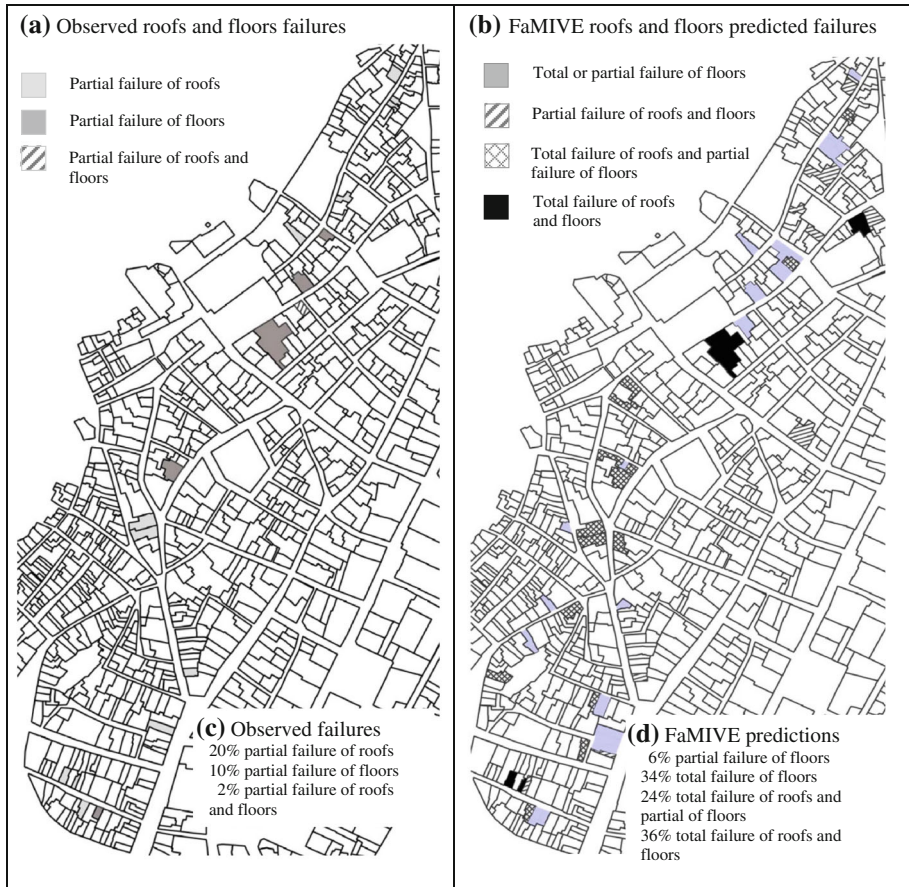
Observed or predicted partial or total failure of the roofs and floors are mapped in Fig. 18a, b, respectively. Regarding FaMIVE the percentage of horizontal structures involved in a partial or total failure is clearly higher than the percentage of the observed collapses. As the survey has been generally carried out from the exterior (either for security reasons or due to the absence of inhabitants), data reliability in this specific subject is the lowest one. Therefore the percentage of real collapses might be possibly higher.

Fig. 18 Observed and predicted roofs and floors failures

A proper maintenance of façades and roofs might avoid building decay resulting in a better seismic performance in accordance with their expected strength, preventing water infiltration and ensuring preservation of wooden elements and strengthening devices conditions.
