# Structural damage in the cities of Reggiolo and Carpi after the earthquake on May 2012 in Emilia Romagna

Marco Andreini · Anna De Falco ·  
Linda Giresini · Mauro Sassu

**Abstract** This paper addresses the structural damage to the main buildings of the cities of Reggiolo and Carpi after the primary earthquake shocks on May 20th and 29th, 2012, in Emilia Romagna. The damage survey, performed via form-based methods, highlights the different seismic behaviour of several types of buildings, especially those having historical features, and the consequences of the damage in terms of costs. Moreover, an analysis of some failure mechanisms activated in Reggiolo enables the evaluation of the local peak ground acceleration, due to the soil amplification.

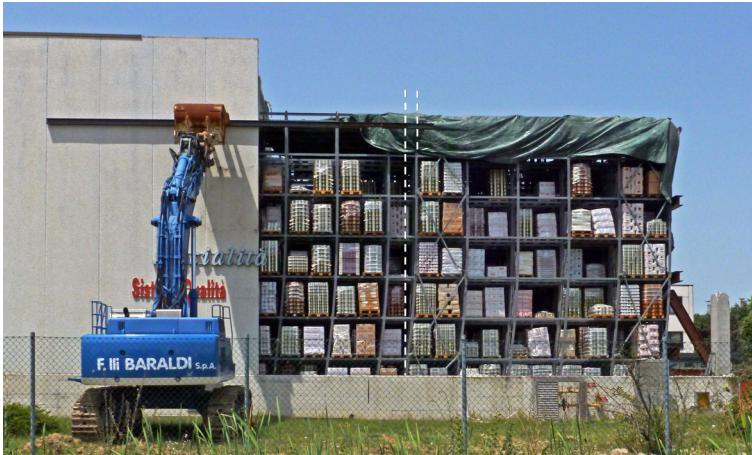
**Fig. 2** Warehouse in Medolla

As emblematic case, a heavily damaged warehouse near Medolla is reported in Fig. 2 which shows an excavator used to provide additional support to the reinforced concrete (r. c.) panels left standing. Besides the collapse of the precast building structure with heavy r. c. panels, the high flexibility of the vertical elements of the interior steel stand, which were heavily loaded and insufficiently braced, triggered a second order P- $\Delta$  effect, which in turn produced considerable lateral displacements of the metallic structure and strong deformation of the vertical braces.

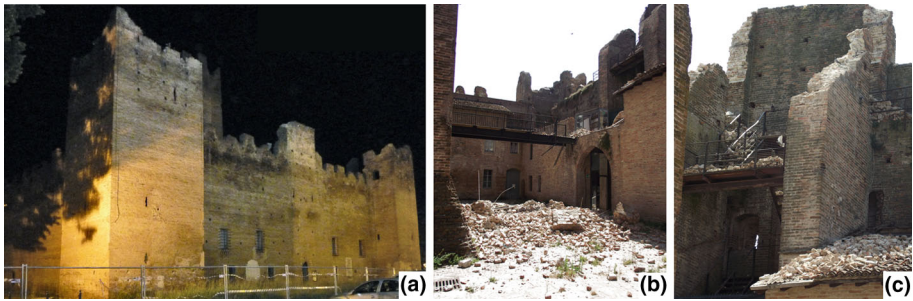
Many damage mechanisms are clearly visible from the outside, including out-of-plane rotations of wall portion, masonry corners or entire façades and, less frequently, collapse of the outer leaf of walls. A large number of buildings have been declared unusable, even though lacking any significant failures. Some examples of old constructions with striking damage are “*la Rocca*” (Fig. 4a), the old Town Hall (Fig. 5) and the retirement home *Santa Maria delle Grazie* (Fig. 6). *La Rocca* was built in the early thirteenth century by the Municipality of Reggio Emilia to defend the city against Mantova. It is a squared brick masonry fortress with four towers at the corners and a main 34 m-high central tower, now the property of the Municipality. The structure was damaged by the 1985 earthquake, restored in 1995 and until 2012 earthquake had been used for guided tours and public events. The damage caused by the earthquake are significant: collapse of merlons and free walls made it completely unusable (Fig. 4b, c).

**Fig. 4** The medieval fortress *la Rocca di Reggiolo*—**a** external view; **b**, **c** masonry fragments after the collapse

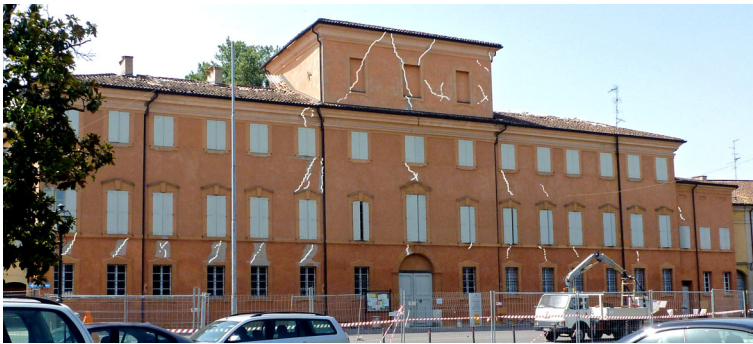
**Fig. 5** *Palazzo Sartoretti*—the old Town Hall (the main façade heavily damaged)

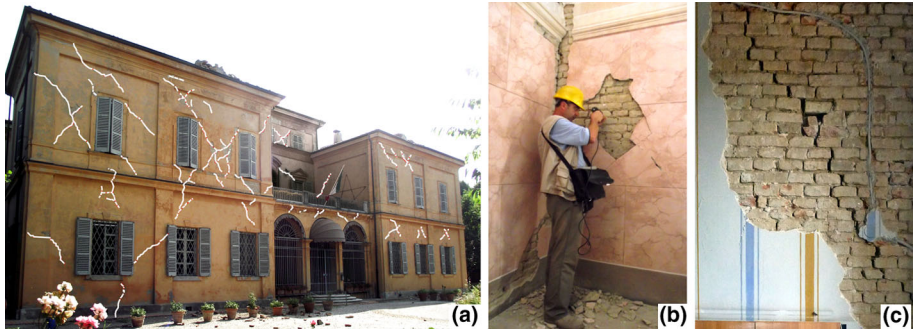
The resulting compressive strength values of the mortar detected in the three buildings were between 0.3 and 0.7 MPa—quite low for ordinary limestone mortar. Chemical-physical analyses were also carried out on mortar. In particular, petrographic analysis and x-ray diffractometry showed an earthy mixture consisting of a clay matrix having a sandy component with size below 0.3 mm. This mortar can therefore be referred to as a raw mixture of clay and sand (Fig. 7).

Fig. 6 Retirement home—a external view; b PNT-G tests; c crack pattern

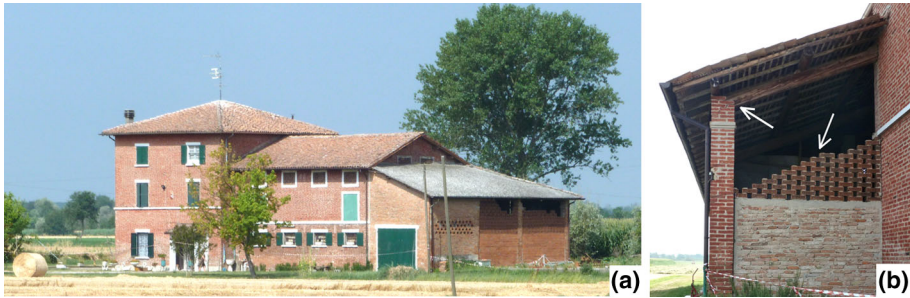
The observed damage has shown that rural dwellings were much less weakened than stable-haylofts and local canopies. In fact, porticos and haylofts present typically external hollow brick walls and isolated masonry piers or masonry walls which support the roof (Figs. 8b, 9). These elements constitute a major source of vulnerability due to the slenderness of the

**Fig. 8** **a** a typical rural house in Reggiolo; **b** the portico with collapsed hollow brick wall and cracked masonry pillar

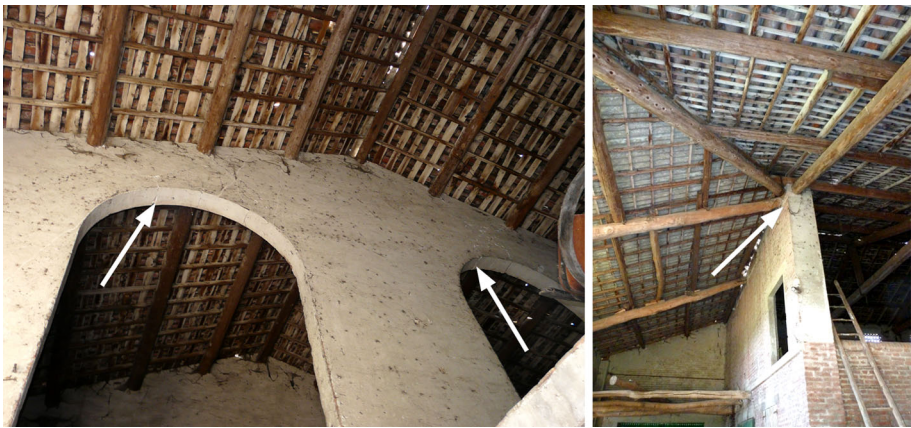
**Fig. 9** Different structures of the roof in the haylofts—arrows indicate damage

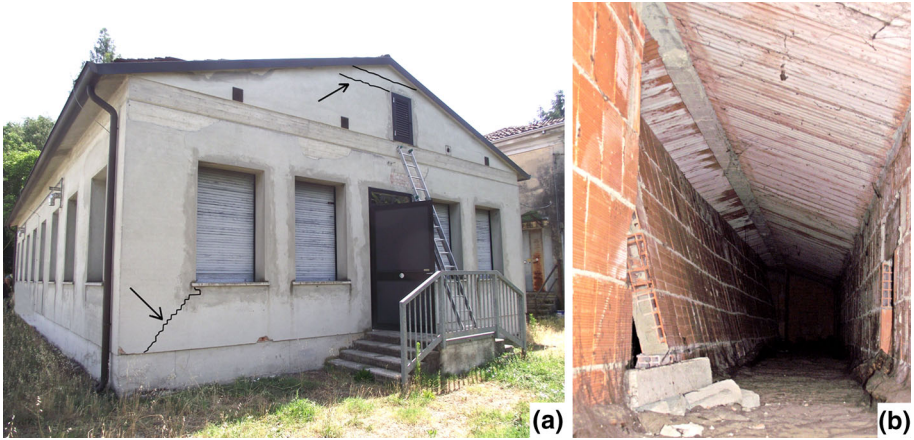
It is worth noting that most r. c. constructions—generally built after the 60s—underwent damage to non-structural elements, especially in the external clay unit panels. Since the survival of r. c. structures during the earthquakes has sometimes been ensured by the presence of infill walls (Decanini et al. 2012a, b); their cracking, although slight, had sometimes determined a bad usability outcome. The most frequently activated collapse mechanisms are out-of-plane ones and slight in-plane cracking. Often damage is mostly concentrated at the ground storey, due to irregular distribution of the infills. In some cases, the hollow brick walls sustaining the coverage elements collapsed and caused damage to the roof, as in the Social Centre (*ex officine IPSIA*, Fig. 10).

**Fig. 10** Social Centre—**a** external view; **b** overturning of the upper masonry roof walls

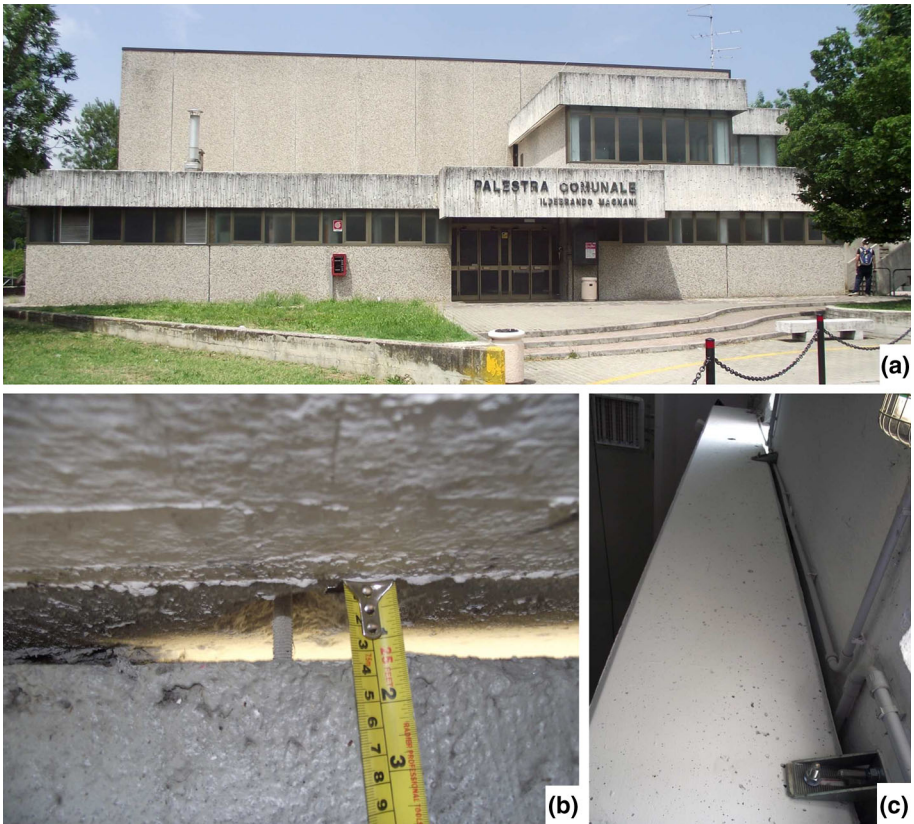
There are no serious collapses in r. c. precast structures, but the vulnerability of some public buildings is evident, such as the *Bambi-Peter Pan* Kindergarten. As for the Social Centre and the Magnani sports hall (Fig. 11), incipient tilting of the external panels is avoided only by thin metal bars.

**Fig. 11** Magnani sports hall—**a** general view; **b**, **c** details of the connections of the panels

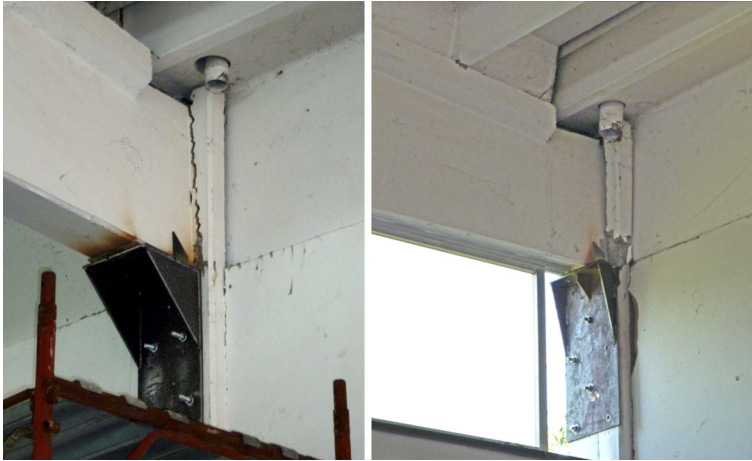
**Fig. 12** Textile factory in Reggiolo: reinforcement added to the support of a precast beam after the earthquake

Figure 12 shows a reinforcement added to the support of a precast beam in a textile factory in Reggio: in order to return to work as soon as possible, the owners repaired the damaged structural elements before the arrival of DPC inspectors.

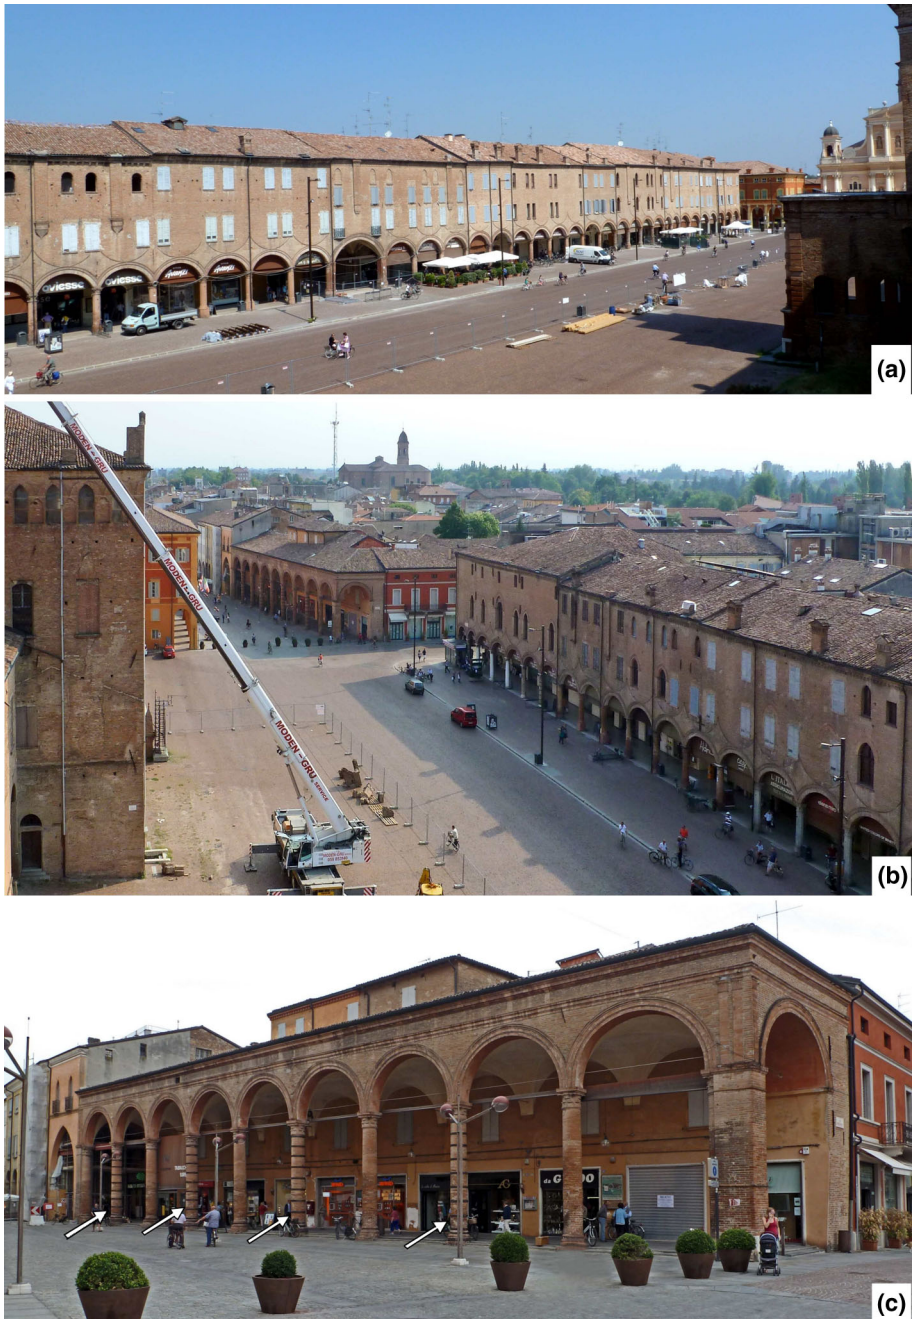
**Fig. 13** **a** The *Portico Lungo* in *Piazza Martiri* seen from the south; **b** an overview of the *Piazza Martiri* arcades from the north; **c** *Portici del Grano* in *Via Alberto Pio*: arrows indicate the columns that have been consolidated

The earthquakes did not cause noticeable damage to the porticos, thanks to the transverse and longitudinal tie rods. The arcades of the age-old *Portici del Grano* were also undamaged, but following the earthquakes the columns were nonetheless consolidated with alternating external metal hoops (Fig. 13c).

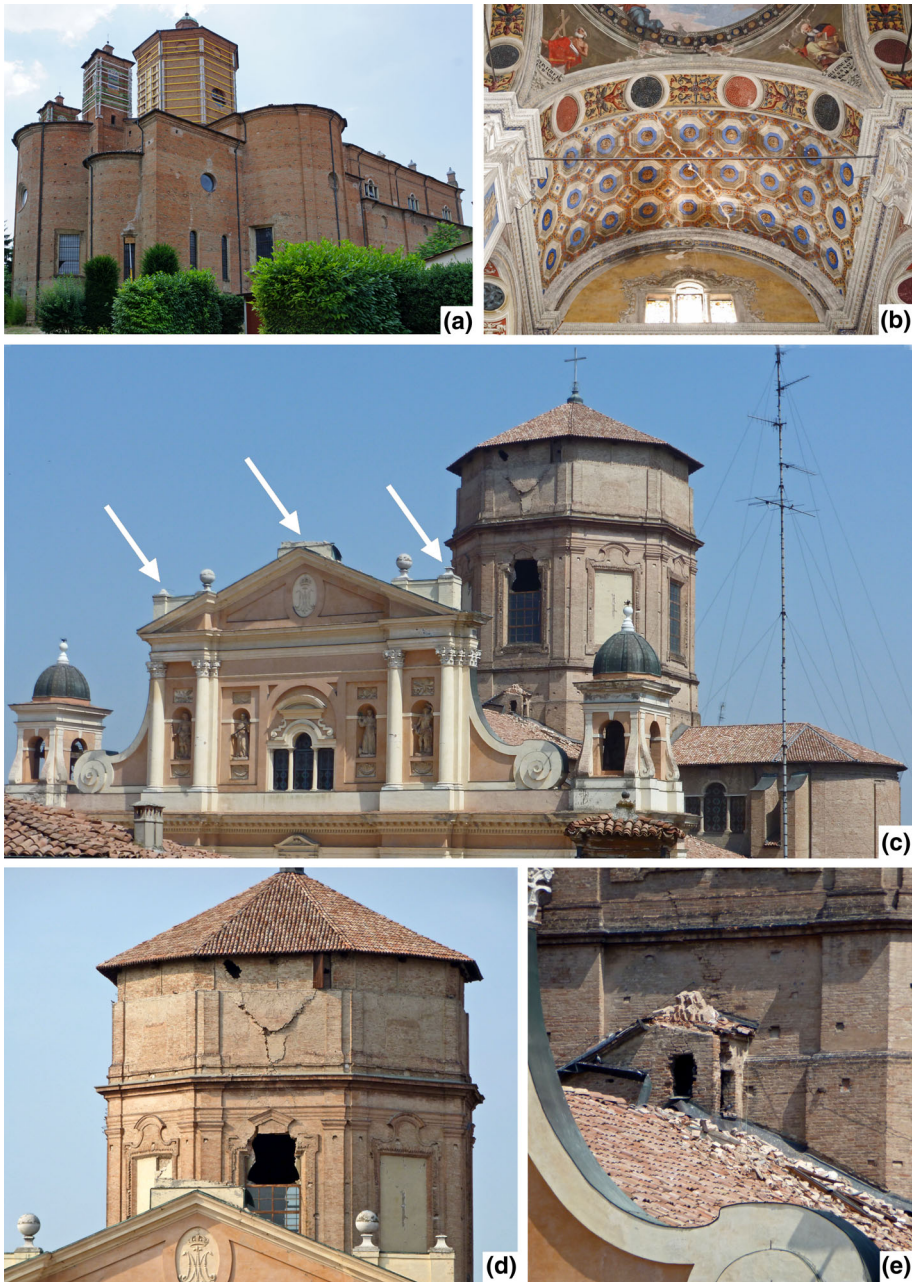
**Fig. 15** **a** Rear side of *San Nicolò* church; **b** new and existing damage in the barrel vault in *San Nicolò*; **c–e** cathedral of *Assunta*: fallen ornaments and damage to roof and dome

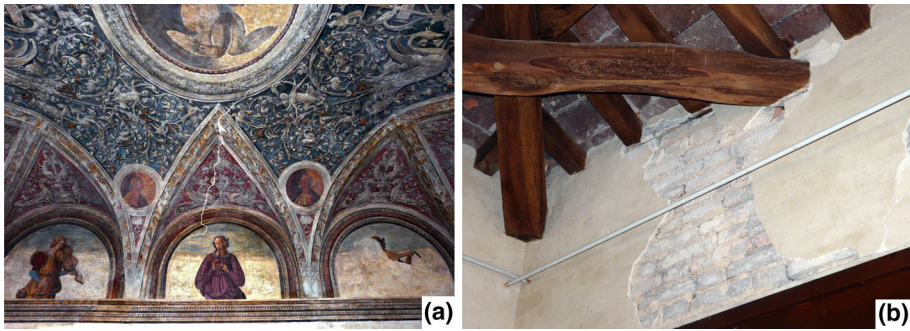
**Fig. 17** *Palazzo dei Pio*—**a** frescoes with cracks. **b** extraction of a roof beam on the upper level of *Torre del Passerino*

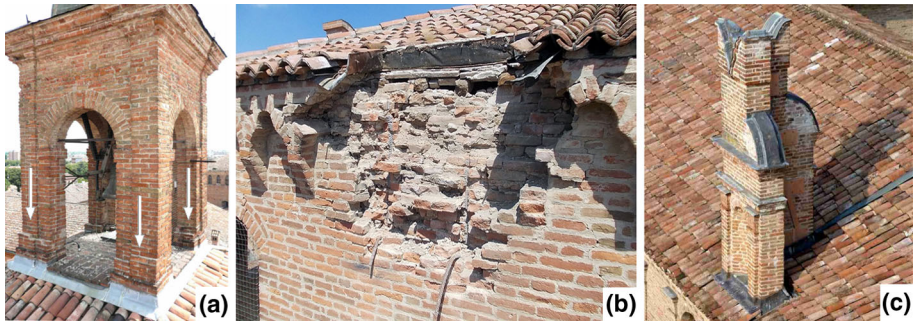
**Fig. 18** *Palazzo dei Pio*—**a** bell tower atop the *Torre dell’Orologio* **b** collapsed merlon on the *Torre del Passerino* **c** consolidated merlon on the main façade

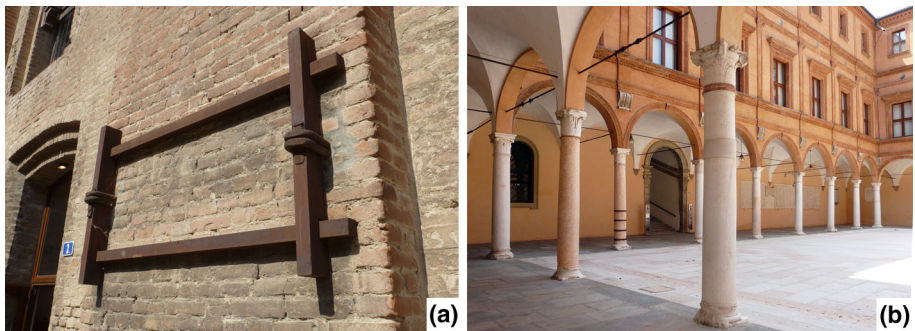
**Fig. 19** *Palazzo dei Pio*—**a** tie rod anchor system recently installed on the *Rocca Nuova* **b** old and recent tie rods in the *Cortile d’Onore*

costs assessment, inclusive of building repairs, seismic strengthening and finishing, according to formulas (3) and (5), originally amounted to about € 2 million, though a subsequent, more accurate evaluation has raised the overall cost estimate to € 3.5 million (Fig. 19).

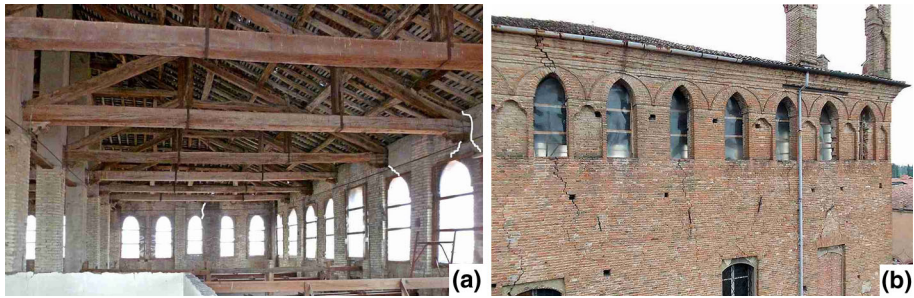
This tower was created in 1450 by joining two adjacent towers. It is connected to the *Palazzo dei Pio* (Fig. 16a) along the north-eastern side. The four-storey brick masonry building is rectangular in section, 20m × 23 m. The floors are mainly supported by brick vaults, often decorated, and the roof is sustained by large wooden trusses resting on the outer walls and isolated columns (Fig. 20a). The building has always been state-owned, but it is currently abandoned and in a poor state of maintenance. Only the lower floors were partially consolidated after the 1996 earthquake. During the two shocks of May 2012 the *Torrione* suffered further damage to its interior walls, with some frescoes and vaulted ceilings with decorated plasters. However, few additional diagonal cracks appeared on the walls and vaults: the recently installed tie rods helped to contain out-of-plane mechanisms. The most cracks are located at the top of the building, on the outer walls, particularly vulnerable to the presence of a great number of openings (Fig. 20b). Moreover, the roof trusses (Fig. 20a), some of which were in conditions of incipient collapse, produced local damage to the walls, due to punching actions during the seismic oscillations. Indeed, many out-of-plumb sections are noticeable on the upper part of the walls.

**Fig. 20** *Torrione degli Spagnoli*: damage at the top of the building—**a** interior view; **b** exterior view

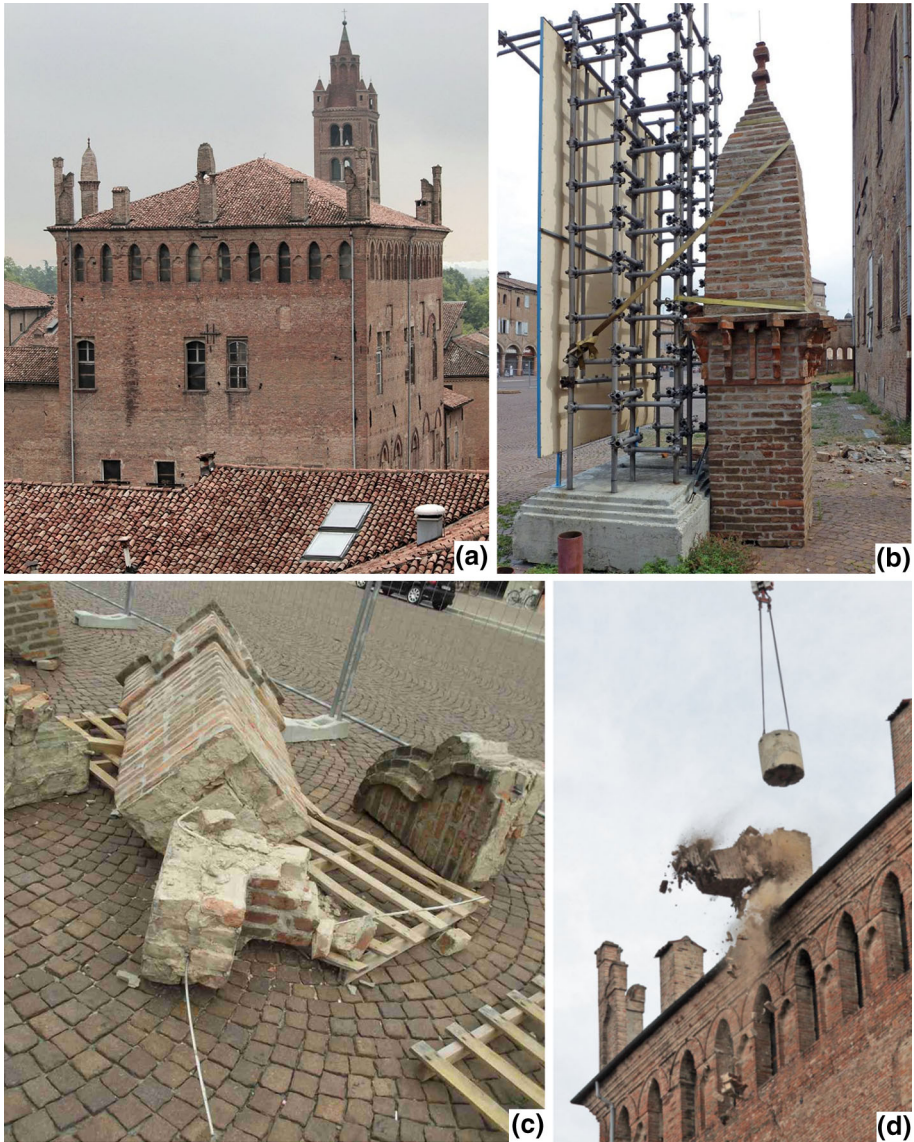
In addition, after May 20th, some tower elements (Fig. 21a) were in conditions of incipient collapse, although they have recently been reinforced with steel bars anchored with resins (Figs. 18b, 21c). In order to avoid risks to the underlying structures, most of them were removed and stocked on the ground (Fig. 21b, c) or demolished (Fig. 21d)

**Fig. 21** *Torrione degli Spagnoli*—a tower elements after May 20th; b, c removal of previously consolidated elements; d demolished elements

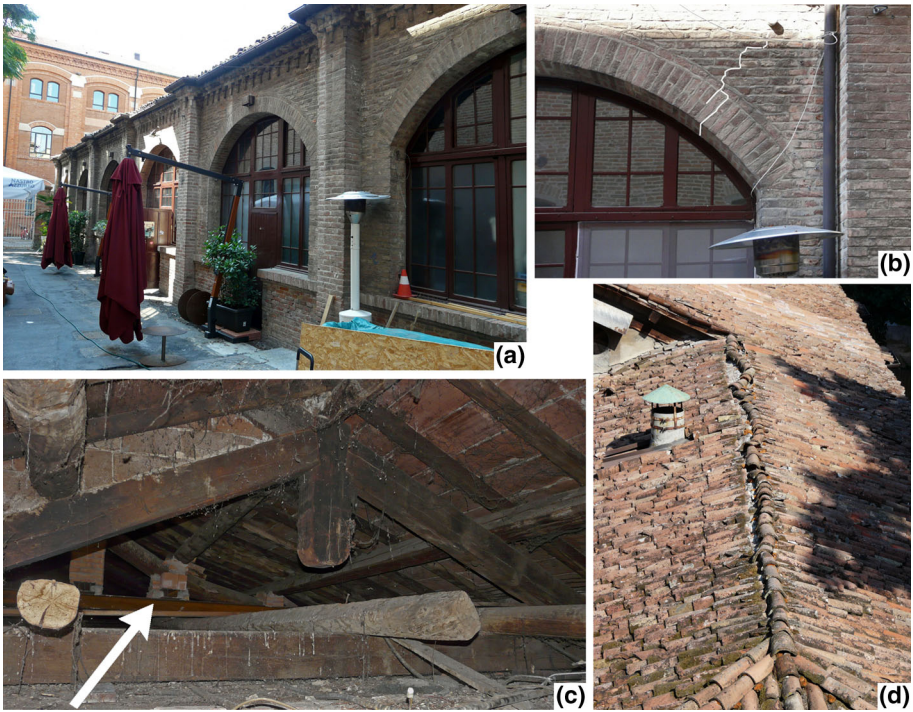
**Fig. 22** The *Mattatoio*—**a** lateral view; **b** cracking of the arch opening; **c** critical situations on roof truss; **d** roof tiles displacement

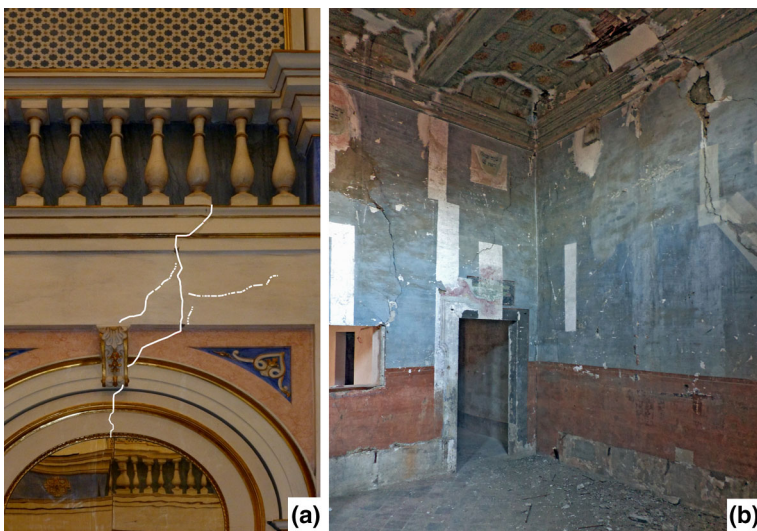
The old Synagogue is located on the top floor of the 1722 building which includes the *Portico del Grano* (Fig. 13c). The new neoclassical Synagogue, the result of nineteenth-century modifications, is instead located on the first floor. The three-storey building housing the two temples is made up of brick masonry; the floors are sustained by wooden beams and the roof by wooden trusses. The rooms are covered by decorated reed mat vaults. After the earthquake, many pre-existing vertical cracks on the walls re-opened and some new inclined cracks were formed. Figure 23a shows a pre-existing vertical crack on the new Synagogue wall, while Fig. 23b shows a portion of the earlier cracking pattern in the ancient Synagogue, with local collapse of the reed mat vault. No out-of-plane collapses took place, but due to the punching action of the wooden roof beams, expulsion of the wall plastering occurred frequently (Fig. 23b).

**Fig. 23** The two Synagogues—**a** an earlier crack in the new Synagogue; **b** cracking pattern in the old Synagogue

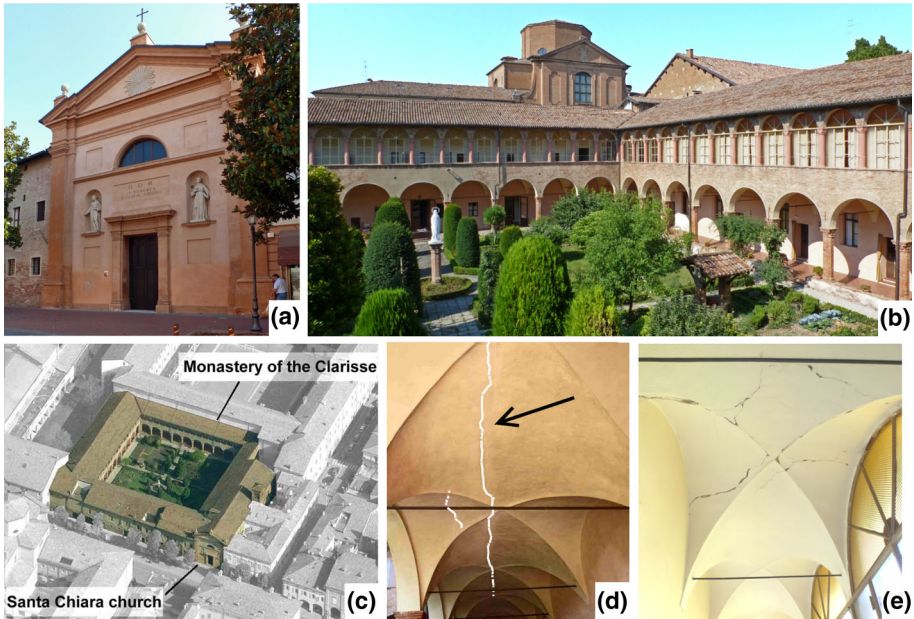
**Fig. 24** The Clarisse Monastery and the Church of Santa Chiara—**a** church facade; **b** the cloister; **c** the Clarisse complex; **d** damaged cross vaults of the cloister; **e** damaged cross vaults in the corridor at the first level

The damage index of the monastery was 0.31 and the viability outcome was partial usability limited to a few rooms on the lower floor and a portion of the cloister.

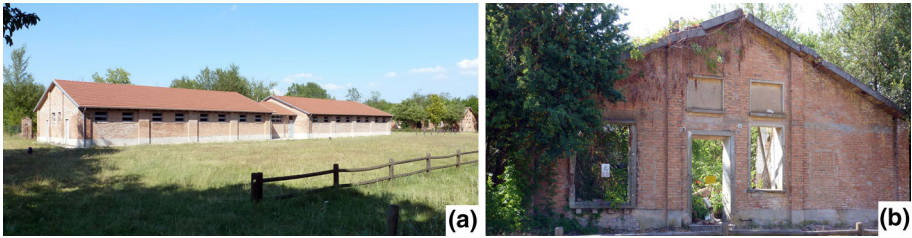
**Fig. 25** Campo di Fossoli—**a** restored barrack used as visitor and exhibition centre; **b** damaged barrack

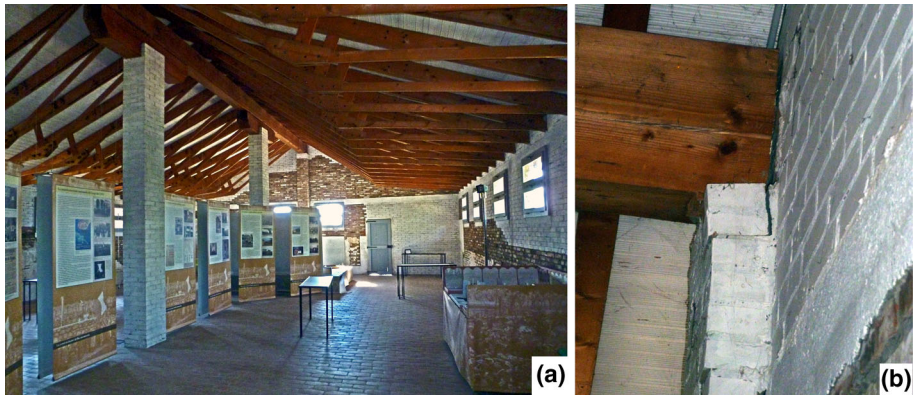
Although not vast, the degree of damage to the previously restored barrack justifies an outcome of unusability: the unseating of the ridge beams (Fig. 26b), damage to the support pillars and the slight in-plane cracking of the gable walls increase the building’s vulnerability

**Fig. 26** *Campo di Fossoli* visitors centre **a** interior view; **b** unseating of wooden ridge beam
