Damage assessment of three medieval churches after the 2012 Emilia earthquake

Abstract The architectural heritage was severely damaged by the seismic sequence that occurred in Emilia (Northern Italy) in May 2012. This paper investigates the seismic behavior of three masonry churches that were damaged by the 2012 Emilia earthquake. The analyzed churches are located in the South-East area of the province of Mantua: they are representative of some churches, denoted as “Matildic churches”, belonging to the territorial area between Lombardia, Emilia Romagna and Toscana and built during the Matilde di Canossa domain, between the X and the XI centuries. The study was based on detailed field surveys, in situ tests, visual inspections and existing archives in order to obtain an accurate knowledge of the churches and a proper evaluation of the damage caused by the earthquake. Then, detailed finite element models of the churches were developed and non-linear dynamic analyses with different peak ground accelerations were performed. The numerical simulations provided a deep insight into the seismic behavior of the analyzed churches, identifying the damage patterns and the main collapse mechani

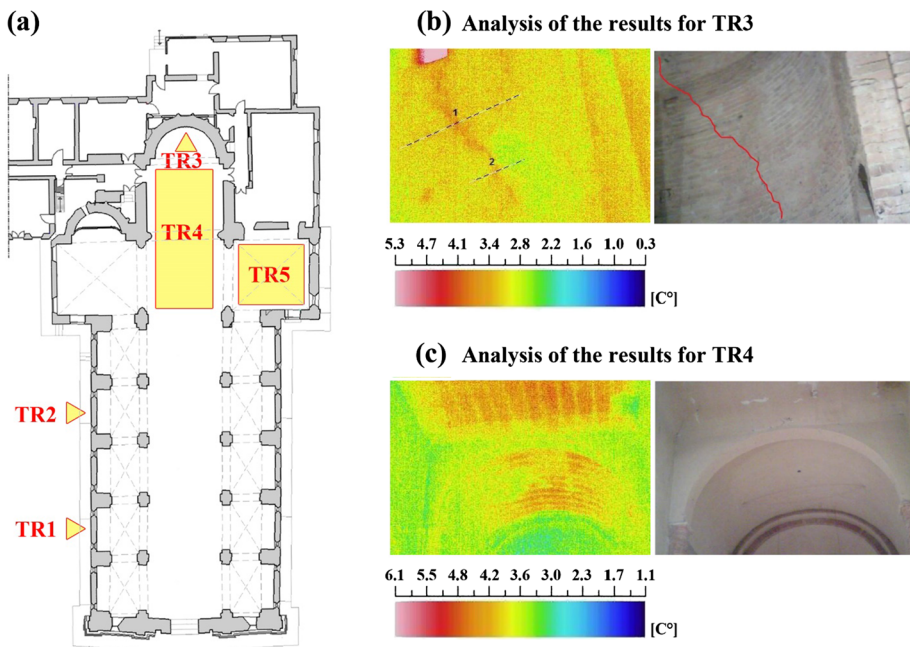
Figure 13a indicates the locations of the termographic tests. In Fig. 13b the results of the test on a portion of the apse wall are shown: the measures of different superficial temperatures highlight the presence of probable through-cracks that may create a discontinuity enabling the access of air. In Fig. 13c the results of the test on the ceiling of the central nave and of the presbytery are reported: different superficial temperatures evidence that the bearing structure is composed of wooden joists. The presence of some zones with

low emission temperatures is observed, highlighting problems of humidity related to water infiltrations from the covering.

Fig. 13 a Locations of the termographic tests, b termographic test on the apse wall, c termographic test on the presbytery and central nave covering

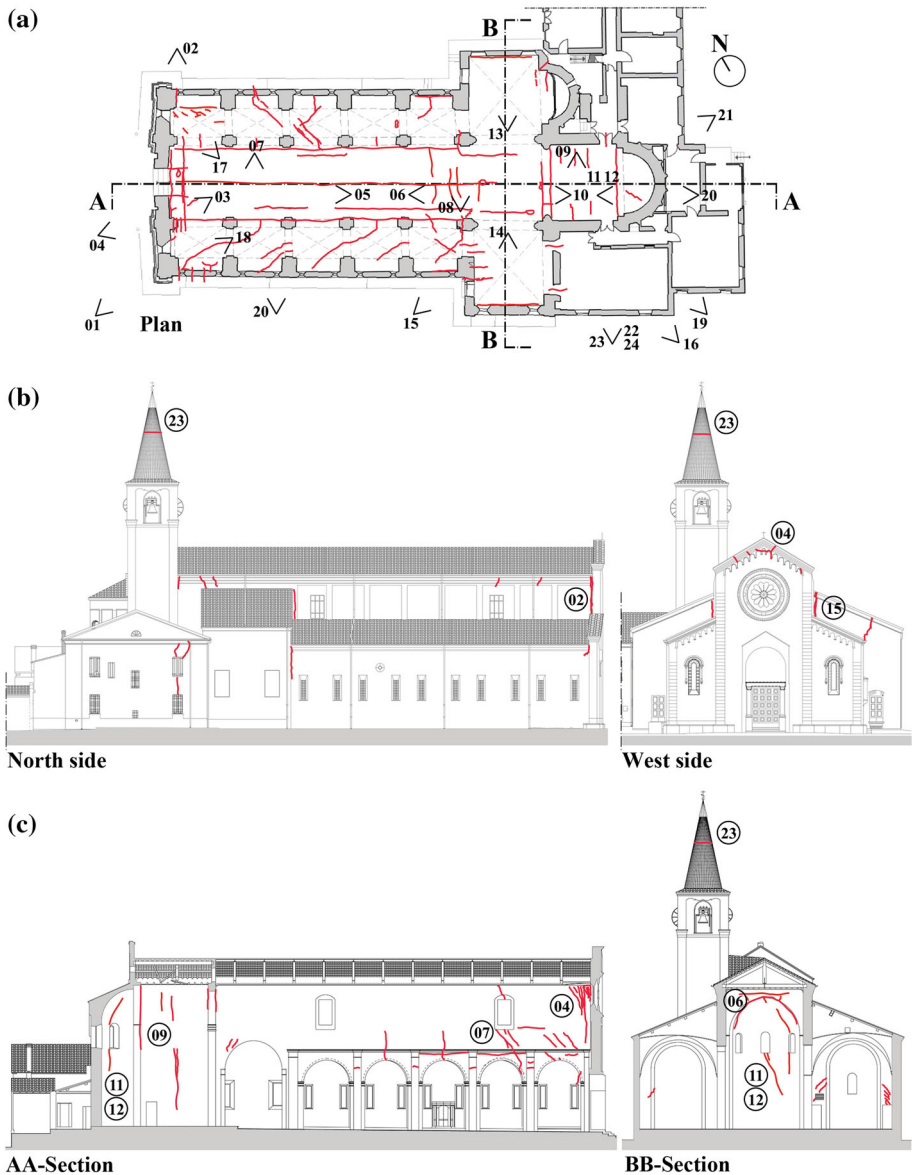
Fig. 14 San Benedetto Abate church damage survey: crack pattern

Figures 14 and 15 summarize the crack patterns observed in San Benedetto Abate church.

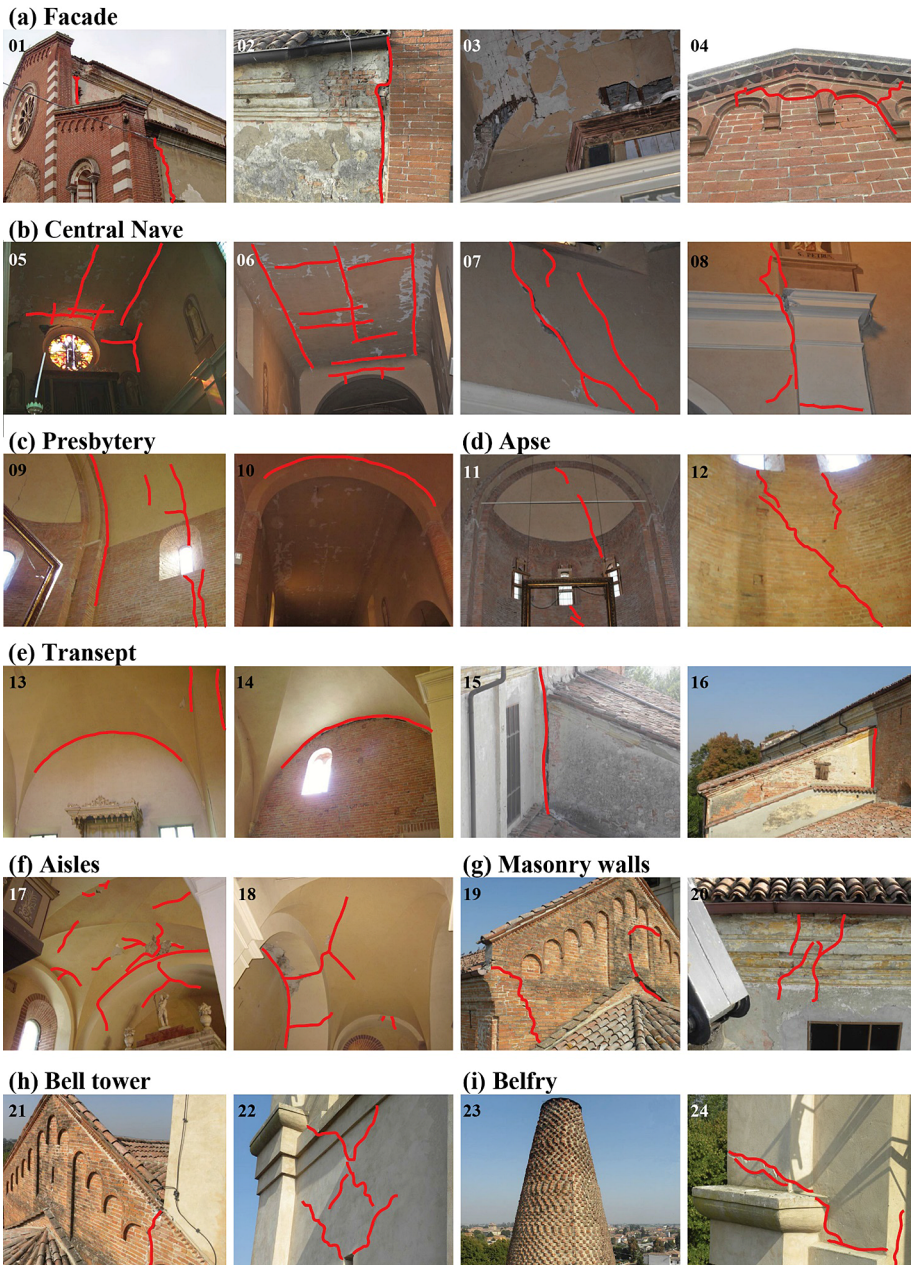
Fig. 15 San Benedetto Abate church damage survey: photographic documentation

- *Façade* The damage survey has revealed vertical cracks between the façade and the longitudinal walls of the hall, Fig. 15a (photos 01–02). Inside the building, the separation of the *incannucciato* ceiling from the façade has been detected, Fig. 15a (photo 03). The thrust of the seismic action in the longitudinal direction combined with the lack of efficient connections between the façade and the longitudinal walls may cause the detachment of these two elements with an out-of-plane overturning of the façade. Some cracks have been found also in correspondence with the moldings of the gable, Fig. 15a (photo 04).

- *Central nave* The damage survey has showed cracks located in the *incannucciato* ceiling, mainly along the longitudinal direction, Fig. 15b (photos 05–06). The thrust of the seismic action in the transversal direction may trigger an overturning mechanism of the longitudinal walls. Cracks have been detected along the longitudinal walls in correspondence with the keystone of the arches, the openings of the upper level and the pilasters edge (vertical and diagonal cracks), Fig. 15b (photos 07–08); sub-horizontal cracks have been surveyed on the pilasters, Fig. 15b (photo 08), and in correspondence with the horizontal molding above the pilasters. These cracks can be related to the presence of the aisles that represent a constraint only for the lower part of the longitudinal walls.

- *Presbytery* Vertical cracks near the openings and transversal cracks on the vault have been detected, Fig. 15c (photo 09). The presence of openings creates a discontinuity in the wall and the corners represent weakness points, where a stress concentration can cause the formation of cracks. The expected collapse mechanism involves the lateral walls of the presbytery. In addition, two cracks are located in correspondence with the arches between the presbytery and the apse, Fig. 15c (photo 09), and the presbytery and the central nave, Fig. 15c (photo 10). They indicate the detachment between the different structural elements.

- *Apse* The damage survey has showed a crack on the semi-dome, Fig. 15d (photo 11), and vertical and diagonal cracks on the wall starting from the openings, Fig. 15d (photo 12). The presence of the openings in the wall may be the cause of damage. The expected collapse mechanism is the apse overturning.

- *Transept* Cracks along the connection between the longitudinal walls and the cross vaults have been detected, Fig. 15e (photos 13–14). The damage was caused by the horizontal thrusts, both in the longitudinal and in the transversal directions, producing the detachment of the elements and the trigger of an overturning mechanism of the

- transept lateral walls. In addition, externally, also in the upper connections between the central nave and the transept, vertical cracks have been observed, revealing a possible overturning mechanism of the entire structure of the transept, Fig. 15e (photos 15–16).

- *Aisles* Diagonal cracks in the *in foglio* vaults have been registered, Fig. 15f (photo 17). In the chapels of the aisles, the thrust action due to the earthquake generates a longitudinal response of the structure, causing high horizontal stresses in the light and thin vaults. Diagonal cracks are associated with different longitudinal relative displacements among the various elements. Some cracks can be observed also in correspondence with the keystone and the impostes of the arches that support the vaults and along the connection between the arches and the external longitudinal walls, Fig. 15f (photo 18). The damage was probably related to a different relative displacement between the edge bearing structures of the vaults.

- *External masonry walls* Cracks have been reported: in correspondence with the connection between two structural elements with different geometries, such as between the presbytery and the apse, Fig. 15g (photo 19); near the corners of the openings, Fig. 15g (photo 19); in the upper parts of the walls, Fig. 15g (photo 20). These cracks can be ascribed to problems related to the materials poor quality or to some masonry features—such as the lack of connection between the elements during the construction phase or the presence of discontinuities, such as openings even if later closed.

- *Bell tower* Vertical and diagonal cracks are localized near the connection between the bell tower and the wall of the church, Fig. 15h (photo 21), and along the tower body, mainly close to the openings corners, Fig. 15h (photo 22). These cracks may be caused by a significant difference in global stiffness between the body of the church and the slender bell tower and by the presence of discontinuities. A rotation of the bell tower was also registered toward the north-east direction.

- *Belfry* Cracking of the masonry pinnacle located on the bell tower has been detected, Fig. 15i (photo 23). In addition, horizontal cracks have been observed near the region of the belfry, Fig. 15i (photo 24). These cracks may be caused by the sliding of the pillars, due to the presence of heavy and thrusting covering. The horizontal thrusts caused by the earthquake, associated with the presence of significant mass, develop high shear stresses that lead to the cracking in critical regions, in correspondence with a reduction of the resistant cross-section.

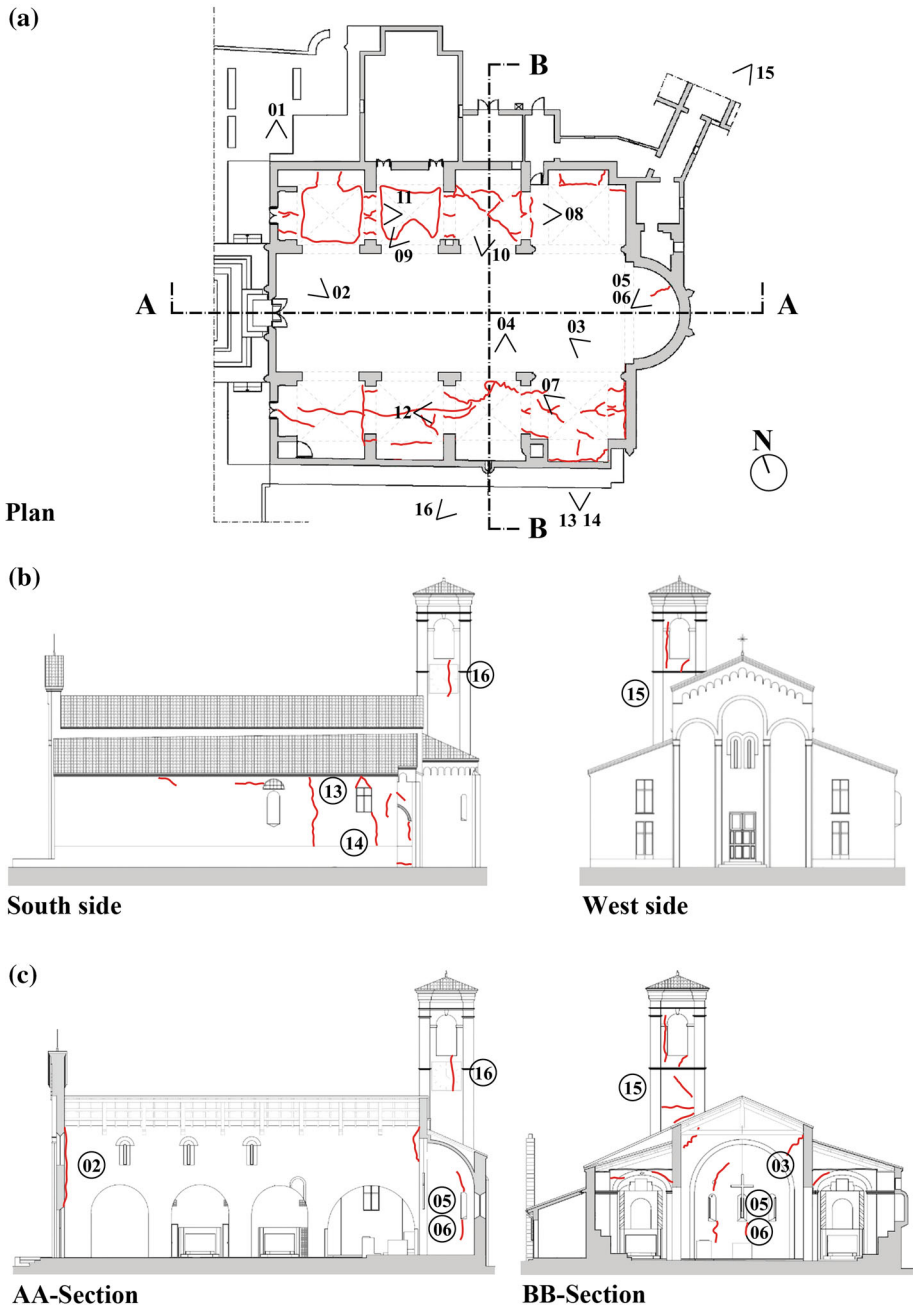
Fig. 16 San Fiorentino Martire church damage survey: crack pattern

Figures 16 and 17 summarize the crack patterns observed in San Fiorentino Martire church.

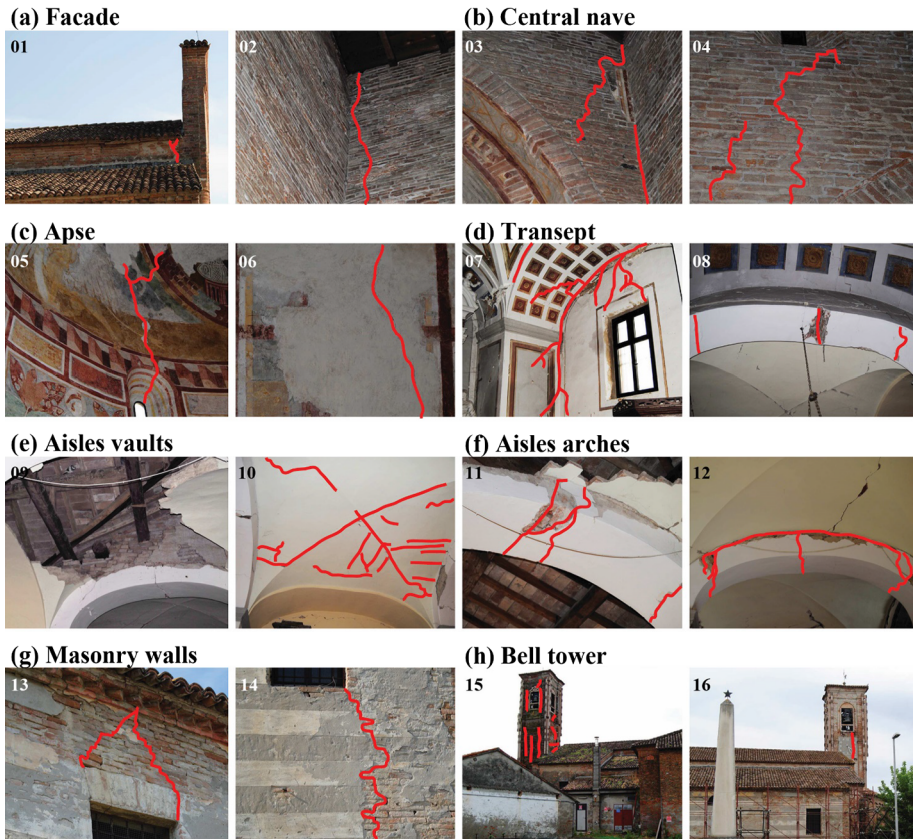
Fig. 17 San Fiorentino Martire church damage survey: photographic documentation

- *Façade* Through vertical cracks along the connection region between the façade and the longitudinal walls of the central nave have been reported, Fig. 17a (photos 01–02). The damage survey has highlighted the lack of effective connections between the elements: such a deficiency could lead to a definitive separation of the façade from the lateral walls with an out-of-plane overturning of the façade.
- *Central nave* A lack of effective connections between the transversal wall delimiting the apse and the longitudinal walls has been observed and some cracks have been identified, Fig. 17b (photo 03). Such damage may cause the out-of-plane overturning of

the apse. In addition, some cracks starting from the corners of the openings can be detected, Fig. 17b (photo 04).

- *Apse* Vertical cracks near the openings of the apse have been reported, Fig. 17c (photos 05–06). The presence of the openings in the wall and the thrusting vaults may be the causes of the damage. Such cracks also can trigger an overturning mechanism of the apse wall.
- *Transept* Vertical cracks in the corners between the longitudinal and transversal walls and cracks along the connection between the longitudinal walls and the cross vaults

have been detected, Fig. 17d (photo 07). The damage was due to the horizontal thrust actions, both in the longitudinal and in the transversal directions, producing the detachment of the elements and the trigger of an overturning mechanism of the transept

lateral wall. Some cracks were also detected at the keystone and imposts of the arches that separate the transept from the aisles, Fig. 17d (photo 08).

- *Aisles* The damage of the aisles concerns:
 - vaults: the damage of the cross vaults consists of: (i) the complete collapse of the vaults of the first two chapels in the left side, Fig. 17e (photo 09); (ii) the partial collapse and a diffused crack pattern in the other vaults, with cracks oriented both along the diagonal ribs and along the edge structures, Fig. 17e (photo 10). The damage was probably due to the excessive vibrations of the edge bearing structures with a different relative displacement between the elements. This caused a detachment between the vaults and the load-bearing masonry walls and, in some cases, the collapse of the structures. It has to be considered that the detachment may be also ascribed to the different periods in which the elements were built and to the consequent impossibility to carry out an effective connection between the aisles and the central nave;

- arches: survey of cracks at the keystone and impost locations with the possible collapse of the arches supporting the vaults, Fig. 17f (photos 11–12);

- walls: diffused vertical cracks on the walls.
- *External masonry walls* Cracks have been reported near the corners of the openings, Fig. 17g (photos 13–14). These cracks can be ascribed to problems related to the materials poor quality or to some masonry features—such as the lack of connection between the elements during the construction phase or the presence of discontinuities, such as openings even if later closed.

- *Bell tower* The bell tower presents widespread damage on the walls, with cracks mainly localized near the connection with the church roof and close to the load-bearing elements of the belfry, Fig. 17h (photos 15–16). In detail, cracks have been observed in the arches and at the edges of the slender pillars of the belfry. The interaction between elements with different behavior can generate cracks due to hammering between the different parts.

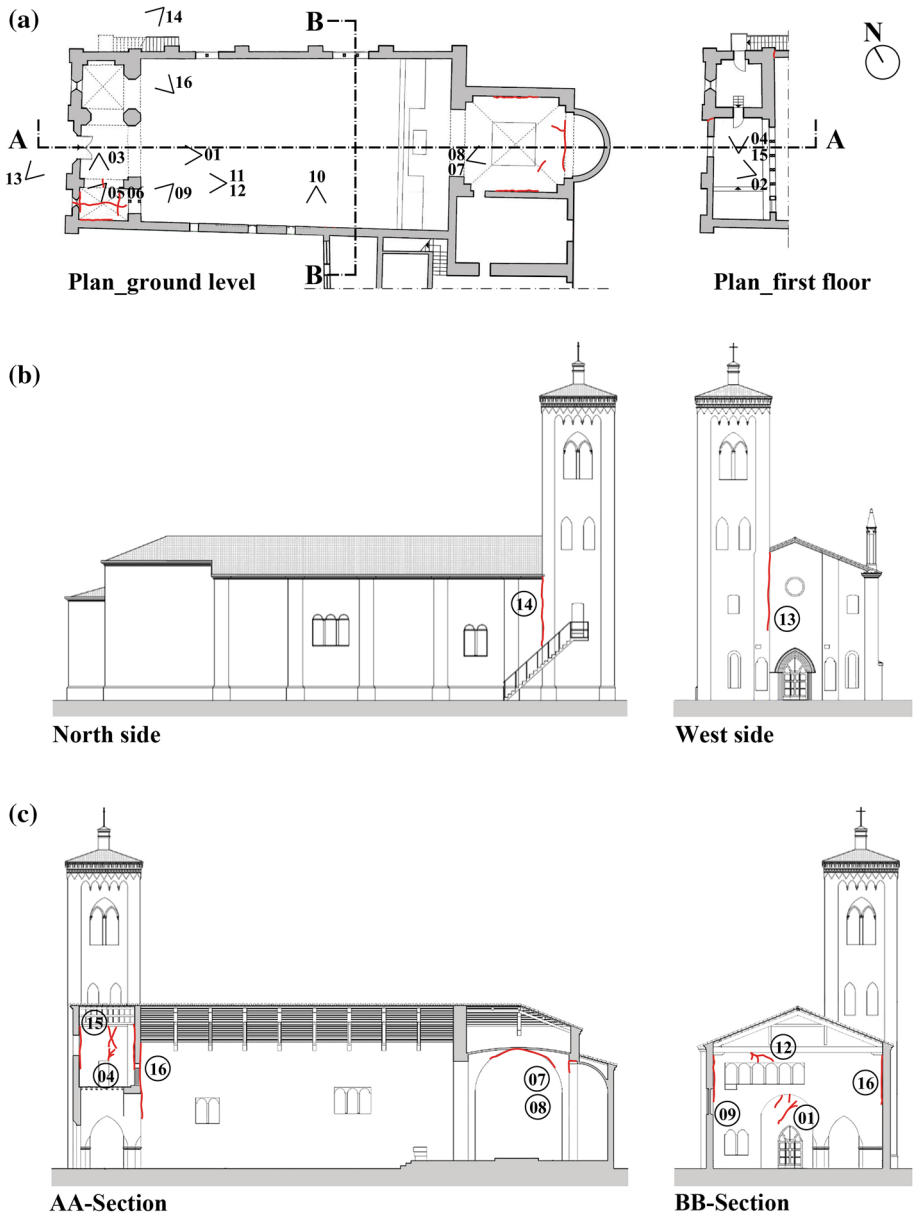
Fig. 18 Santa Maria Assunta church damage survey: crack pattern

Figures 18 and 19 summarize the crack patterns observed in Santa Maria Assunta church.

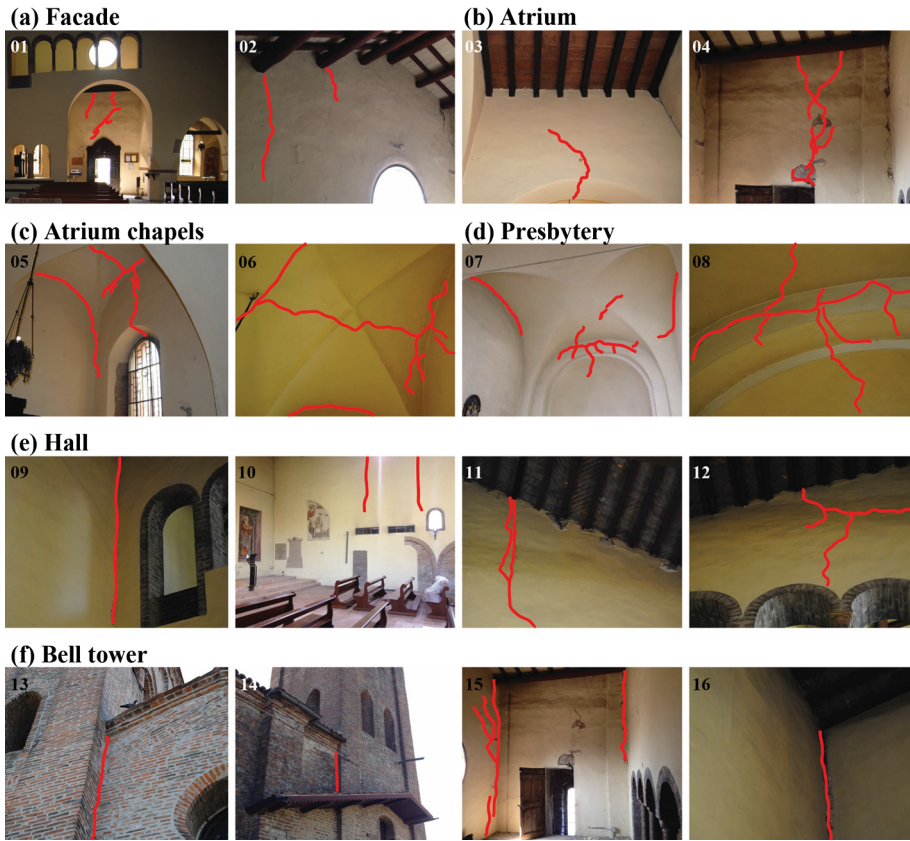
Fig. 19 Santa Maria Assunta church damage survey: photographic documentation

- *Façade* Vertical cracks in correspondence with the entrance door extended up to the rose window have been reported on the internal side of the church, Fig. 19a (photo 01). In addition, vertical cracks extend from the wooden rafters of the roof, Fig. 19a (photo 02). These cracks can be related to the presence of openings and concentrated loads, and they are due to the seismic action longitudinal component.
- *Atrium* Vertical cracks have been observed in the longitudinal walls of the atrium: at the ground floor in correspondence with the keystone of the arches of the lateral adjacent chapels, Fig. 19b (photo 03), and at the first floor in correspondence with some openings, Fig. 19b (photo 04). The latter cracks are due to the presence of discontinuities and to the seismic action longitudinal component.

- *Atrium chapels* The damage survey showed vertical cracks starting from the openings of the façade, Fig. 19c (photo 05), along the connection region between the vaults and the walls, Fig. 19c (photo 05) and in the cross vaults, Fig. 19c (photo 06). These cracks

are due to the presence of openings and to an excessive oscillation of the walls that are not restrained by the thin and light vaults system.

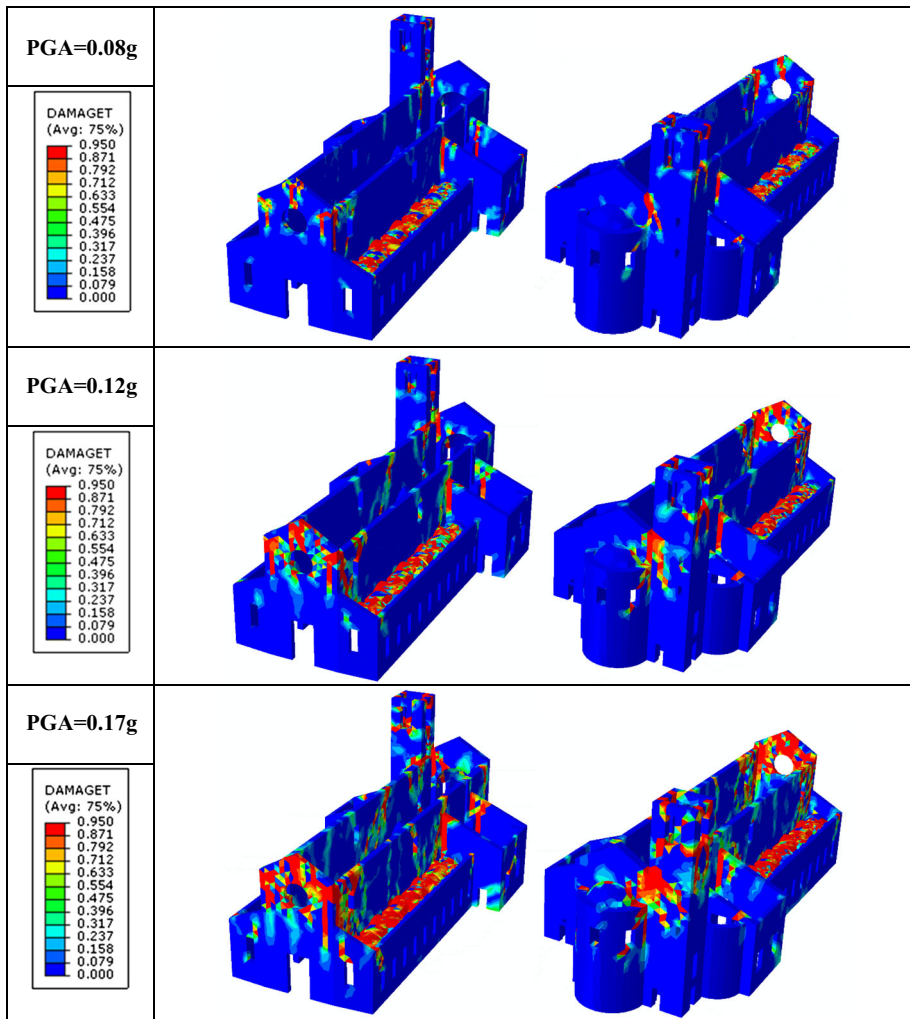
Fig. 28 San Benedetto Abate church: tensile damage contour plots at the end of the non-linear dynamic analyses for different peak ground accelerations

The non-linear dynamic analyses under higher values of PGA highlight a widespread damage in the aisles chapels: it is consistent with the cracks observed in the vaults *in foglio* of the aisles from in situ surveys. A vertical damage is evident in the connection region between the façade and the longitudinal walls: a possible overturning mechanism of the façade can be expected considering the poor connection between the walls. The façade exhibits a widespread damage that clearly increases with the peak ground acceleration. The connection region between the bell tower and the perimeter walls shows a damage concentration due to the different stiffness and geometry of the elements. Moreover, a considerable damage spreading from the corners of the openings is registered in the belfry: it is consistent with the crack pattern observed after the field survey. Vertical damage starting from the top is recognizable in the walls of the central nave. Additional damage can be found near the openings in the walls, starting from the corners: it is compatible with the cracks observed from the in situ survey.
