Data collection after the 2010 Maule earthquake in Chile

Juan Carlos de la Llera^{1,2} · Felipe Rivera¹ · Judith Mitrani-Reiser³ ·
Rosita Jünemann^{1,2} · Catalina Fortuño¹ · Miguel Ríos^{1,4} ·
Matías Hube^{1,2} · Hernán Santa María^{1,2} · Rodrigo Cienfuegos^{1,5}

Received: 31 March 2015 / Accepted: 21 April 2016 / Published online: 11 May 2016
© Springer Science+Business Media Dordrecht 2016

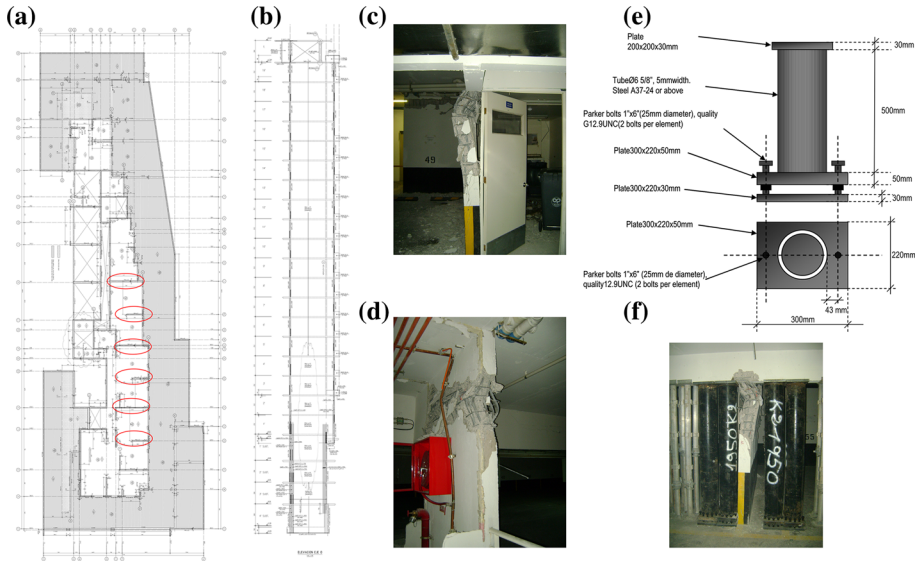
4.2.2.3 Stabilization process After the second stage of visual inspections of damaged buildings, engineering offices recommended that structures be either repaired or demolished. However, in some cases the buildings were so severely damaged and at collapse risk that it was necessary to stabilize them before taking any other action, prior to getting anyone to work inside these buildings. This was the case for tall buildings in Santiago and Concepcion, where local firms (e.g., SIRVE) developed interesting stabilization techniques that were later adopted by other constructors in their damaged structures. The data collected during stabilization was very unique, since to our knowledge this was the first time that a process like this followed a formal methodology. This allowed transferring the proposed stabilization techniques into other projects. One example is shown for the particular case of a damaged RC building in Santiago (Fig. 6). The emergency stabilization included an important number of struts readily available in the market; however, these elements have low axial capacity and the solution was insufficient to ensure building stability during high-intensity aftershocks. Consequently, a more robust stabilization system was designed that consisted of 10'' Yoder tubes with Parker bolts installed directly below the wall offset and in all basement levels (Fig. 6e). The bolts were required to

Fig. 6 EM Building: **a** floor-plan and damaged walls; **b** typical wall elevation; **c**, **d** examples of interior damage; **e** Yoder tubes stabilization solution for EM Building: drawing and **f** implementation

partially transfer vertical load into the strut. The Parker bolts were calibrated to control the axial load on each tube and avoid damage to the slab. This procedure was repeated in a large number of severely damaged buildings and ended up being very successful in strong aftershocks after the earthquake.

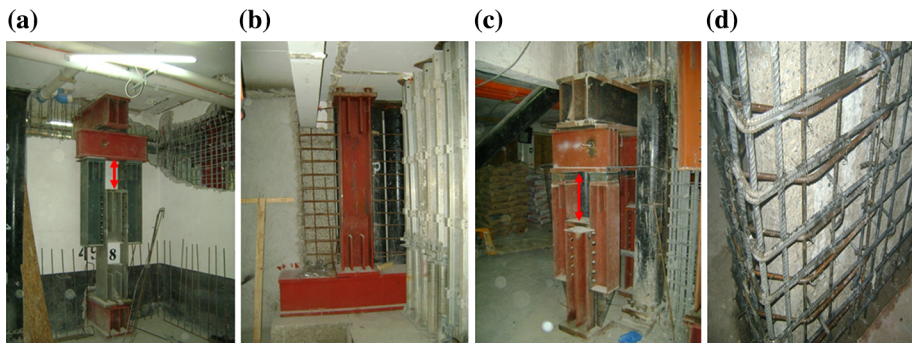
Fig. 7 Lifting process for EM Building: **a–c** struts and beam system; **d** reinforcement of damaged walls

Once the permanent stabilization system was in place, some buildings needed to be straightened up prior to retrofitting the walls. In lifting the building, a second system was used as shown in Fig. 7a. The system consists of beams that go through the top and bottom of the wall as well as parallel vertical struts with servo-controlled lifting jacks. In the jacking-up process, lifting occurred simultaneously for the entire building plan. Jacks were installed with continued struts running down to the building foundation without transferring vertical load into the slabs (Fig. 7b). At the top, where the strut reacts against the

shoulder of the wall, a transfer beam was installed (Fig. 7c). The Yoder struts were maintained throughout the retrofit process for security reasons. Afterwards, the walls were reinforced and detailed according to new standards (Fig. 7d).

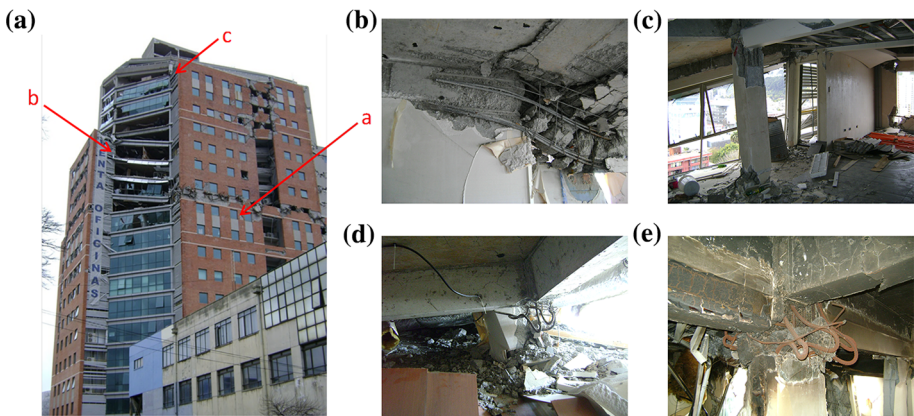
Fig. 8 Observed damage in TO Building: **a** building façade; **b–e** examples of interior damage

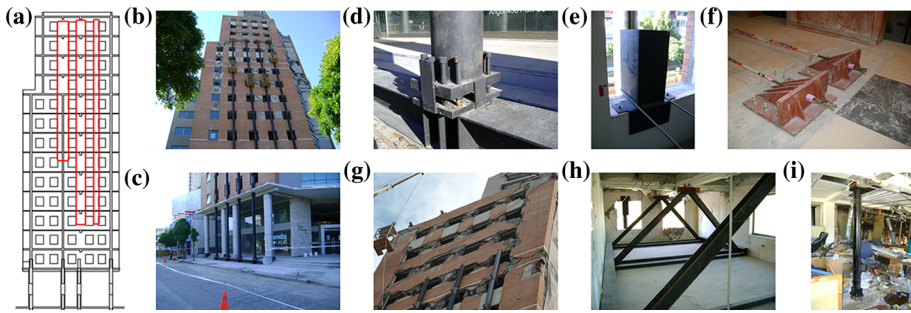
Fig. 9 Vertical stabilization system for TO Building using Yoder tubes: **a** reinforcement diagram, **b–c** stabilization elements from the outside; **d** support beam for Yoder tubes; **e** lintel anchorage for Yoder tubes; and **f** cable anchorage; and **g** reinforcement steel cables; **h**, **i** examples of interior reinforcement elements

A special strut and tie system was designed to stabilize the northeast and southeast facades of the buildings, as well as the slabs from stories 12 through 20. Because the stairwell was the only element that remained stable, it was used to tie the slabs and other stabilizing elements. The stabilization methodology consisted of replacing the vertical damaged elements by strong 10" Yoder tubes on the outside of the building, since it was very dangerous to work inside the structure (Fig. 9). The Yoder tubes were bolted to distribution beams (Fig. 9d) using anchoring bolts tightened to a torque that was defined by laboratory tests to obtain an in situ controlled preload close to 80 % of the tube capacity. The Yoder tubes were also anchored to the facade lintels through the connection system shown in Fig. 9e, placed above lintels in the undamaged stories, and below the lintels in the damaged ones. This anchorage system prevents buckling of the tubes, works as vertical support of the Yoder tubes in the undamaged stories, and becomes a lintel support in the damaged stories. Additionally, the Yoder tubes were tied to the stairwell through the cables shown in Fig. 9f to prevent out-of-plane collapse of the façade envelope. The southeast façade elements presented very low shear strength, and hence they were supported by the steel cables shown in Fig. 9g. Finally, once the external stabilization system was in place, some interior supports were also implemented, as shown in Fig. 9h, i.
