Seismic performance of the infill masonry walls and ambient vibration tests after the Ghorka 2015, Nepal earthquake

Humberto Varum¹ · André Furtado¹ · Hugo Rodrigues² ·
João Dias-Oliveira¹ · Nelson Vila-Pouca¹ · António Arêde¹

Keywords Masonry infill walls · Damage survey · Ambient vibration tests · Nepal · RC structures

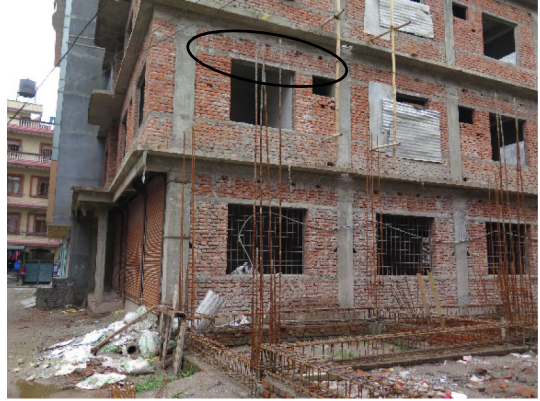
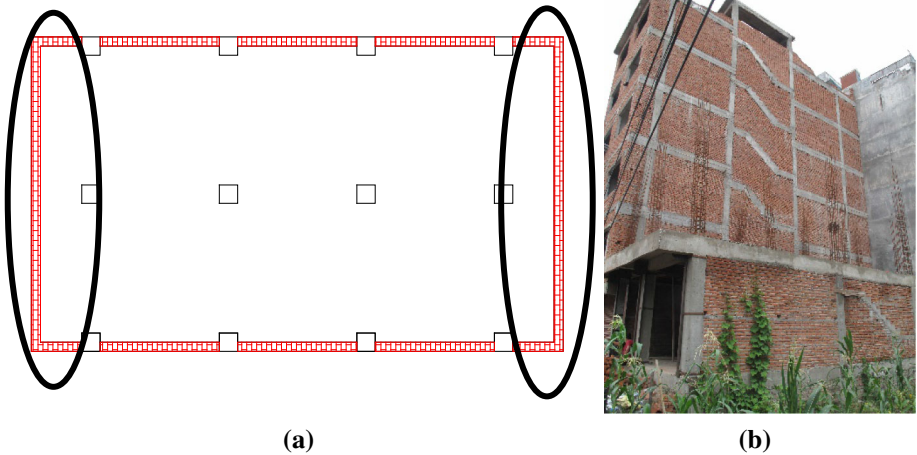
It was observed some cases of IM walls corners without RC columns on buildings boundaries or balconies (Fig. 7).

Fig. 7 Six storey building with IM wall corners with no RC column on the building boundaries

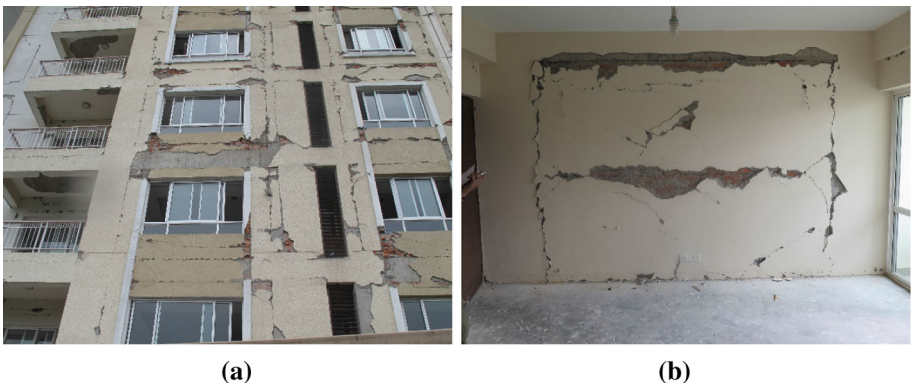
One of the most common damages observed was the detachment of the IM panel from the surrounding RC structure (Fig. 9), which occurred in interior and exterior partition walls, with and without openings. This type of damage demonstrates the real behaviour of the

Fig. 9 Detachment of the IM panel from the surrounding RC structural elements by the **a** Exterior IM walls from a 16 storey building façade, and **b** Interior partition wall

structure, since there is no connection between the wall panel and the surrounding panel. The joints interfaces when reach certain level of in-plane drift demand tends to reduce/eliminate the monolithic behaviour by transforming this into two independents elements behaviour (RC frame and IM panel).

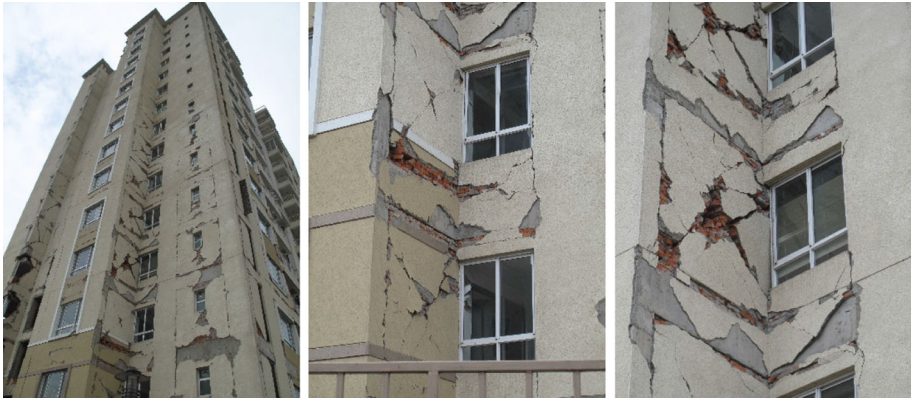
After the detachment of the panels, several local failures can occur, namely the diagonal cracking, caused by tensions stresses along the perpendicular direction of the diagonal compressive strut (Fig. 10).

Fig. 10 Diagonal cracking of the IM walls in a 16 storey high-rise building façade

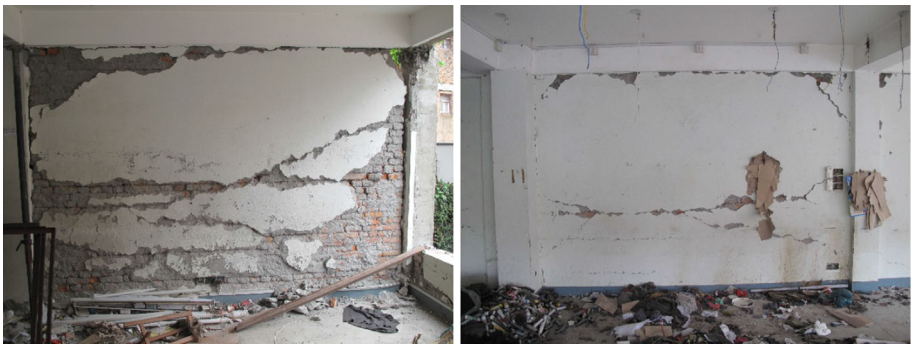
The shear-friction failure was also observed, namely caused by the shear forces that tended to separate the behaviour of the IM wall in two distinct parts. According to the observation of damages it was possible to assess that due to the high stiffness of such non-structural elements, their deformation was non uniform in height which lead with the shear cracking of the IM wall (Fig. 11).

Fig. 11 Shear friction failure observed in interior partition walls of low and medium-rise residential buildings

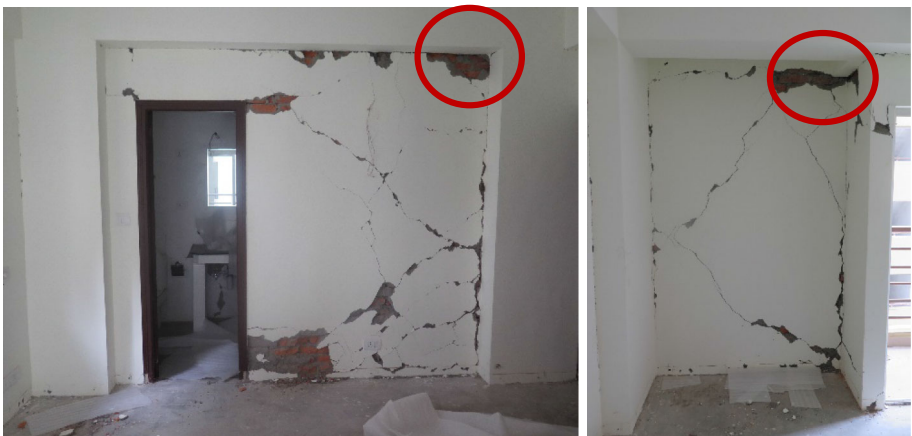
The accumulation of stress in the top and bottom corners leads to some general cracking's and plaster detachment, as observed in Fig. 12.

Fig. 12 Stress accumulation in the top and bottom corners observed in interior partition walls of a high-rise residential building

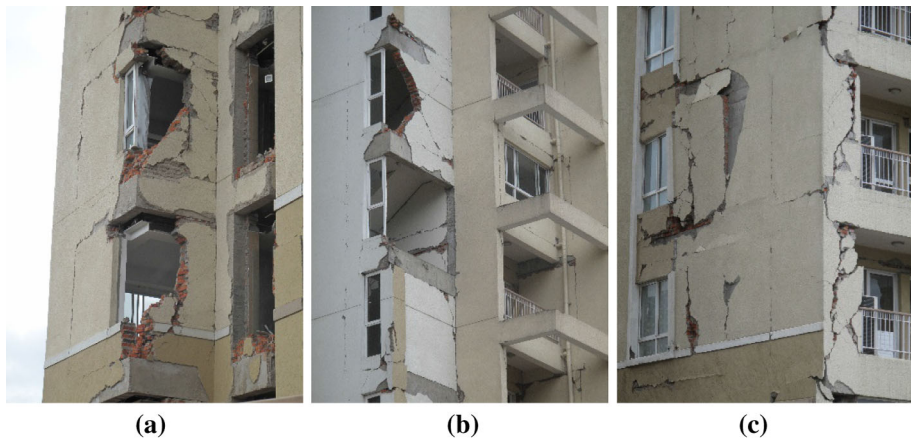
Fig. 13 Out-of-plane collapses of IM walls on **a**, **b** Corners and **c** Confined

Since no brick crushing occurs, the volumetry of the infill and bare frame locks together creating a limitation of flexural deformation, which do not allow the out-of-plane return.

These exterior partition walls placed when subjected out-of-plane loadings they tends to separate of the surrounding frame as a rigid body behaviour. The majority of the collapsed walls happen to be these ones due to a rotation support non-provided by the surrounding RC frame (Fig. 13).

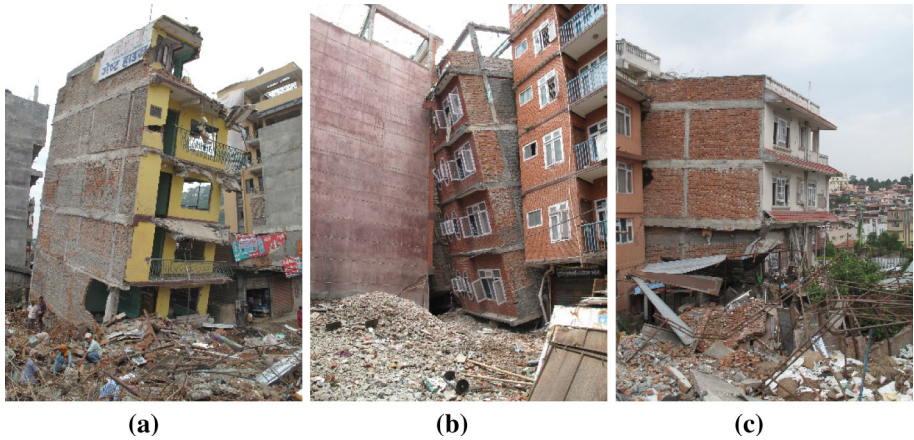
Regarding the RC buildings' performance, it was observed several collapses caused by irregular distribution height distribution of the IM walls leading to soft-storey mechanism. The common buildings in Nepal are composed by commercial use in the ground level and residential apartments on the others (Fig. 14a, b). An isolated example of a soft-storey mechanism that lead to the collapse of the 3rd floor of a residential building was also observed (Fig. 14c).

Fig. 14 Examples of RC buildings with soft-storey mechanism: **a** Collapse of the 1st storey, **b** collapse of the 1st storey of both of the buildings and **c** collapse of the 3rd storey—isolated example

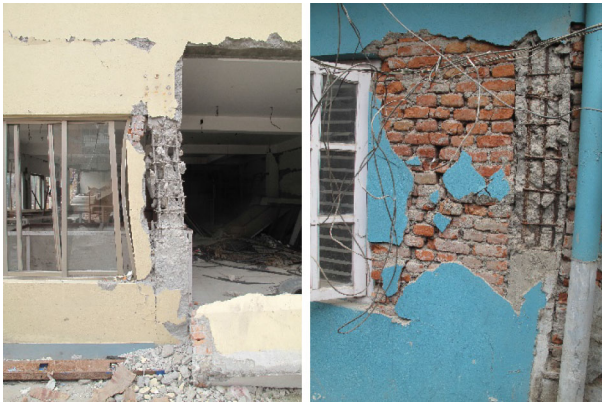
The importance of the openings placements in the IM walls is origin to short-column mechanisms on openings adjacent to columns, increasing their shear stresses, and damages (or even their collapse) as observed in Fig. 15.

Fig. 15 RC buildings subjected to short-column mechanism

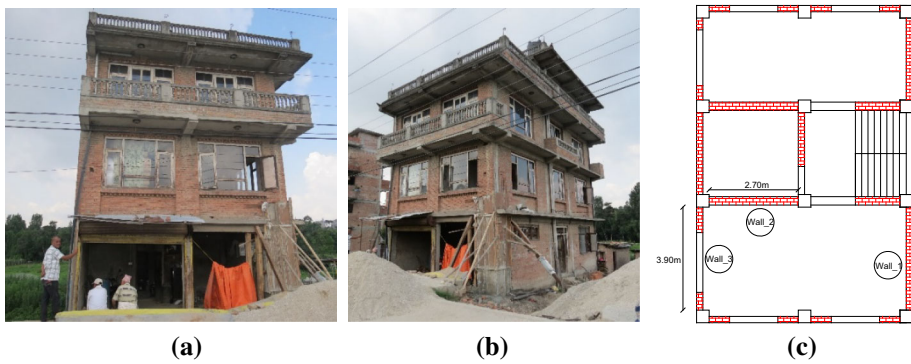
The building under study is a non-engineered (NE) three storey damaged building (NE3D) after the Ghorka earthquake, and is located in Bahktapur. A general view of the building is illustrated in Fig. 16a and b and is composed two longitudinal bays and three transversal bays, according to the building’s plan of in the building plan in Fig. 16. The first and second natural period of the structure are 0.27 s (transversal direction) and 0.38 s (longitudinal direction) respectively and are indicated in the response spectra of the main shock of 25th April 2015 in Fig. 17. From the visual inspection it was evaluated the level of damage according to EMS-98 (Grünthal 1998) which was classified as Grade 2: Moderate damage. This classification is justified by the observation of cracks in the ground-floor RC

Fig. 16 General view of the NE3D building, **a** front view, **b** lateral view and **c** building plant and localization of the IM walls under study

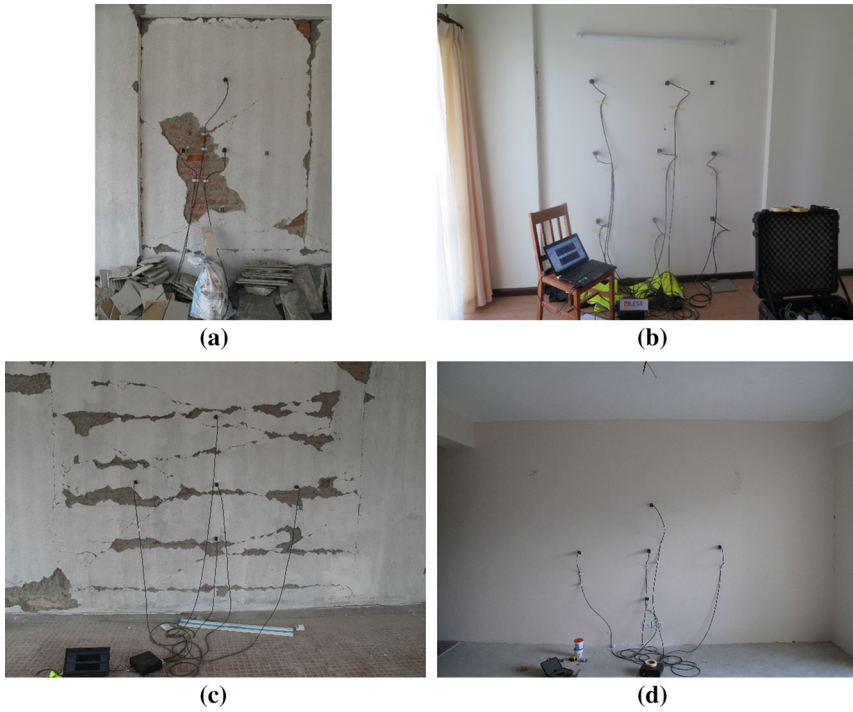
Wall	Dimensions (m)	Damage	Openings
1	1.6×2.6	No	No
2	1.6×2.6	Shear crackling Detachment of the panel	No
3	3.1×2.6	No	No
4	3.1×2.6	Shear crackling Detachment of the panel	No

Fig. 31 General view of the walls tested in E12D. **a** Wall 1, **b** Wall 2, **c** Wall 3 and **d** Wall 4

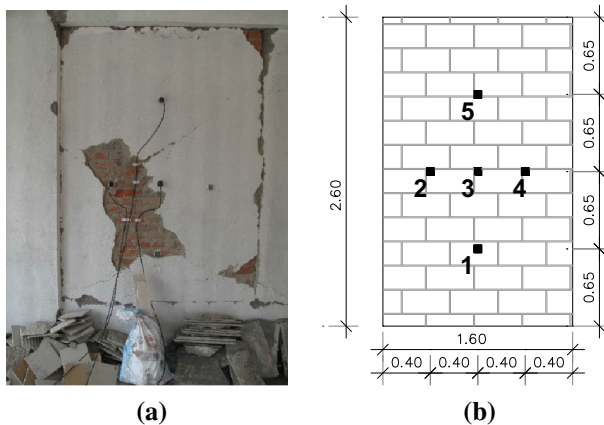
The Wall 2 has the same geometric dimensions of the Wall 1, but is significantly damaged as it can be observed in Fig. 34a. Visible detachment of the panel from the surrounding RC elements and detachment of the plaster in the center of the panel was observed.

Fig. 34 **a** Geometric dimensions and **b** test setup of the Wall 2- E12D

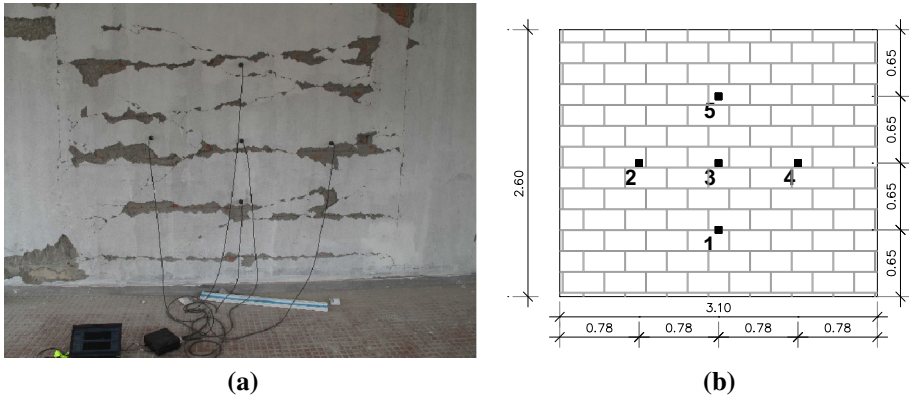
The Wall 4, located in the ground-floor, has the same dimensions of Wall 3, but with damages Fig. 38a. For the ambient vibration test it was used only 5 accelerometers and only one experiment test setup was adopted (Fig. 38b).

Fig. 38 a Geometric dimensions and b test setup of the Wall 4
