A knowledge-based approach for the structural assessment of cultural heritage, a case study: La Sapienza Palace in Pisa

Keywords Existing building · Cultural heritage · Masonry structure · In situ survey · Multidisciplinary approach · Static assessment · Vulnerability analysis

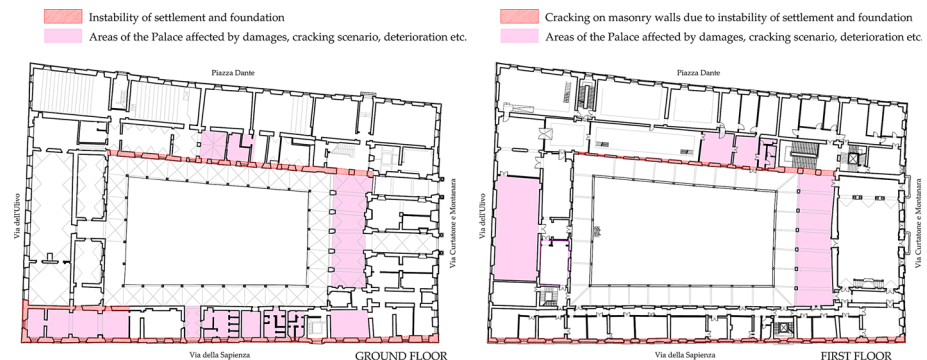
Fig. 7 Areas affected by problems and structural deterioration between the eighteenth and nineteenth centuries

The inadequacy of the foundation structure to sustain the increasing loads due to the enlargements of the building appeared clearly since the early 1900s (Fig. 7). A deep in situ investigation of foundations was executed (Caprili et al. 2015c) through micro-core samplings at different angles in the proximity of the masonry walls, at locations planned according to the evolutionary reconstruction of the building: different types of foundations were determined (Fig. 10). The investigations performed in correspondence to the interior colonnade revealed the lack of connections between single columns, with an isolated square footing placed at -1.90 m from ground level, below the foundation of the portico pillars, laid at -1.75 m. The foundation of the portico interior walls reaches different depths (between -1.0 and -1.5 m), with width varying between 1.50 and 2.40 m. The two investigations performed along Vicolo dell'Ulivo provided similar results, with foundation depths of 2.75 and 2.10 m, and widths of 1.75 and 1.60 m, respectively. The Piazza Dante side foundation reaches a depth of about -1.50 m below with a width of 0.90 m.

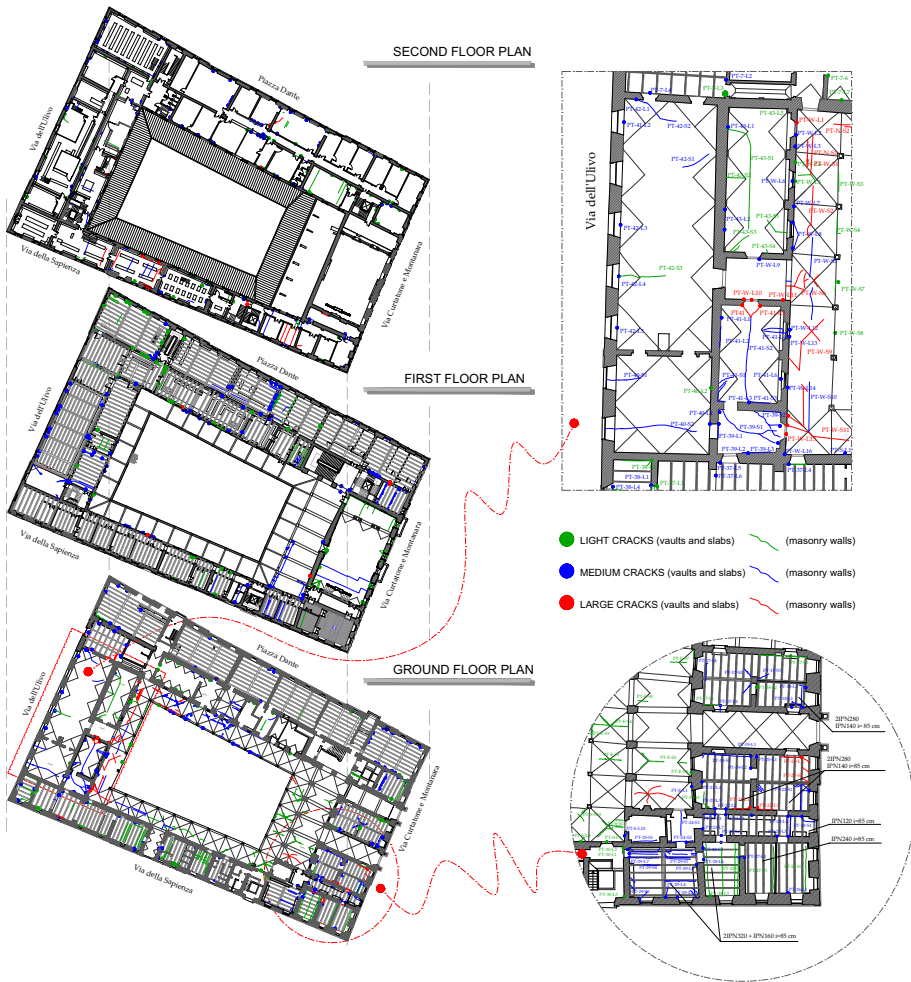
The cracking scenario (Fig. 11) is the result of the modifications undergone by the Palace during the centuries, with increasing loads due to the library, to the activities developed inside the building and to the differential subsidence related to the heterogeneity of soil and foundation structure (Figs. 7, 10). The progressive growth of the cracks, especially in proximity of the different structural units, is still quite evident in the building's vertical and horizontal surfaces. A wide cracking scenario is present in the corner between Via Curtatone e Montanara and Via della Sapienza, due the incorporation of ancient tower houses into the current structure, and in correspondence of the vaulted surfaces of colonnade, characterized by the evidence of differential settlements and by structural problems already identified during the 18th and 19th centuries (Fig. 10).

Fig. 11 Description of the cracking scenario at the different floors of the building

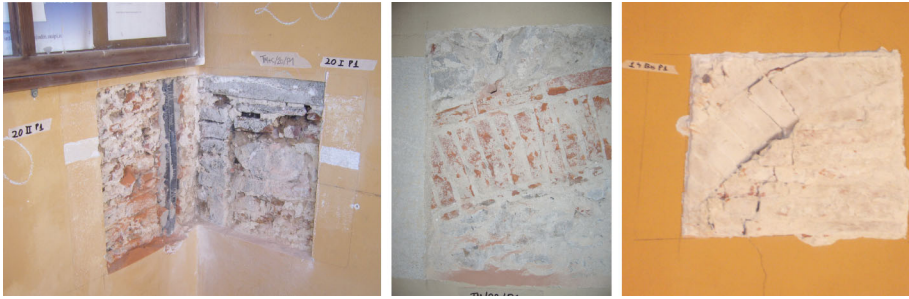
A diffused lack of connection between masonry walls and different masonry typologies (even in the same element) are evident and related to the evolution of the Palace: Fig. 13, for example, show the presence of masonry arches of ancient openings nowadays closed

Fig. 13 Discontinuities of vertical masonry walls: absence of connection between perpendicular walls, arches identified in correspondence of the first floor level, probably old windows currently closed

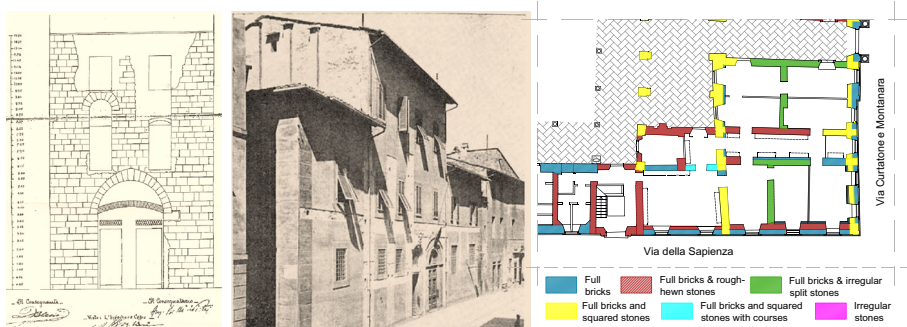
The discontinuity and heterogeneity of masonry for their respectively different construction typologies, realized in different periods with lack of mutual connections, yields to the development and progressive spreading of a diffused cracking scenario visible both in vertical and horizontal structures, allowing the clear recognition of US1 inside the aggregate (Fig. 15).

Fig. 15 US1—corner between Via Curtatone e Montanara and Via della Sapienza, heterogeneity of masonry vertical walls and incorporation of tower houses

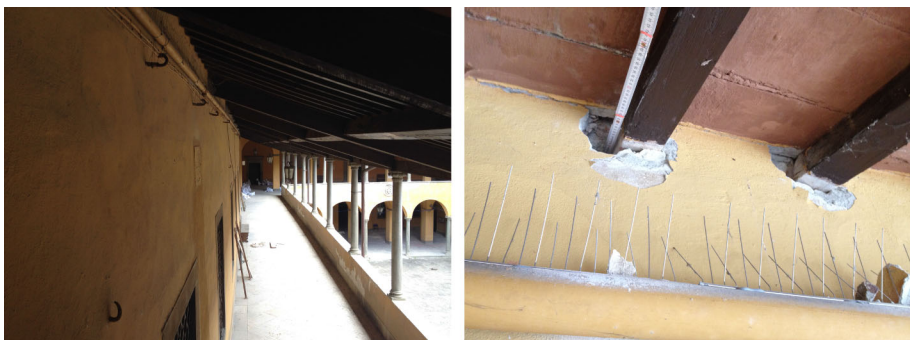
**Fig. 16** Internal colonnade (1st floor): relative displacements between wooden elements and masonry walls

Some problems are present, moreover, in correspondence of the first floor colonnade, with relative displacement between the wooden secondary elements of the roof and the masonry wall. The problems depend on a low support length equal to few centimeters and to the effects of daily thermal variations. In order to prevent the pull out of such elements, an additional steel profile shall be placed in correspondence of the whole perimeter of the

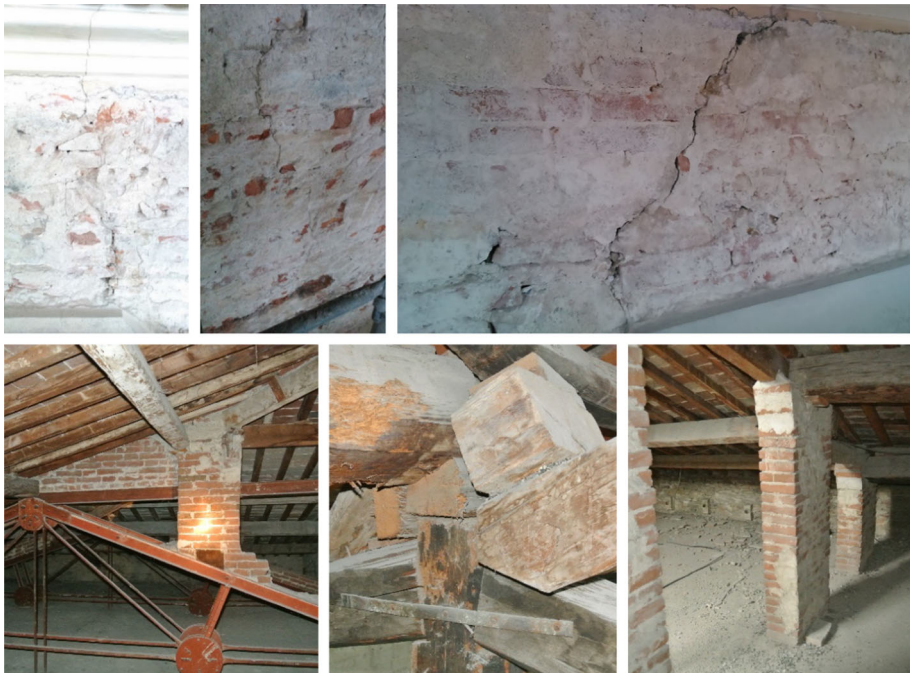
The roof structure presents diffused maintenance problems (Fig. 18): the wooden elements, subjected to specific investigations aiming to determine the damage level due to humidity, insect, insufficient maintenance, are affected by a high degree of degradation. Several criticisms are present both in the primary and in the secondary elements; several other wooden beams are not able to satisfy the safety checks foreseen by actual standards for constructions in terms of strength and deformability. The structural survey of the roof system also evidenced significant cracks in correspondence of the support of wooden trusses on the masonry walls and on the eaves (more recently realized), due to the horizontal thrusts of the trusses themselves. Connection between elements (both steel and wooden ones) are not correctly realized and need to be improved to globally increase the safety level. As an example, it is necessary to remove brick elements sustaining the wooden beams directly loading on the storey slab, to replace existing connections with more safety and efficient systems and so on.

Fig. 18 Degradation and problems affecting the roof structure of the Palace

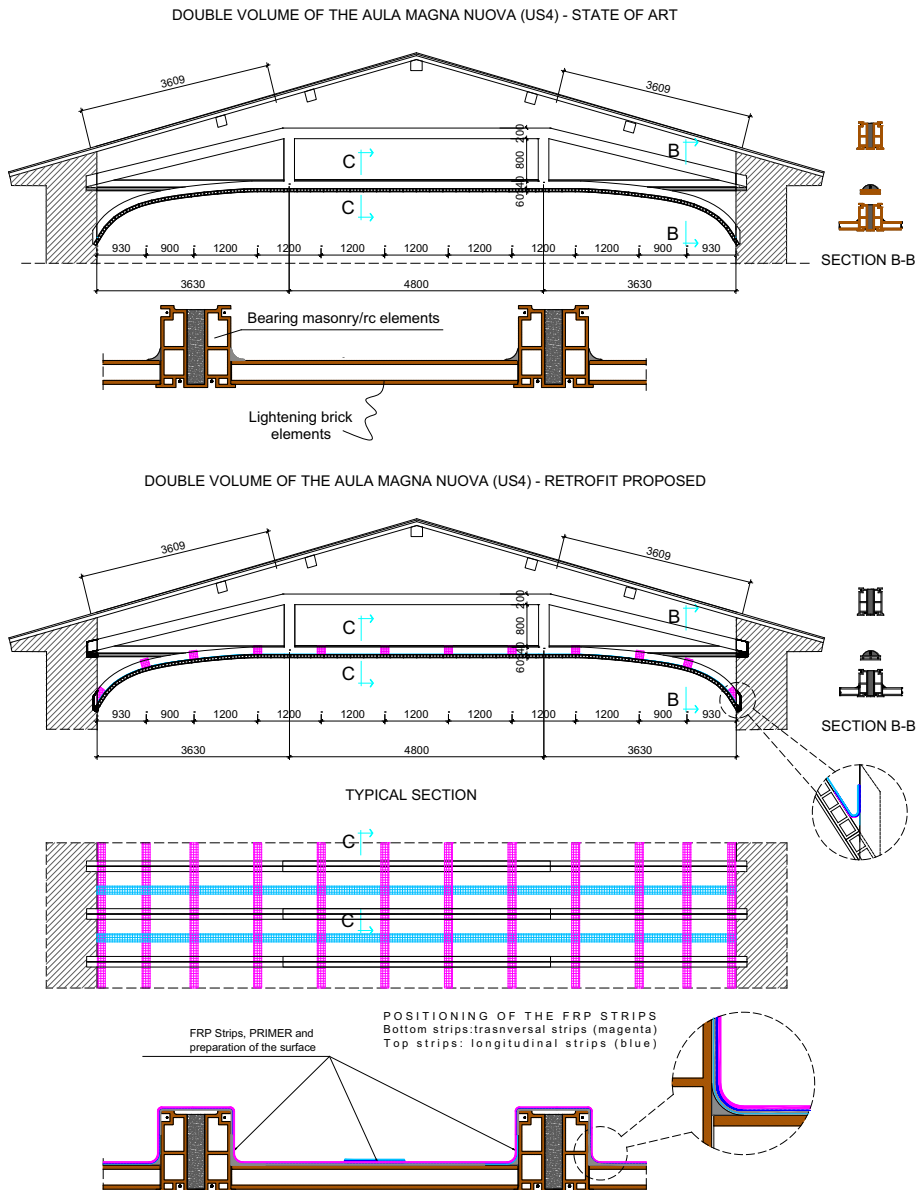
The analysis of US4 evidenced, as already mentioned, the presence of brittle brick elements constituting the pseudo-vaulted structure of the double volume of the Aula Magna Nuova, made up of reinforced-brick trusses with lightening elements of reduced thickness. The support length of such elements is about 2–3 cm, with following risk of possible cracking and collapse. In order to increase the safety margin without altering the

Fig. 22 Scheme of the retrofit foreseen for the vaulted surface of the Aula Magna Nuova

original structural configuration of the roof system, the retrofit proposed in Fig. 22 was designed.
