Seismic performance of RC buildings during the M_w 7.8 Muisne (Ecuador) earthquake on April 2016: field observations and case study

Alexander Kagermanov¹ · Paola Ceresa¹ · Enrique Morales² ·
Jose Poveda¹ · Jerome O'Connor²

Abstract The $M_w = 7.8$ Muisne event of April 16, 2016 occurred on Saturday at 18:58:37 local time off-shore of the west coast of northern Ecuador. Several cities in the province of Manabí were directly affected and a state of emergency was declared in six provinces encompassing a total area of 70,000 km². The building stock was severely damaged. 80% of the buildings were destroyed in the city of Pedernales, while several multi-storey reinforced concrete structures totally collapsed in the cities of Manta and Portoviejo. Field observations on the seismic performance of reinforced concrete buildings inspected by the authors are presented in this paper. Also, numerical results from three-dimensional pushover analysis of a representative case study building are discussed. The effect of corrosion and masonry infills, which played a key role in the observed damage, was directly taken into account in the analytical model.

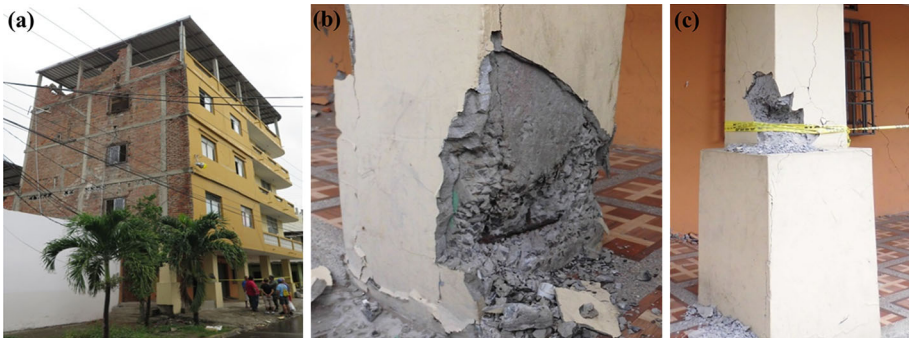
Some typical residential buildings that were found particularly vulnerable to the ground shaking are shown in Fig. 6. The five-storey RC building in Fig. 6a is located in Tarqui, which was the most affected area in Manta declared as ground zero zone. The building presented a soft-storey at the ground level due to removal of masonry infills from the facade plane. Spalling of concrete cover and 20 mm thick plaster was observed at the bottom of the columns, as well as corrosion of longitudinal and transverse reinforcement (Fig. 6b). Some of the ground-floor-columns had been strengthened, hence failure localized immediately after the section reduction in the form of concrete crushing (Fig. 6c). Also note the out-of-plane damage to the infills at the roof level, where the typical layout of the columns was changed during the construction of an additional storey. This type of

Fig. 6 5-Storey RC building with masonry infills located in Tarqui (Manta) (a), and its damage to the ground-floor-columns (b, c)

structural alterations, whereby additional stories are added at different construction periods without reassessment of the structural performance, was commonly observed. This intervention increases the mass and axial load in the existing columns, and introduces stiffness and strength irregularities which can result in undesirable performance.

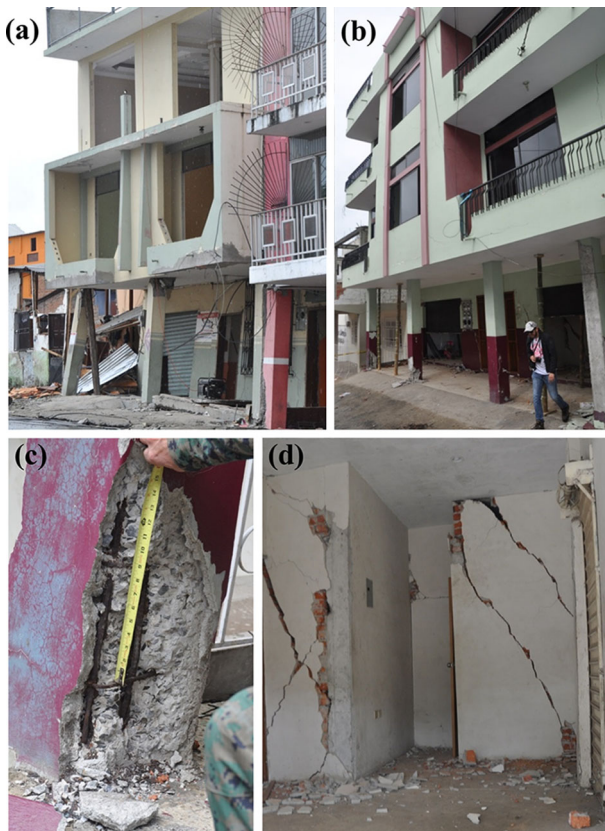
Fig. 7 Soft-storey buildings in Manta (a), damage to the columns (c) and partitions (d)

Further examples of soft-storey frame buildings are shown in Fig. 7a, b. All of these structures were located in Manta, where ground accelerations close to the 475-year design level were recorded. Typical column reinforcement consisted of 14 mm longitudinal bars with 8 mm stirrups spaced at 200–250 mm (250 mm in Fig. 7c), although the current code prescribes a minimum spacing of 100 mm within the plastic hinge region L_o , with $L_o \geq 450$ mm. Figure 7d shows some damage to masonry partitions at the ground level of the building in Fig. 7b, where most of the lateral drift was concentrated.

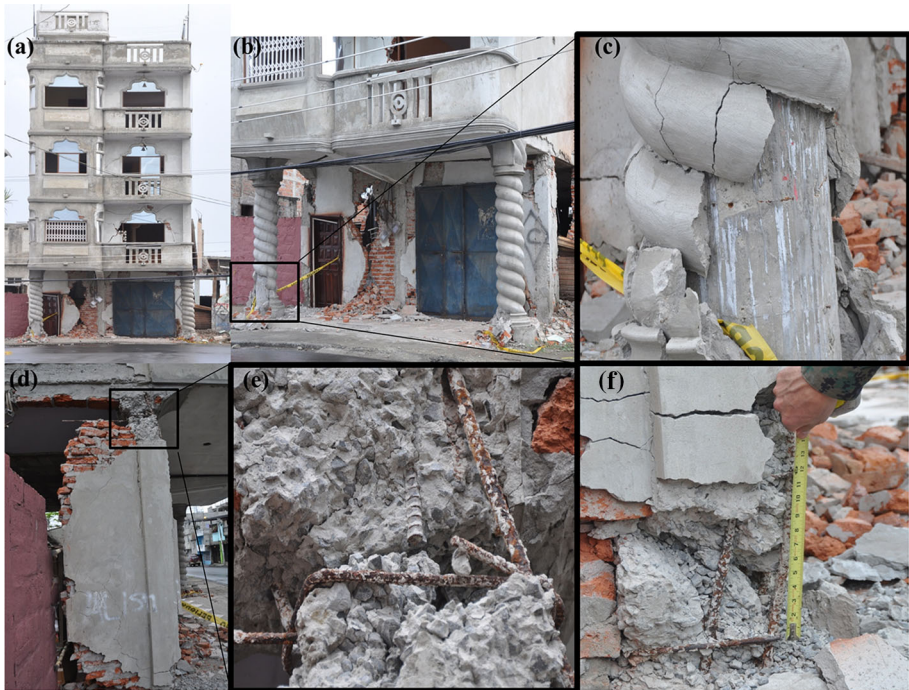
The four-storey building in Fig. 8 was located also in Manta. It is an interesting case of structure that performed relatively well despite presenting several structural and architectural deficiencies, such as removal of an intermediate column at the ground level (Fig. 8b) and the use of heavy column cladding (Fig. 8c). Important detailing deficiencies were found in the column end regions, with stirrups bent at 90° with 300 mm spacing (Fig. 8e, g), and longitudinal bars cut off (Fig. 8e), thus impairing the bending moment capacity in the region of highest moment demand, which ideally should remain elastic according to capacity design principles. According to the current Ecuadorian code, lap splices of column longitudinal bars must occur at column mid-height, outside the plastic hinge regions. Moreover, significant corrosion and loss of bond was observed in Fig. 8e. Despite these deficiencies, the structure did not lose its vertical load carrying capacity, which was partially transferred to the masonry infills.

Fig. 8 4-storey RC building with several deficiencies located in Manta (a), structural irregularities and heavy cladding (b, c), and detailing deficiencies (d, e, f)

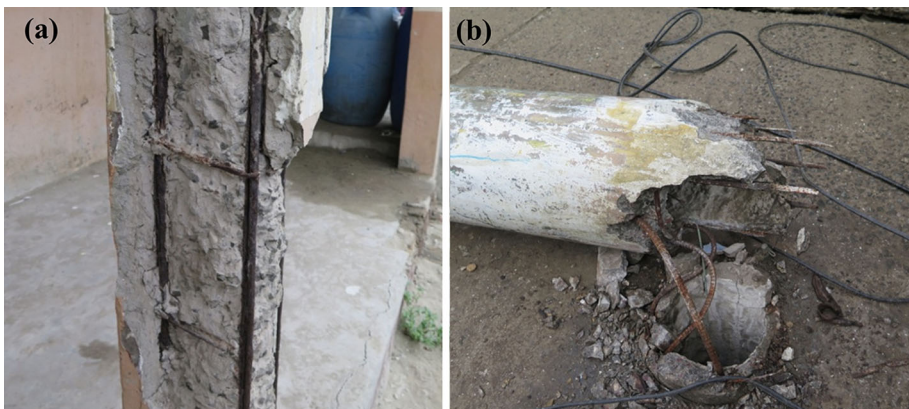
Moreover, insufficient concrete cover, usually <20 mm, accelerated the degradation process. Cover concrete/plaster spalling and fracture of stirrups at the ground-floor-column of an old two-storey building is shown in Fig. 9a. This failure occurred at column mid-height as a result of extensive corrosion and expansion of reinforcement. Also, several columns were found excessively slender (20×20 cm² in Fig. 9a). The current NEC-2014 code specifies minimum column dimensions of 30×30 cm². An electrical RC post with a hollow circular cross-section is shown in Fig. 9b, which failed due to insufficient anchorage length and corrosion of the rebars. Note also that smooth rebars were used in Fig. 9a.

Fig. 9 Damaged column (a) and collapsed electrical post (b)

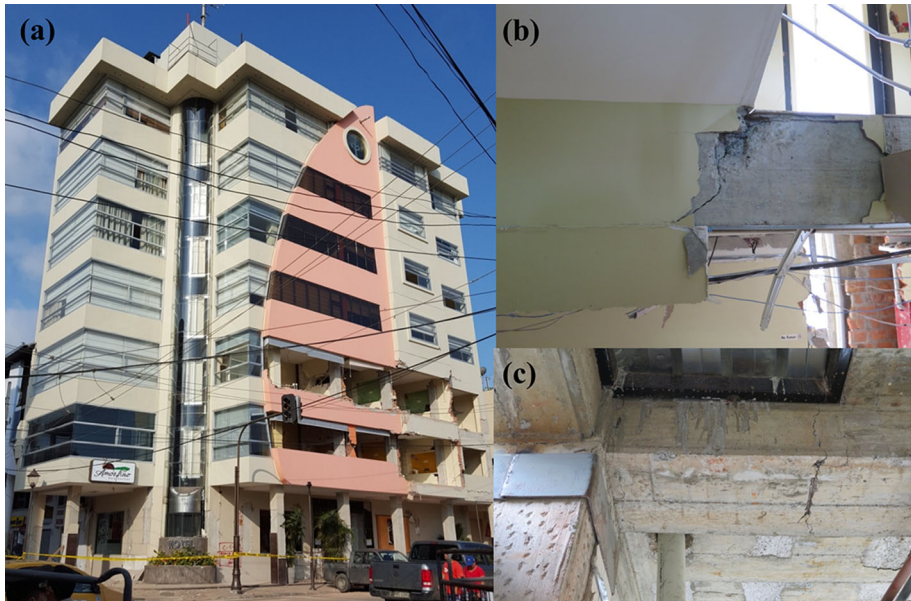
The Ceibo Dorado Hotel, constructed in 2010 and located in the ground zero zone in Portoviejo, is shown in Fig. 10a. It consists of an L-shaped 7-storey RC structure with no seismic joints between adjacent blocks. Damage to interior masonry partitions and exterior infills was observed mostly at lower storeys. Structural irregularities introduced by the interior staircase resulted in concrete crushing and flexure-shear cracking of the landing slab (Fig. 10b). Also, signs of flexural yielding and beam elongation were noticed in some beams framing into perimeter joints (Fig. 10c), likely accentuated by torsional effects. Overall the structure performed relatively well and without any apparent permanent drift, despite being its natural period close the local amplification peak at 0.5 s in Portoviejo.

Fig. 10 7-storey Hotel Ceibo Dorado in Portoviejo overall damage (a), damage to the staircase (b) and perimetral beams (c)

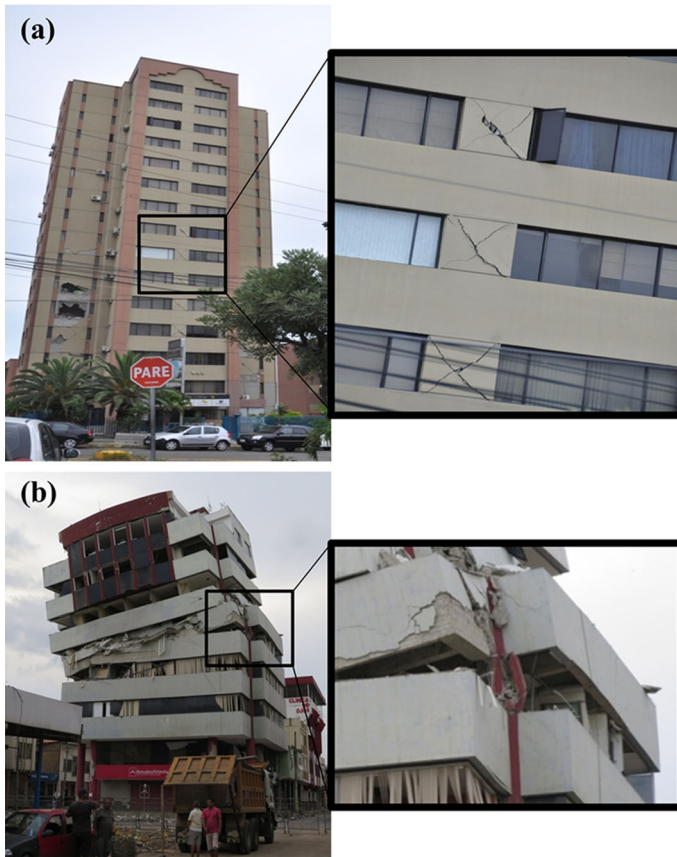
The 15-storey hotel Oro Verde, built in the late 1970s and located at the beach front in Manta, is shown in Fig. 11a. It is a good example of a long period structure with damage at intermediate storeys, presumably due to higher mode effects. The damage consisted of diagonal shear cracks localized in masonry infills (Fig. 11a). Note that the structure is isolated from neighboring buildings, hence no group interaction occurred.

An impressive local collapse was triggered in the Mutualista Pichincha building, a 10-storey RC structure built in the late 1980s and located in downtown Portoviejo (Fig. 11b). The upper three storeys collapsed on top of the lower part of the building across a soft-storey plane, likely influenced by the short-column effect from interaction with external cladding panels (see close-up). Local witnesses reported that the upper part was slowly “creaking” with every aftershock. The building was recently demolished under controlled implosion.

Fig. 11 15-storey RC building in Manta (a) and partial collapse of 9-storey RC building in Portoviejo (b)

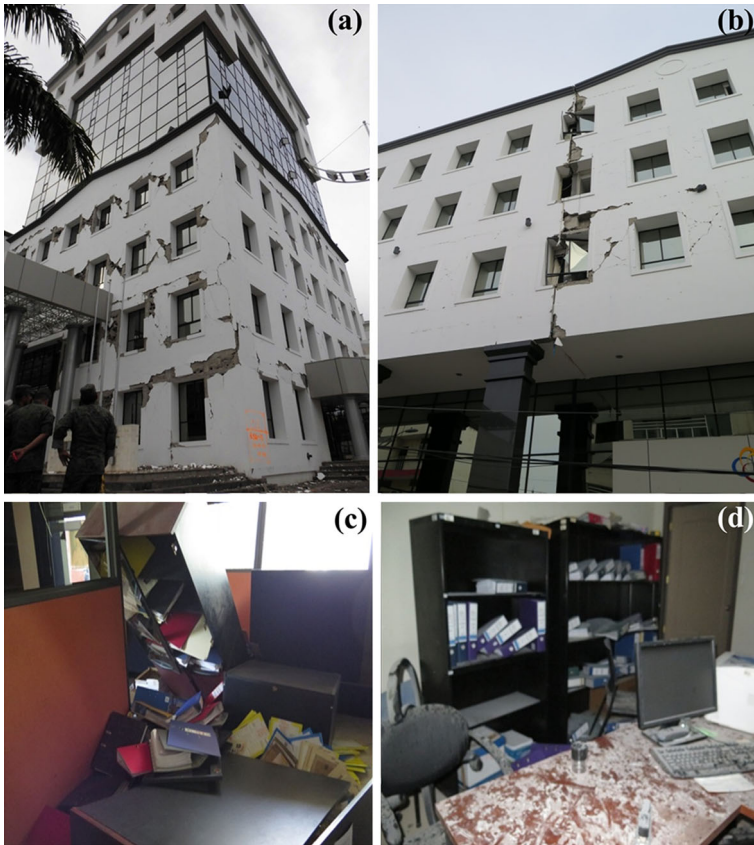
The Supreme Court building in Portoviejo, constructed in 2002 (Fig. 12a), is a 9-storey RC structure with 3 independent adjacent blocks, stiff rectangular columns (0.5×1 m²)

and 4.5 m long shear walls. The structure did not suffer any important damage, with only minor damage at the construction joint due to pounding between slabs (Fig. 12b). However, non-structural damage was important. Diagonal shear cracks were noticed in the facade masonry, consisting of hollow concrete bricks. Damage to the contents, e.g. overturning of bookshelves, was significant in the upper storeys (Fig. 12c) where greater floor accelerations occurred, whereas in the lower storeys drift sensitive components were more affected (Fig. 12d).

Fig. 12 **a** Exterior damage to the Supreme Court building, **b** pounding at the construction joint, **c** non-structural damage at upper stories and **d** at lower stories

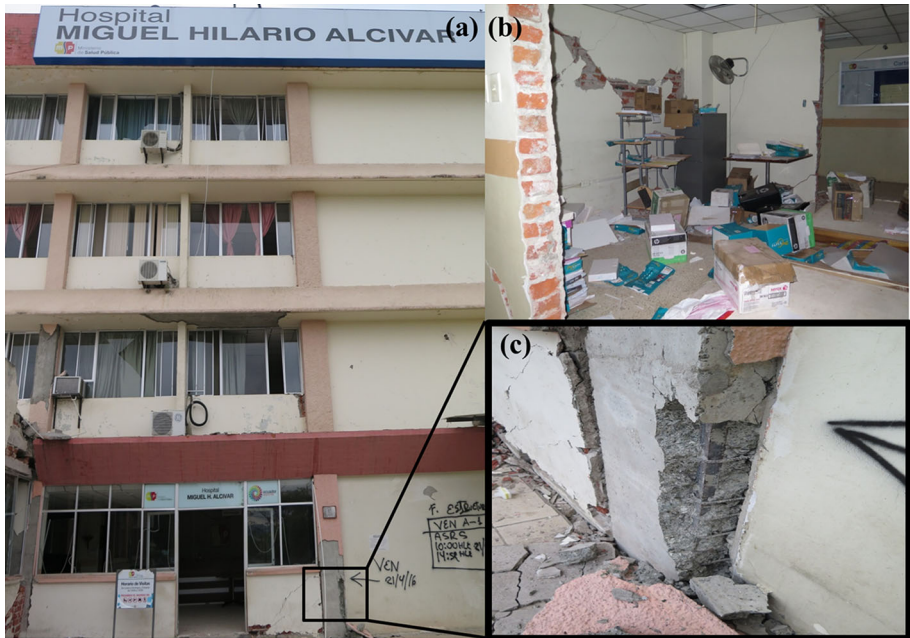
As previously mentioned, many hospital facilities were left inoperative due to extensive non-structural damage, although none of them completely collapsed. The structural system was similar to that of residential buildings, i.e. RC frames with URM infills, but with stiffer and stronger members resulting in higher floor accelerations and wide-spread damage to acceleration sensitive components, such as medical equipment. The Miguel Hilario Alcivar hospital in Bahía de Caráquez (Fig. 13) represents an interesting example of retrofitted structure after the 1998 Bahía de Caráquez earthquake. Retrofitting consisted in the addition of six shear walls and jacketing of some perimeter columns. Minor structural damage occurred during the present earthquake, with some spalling of plaster and concrete cover in the boundary wall elements (Fig. 13c). However, damage to the contents and the psychological impact on people located in the building during the earthquake left it inoperative (Fig. 13b).

Fig. 13 a Damage to the retrofitted Miguel Hilario Alcivar hospital in Bahía de Caráquez, b interior damage to partitions and content, and c structural damage in the wall boundary

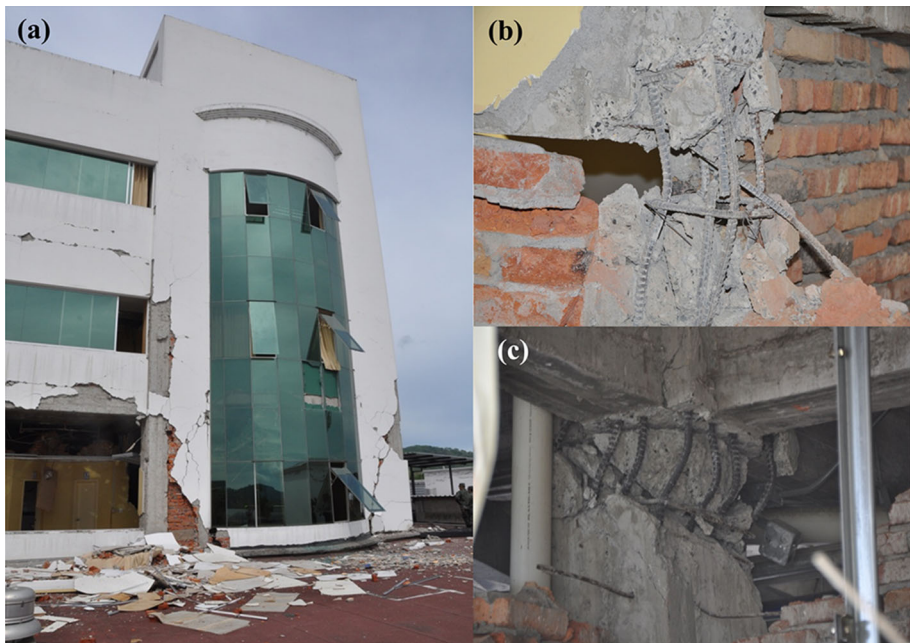
The Solca Hospital in Portoviejo was left only 40% operative after the earthquake. The building was built in early 2000s and it consisted of multiple, up to three-storey units separated by expansion joints. One of the units presented an additional two-storey tower which did suffer extensive damage to the non-structural and structural components (Fig. 14a). In Fig. 14b, damage to a non-structural column of an interior infilled frame is shown. The interior column of the tower (Fig. 14c) presented insufficient number of

stirrups and lack of transverse confinement, resulting in combined axial-shear failure and buckling of longitudinal reinforcement.

Fig. 14 a Damage to the building tower of the Solca hospital in Portoviejo, b failure of a non-structural column, and c shear failure of an interior column
