Remarks on damage and response of school buildings after the Central Italy earthquake sequence

Keywords School buildings · Earthquake · Usability and damage assessment · Seismic risk

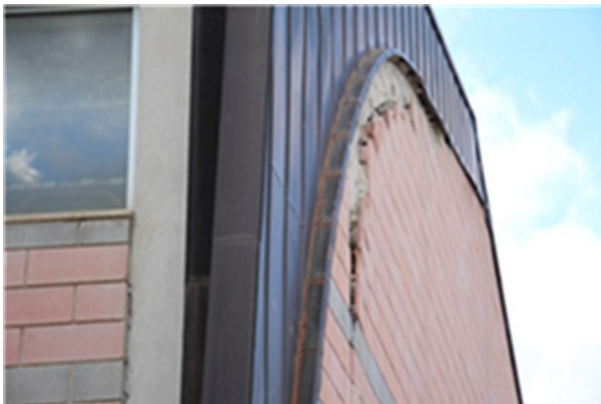
Although the maximum PGA recorded in Norcia on the October 30 event was very high ($a_g = 0.48$ g), no structural damage was observed on all structures. On the contrary, a significant damage was found on the infill walls due to both significant slenderness and

poor connection with the surrounding resisting members of the frames. To this purpose, Fig. 7 shows cracks due to the separation of the external layer from the structural frame.

Fig. 7 Separation of the external layer of infill panels

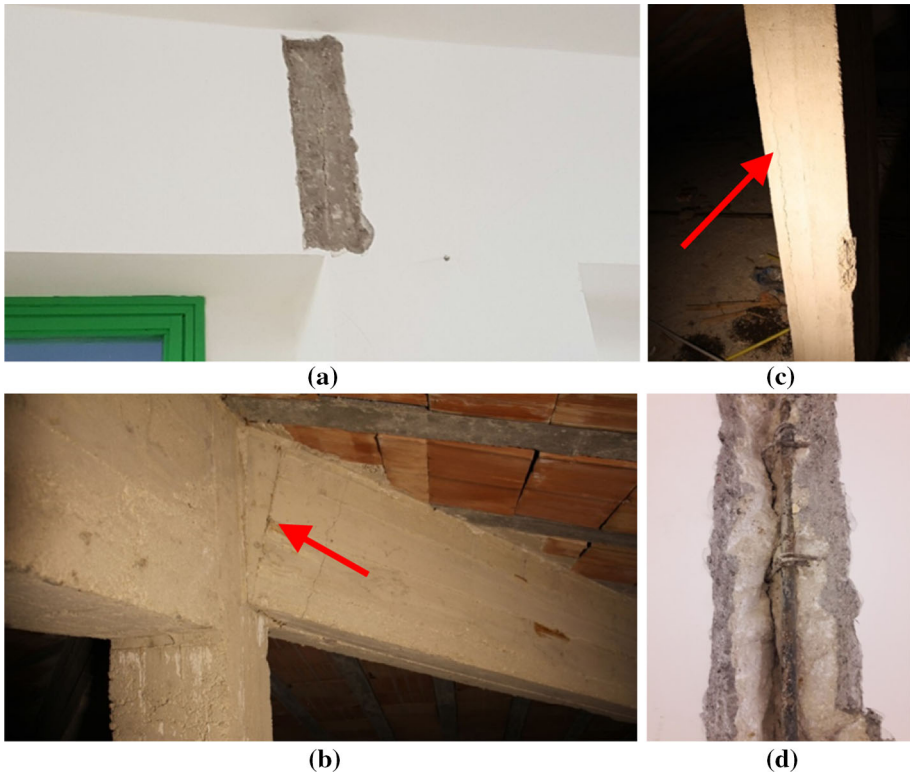
RC resisting elements suffered moderate structural damage. In particular, at the first storey, cracks involving the section end of some beams of the block A were observed (Fig. 9a). According to the AeDES survey form, a D2-D3 damage level was evaluated. Similarly, cracks were observed in some beams and columns at the upper storey (Fig. 9b, c). Smooth bars (Fig. 9d) were used with low percentage of both longitudinal and transverse reinforcements.

Fig. 9 Cracking failure at the end of beams (a, b) and columns (c). Smooth bars with poor transverse reinforcement (b)

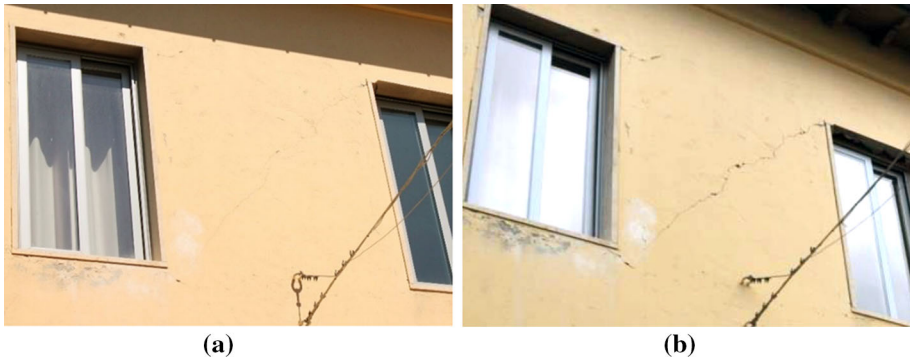
The first visual inspection after the Mw6.0 earthquake revealed significant damage to more than 2/3 of the vertical load bearing elements (masonry piers) (Fig. 11) and the nonstructural partition walls (Fig. 12). Namely, the structure had shear cracks in many of the load bearing walls, likely, the inertia force that loaded the structure during the first event was close to the maximum strength of the building. Damage to spandrels was also observed. The most evident damage was due to the interaction between the URM piers and the RC slabs, both at the first and the second floors (Fig. 13). The stairway structure shows

Fig. 11 Shear crack in a second floor pier: situation after Mw6.0 event (a) and after Mw5.9 and 6.5 events (b)

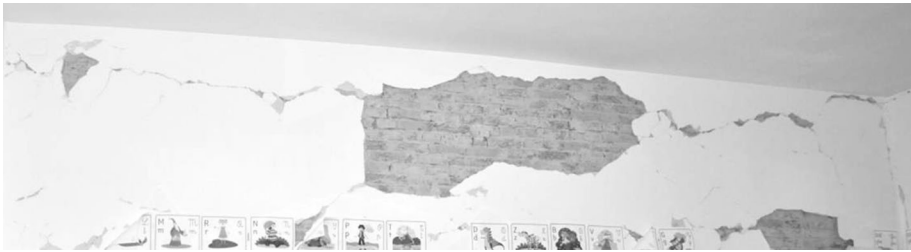
Fig. 12 Damage on 24-cm-thick wall after Mw5.9 and 6.5 events

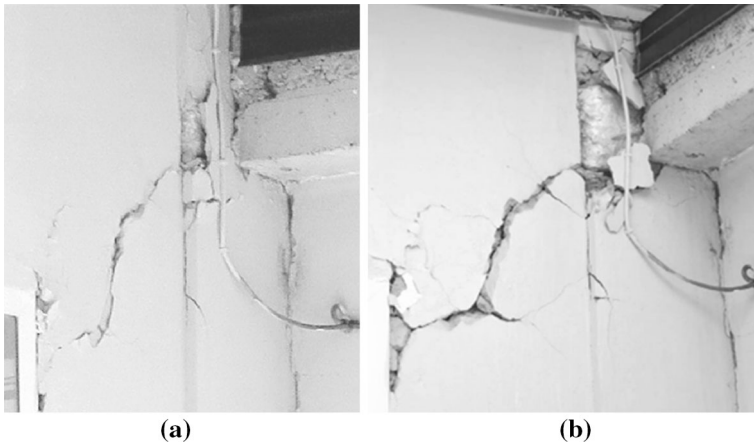
Fig. 13 Pounding damage: situation after Mw6.0 event (a) and after Mw5.9 and 6.5 events (b)

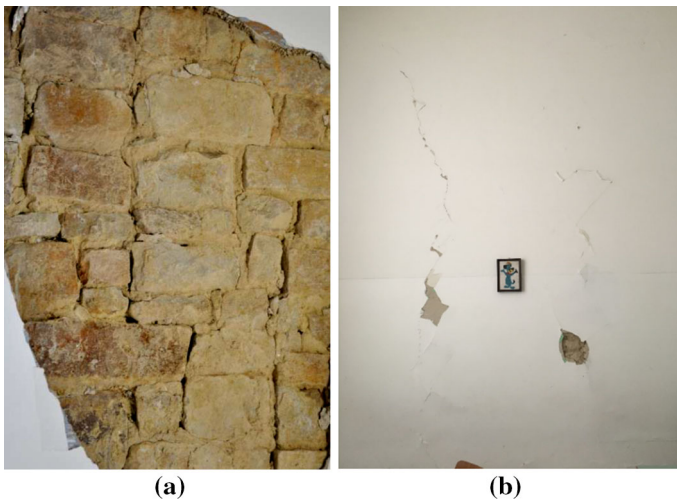
Fig. 15 Double-leaf stone masonry with poor mortar constituting the older part of the building (a), damage on a stone URM wall: situation after the Mw6.0 event (b) (almost identical also after the Mw5.9 and 6.5 events)

Despite the relatively low PGA (0.049 g), the first visual inspection after M6.0 earthquake revealed significant damage to large sections of the vertical load bearing elements, especially shear cracks in masonry piers (Fig. 15b) and triggering of out-of-plane wall mechanism at the South corner of the building (Fig. 16a). This mechanism was further reactivated by the October earthquakes, as demonstrated by the worsened crack pattern noticed during the second survey after Mw5.9 and Mw6.5 earthquakes (Fig. 16b). The detailed visit of the structure after the two October events showed a worsening of the damage, mainly concentrated in the observed local mechanism. In any case the general crack pattern resulted to be substantially the same as reported during the first survey. No evidence of foundation settlements was observed after the three events.

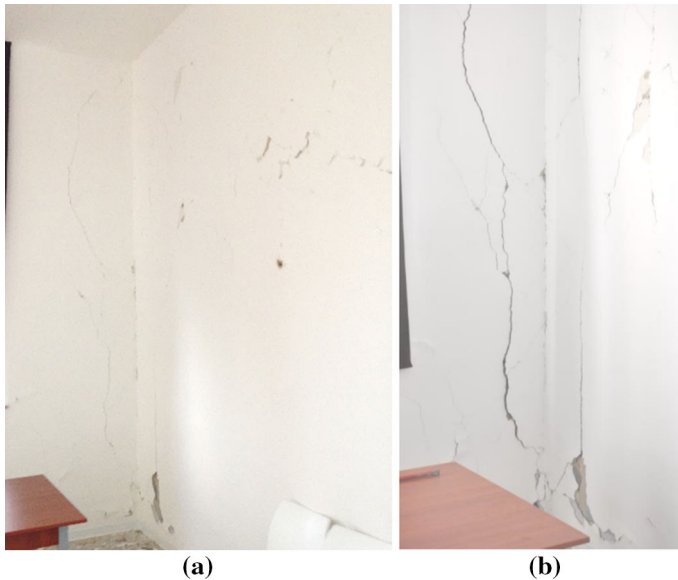
Fig. 16 Damage at the South corner of the building (inside): situation after the Mw6.0 event (a) and after the Mw5.9 and 6.5 events (b)
