Seismic behaviour of ordinary masonry buildings during the 2016 central Italy earthquakes

Abstract Between August 2016 and January 2017 nine shallow earthquakes ranging from 5.0 and 6.5 of moment magnitude affected Central Italy, involving several municipalities wherein unreinforced masonry buildings are more than three quarters of all constructions. Damage state has been very severe, with sixteen settlements belonging to the municipalities of Amatrice, Arquata del Tronto, Accumoli, Castelsantangelo sul Nera and Norcia experiencing a cumulative European macroseismic scale intensity larger than IX. Ground motion demand in terms of peak ground velocity was approximately two or three times what expected for a 475 years return period while the pseudoacceleration response spectra showed values between once and twice gravity acceleration for the period range typical of two and three storeys unreinforced masonry buildings. Moreover, since October 2016, such large seismic demand acted on structures damaged from previous shocks testifying the effects of damage accumulation, too. The significant shaking alone cannot explain the extremely severe damage of some settlements, with large portion

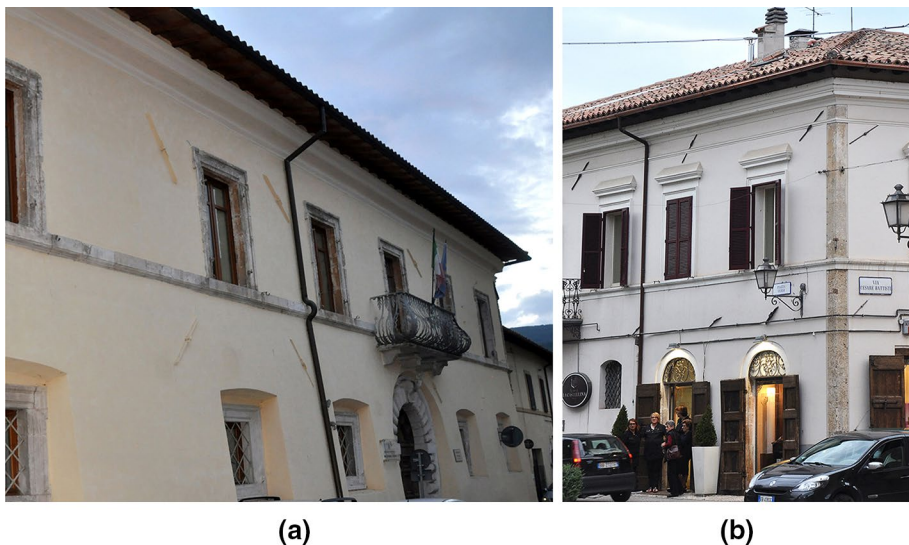
Fig. 3 Norcia. Two-storey buildings, tapered wall thickness, systematic use of tie rods. **a** Via Cavour; **b** Piazza Giuseppe Verdi

reasonable quality masonry, steel ties certainly contributed to preventing collapse (Figs. 3, 8). Nevertheless, besides the low masonry quality, the limited presence of connections in many buildings, the reduced strength of lateral walls compared to large-units wall intersections (Fig. 14), as well as the presence of intermediate floors having scarce diaphragm effect, poor details at the bearings, and no connections to the walls parallel to beams, should be recalled (Fig. 6).

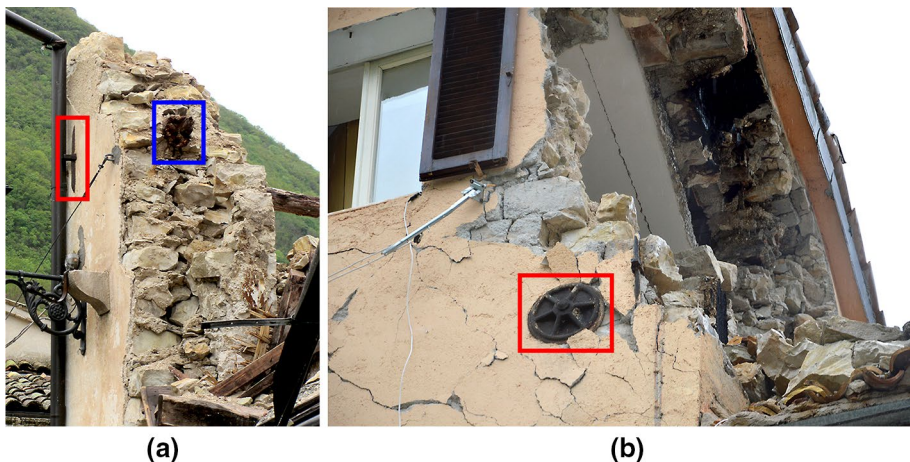
Fig. 4 Timber tie rods (blue frame) and steel wall anchors (red frame) in Castelsantangelo s/N: **a** Via Parco della Rimembranza; **b** via delle Mura Castellane

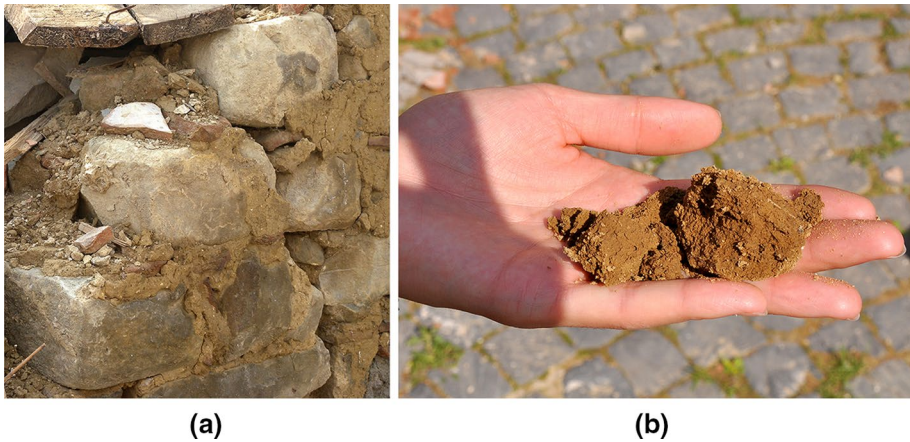
Fig. 5 Mud mortar in: **a** Accumoli, Illica; and **b** Amatrice, Sant'Angelo

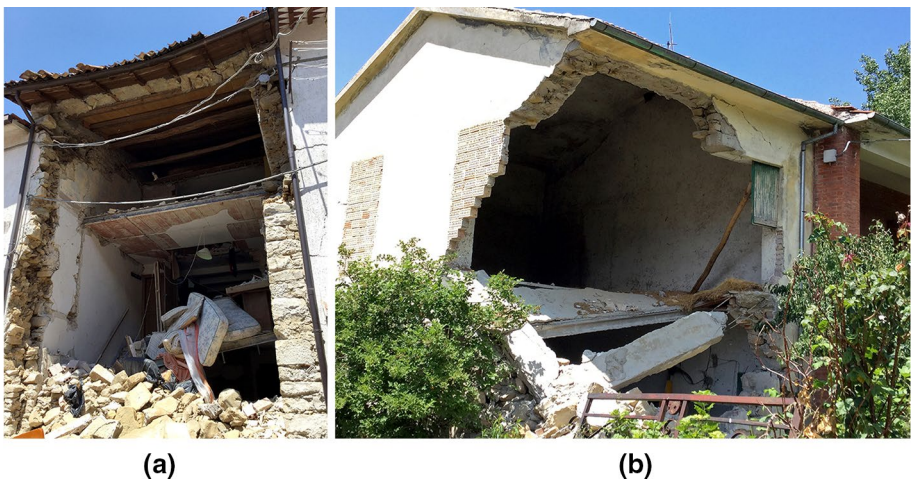
Fig. 6 **a** I-beam and hollow clay block floor, Amatrice, Retrosi; **b** Precast reinforced concrete beams and hollow clay block floor, Amatrice, Moletano

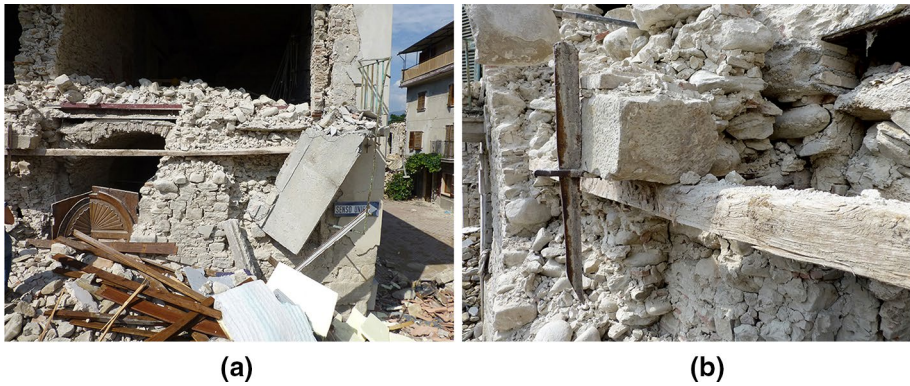
Fig. 7 Iron wall anchor of timber tie, Amatrice, via Roma. **a** General view; **b** Close up of a wall anchor

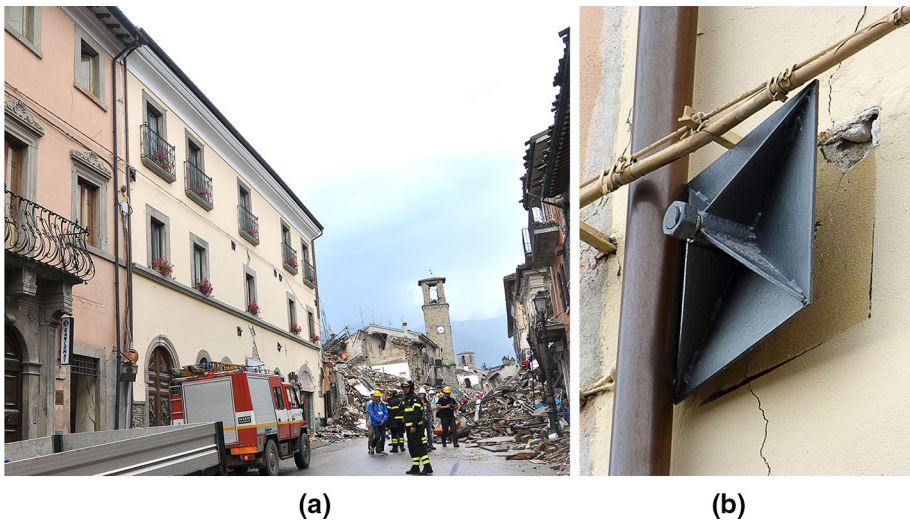
Fig. 8 Steel tie rods in the lightly coloured building. Amatrice, corso Umberto I. **a** General view; **b** Close up of a wall anchor

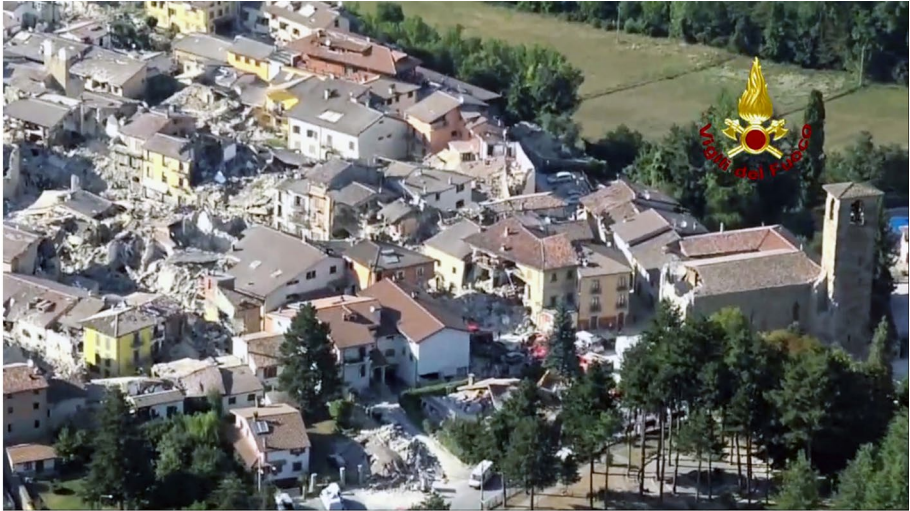
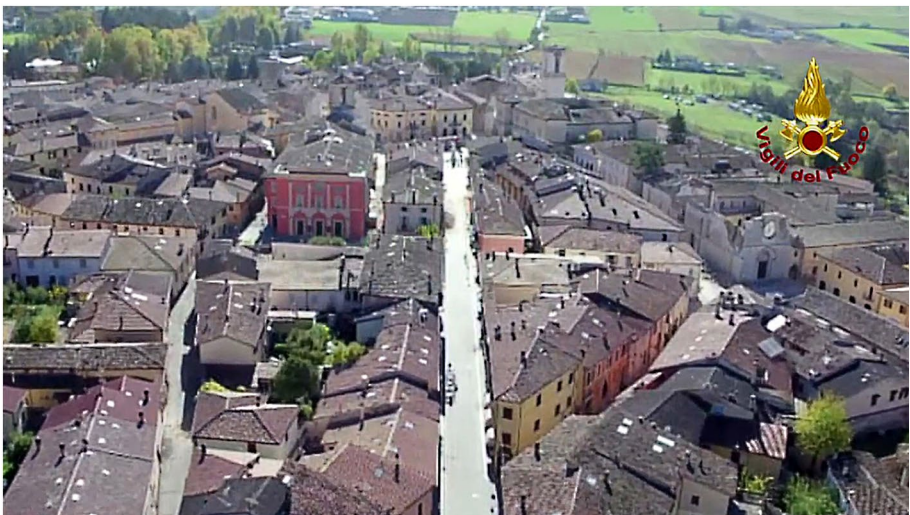
Field surveys in the most affected area have shown catastrophic collapses, with the historical centres of some settlements being almost completely destroyed. However, such dramatic performance was observed in Amatrice (Fig. 9a) and Arquata d/T, whereas residential buildings in the historical centre of Norcia have shown a much

Fig. 9 **a** Amatrice, after the 24th August event; **b** Norcia, after the 30th October event. Snapshots from the movies released by the Firefighters Corps (www.vigilfuoco.tv)

better performance (Fig. 9b), despite ground motion being similar or even more severe in the last settlement (Table 1; Fig. 2).

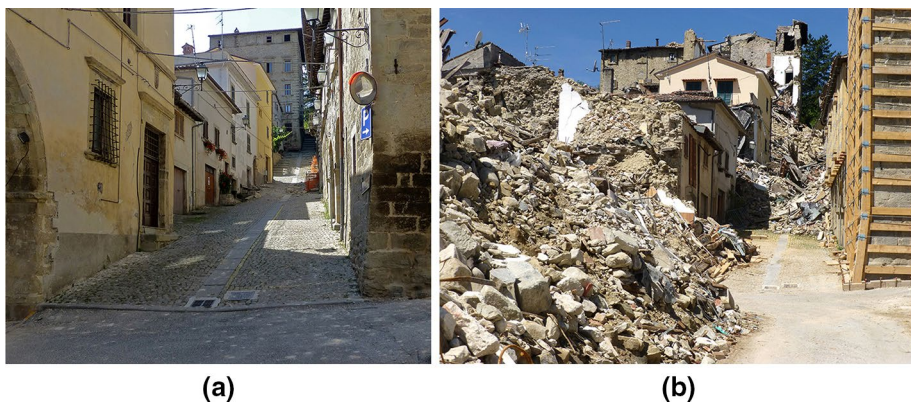
The effect of damage accumulation played a significant role in defining the actual destruction situation of some settlements, although the difference in the quality of structural details and masonry illustrated in Sect. 2 is decisive for the seismic response of buildings to repeated shocks. For instance, being comparable the ground motion experienced in Norcia and Accumoli on the 24th August and the 30th October (Table 1; Fig. 2), the final state is completely different leading to the almost total destruction of ordinary historical buildings in Accumoli (Fig. 10).

Fig. 10 Damage accumulation in Accumoli, via Tito Vespasiano: **a** After August 24th; **b** after October 30th

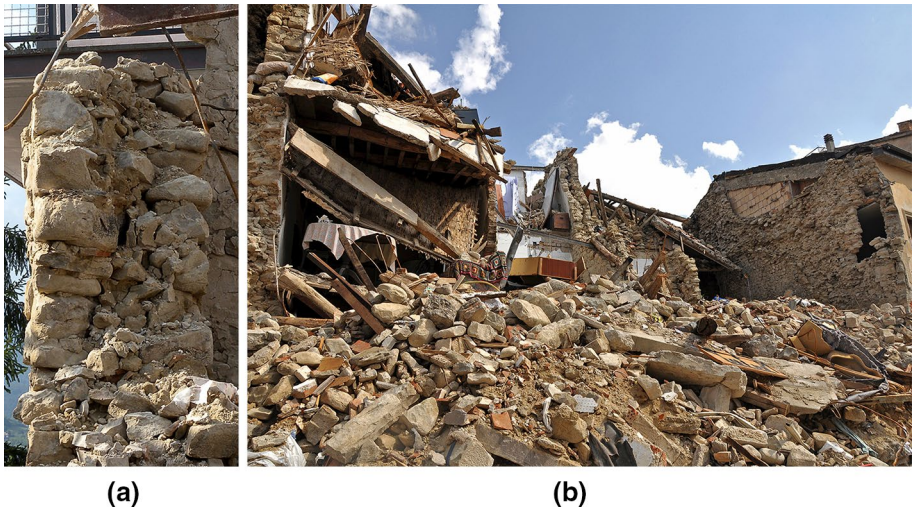
In several cases the main damage mode of the buildings has been the disintegration of masonry, due to a combination of undressed units and very poor mortar quality (Fig. 11). Although delamination of external masonry leaf has been reported in other Italian earthquakes (e.g., Decanini et al. 2004; Augenti and Parisi 2010), it has been extremely common in some settlements of Amatrice, Accumoli and Arquata d/T involving large portions of whole blocks.

Fig. 11 Poor performance of undressed natural stone buildings in: **a** Accumoli, Illica; **b** Amatrice, corso Umberto I

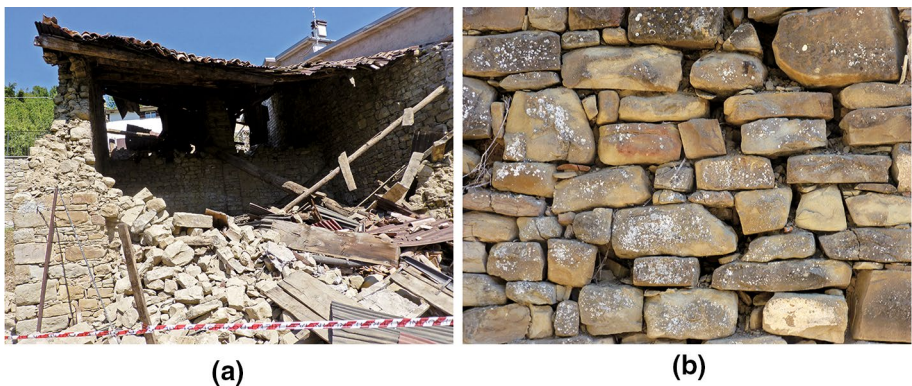
Therefore, the critical role of mortar has been clearly highlighted by this sequence, with collapses occurring even when the units' assemblage was reasonably accurate at least on the external leaf (Fig. 12), and mortar composition and strength should be always investigated to make an exhaustive assessment (Artioli et al. 2010; Liberatore et al. 2016).

Fig. 12 Masonry disintegration due to poor quality mortar in a reasonably accurate units' assemblage of the external leaf. Amatrice, Cossito: **a** front view; **b** detail of masonry on the left-lateral wall

structure, rather than real limitations, such intervention alone cannot explain most of the observed collapses. These failures seem related to a very poor quality of masonry, especially of the mortar (Fig. 12), frequently combined to low maintenance conditions of timber roofs and lack of proper connections in traditional structures.

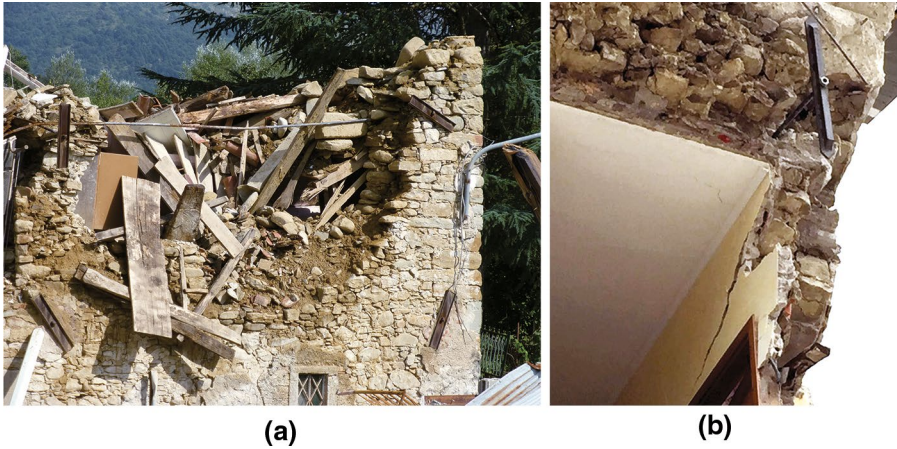
These mortar characteristics could at least partially explain the performance found after the 24th August event, worse than that of the 2009 L'Aquila Earthquake. Additionally, several experiments show that undressed natural stone with proper mortar can have substantial seismic strength (e.g., Magenes et al. 2014; Silva et al. 2014; Giaretton et al. 2017). If disintegration due to poor masonry quality occurs any modelling of building response becomes unreliable (Sorrentino et al. 2017). As shown in Fig. 13, when masonry has such a low strength even the systematic use of steel ties is ineffective. When combined with a

Fig. 13 Collapse of a masonry building having steel ties combined to poor mortar. **a** Amatrice, Petrana; **b** Arquata d/T, Piazza Umberto I

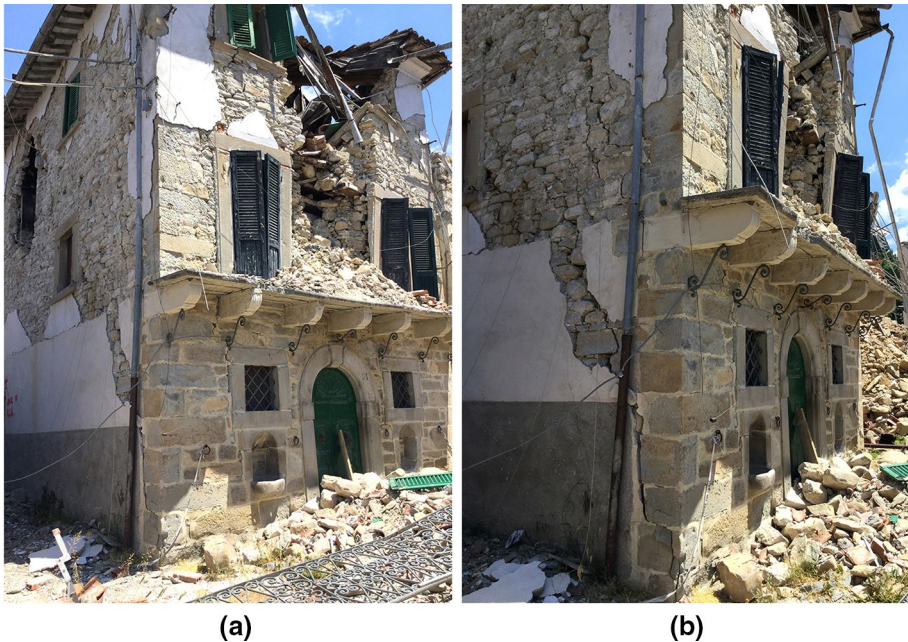
Fig. 14 Reduced strength of lateral walls compared to large-units wall intersections, Amatrice, Retrosi

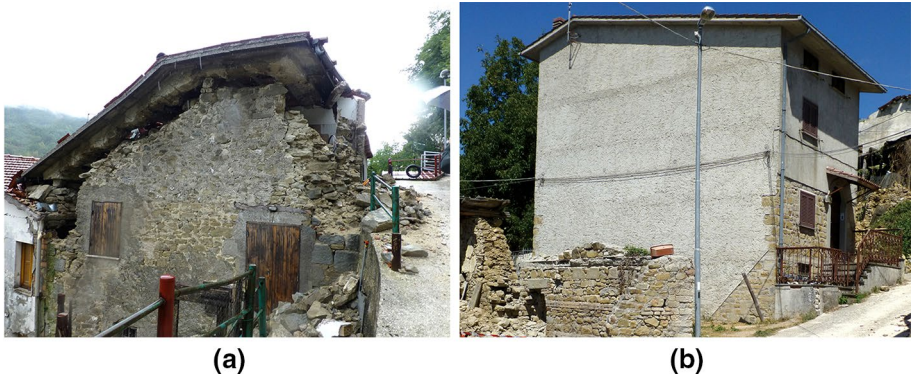
Fig. 15 Replaced reinforced concrete roofs: **a** Arquata del Tronto, Pescara del Tronto; **b** Amatrice, San Tomasso

Media attention immediately after the August event blamed buildings with original roofs replaced with reinforced concrete structures. After being compulsory in case of structural interventions for more than two decades after the 1976 Friuli and 1980 Irpinia Earthquakes, building codes assumed a more careful approach after the performances observed in the 1997–1998 Umbria-Marche sequence (Penazzi et al. 2000). The current seismic swarm has shown again similar responses, with complete collapses of buildings under still monolithic roofs (Fig. 15a) or local effects associated to the compressive failure or out-of-plane response of masonry at the contact with reinforced concrete ring beams. However, there are several examples, such as that in Figs. 13 and 16a, of very high damage despite the original timber structures were not replaced. On the opposite side of possible performances there are several cases, such as that of the house in Fig. 15b, which have a replaced reinforced concrete roof but no visible damage. Similarly, there are examples of houses with a timber roof that survived the earthquake (Fig. 16b), especially if timber elements were properly designed and connected to walls (Senaldi et al. 2014). Therefore, it seems that although replacing a timber roof by a reinforced concrete roof has been motivated by past lack of confidence in the original

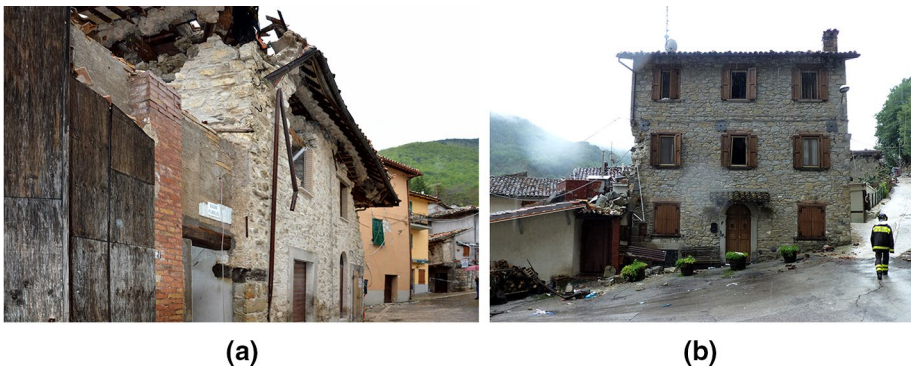
Fig. 16 Timber roofs: **a** Castelsantangelo sul Nera, via B. Vittazzi; **b** Arquata del Tronto, Pescara del Tronto

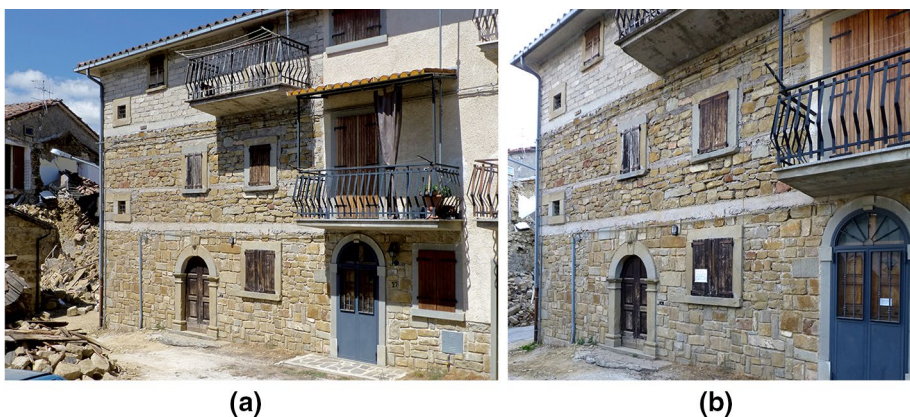
A more radical building activity is that highlighted by the structure in Fig. 17, which has been completely demolished around 1985 and rebuilt using the same natural stone units but a modern mortar. To the satisfactory earthquake performance certainly contributed the ring beams, present at each floor and at opening height at the first storey, but the lack of evident damage suggests an adequate strength of the stonework as well.

Fig. 17 Demolished and rebuilt natural stone masonry, resorting to modern mortar and ring beams. Amatrice, San Capone. **a** Post 24th August; **b** post 30th October

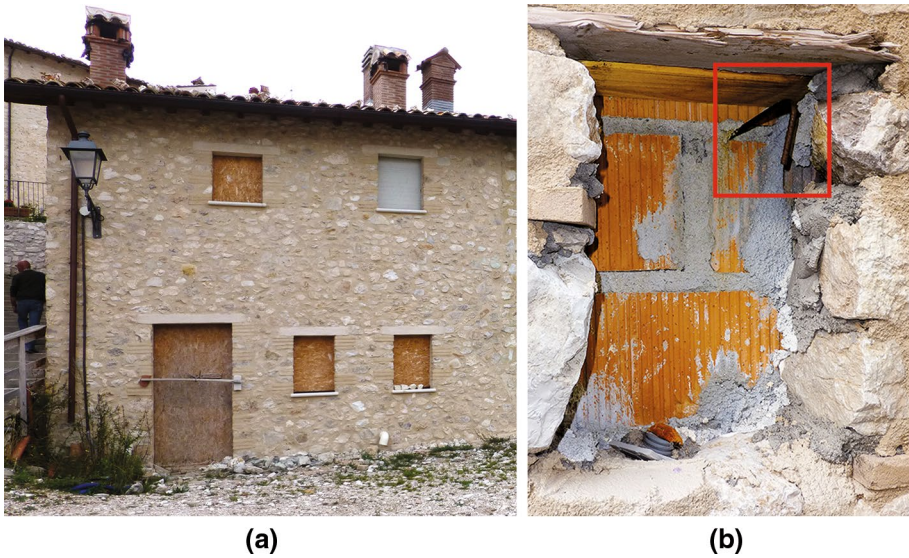
Demolition and reconstruction has been observed also in other instances. In Castelluccio di Norcia the building in Fig. 18a presents a natural stone masonry veneer. However, the actual structure is made of hollow clay blocks, as visible in a local gap (Fig. 18b), as observed also in Montegallo and as documented by a previous research on another building damaged by the 1979 earthquake (Binda et al. 2005). The building in Fig. 18 has survived undamaged the August events and despite a second inspection was impossible because the whole historic centre has been made off limits, aerial views after the October events showed that it still stands. The veneer is connected to the blockwork by means of carbon steel rebars (Fig. 18b), which proved effective in the current seismic sequence occurred just after construction, but could be corroded over time. Hence, stainless steel reinforcement is to be recommended.

Fig. 18 Demolished and rebuilt clay block masonry with connected natural stone veneer. Norcia, Castelluccio di Norcia. **a** General view; **b** close up of a cavity, with clay block and connection rebar visible within the red frame

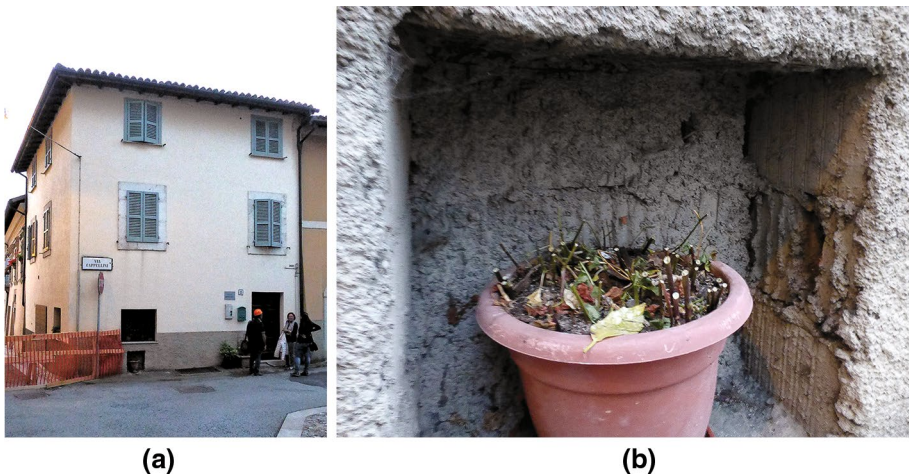
A somewhat similar example is that in Fig. 19a, located in the very historical centre of Norcia. The building seems a typical vintage construction, but its plaster finishing covers a hollow clay block structure (Fig. 19b) as a result of a mid 1980s demolition and reconstruction. Interventions such as those just documented have been considered in the past as unacceptable, but the extremely poor performance of entire historical centres and the very high toll in terms of lost human lives suggest that a general reconsideration is necessary. Preservation of environment values (shape and surface aspect of the buildings), while internal structure is replaced, should not be considered out of question, both in the case of collapsed buildings as in the case of documented very poor characteristics of masonry in slightly damaged buildings.

Fig. 19 Demolished and rebuilt plastered clay block masonry. **a** General view; **b** close up of a cavity, with clay block visible. Norcia, via Anicia intersection with via Cappellini

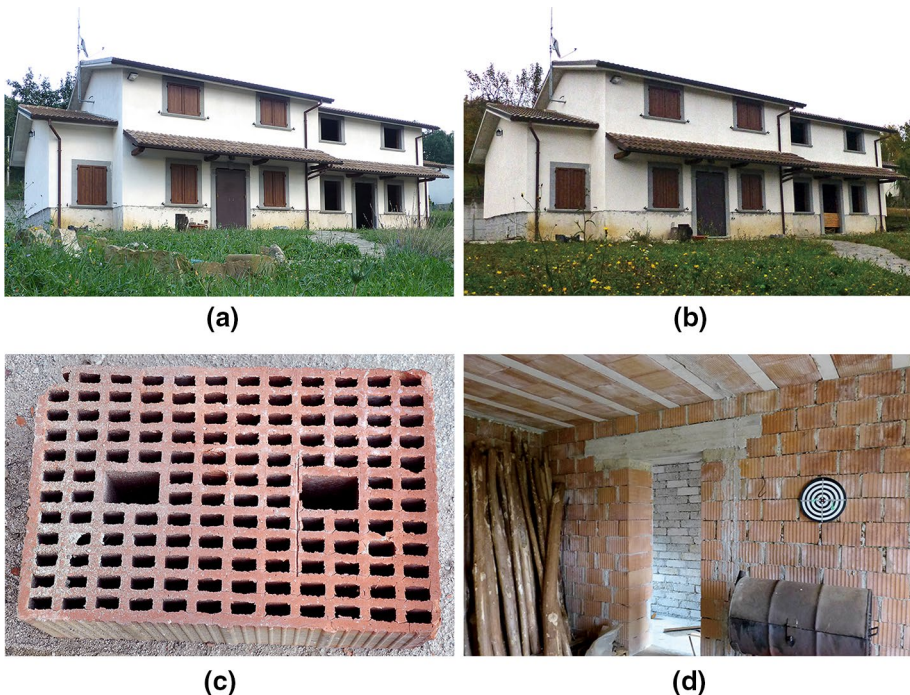
negligible damage both main events (Fig. 20a, b). The building has a blockwork structure, with vertically perforated clay units (Fig. 20c). Walls are single leaf, with reinforced concrete lintels, and floors are made with precast reinforced concrete beams and hollow blocks (Fig. 20d). According to the most common practice in Italy such floors are partially cast in situ, for which the Italian Building Code (DMI 2008) prescribes a 40-mm thick slab with two-way reinforcement. Similar success stories have been documented by the authors in several settlements of the municipality of Amatrice and by other investigators in that of Norcia (Mosele 2017). Such buildings can be also fairly irregular in plan (articulated layouts with non orthogonal wall alignments) and in elevation (different roof levels), but they are usually just two floors above ground, or three in very limited instances.

Fig. 20 Clay block masonry building. **a** After the 24th August event; **b** after the 30th October event; **c** close up of a block; **d** view of bare wall and floor. Amatrice, San Capone

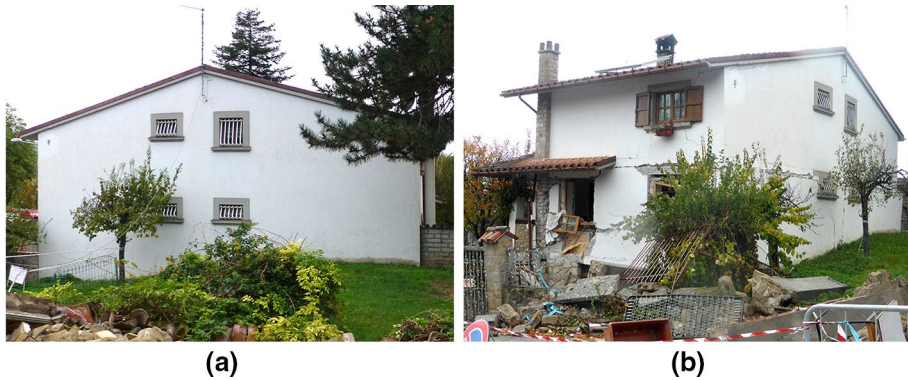
Fig. 21 Solid concrete block masonry building. **a** After the 24th August event; **b** after the 30th October event. Amatrice, viale Saturnino Muzii

visible in the top floor of the house in Fig. 17, as well as in the building adjacent to Amatrice historical centre in Fig. 21. This last building, dating back to the mid 1980s, has 600 mm thick walls in the basement, 450 mm walls at ground floor, and 300 mm walls at first floor. It survived the August events without any damage, despite the widespread collapses of nearby standing structures. The October events, on the contrary, caused a heavy rocking response in the piers of the ground floor and moderate shear cracking at the first floor. Overall the performance can be certainly considered code compliant, bearing in mind the severity of the shaking in Amatrice. Similar success histories have been observed in Accumoli and Casale (municipality of Amatrice), whereas in San Lorenzo a Flaviano and Saletta (municipality of Amatrice) performance has been much poorer.

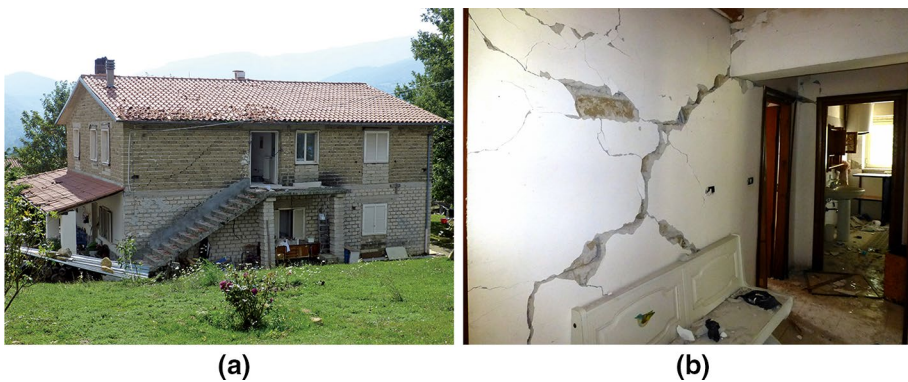
Fig. 22 Solid concrete block masonry (ground floor) and tuff masonry (first floor) building. **a** External view; **b** internal view at first floor above ground. Accumoli, Illica

In Illica there is a modern masonry building, having a ground floor made of solid concrete units, and a top floor made of tuff solid blocks (Fig. 22a). Whereas the bottom floor survived the August events with just slight damage, the top storey suffered heavy stair stepped shear cracks (Fig. 22b). This response seems to indicate that mortar had a lower strength of stone units, but the overall performance is still acceptable although less satisfactory of that of the concrete block masonry at ground floor, which is also usually where
