Damage assessment and the effectiveness of prevention: the response of ordinary unreinforced masonry buildings in Norcia during the Central Italy 2016–2017 seismic sequence

R. Sisti¹ · M. Di Ludovico²

· A. Borri¹ · A. Prota²

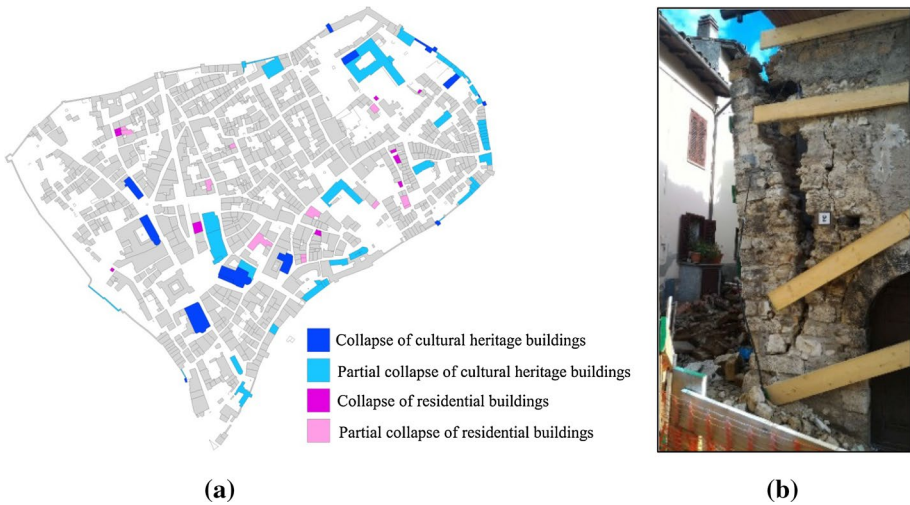
The lightly or severely damaged MSUs formed the largest part of the structures in Norcia’s historical centre, but only a few residential buildings totally or partially collapsed. The collapses were detected in a few buildings in a poor state of conservation, and often the collapse was a consequence of progressive damage caused by the occurrence of new shocks. Several collapses, however, involved cultural heritage buildings, which were clearly more vulnerable than residential ones.

Figure 5 depicts the MSUs affected by collapse in the historical centre of Norcia (blue filled areas in the plan view for cultural heritage buildings and pink filled areas for residential buildings). Note that all the churches in the historical centre collapsed, causing huge losses to the city’s cultural heritage.

Fig. 5 Identification of collapse in residential and cultural heritage buildings (a); collapse of a masonry unit (b)

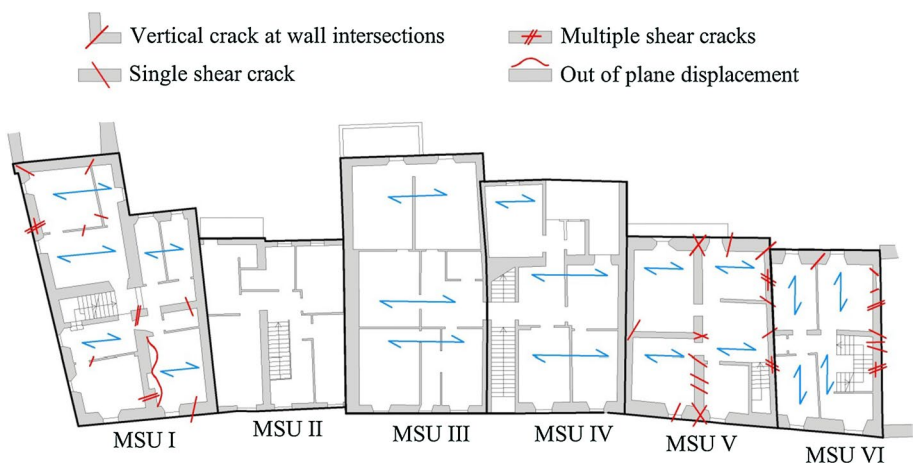
MSUs I, II and IV have three storeys, while the remaining ones have only two. Furthermore, MSUs V and VI have a basement floor. Prior to the strengthening interventions, undressed natural stones (pebbles) with very poor lime mortar comprised all the original walls and there were different types of floor: timber floors, RC hollow brick slabs, and jack-arch floors. Following the 1979 earthquake, damage to the vertical load bearing walls was mainly detected on the first floor of MSUs I, V and VI due to the poor masonry quality and the lack of connections between the orthogonal walls (see Fig. 15). Figure 15 shows the type of damage detected on the MSUs: shear cracks; out of plane displacements; and vertical cracks at wall intersections.

Fig. 15 Crack pattern on the first storey due to the 1979 earthquake. The red lines represent the cracks

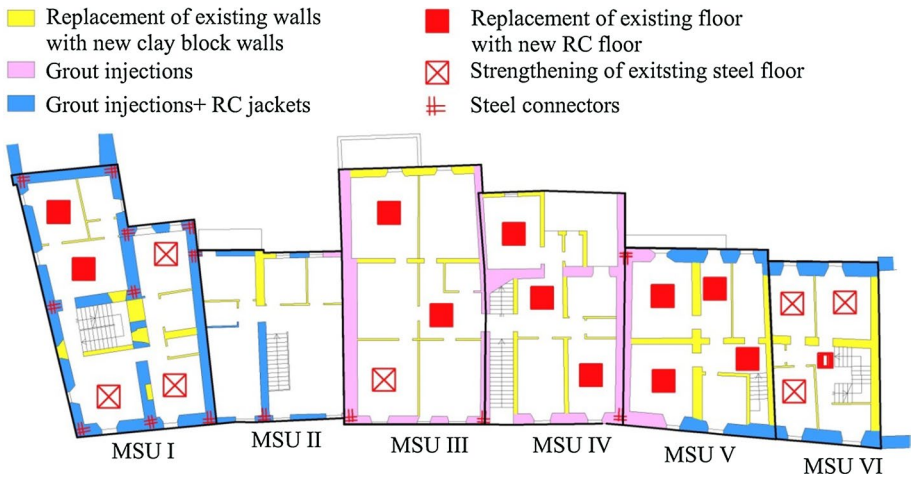
Fig. 16 Strengthening interventions on the first storey of the MSU aggregate

A repair and strengthening intervention design was submitted to the Umbria region in 1984. The strengthening interventions proposed are depicted in Fig. 16, along with their location. The analysis of the retrieved documentation shows that the following interventions were designed:

- The enlargement of the foundations by adding two RC elements placed besides the masonry ones, even if no foundation settlement had occurred.
- The strengthening of masonry walls through grout injections or grout injections plus RC plaster jacketing (violet or blue walls in Fig. 16), and the insertion of steel connectors to improve the connection between orthogonal walls.
- The reconstruction of damaged internal walls, with new walls composed of clay blocks (yellow walls in Fig. 16).
- The replacement of existing timber floors with new RC floors and the reinforcement of the existing steel floors and vaults with an RC slab applied at the extrados (red boxes filled or not filled at the floor location in Fig. 16).
- The construction of RC ring beams at the roof level of each MSU.

In 1988, some changes to the original projects were made and the vertical masonry load bearing walls of two central MSUs (III and IV) were strengthened by grout injections alone instead of by the combination of grout injections and RC plaster (see Fig. 16).

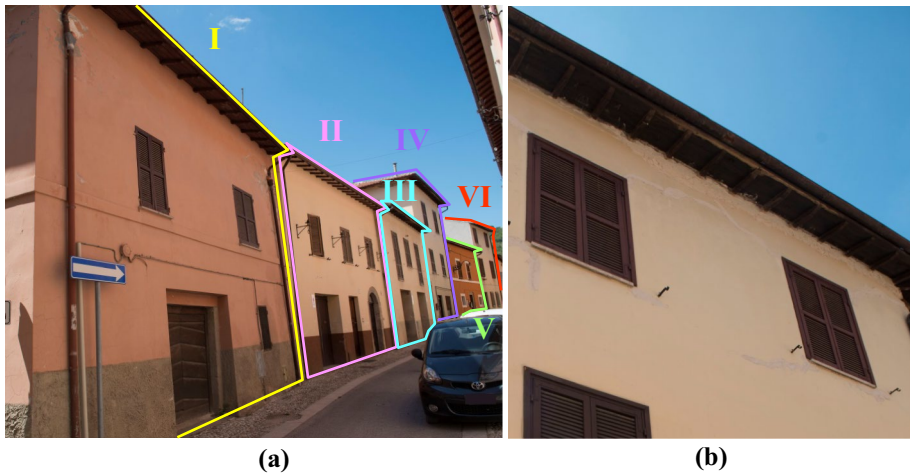
After the M6.5 earthquake, the two central MSUs (III and IV) were unusable and a medium-severe damage level (D2-D3) was observed on both the vertical load bearing elements and floors. By contrast, no damage (MSUs II and V) or slight and limited damage (MSUs I and VI) was observed in the aggregate parts strengthened according to the original retrofitting project. This clearly confirms the effectiveness of sound strengthening interventions in terms of limiting or avoiding structural damage, even in historical aggregate masonry MSUs.

In particular, Fig. 17a shows the main façades of the six MSUs as they appeared a few months after the 2016-10-30 earthquake. No damage is visible from the outside, except for some shear cracks that start from the windows on a second floor wall of MSU IV, which is assessed as unusable.

Fig. 17 Façade of the six MSUs (a); shear cracks on a second floor wall of MSU IV (b) (when the photo was taken, the cracks had already been plastered; for this reason, they are not very evident)
