Seismic performance of Reinforced Concrete Frame with Masonry Infill buildings in the 2010/2011 Canterbury, New Zealand earthquakes

Rijalul Fikri¹ · Dmytro Dizhur¹ · Kevin Walsh^{2,3} · Jason Ingham¹

Received: 28 August 2017 / Accepted: 15 September 2018 / Published online: 19 September 2018
© Springer Nature B.V. 2018

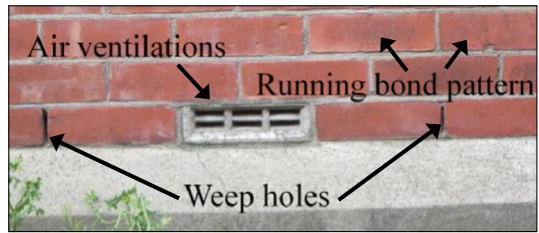
Fig. 4 An example of an RCFMI building having masonry cavity infill wall construction

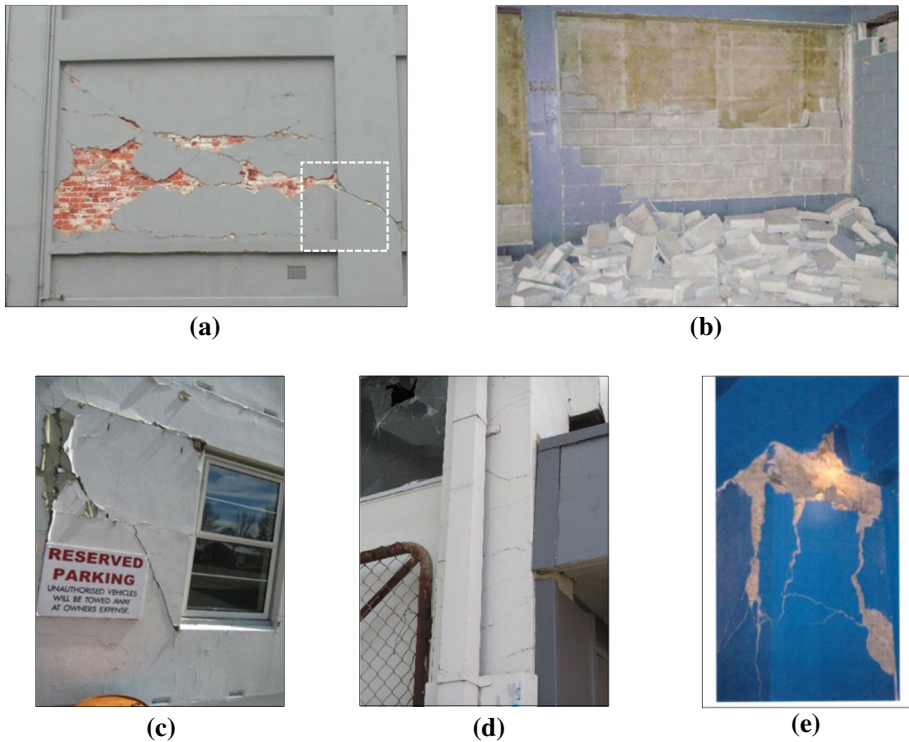
The most common failure modes observed for the masonry infill walls were in-plane failures (35 out of 191 buildings; 18%), followed by out-of-plane failures (12 out of 191 buildings; 6%). Meanwhile, the general failure modes observed for RC frames were joint failure between RC beams and columns (22 out of 191 buildings; 12%), with some RCFMI buildings sustaining flexural yielding (19 out of 191 buildings; 10%) and shear failures (17 out of 191 buildings; 9%) in RC columns.

Failure modes	RCFMI building component	Descriptions
Diagonal tension (in-plane)	Masonry infill walls	Presence of diagonally oriented cracks typically in an x-shape (Fig. 6a, c)
Out-of-plane		Failure of masonry wall due to out-of-plane deformations (Fig. 6b)
Shear failure	Reinforced concrete (RC) frame	Diagonal cracking of RC columns and beams (Fig. 6a)
Flexural yielding		Horizontal cracking of RC columns and beams due to yielding of flexural reinforcement (Fig. 6d)
Joint failure		Significant cracking in beam-column joints (Fig. 6e)

Fig. 6 Observed failures modes for RCFMI building components in the Canterbury earthquakes. **a** In-plane failure of clay brick infill and shear failure of RC column (highlighted in box), **b** out-of-plane failure of concrete block infill, **c** shear cracking of infill due to presence of opening, **d** flexural yielding of RC column, **e** RC joint failure

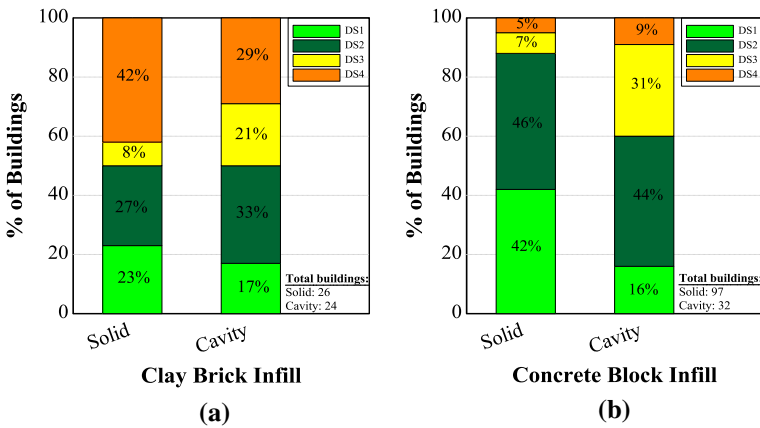
Figure 8 illustrates the damage sustained by infill material and the correlation between wall morphology and building damage following the 2011 Lyttelton earthquake. In general, it was observed that clay brick was the more vulnerable infill material in comparison with concrete block. However, there was no clear indication that wall morphology specifically affected the performance of buildings in the 2011 Lyttelton earthquakes.

Clay brick infill exhibited a reasonably similar performance in the 2011 Lyttelton earthquake for both solid and cavity-wall construction, with 50% of the total surveyed clay brick RCFMI buildings sustaining moderate to heavy damage (DS3–DS4). Despite the fact that 40% of the concrete block RCFMI buildings having cavity-wall construction experienced moderate to heavy damage (DS3–DS4), the majority of RCFMI buildings (82%)

Fig. 8 Extent of damage to infill material. **a** Clay brick, **b** concrete block

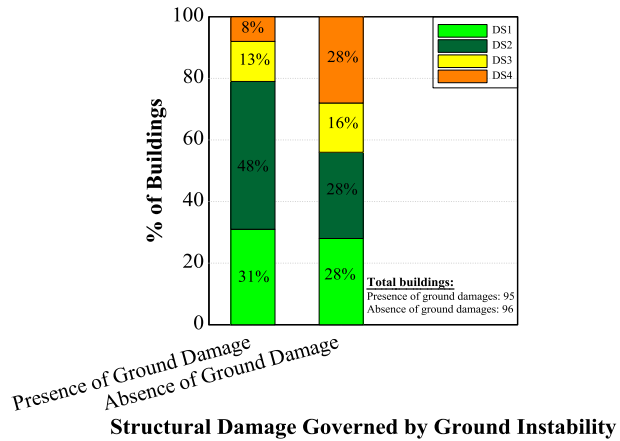
Ground instability observed in the 2011 Lyttelton earthquake included liquefaction (silt ejection), lateral spreading, and/or differential settlement that potentially affected foundation subsidence (Cubrinovski et al. 2011). In Fig. 10 the different levels of damage to RCFMI buildings following the 2011 Lyttelton earthquake due to the influence of ground instability are shown. It was observed that 95 of the total surveyed 191 RCFMI buildings exhibited various level of damage generated by the combined effects of ground instability and earthquake shaking, with 20 out of 95 (21%) buildings sustaining moderate to major

Fig. 10 The influence of ground instability on structural damage

damage (DS3–DS4). In contrast, there were 96 out of 191 RCFMI buildings that sustained earthquake-induced shaking alone without being affected by ground instability, with 42 out of 96 (44%) buildings experiencing moderate to heavy damage (DS3–DS4). The results suggest that ground instability had no discernible influence on observed damage to RCFMI buildings in the Canterbury earthquakes.

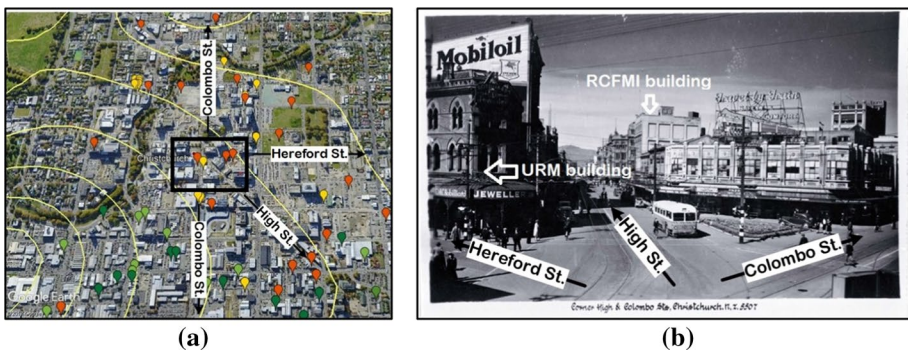
It was also observed that some RCFMI buildings that were clustered together in the Christchurch CBD were assigned heavy damage (DS4) and were subjected to PGA levels ranging from 0.43 to 0.49 g. The high level of damage that occurred to these RCFMI buildings in the Christchurch CBD was attributed to their date of construction, recognising that the city developed outwards from the city centre and therefore the buildings located in the CBD were generally the oldest and consequently the most seismically vulnerable (see Fig. 14). Unfortunately, in most cases it was not possible to obtain accurate records for the specific ages of these buildings. According to photographic records obtained from Christchurch City Libraries, these buildings were well established in the 1950s (see Fig. 14b) and the actual date of construction of these buildings is therefore surmised to be prior to the 1950s. Therefore, the observed seismic vulnerability of these pre-1950s buildings was unsurprising.

Fig. 14 ‘Triangle corner’ at the intersection of Hereford St., High St., and Colombo St., illustrating early commercial buildings having different construction forms. **a** Map view of ‘Triangle corner’, **b** photograph from the 1950s (Reproduced from Christchurch City Libraries)
