24 January 2020 Sivrice-Elazığ, Turkey earthquake: geotechnical evaluation and performance of structures

Abstract

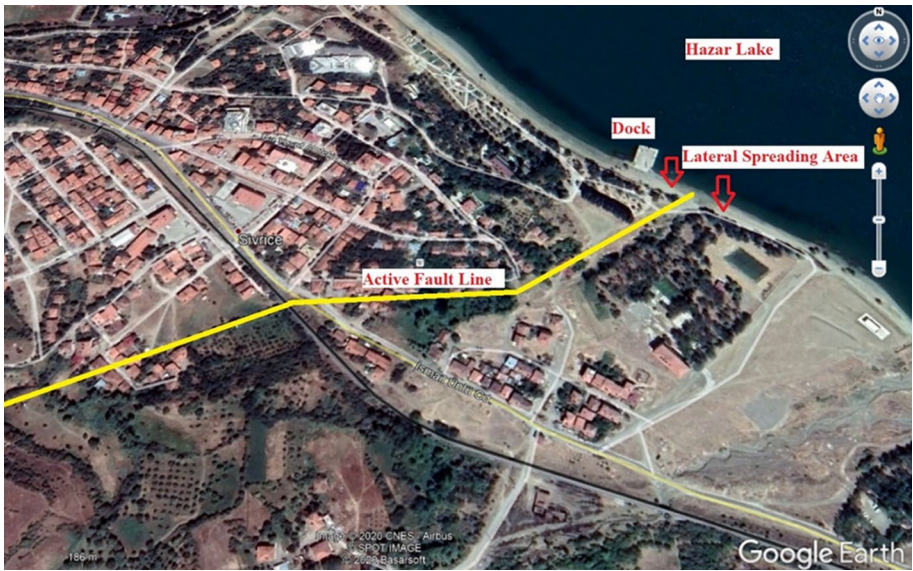
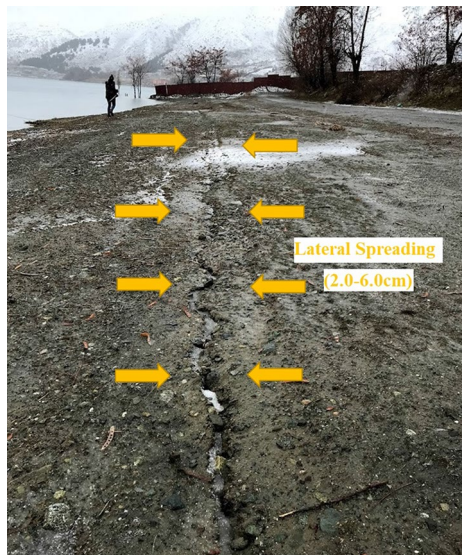
Fig. 14 Active fault (yellow line), dock, lateral spreading area (investigation area 1) (modified Google Earth)

Fig. 15 Lateral spreading (investigation area 1)

During the observations in this region, it was seen that the slope was low and there were lateral spreading incidents in the fields close to the water body (Fig. 14). The inclination of the area with lateral spreading was between 2° – 3° , and 2–6 cm displacements occurred on the soil because of lateral spreading (Fig. 15). The failed dock caused by the liquefaction

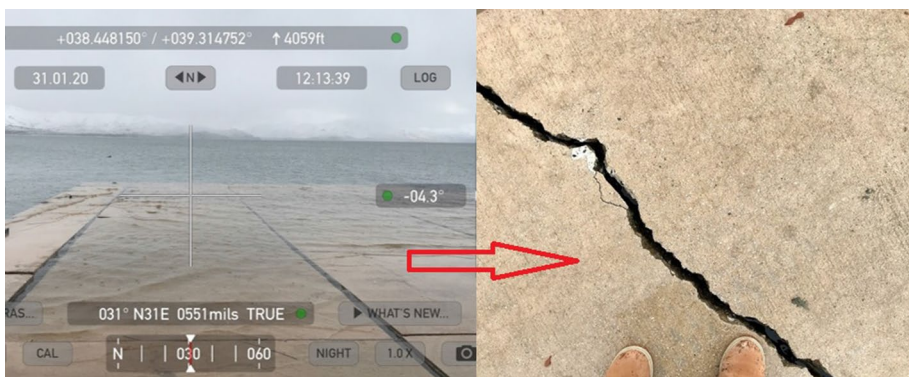
and lateral spreading incidents in the investigation area and the fractures occurring in the concrete blocks of the dock were shown in Fig. 16.

Fig. 16 Failed dock because of lateral spreading and liquefaction, and concrete block crack (investigation area 1)

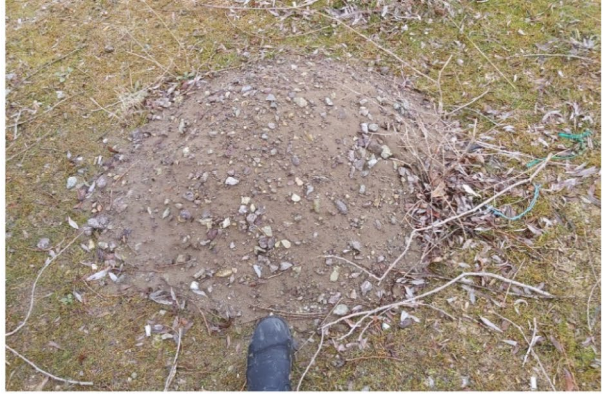
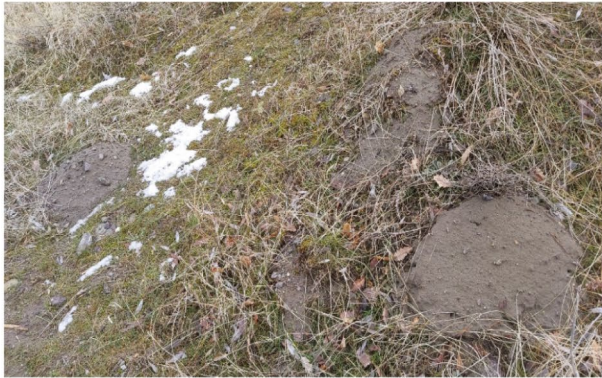
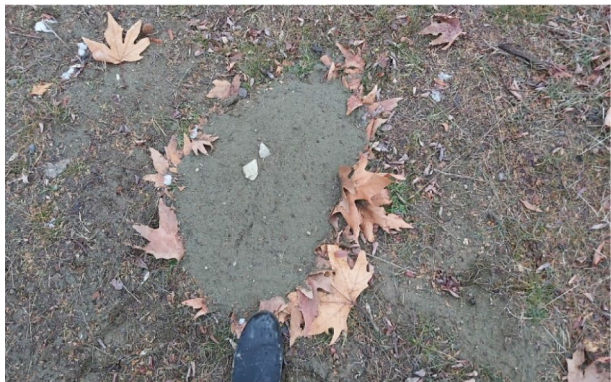
Liquefaction is that the layers below the groundwater level temporarily lose their strength due to the dynamic loads that occur during an earthquake and act like a viscous liquid rather than like a solid. Figure 17 shows sand boils caused by soil liquefaction in the investigation areas 2, 3, and 5 after the earthquake. The soils are seen to consist of non-plastic silty fine sand.

Fig. 17 Sand boils caused by soil liquefaction

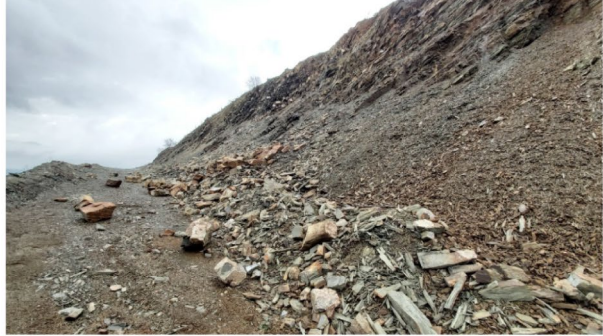
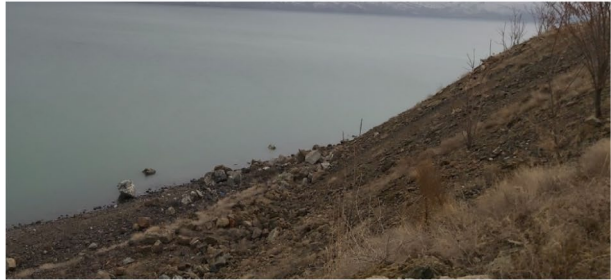
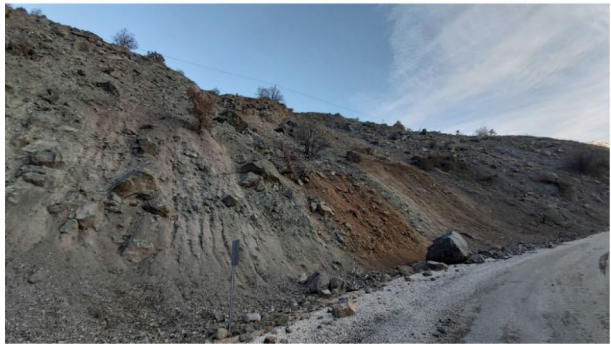
Mass movements triggered by the earthquake are one of the important natural disasters. Especially, massive earthquakes trigger mass movements such as landslides, rockfalls, and debris flows. Earthquakes are one of the most important factors affecting the stability of rocks. Fractures and falls can be seen in rocks because of earthquakes. In the field investigations carried out in the region, it was seen that the rocks with sizes ranging from 20 to 110 cm fell in investigation areas 4 and 7. Because of the incline of the slope, these rocks rolled up to the existing vehicle road and the Hazar Lake (Fig. 18).

Fig. 18 Rockfalls

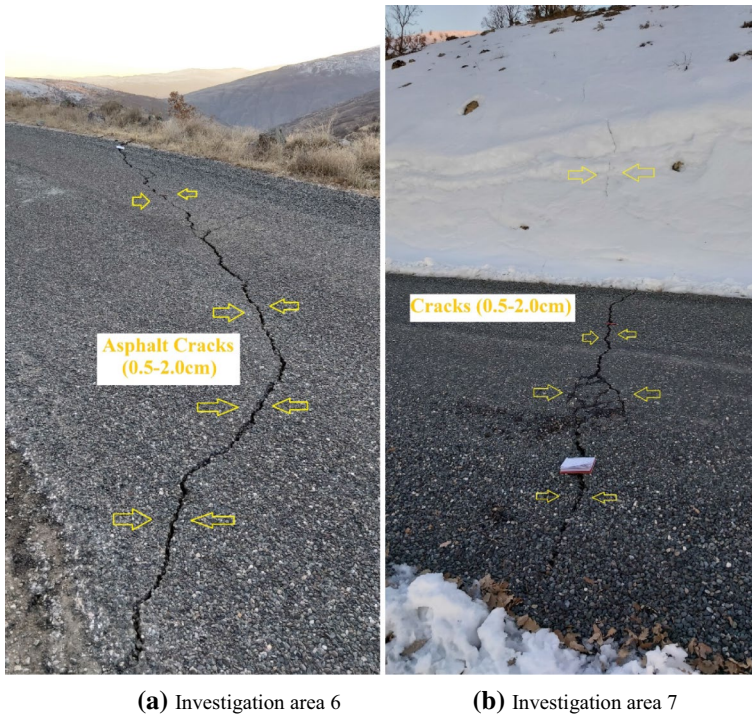
Deformations occur on the soils because of seismic effects like earthquakes. These deformations can occur in different ways depending on the magnitude of the earthquake, the soil class, and the inclination of the soil where the deformations occur. In the field investigations carried out at investigation areas 6 and 7, soil deformations were seen, which not caused stability failures and landslides. These soil deformations that occurred after the earthquake caused cracks in the asphalt pavements of existing roads in the sizes of 0.5 to 2.0 cm. Soil deformations occurring after the earthquake can be seen in Fig. 19.

Fig. 19 Cracks from soil deformation

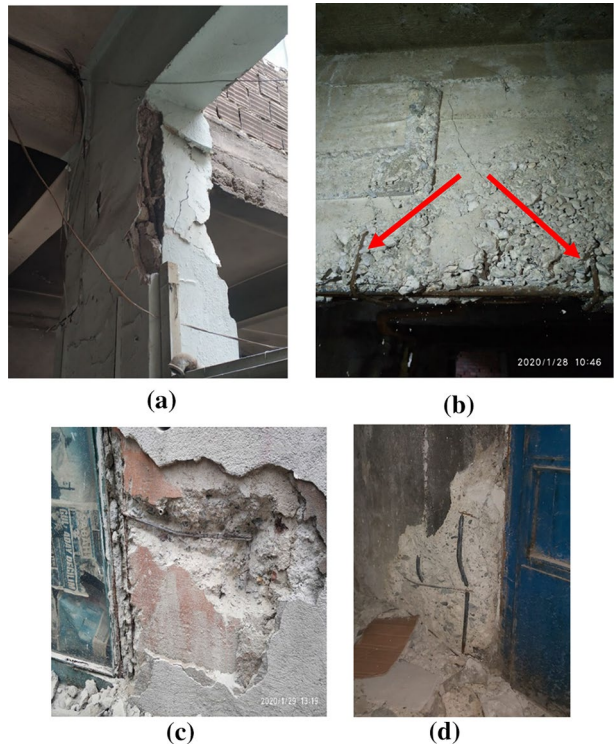
of structural members. Also, longitudinal reinforcement bars were buckled owing to this wrong implementation. This situation caused the columns to display low performance against the shear forces of earthquake and lose the axial load carrying capacity. During bending the seismic ties and hooks, the achieved bending degree should be 135° and reinforcement bar should not deformed. But the transverse reinforcement of structural elements in damaged buildings were smooth and hooks of the ties had been bended 90° . Figure 20 demonstrates this type of failure.

During an earthquake, the structural performances of buildings substantially reduces due to improper design of beam-column joints. The joints must be remained in the elastic region to prevent serious failures after an earthquake. These joints are particularly important for the distribution of force and moment. The shear and bond mechanisms are the common failures of these joints. In Elazığ earthquake, many RC buildings heavily damaged because of the failures of these joints. It was seen that poor detailing at joints of beam-column and poor quality of materials with low workmanship were the main reasons of these failures. Also, the lack of transverse and seismic cross ties, and inadequate anchorage bars of beam and column in reinforced concrete elements lead to joint failure. In this region, the maximum tie spacing should not be exceed 10 cm. In only RC frame systems, sum of ultimate moment resistances of columns framing into a beam-column joint should be at least 20% more than the sum of ultimate moment resistances of beams framing into the same joint. Figure 21 shows beam-column joints failures.

Fig. 20 Damaged structures (a Rüstempaşa district; b Abdullağaşa district; c, d Mustafapaşa district) due to inadequate spacing between shear reinforcements during the Elazığ-Sivrice earthquake

Fig. 21 Beam-column joint damage

- Using plain bar and insufficient spacing of transverse reinforcement caused considerable damage. In addition, the ends of the stirrups were not bent 135° and thus, this application had reduced the wrapping effect of the stirrup. To avoid damage to structural members, attention should be paid to detailing of transverse reinforcement, and close-spaced stirrups should be used.

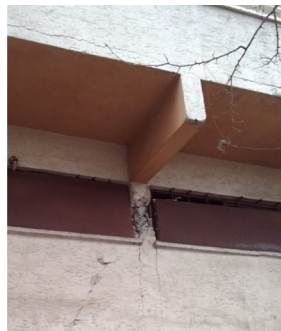
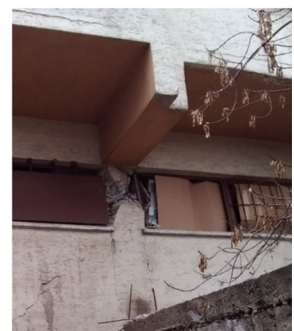
Short column application is created by opening a band window on the exterior wall to provide lightening for basements of buildings. This implementation diminishes the effective length of a column and shortened column becomes more rigid and brittle than other columns. Hence, a short column is exposed to more shear forces arising from dynamic loads. The occurring shear effect lead to serious damages in this structural element. Figure 22 illustrates this kind of critical failure. According to TEC-2007 and current code shear force for transverse reinforcement should be calculated. Then, the moments at bottom and top

Fig. 22 Shear failure of a column (Mustafapaşa district)

- Existing short columns caused serious damages especially to basement floors of buildings. It is possible to avoid this kind of damages such as increasing of shear strength of this part of the column by building a wall around the column in this area.

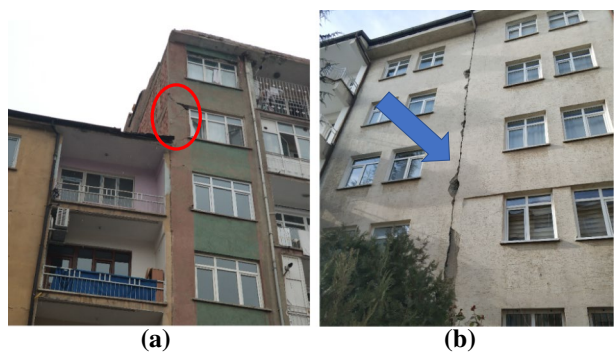
Inadequacy of building land in the city center forces people to build adjacent buildings. Therefore, one or two façades of buildings contacts to one another or there is little gap between buildings. Therefore, these structures collide each other during an earthquake. A more dangerous situation may occur when the floor levels of adjacent structures are not aligned. The base of a building can hit the columns of another building, causing damage. To prevent such damages, there must be adequate gaps between the adjacent buildings. According to the code, minimum size of gaps should be 30 mm up to 6 m height and from there on a minimum 10 mm should be added for each 3 m height increment. Unless a more unfavorable value is obtained in accordance with requirement defined in previous statement, sizes of gaps should not be less than the sum of the absolute values of average storey displacements multiplied by the coefficient α . If adjacent floor levels of buildings at all stories are the same, then the amount of gap is $\alpha = 0.25\left(\frac{R}{I}\right)$, and $\alpha = 0.50\left(\frac{R}{I}\right)$, if not. In these equations, the structural behavior factor and building importance factor are shown as R and I , respectively. Damaged buildings due to inadequate gap are given in Fig. 23.

Fig. 23 Damages to adjacent buildings during the Elazığ earthquake (a Rüstempaşa district; b Abdullapaşa district)

- Each building has different natural vibration periods due to their structural and material properties. During the earthquake, hammering effect occurs between attached buildings or buildings which have insufficient gap. This effect can be devastating for buildings. To avoid this kind of damage, proper gaps should be left between the attached buildings.

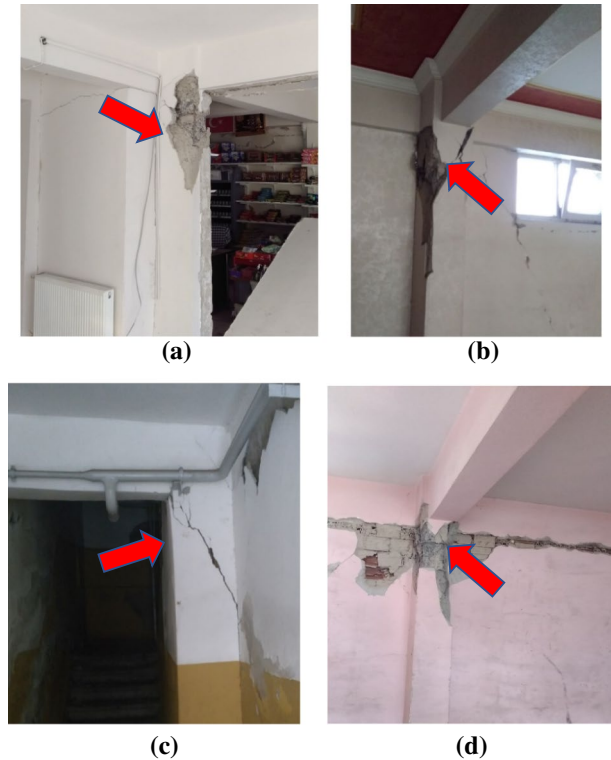
In Turkey, especially available old RC building stock was constructed with strong beam and weak column design before the improvement of current earthquake codes. The beams of these buildings are deep and rigid while the columns weak and flexible. Therefore, flexible columns failure before beams. In this type of design, deep and rigid beams exhibit elastic behavior, while shear failure or compression crushing cause brittle failures at these weak columns during an earthquake. The design of strong beam–weak column was the main reason of the partial and total collapse of buildings during the Sivrice-Elazığ earthquake. Figure 24 shows columns of different buildings which failed severely. To prevent this kind of damages or collapses arising from the strong beam–weak column design, current and former seismic codes require that sum of ultimate moment of columns framing into a beam–column joint should be at least 20% more than the sum of ultimate moment of beams framing into the same joint. Thus,

Fig. 24 Failure of a due to strong beam–weak column effect during the Sivrice-Elazığ earthquake (a, b Rüstempaşa district; c, d Mustafapaşa district)

plastic hinges occur at the ends of the beam and brittle failure prevents. But this situation had not been seen at observed buildings which damaged seriously.

- If rigid and deep beams are built with weak columns as compared with the beams, plastic hinge occurs at the end of such columns. This situation causes brittle failures and then total collapses can be seen. To prevent this type of damage, columns should be stronger than beams and plastic hinges should be designed to be on beams firstly.

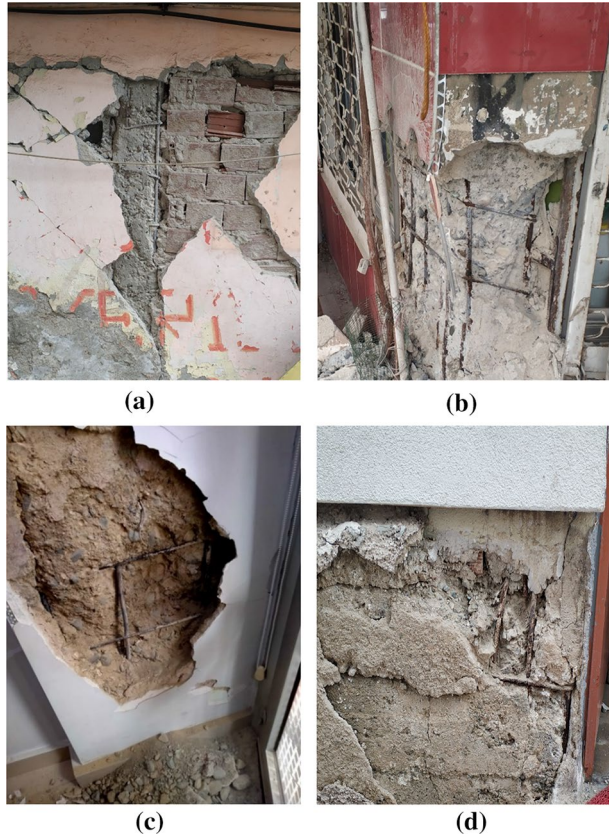
Concrete compressive strength is one of the main factors required for reinforced concrete structures to show expected performance against earthquakes. But during the field observations, it was seen that many damaged buildings had not sufficient concrete quality. In Turkey, using of ready-mix concrete became common after 1999 Kocaeli earthquake. Before this earthquake, handmade concrete was generally used without using a vibrator. Because of this wrong application, a homogenous mixing could not be obtained, and the expected compressive strength could not be provided. TSC-2007 requires that compressive strength of concrete should be minimum 20 MPa in all buildings, while this value is required to be minimum 25 MPa for all buildings according to new seismic code, TBEC-2018. In addition, inadequate concrete cover caused corrosion in reinforcement bars, leading to diminishing diameters of these bars. Figure 25 shows poor quality of concrete and corroded reinforcement bars in various buildings that existed in the earthquake region. Moreover, Provincial Directorate of the Ministry of Environment and Urban Planning declared that the compressive strengths of the concrete cored from collapsed and damaged structures were around 7–10 MPa.

Fig. 25 Failure of column due to poor concrete quality during the Elazığ-Sivrice earthquake (a Rüstempaşa district; b Mustafapaşa district; c Ulukent district; d Sürsürü district)

- Material quality and workmanship is one the main factors affected the earthquake performance. Our field observation shows that, poor concrete quality and/or corrosion of reinforcement bars reduce the structural performance of load bearing elements. Hence, expected performance against earthquake cannot be provided. To prevent damage arising from this situation, selection and application of materials and workmanship should be paid attention.

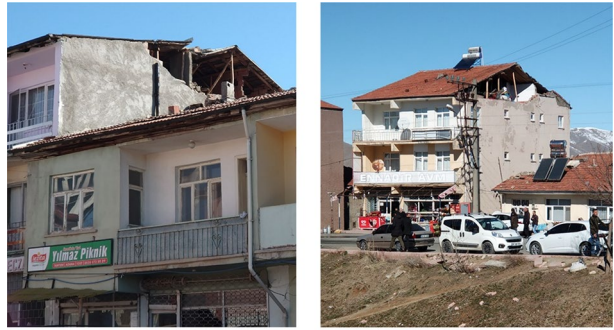
Existing gable walls were weak against the out-of-plane mechanism during the earthquake because these walls were constructed without bond beams. This type of failure is not a structural damage but falling parts of wall can be cause loss of lives and properties. The main reason of damages to such walls is the large unsupported wall lengths. It was determined that poor wall-to-wall, wall-to-floor connections, and absence of lateral supporting walls were the other reasons of these damages. Reinforced concrete vertical and inclined bond beams should be used to prevent such damages. Gable walls of investigated buildings were built without bond beams. Figure 26 demonstrates the out-of-plane failures of gable walls of various reinforced concrete buildings in the affected region.

Fig. 26 Damages to gable walls at Sivrice township during the Sivrice-Elazığ earthquake

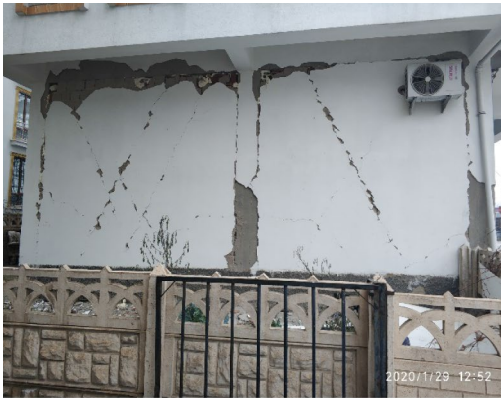
(a) In-plane damage (Ulukent district)

in-plane demands. Hence shear cracks are generated in the plane (Fig. 27a) However, exposed to the effect of in-plane and out-of-plane loading, where the E–W and N–S components of acceleration are important, infill walls of upper stories may fail under the combination of in-plane and out-of-plane effects. The in-plane resistivity decreased bearing capacity and out-of-plane loading increased owing to the continuous time history loading (Onat et al. 2018; Onat 2019; Yön et al. 2019). Hence partial or total out-of-plane mechanism was developed (Fig. 27c, d). The other damage type in the infill wall was disconnection of wall from the frame. Poor detailing of wall-to-frame or wall-to-floor connection caused this kind of damage (Fig. 27b).

- The reason of infill wall damage is lower strength of infill materials and weak connections to frames. To avoid this kind of damage, sufficient connection and high strength mortar should be used between wall and frame.

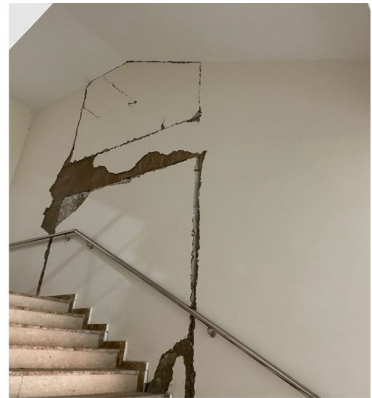
(b) Disconnection of wall from the frame (Sivrice township)

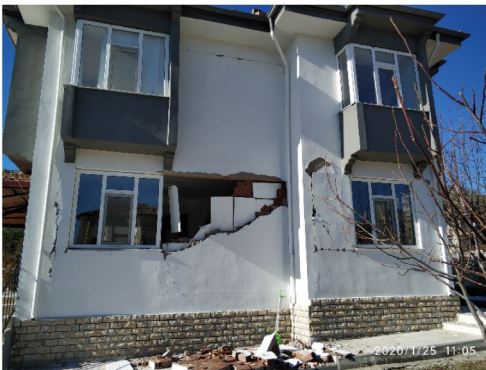
(c) Partial out-of-plane damage (Sivrice township)

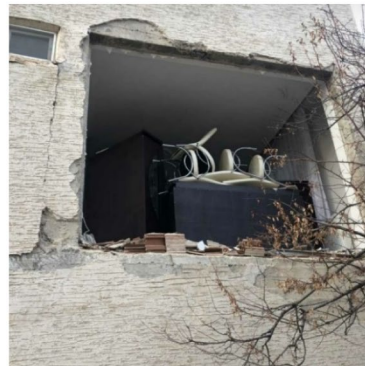
(d) Total out-of-plane damage (Abdullahpaşa district)

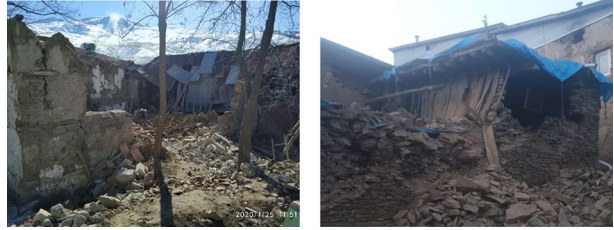
Fig. 29 Damages due to heavy earthen roof at Sivrice township

They are usually constructed over wooden logs and lose their capabilities owing to weather conditions, like snow and rain. Homeowners cover a new earthen layer on the existing roof to avoid the percolation of water. Therefore, mass of the roof increases during the years. This situation can cause large inertial forces during an earthquake. Structural walls cannot carry the heavy mass and roof is demolished partially or totally. This situation was observed during the January 24, 2020 Sivrice-Elazığ earthquake. Figure 29 illustrates this type of collapses.

- The field observations show that existing of earthen roofs create heavy masses on the top of buildings. Hence, the seismic effect forced the structural walls during the earthquake caused partial or total collapses especially in adobe dwellings. According to the results obtained, adobe structures and this type roofs should not be constructed.

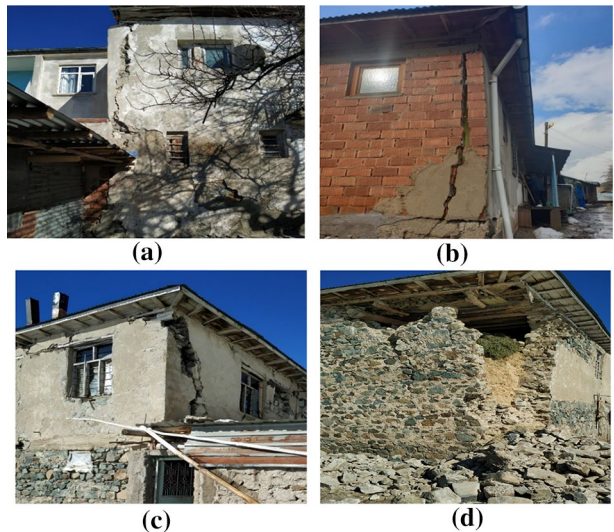
This failure type commonly occurs due to weak connections of wall-to-wall when forced by the out-of-plane mechanism. This mechanism requires subjects to intersect of the walls. Thus, vertical cracks develop, and wall corners are separated. Serious damages are caused because of weak connections among adjacent walls and the absence of bond beams. Similar failures are seen at the corners of the roof level because of reduced compression stress and increased seismic acceleration at upper stories. Top corners are more vulnerable to failure due to cantilever-like behavior when there is no slab in-plane rigidity at the roof level. The corner damages at different buildings are shown in Fig. 30.

Fig. 30 Corner damages of masonry buildings in Sivrice township

- It was seen that weak wall-to-wall connections and absence of vertical and horizontal bond beams created structural corner failures. Using of sufficient bond beams and proper wall-to-wall or wall-to-bond beam connections can eliminate this type of damage.

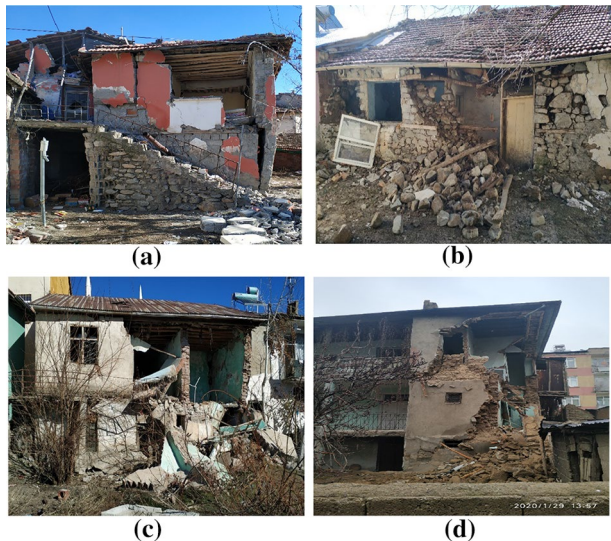
Fig. 32 Out-of-plane mechanism at **a–c** Sivrice township and **d** Elazığ city center

the walls that are not supported by wooden beams and then can be overturned in the out-of-plane direction. In the affected region, the out-of-plane mechanism is typically observed. Figure 32 illustrates this type of damages for different dwellings.

- Out-of-plane mechanism is one of the main structural damages to masonry buildings. The main mistakes that caused this damage are the absence of vertical and horizontal bond beams, weak connections between the walls, and large unsupported walls. This type of damage can be prevented by using sufficient wall-to-wall and wall-to-roof connections. Also, large unsupported walls should not be constructed, and horizontal and vertical bond beams should be implemented.

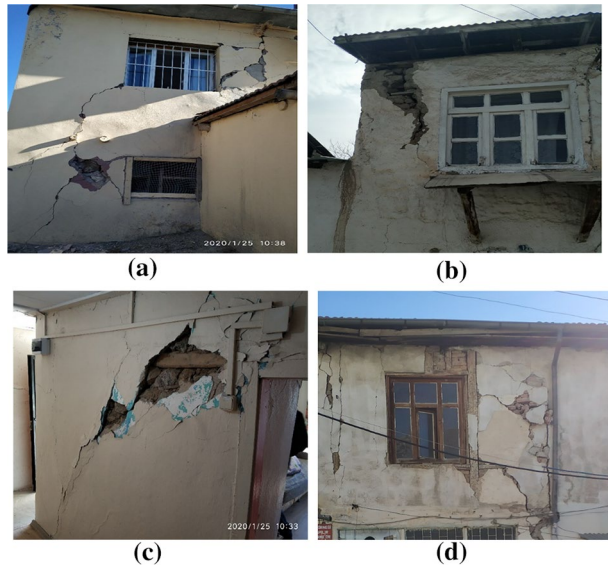
Fig. 33 In plane mechanism in Sivrice township

The seismic response of masonry structures is related to in-plane stiffness of the walls. In-plane mechanism is generally observed in many masonry structures by shear cracking. Shear forces enhance because of earthquake loads and can damage walls and their connections. These damages generally occur near openings owing to the lack of bond beams that add lateral strength to walls. In the earthquake region, many masonry buildings did not have sufficient, proper vertical and horizontal bond beams to increase the lateral seismic performance of the walls. Figure 33 shows in-plane mechanism of the masonry buildings in the earthquake region.

- Absence of bond beams and presence of large openings that reduce the lateral rigidity of the load bearing walls weaken the structural performance walls. Increased shear force with ground motion develop in-plane damages. To prevent in-plane failures, it should be abstained from the construction of large openings, and vertical bond beams should be built near the openings.

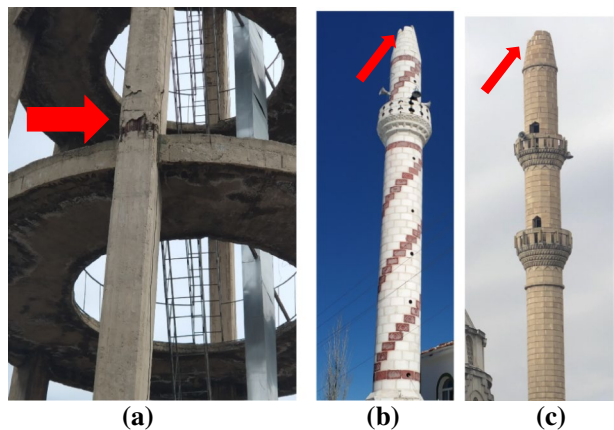
Water towers are sensitive structures under the influence of the earthquake. The bearing elements of these structures should be well detailed. However, poor detailing caused damage to the structure in this earthquake (Fig. 35a). However, since the minarets are tall and thin structures, they are frequently affected by earthquakes (Atmaca 2020). Local damages were seen at the top of the conical portion of minarets (Fig. 35b).

Fig. 35 Damage to elevated water reservoir (a) and masonry minarets (b, c)
