# Geotechnical aspects of reconnaissance findings after 2020 January 24th, M6.8 Sivrice–Elazig–Turkey earthquake

## Abstract

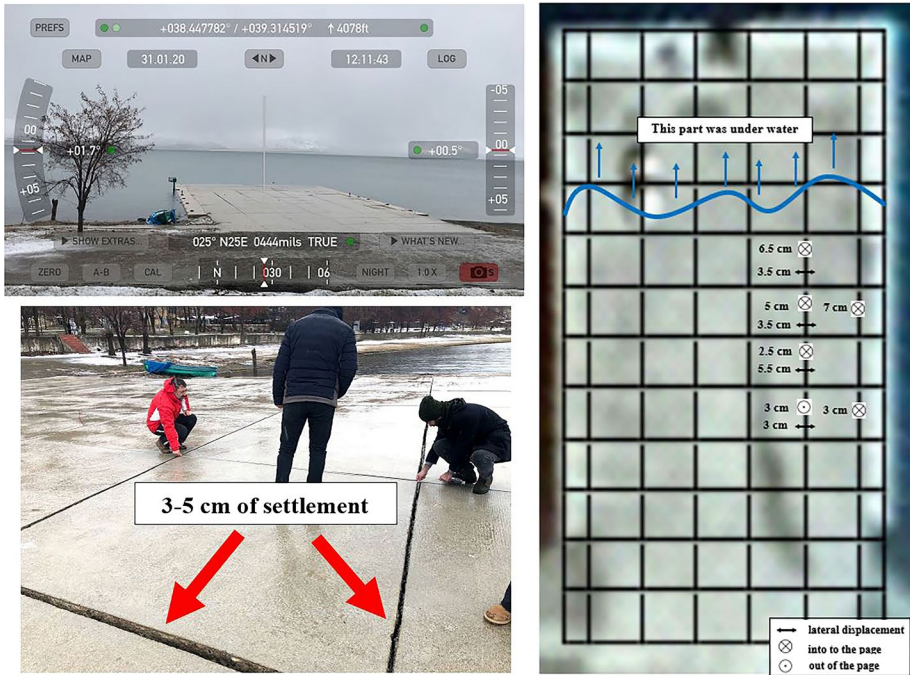
Seismically-induced lateral spreading and volumetric settlements were observed at partially inundated Sivrice Dock and its immediate neighboring beach. Observed ground failures were mapped as presented in Fig. 5, a more detailed discussion of which is presented in Cetin et al. (2020). The dock is underlain by gravelly fill, and due to lateral spreading and volumetric densification of the gravelly fill layer, both lateral and vertical displacements were observed and mapped, the magnitude of which varied in the range of 3–5.5 cm, and 2.5–7 cm, respectively.

**Fig. 5** Seismically-induced volumetric settlement in the dock of Lake Hazar (38°28'10.0"N 39°17'03.6"E/31.01.2020/12:11 & 38°26'53.2"N 39°18'53.4"E/31.01.2020/12:14)

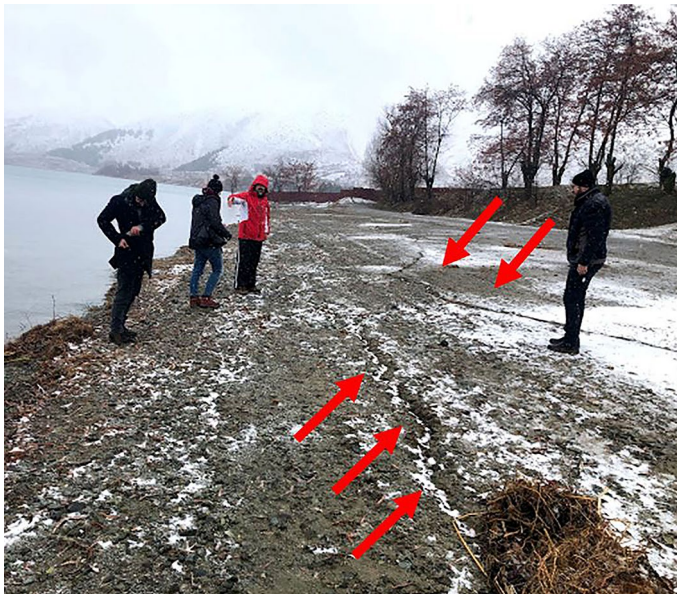
Similarly, liquefaction-induced lateral spreading deformations, presented in Fig. 6, were mapped along a 90 m by 24 m shoreline neighboring to Sivrice Dock, with induced crack widths varying from 3 to 5 cm. The total maximum lateral deformation at the most critical section was mapped as 10–14 cm. Immediately in the south-east of this local beach, there is another beach, where no signs of permanent ground deformations or liquefaction manifestations were evident, as shown in Fig. 7. This beach was observed to have a milder slope when compared to the lateral spreading site.

**Fig. 6** Seismically-induced lateral spreading on the beach of Lake Hazar (38°26'50.7"N 39°18'56.9"E/31.01.2020/12:21)

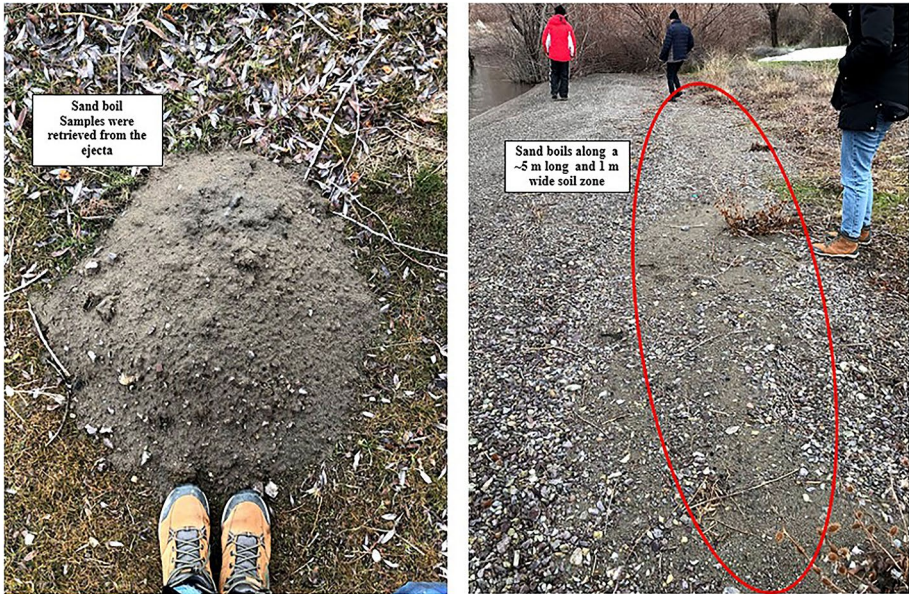
Seismically-induced liquefaction manifestations in the form of sand boils were observed at Site 8, Site 12, and Site 15, as shown in Figs. 8, 9 and 10. Soil samples were retrieved to perform sieve analysis at Middle East Technical University Soil Mechanics Laboratory. The resulting gradation curves for the samples collected from sand boils are presented later in this manuscript.

**Fig. 8** Sand boils observed at Site 8 ( $38^{\circ}27'49.7''\text{N}$   $39^{\circ}24'01.1''\text{E}$ /31.01.2020/14:38 &  $38^{\circ}27'49.8''\text{N}$   $39^{\circ}24'03.0''\text{E}$ /31.01.2020/14:14)

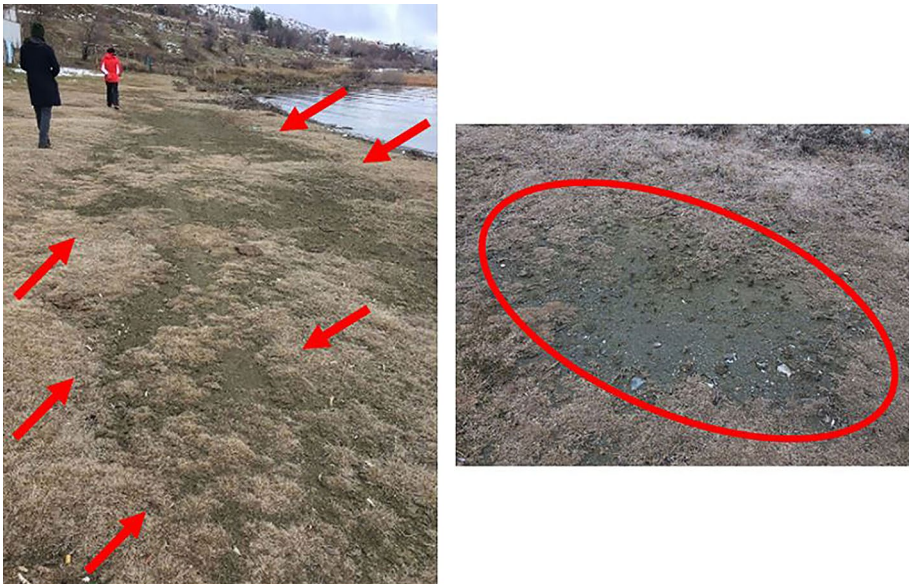
**Fig. 9** Sand boils observed at Site 12 ( $38^{\circ}29'58.5''\text{N}$   $39^{\circ}30'24.6''\text{E}$ /31.01.2020/15:29 &  $38^{\circ}29'57.7''\text{N}$   $39^{\circ}30'24.0''\text{E}$ /31.01.2020/15:30)

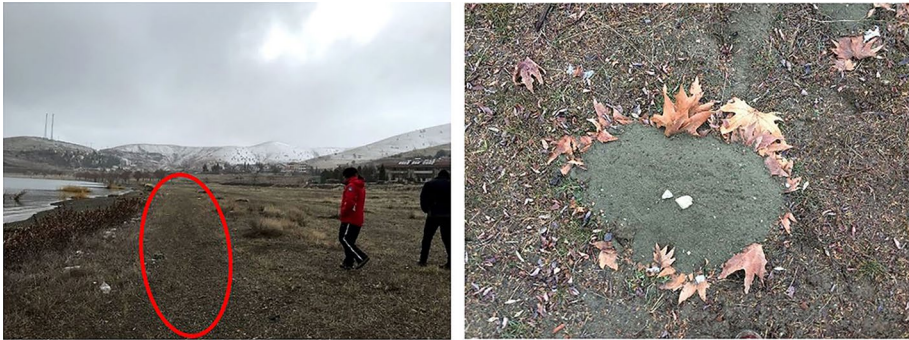
**Fig. 10** Seismic soil liquefaction-induced sand boils at Site 15 ( $38^{\circ}29'32.3''\text{N}$   $39^{\circ}21'03.8''\text{E}$ /31.01.2020/16:57 &  $38^{\circ}29'34.5''\text{N}$   $39^{\circ}21'03.6''\text{E}$ /31.01.2020/17:11)

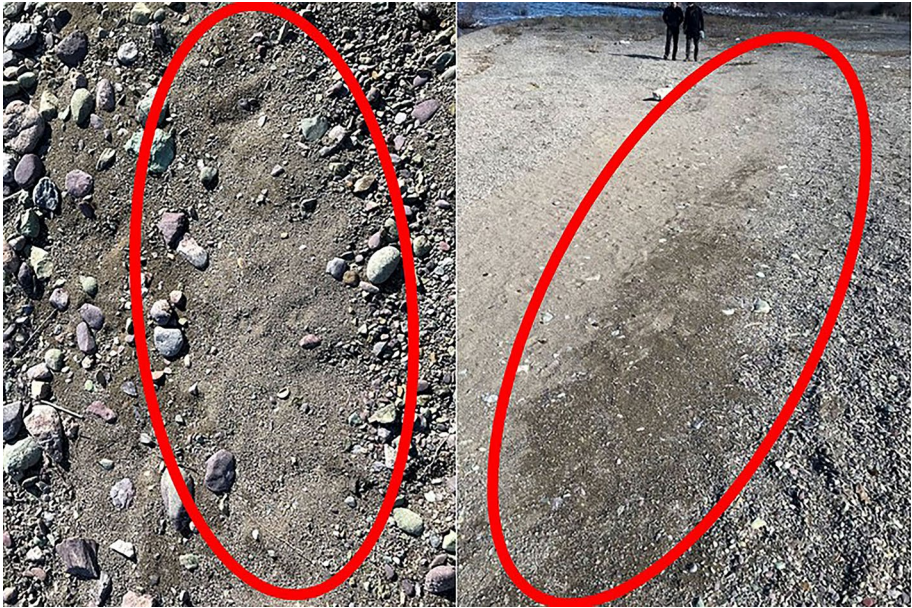
**Fig. 12** Seismic soil liquefaction-induced sand boils at Kale shore ( $38^{\circ}25'15.2''N$   $38^{\circ}45'32.2''E/01.02.2020/12:32$  &  $38^{\circ}25'15.2''N$   $38^{\circ}45'23.9''E/01.02.2020/12:45$ )

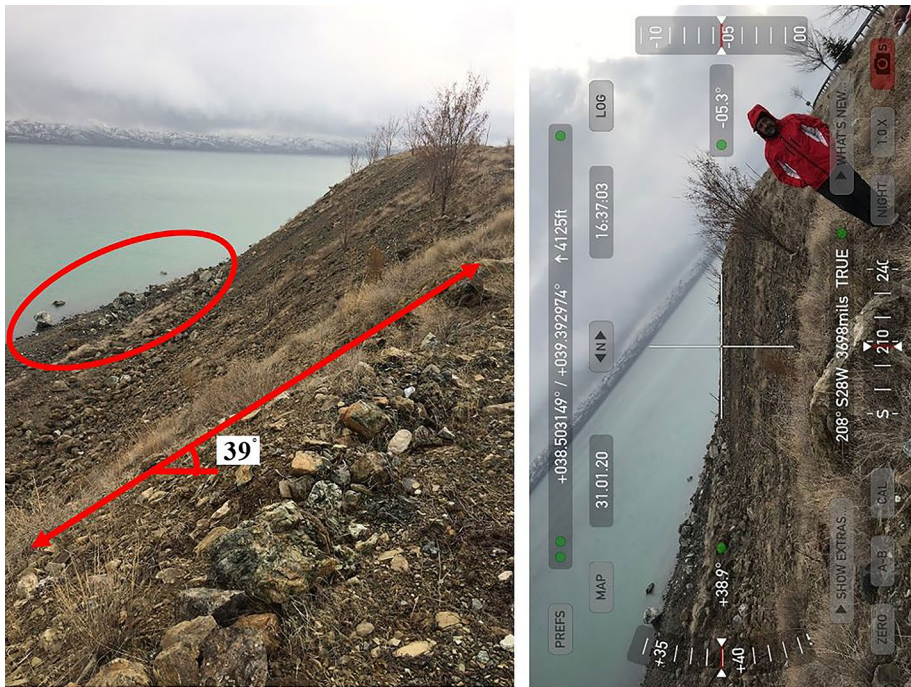
**Fig. 18** Rock falls at Site 14 (38°30'11.4"N 39°23'34.9"E/31.01.2020/16:37 & 38°30'11.3"N 39°23'34.7"E/31.01.2020/16:37)

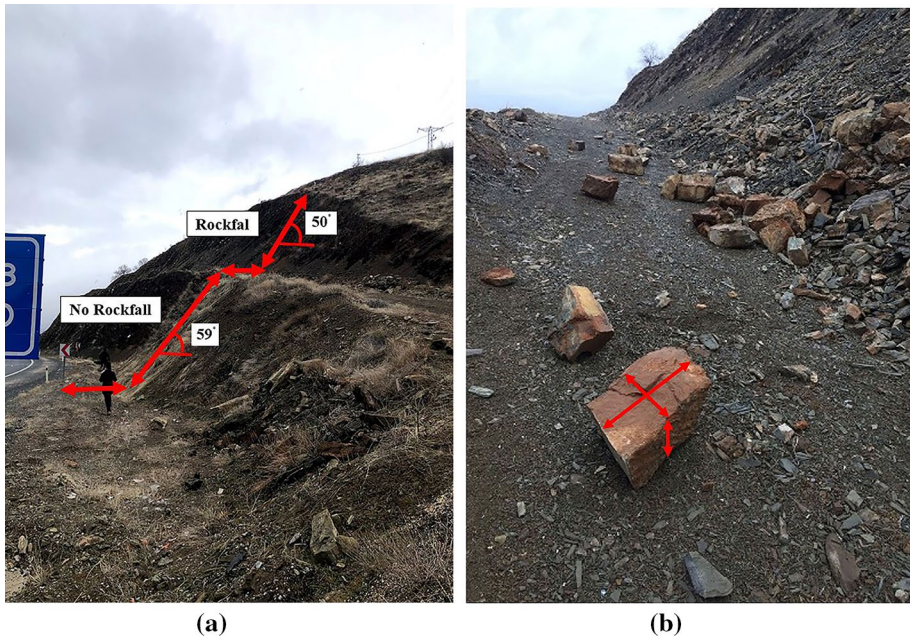
Rock falls were mapped at a site located near northern shores of Lake Hazar, as shown in Fig. 20. At this site, the surface geology is composed of Phyllites with schistosity texture. The cross section is estimated as 15 m—high with a slope of 50°. The dimensions of the some fallen rock blocks and the distance of these blocks to the toe of the upper bench were measured in the field, as summarized in Table 6. No fallen blocks were observed on the lower, second bench of the highway cut. Slope angle, length and height of different sections of the upper and lower benches, and possible heights where rock falls were initiated from, were also mapped in the field.

**Fig. 20** Rockfalls site **a** general view (38°31'40.3"N 39°28'02.9"E/31.01.2020/16:20), **b** fallen rocks (38°31'41.0"N 39°27'59.6"E/31.01.2020/16:13)

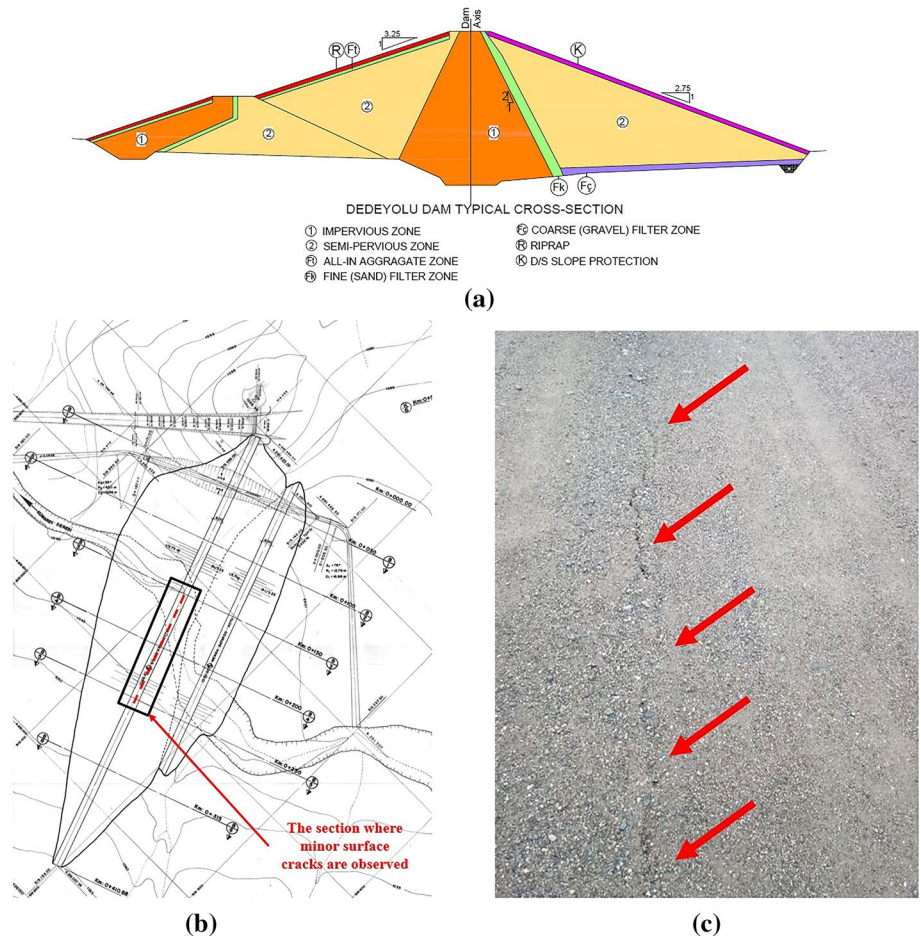
DSI reconnaissance team has investigated the dam and documented 3–8 mm wide, minor longitudinal surface cracks along the crest road, as shown in Fig. 22c. A few test pits were opened, which confirmed the limited extent of crack to clay core. Even though Dedeyolu Dam was tested by higher levels than the design basis event ( $PGA_{\text{design}} \approx 0.2\text{ g}$ ), the performance of it was observed to be satisfactory.

**Fig. 22** **a** General layout of Dedeyolu Dam (Courtesy of DSI), **b** Typical cross section of Dedeyolu Dam (after DSI), **c** minor, 3–8 mm wide, longitudinal cracks along the crest of Dedeyolu Dam (Courtesy of DSI)

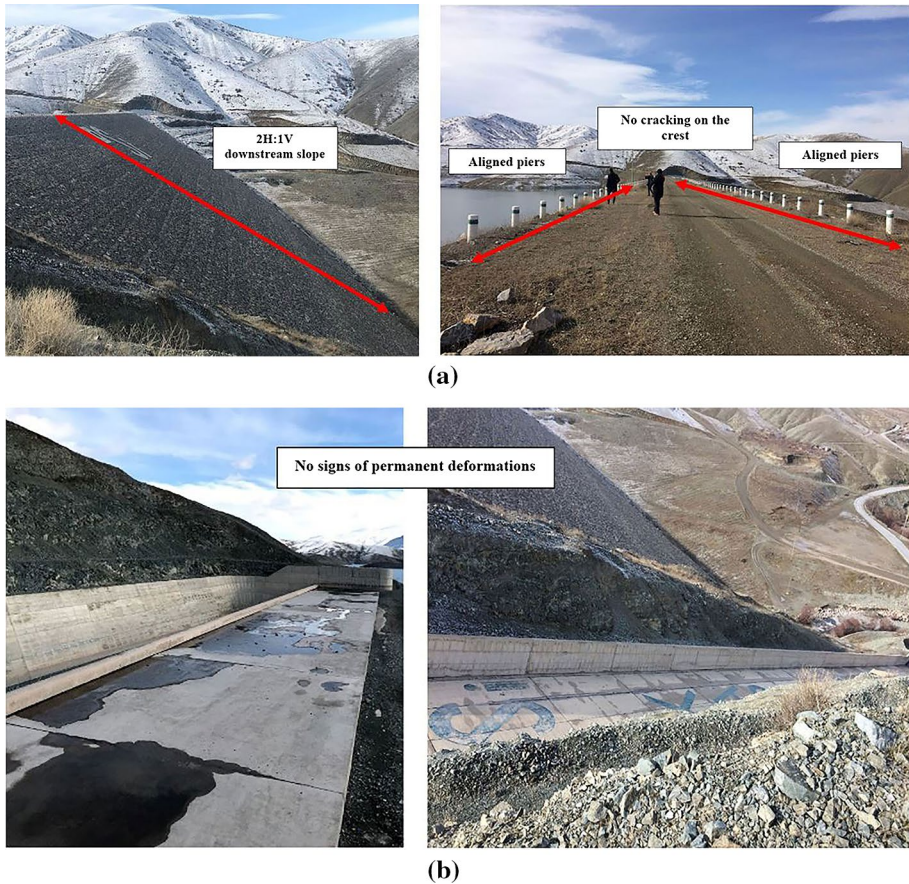
Reconnaissance team has investigated the dam and documented no signs of seismically induced permanent deformations along the dam crest. During site visit, the water level was measured at +854.70 m elevation. Both the upstream and downstream slopes along with the dam axis itself were documented to be unaffected from the shaking. Also, no damage

**Fig. 25** **a** Side and crest view of Kapikaya Turgut Ozal Dam, **b** water in-take structure and spillway of Kapikaya Turgut Ozal Dam

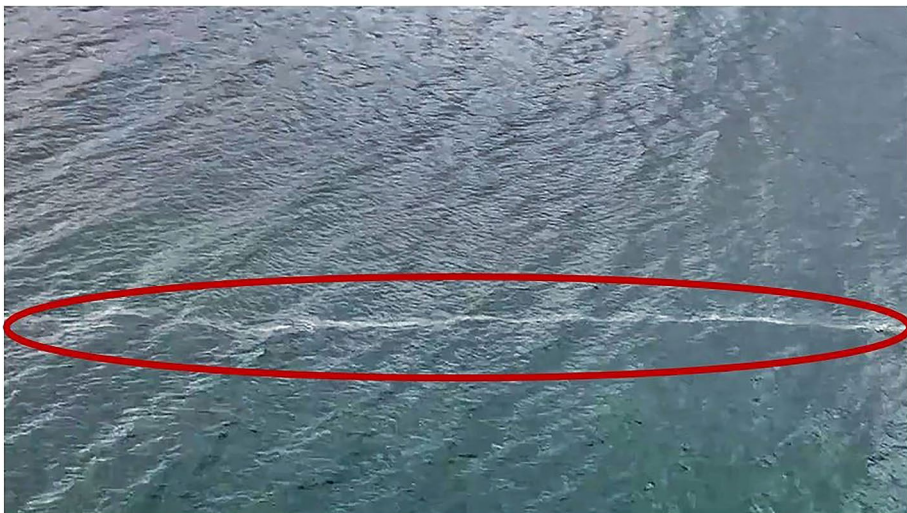
**Fig. 27** Gas and water bubbles along the fault trace observed crossing Karakaya Dam reservoir (Courtesy of Anadolu Agency)

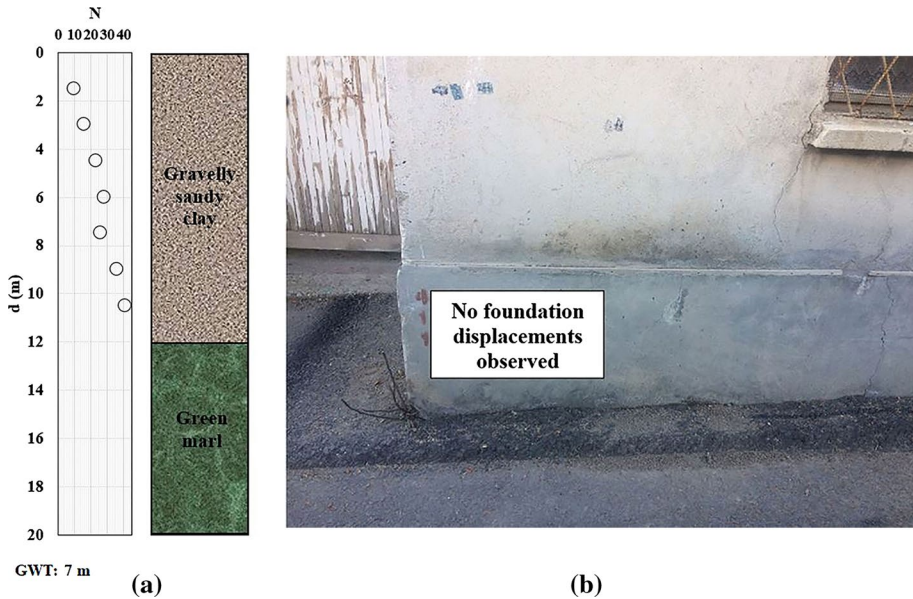
**Fig. 29** **a** Typical borelog for Malatya-Battalgazi (M. Gor, personal communication 2020), **b** An example of no foundation displacements observed at a residential R/C building in Battalgazi ( $38^{\circ}25'20.7''N$   $38^{\circ}21'59.3''E/01.02.2020/8:31$ )

shown in Fig. 29b, no signs of permanent foundation displacements of R/C buildings were mapped in Battalgazi. The foundation systems are reported to be shallow individual footings combined with strap beams.

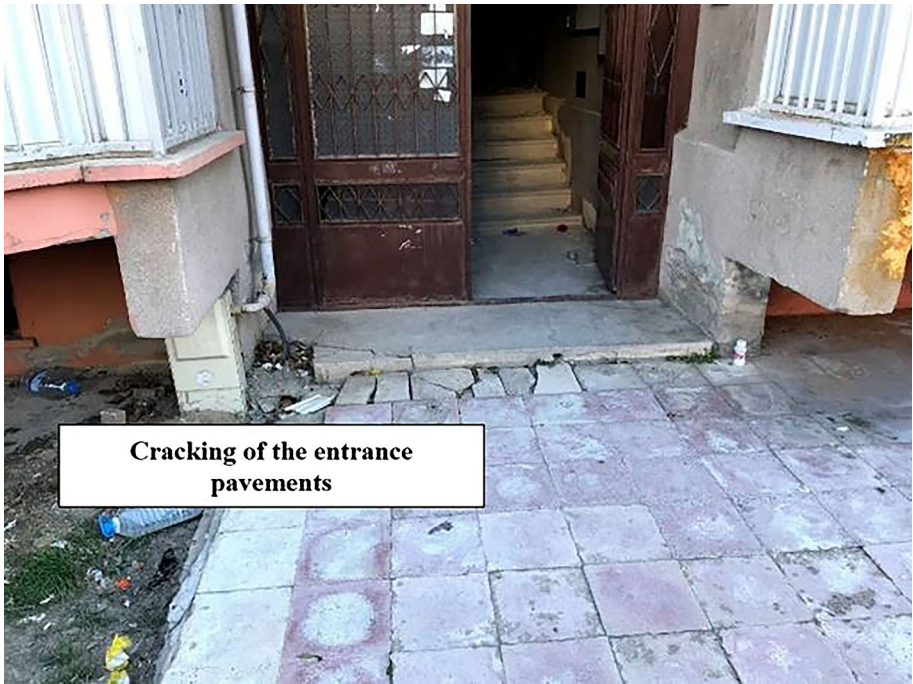
**Fig. 31** Cracking of entrance pavement due to seismically-induced lateral displacements observed at the entrance of the of a residential building (38°39'21.9"N 39°09'10.4"E/01.02.2020/14:50)

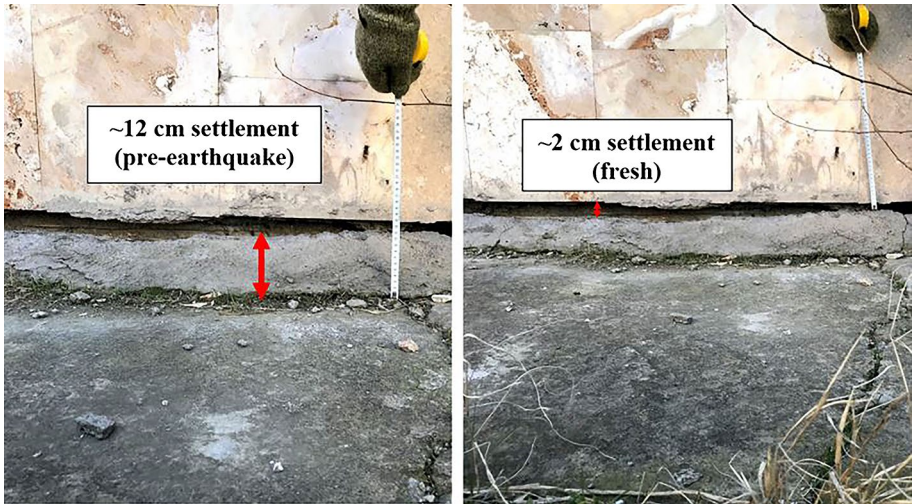
As shown in Figs. 35 and S4–S5 (given as part of the electronic supplement), the reconnaissance studies documented none to 1–13 cm foundation settlements. In Fig. 35,

Fig. 35 Settlement observed (38°40'07.0"N 39°11'04.8"E/01.02.2020/15:47)

pre-earthquake as well as additional seismically-induced fresher settlements were identified and documented separately.

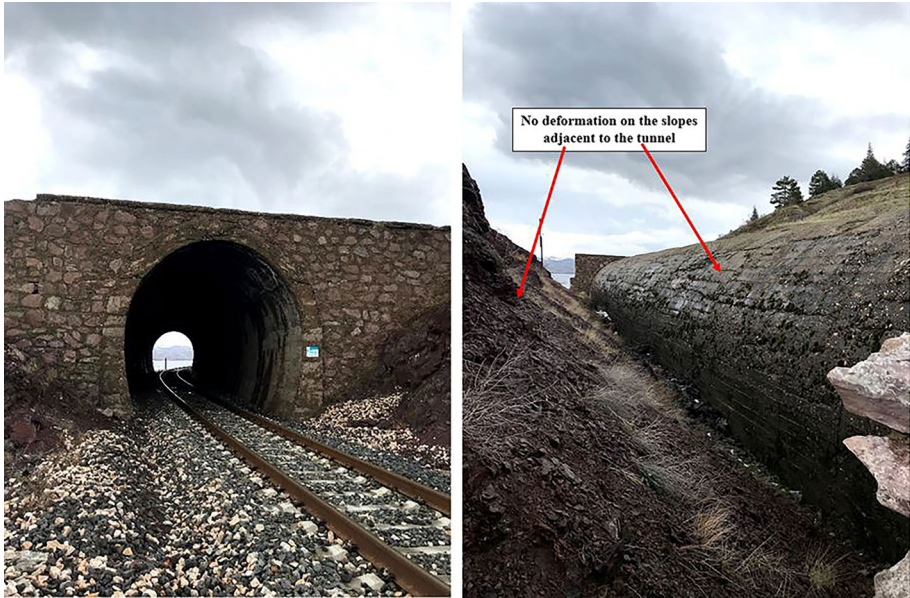
**Fig. 39** A railway tunnel and rails exhibiting no damage ( $38^{\circ}28'52.8''\text{N}$   $39^{\circ}27'18.2''\text{E}$ /31.01.2020/15:08 &  $38^{\circ}28'53.2''\text{N}$   $39^{\circ}27'18.4''\text{E}$ /31.01.2020/15:09)
