# Performance of structures in İzmir after the Samos island earthquake

## Abstract

**Keywords** Earthquake damage · Samos earthquake · Site effects · RC building deficiencies · Turkish seismic codes

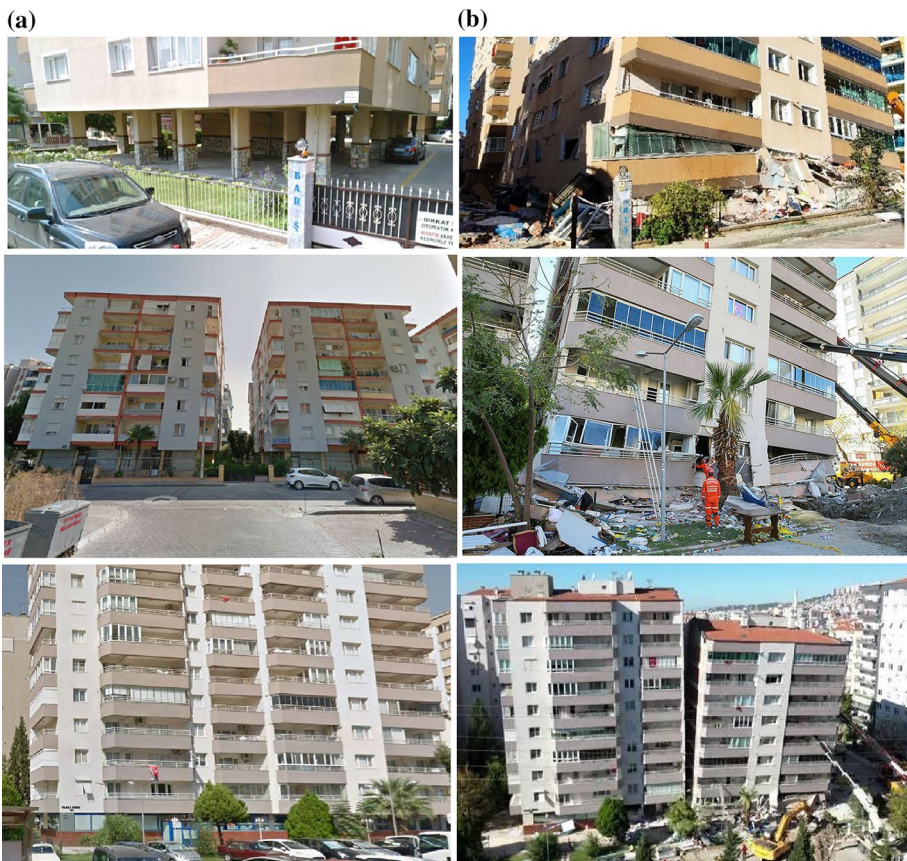
A number of buildings suffered severe damage or partial collapse at their first stories due to the presence of soft story (Fig. 7). A typical feature of the buildings in Turkish city centers is the presence of commercial space at the ground levels. In order to create wider space, infill walls are generally removed in these stories where the seismic demands are maximum. In addition, poor beam-column connections and the presence of weak columns are the key reasons for the development of soft-story mechanisms. The conditions of some example buildings with soft story feature are shown on the left column of Fig. 7 before the earthquake, their performance after the earthquake is shown on the right column of the figure. Due to the soft/weak stories, building collapses occur partially in the ground floor in some cases, whereas total collapse was observed in some other buildings. This is a very common type of failure frequently observed in many recent earthquakes [Elazığ 2020; Van 2011 (METU 2011); Bingöl 2003; İzmit 1999 (Scawthorn et al. 2000)]. The soft story feature does not always imply poor performance but it is clearly a damage exacerbating feature of deficient RC buildings in Turkey.

**Fig. 7** Failure due to soft/weak story. **a** Before the earthquake (left), **b** after the earthquake (right)

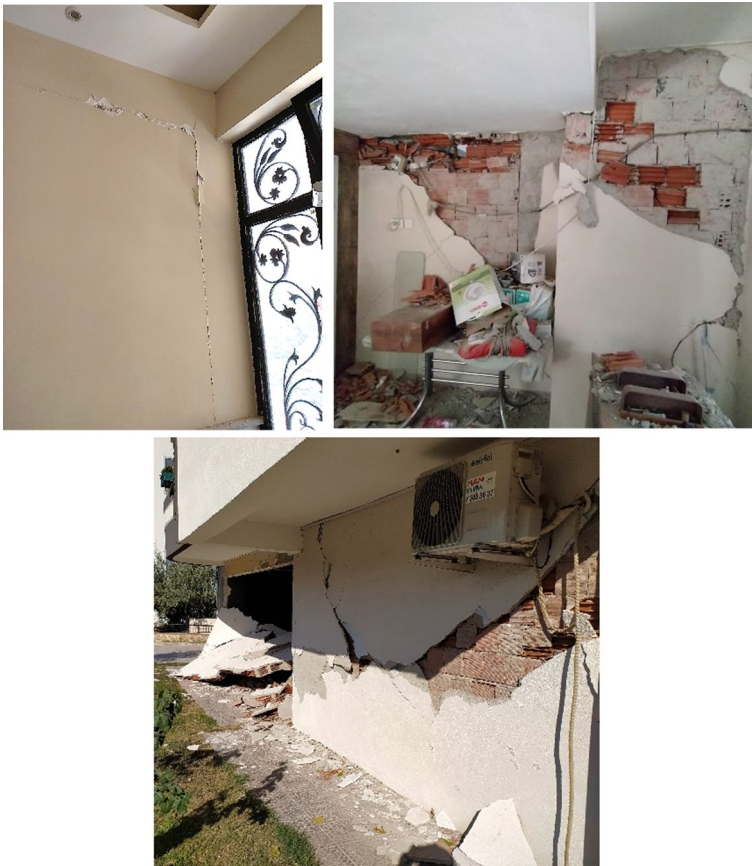
The most widely observed damage in RC buildings of Turkey is infill wall damage, and İzmir has not been an exception. The most common infill material is hollow-core clay bricks in the İzmir Region. Infill wall damage consisted of interface cracking at frame-boundary interfaces, diagonal cracking, and crushing (Fig. 8). The structural benefits and harms of the infill walls were similar to those observed in previous earthquakes (METU 2011; Bayraktar et al. 2015). In some buildings, the infill walls appeared to stiffen the building and reduce the lateral deformation demands. One of the very important examples exhibiting the significance of infill walls in saving a building that had inadequate lateral strength is shown in Fig. 8 where performance of one of the buildings in an eight-story apartment complex comprising of four buildings is shown. In the building shown in Fig. 8, there were extensive infill walls in the first story which prevented soft story formation. In the other three buildings, this floor had no infill walls at all (Fig. 7, top row). Three of the buildings without infill walls were either heavily damaged or collapsed, resulting in nine fatalities. The one with the masonry infill walls in the first story, on the other hand, experienced moderate infill wall damage without any significant structural damage (Fig. 9). This

**Fig. 8** Types of Infill wall damages observed in İzmir

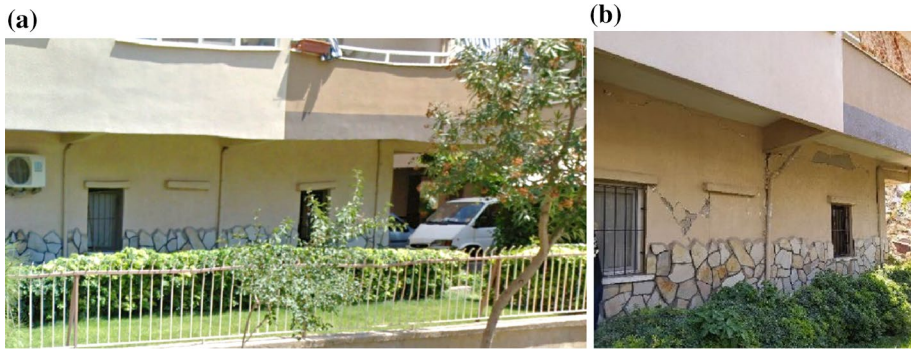
**Fig. 9** Contribution of infill walls. **a** Before the earthquake (left), **b** after the earthquake (right)

can be viewed as a striking example of the “unintended” benefit of infill walls contributing to lateral stiffness, strength, and axial capacity.

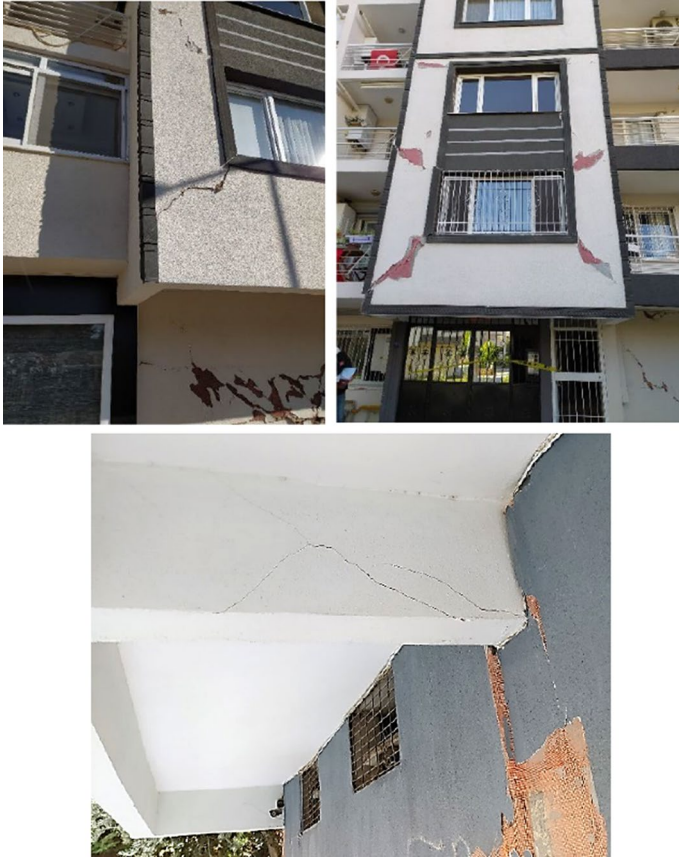
The footprint area of buildings and the upper floor plan areas are significantly different in some of the buildings due to the presence of overhangs. These cantilever overhangs can be excessive, at the order of few meters, and prematurely crack under the weight of the exterior walls carried by the overhangs. Figure 10 shows wall cracking, and severe damage at the corners of heavy overhangs. Damage in heavy overhangs is not only limited to the partition walls, but also exist in the structural system. Flexural and shear cracks (residual crack widths above 1 mm) were observed in the structural members connected to these overhangs (Fig. 10). It is interesting to note that such localized damage in the overhangs resulted in unreparable damage due to residual lateral and vertical deformations reaching substantial cantilever tip settlement; hence these buildings could not be re-occupied. The damage observed in overhangs, cantilever connections and ground floor columns in some buildings did not directly lead to structural collapse, but prevented re-occupation, hence leading to demolition. The effect of these overhangs on the continuity of frames and lateral load path needs to be considered as part of the design. It is also noteworthy that except the most recent one (TBEC 2018), previous Turkish seismic codes did not require consideration of vertical ground motion for such overhangs.

**Fig. 10** Damage in overhangs

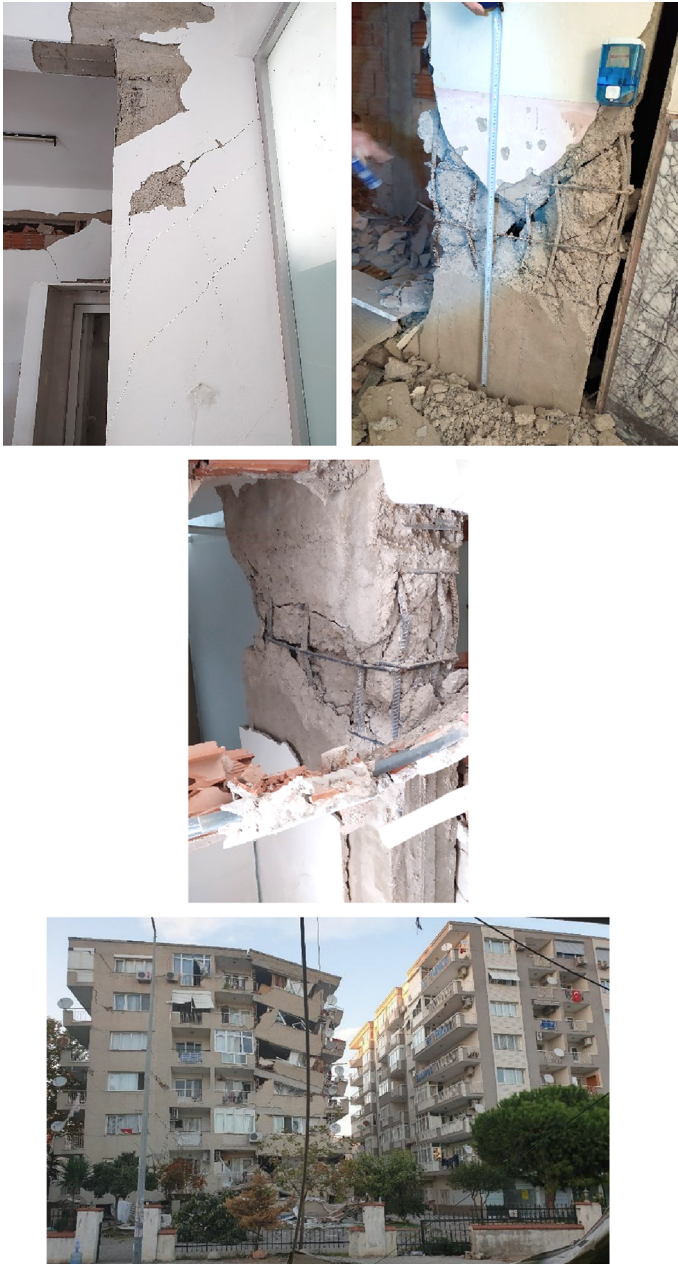
row) collapsed at its lower two stories, whereas the other building had almost no damage as observed from a street survey. However, assessment of this building from inside revealed heavy shear damage and significant corrosion in columns (Fig. 11). This observation clearly shows that damage assessment based on examination without entering the building may lead to misleading results.

**Fig. 11** Damage in the columns of two heavily damaged buildings

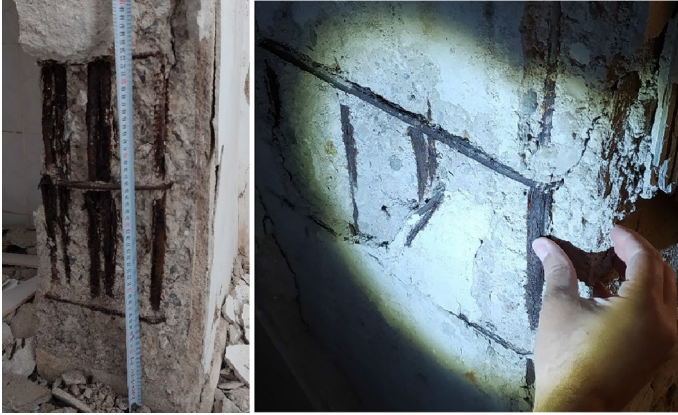
Our investigations revealed that corrosion in reinforcement is a widespread problem in İzmir due to high humidity levels (Fig. 12). Excessive corrosion was especially observed at the bottom of columns in the basement or ground floors. Loss in the cross-sectional area of reinforcement due to corrosion was significant in some instances, reaching the ratios of 25–65%. In certain cases, the earthquake appeared to have triggered spalling in columns that made the corrosion visible whereas in most other cases the level of corrosion was so high that it was clearly seen in the buildings that had no structural damage. The critical problems associated with corrosion in the building columns are reduced moment and

shear capacities due to loss of bond strength, and concrete spalling leading to premature rebar buckling. Hence, addressing problems related to corrosion detection and protection remains critical for seismic risk reduction in regions with high water table level.

**Fig. 12** Corrosion induced damages

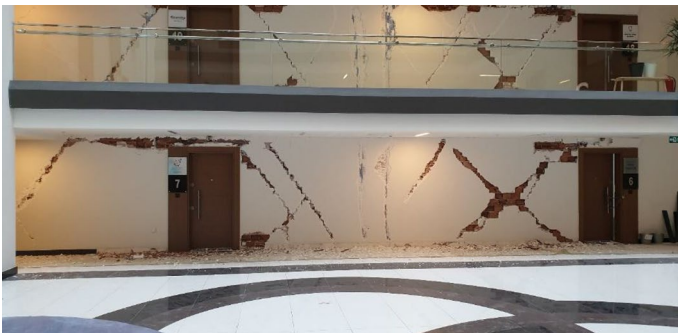
**Fig. 13** Non-structural damage in infill walls due to large openings in the slab

and poor design led to excessive drift of office areas, and the infill walls around offices suffered heavy damage. This observation emphasizes the importance of considering slab discontinuity and developing proper load transfer mechanisms to the shear walls. Several other examples of such behavior were observed in the city.

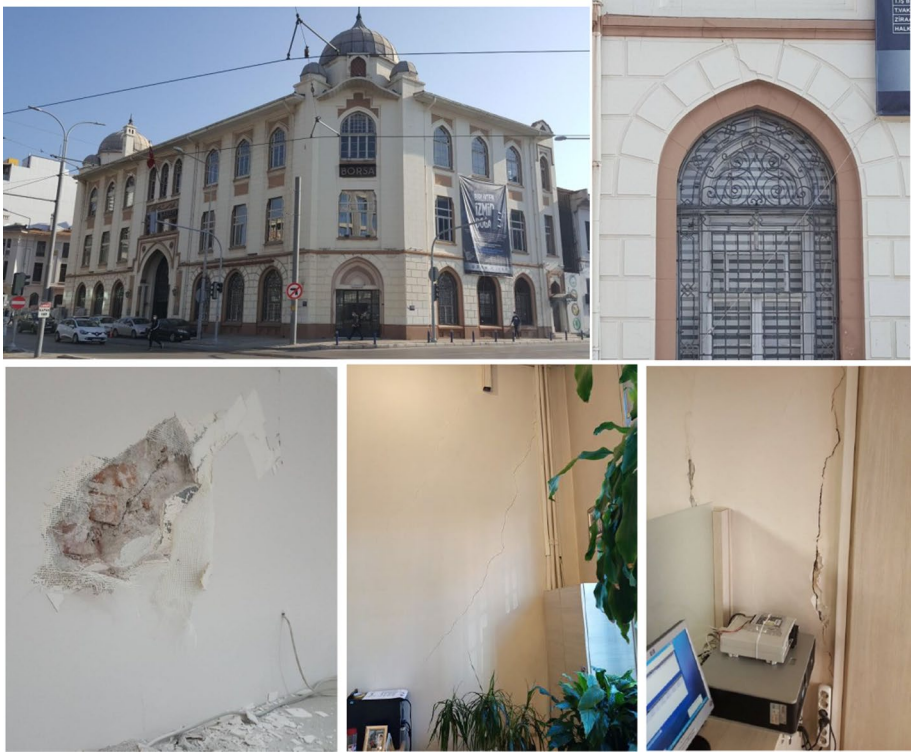
In general, previously renovated historical structures exhibited adequate performance but a few suffered damage. Some early twentieth century structures and historical mosques belong to this class. The İzmir Commerce Building which had a basement and three floors built in 1920's, sustained damage. It is originally constructed as a mixed masonry and reinforced concrete structure. The exterior façade of the building was built with stone-brick mix masonry walls, and the internal spaces were supported with RC frames. Later in its history, internal partial stories were added to the system with structural steel framing. An overview of the building and the damage it experienced from inside and outside are presented in Fig. 14 (Alkan 2020). The building suffered both structural and non-structural damage. Diagonal and vertical cracks in the walls imply that the capacity of these walls was exceeded. It is reported that the disruption of the original frame due to the partial stories added by dividing the stories with high headspace inside the building is the main cause of damage.

Fig. 14 İzmir commerce building: general view and observed damages

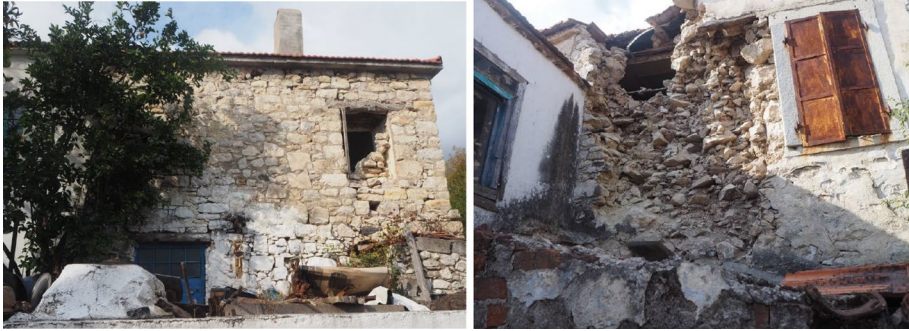
**Fig. 16** Typical masonry wall in Kösedere and example of a collapsed wall

this construction and the observed damage are shown in Fig. 16. The collapsed walls had thicknesses varying from 40 to 60 cm. In general, wall damage was observed as separation at the wall-to-wall connections (Fig. 16a), cracks in wall bodies (Fig. 17b), and at the window/door openings (Fig. 17c). Due to cracking, the structures were on the verge of losing the box behavior, which is the key mechanism to provide the out-of-plane stability of masonry walls and overall lateral structural strength.

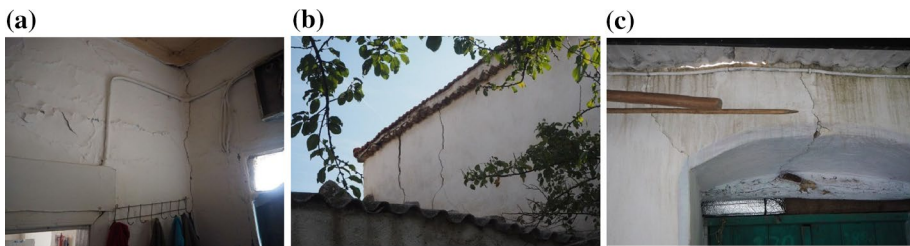
**Fig. 17** Typical wall damages. **a** Separation at wall-to-wall connection, **b** cracking in the body of a wall, **c** Cracking at door opening

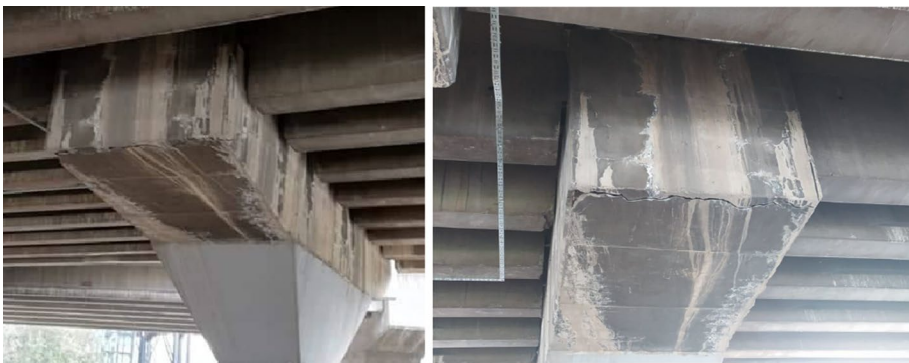
rupture or fracture was observed in non-structural bridge elements (precast panels, pedestrian railings, lighting poles, etc.). The earthquake performances of longitudinal joints between twin bridges were also satisfactory, and some small concrete pieces not more than 2–3 cm fell on the ground only at some local zones. After the examination of the superstructure and infrastructure of the bridges, no earthquake-related damage was detected. Bridges were available for use right after the earthquake. As a result, it was determined that bridges that performed successfully during the earthquake were serviceable without a need of emergency intervention (Fig. 19).

**Fig. 19** A typical before-and-after earthquake photo (December 2019 and November 2020)

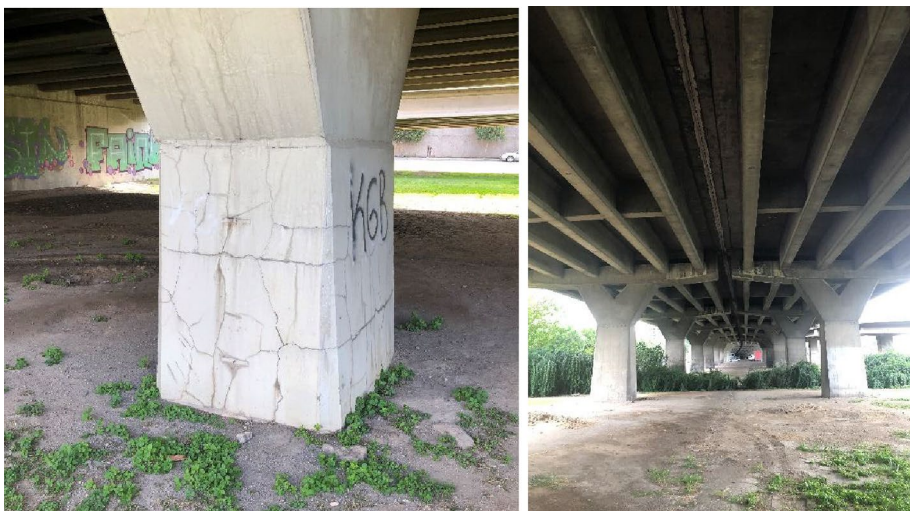
In some of the bridges, cracks, not due to the strong motion, were observed. Most of the cracks are pre-existing ones and were caused by rainwater and are ASR (Alkali-Silica Reaction) cracks, which are the result of a chemical reaction that occurred years ago in the bridge elements. No further opening of the cracks was observed after the earthquake (Fig. 21).

**Fig. 21** ASR based cracks (non-seismic) and general view

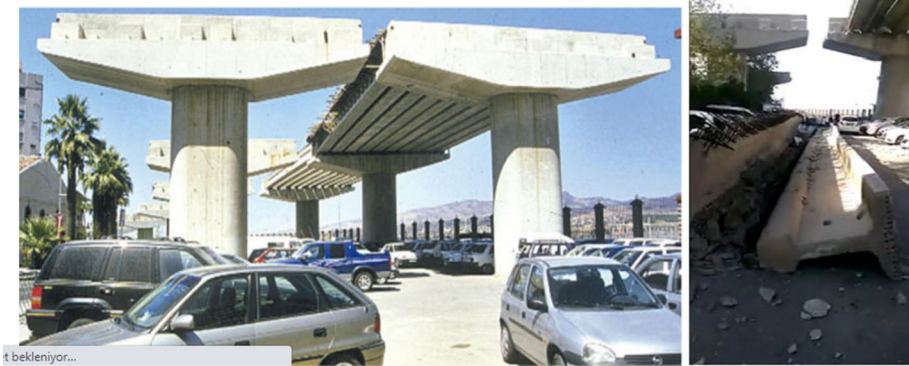
One case of bridge failure due to the earthquake was observed in an incomplete and abandoned bridge. The bridge girders, which were started to be built 20 years ago and discontinued because of a route change, fell during the earthquake because their lateral stability was not sufficient for the last 20 years (Fig. 22).

**Fig. 22** An incomplete bridge construction 20 years ago without providing a lateral girder stability at the site (10 years ago and now)
