Post-earthquake damage classification and assessment: case study of the residential buildings after the $M_w = 5$ earthquake in Mila city, Northeast Algeria on August 7, 2020

Abstract

6 Residential building damage and common failure patterns

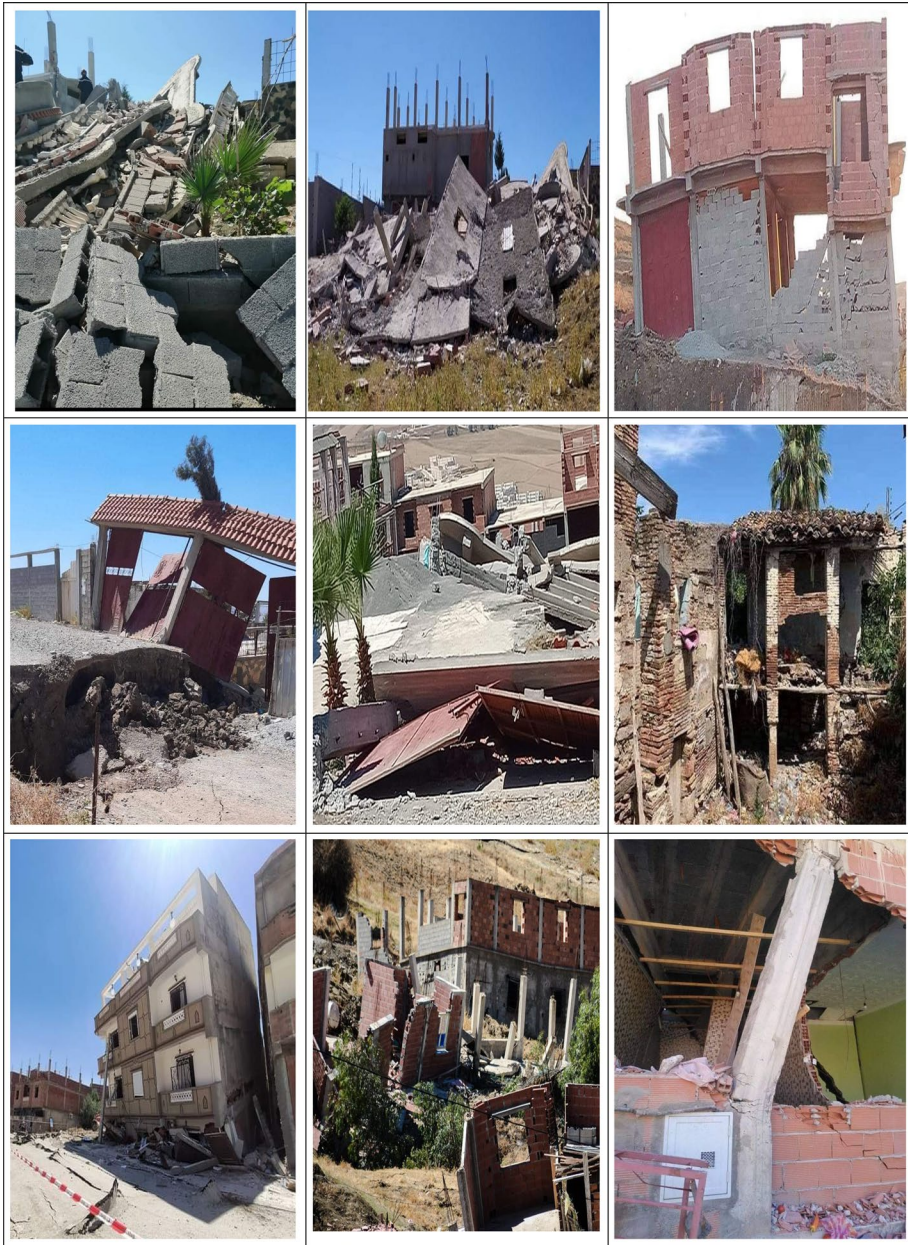
Fig. 1 Illustration of typical structure damage following the Mila earthquake

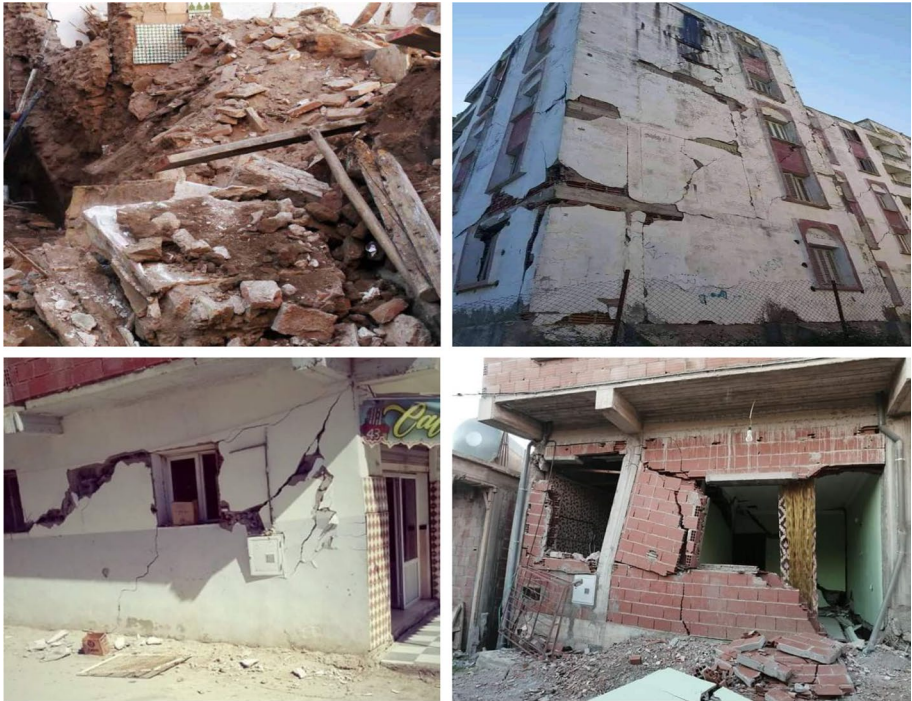
De Luca et al. 2018) and Turkey after recent earthquakes (Karimzadeh et al. 2018; 2020). Most of the residential structures in Mila's old town were constructed with URM. To prevent masonry failure, proper detailing and strengthening should be employed. However, this was not always the case in older structures. Even though "zero mechanism" was frequently mentioned in many post-earthquake evaluations in African nations (i.e., the disintegration of the material) (Indirli et al. 2013), due to the construction type, i.e., solid brick structure, this mechanism was not detected during the Mila earthquake. The partial collapse or overturning of gable walls was one of the most typical failure types in Mila's residential structures. Gable walls are often just 9 cm thick. In addition to the attic gable walls, the parapet walls were frequently damaged, but to a lesser extent. The preceding part depicted the roof type, and it was observed that the connections between the timber framework and the walls were frequently insufficient or non-existent. Roof rafters and ridge beams frequently collide with gable walls, causing substantial damage and failure due to their weight and magnified accelerations at the gable's height. The same thing happens with the mezzanine wood structure (which rests on the longitudinal walls) and sidewalls—the wall and horizontal parts are not or are very poorly attached. Figure 14 depicts damage examples from the most prevalent gable wall collapses.

Fig. 14 In-plane and out-of plane damage

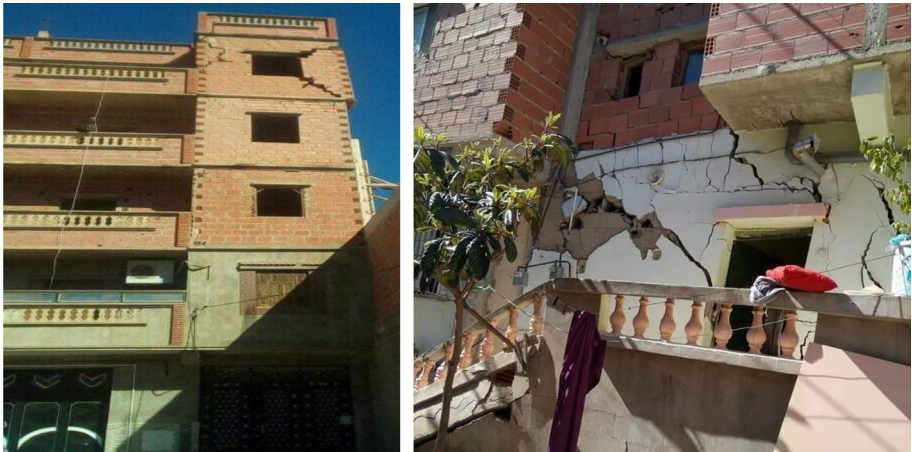
Many buildings have an architectural design that includes protrusions for entrances or other floor plan irregularities. Cracks frequently emerge at the junction of orthogonal load-bearing walls in these areas; torsion ensues, which can compromise the building's overall stability. Because building entrances with stairs are widespread in these locations, the staircases and related load-bearing walls are frequently damaged. Figure 15 depicts one example.

Fig. 15 Plan irregularities caused damage to the connecting components

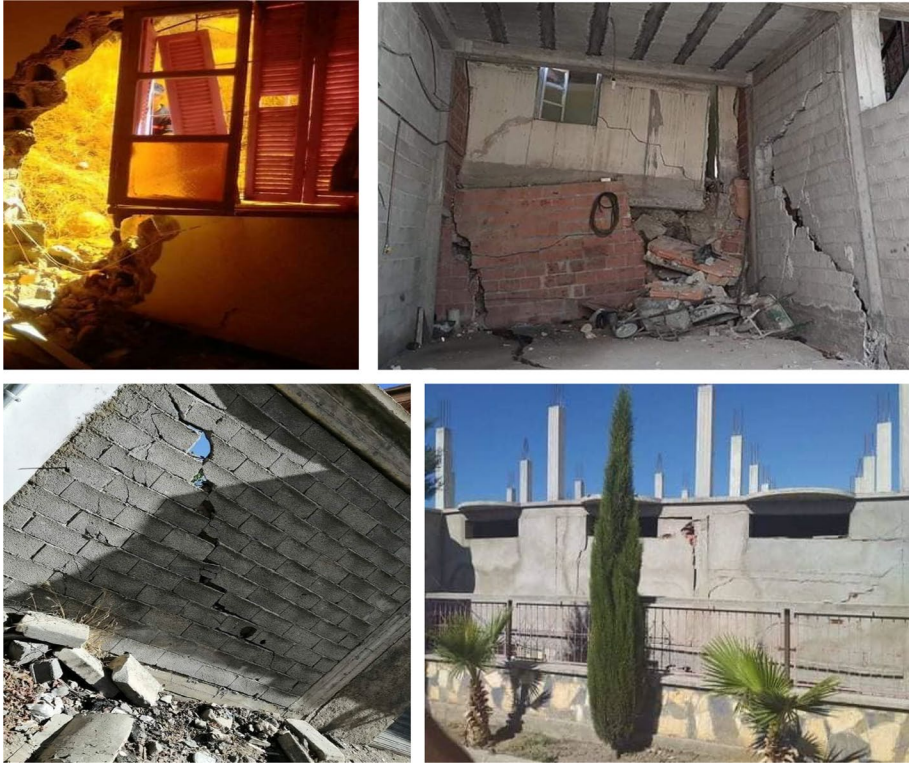
Fig. 16 Damage to partition walls

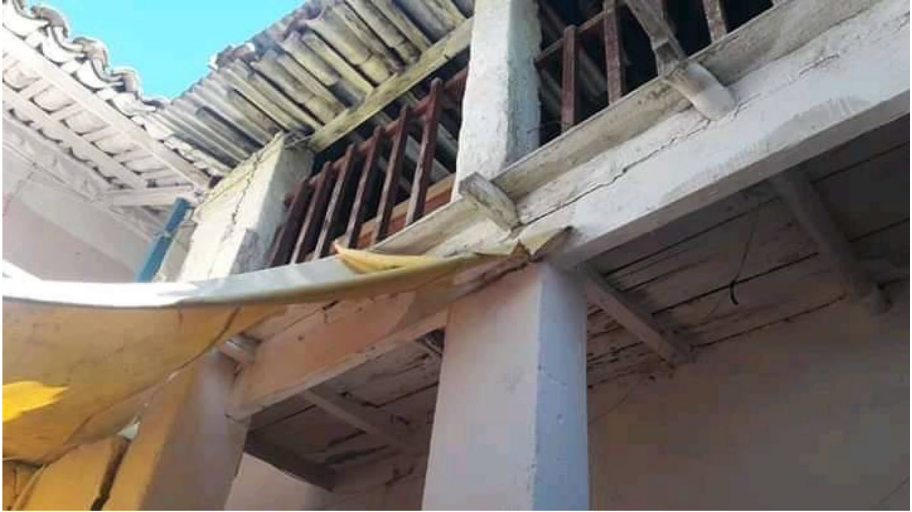
extensively modified during the conversion of attics to residential use. Timber tie components were frequently cut to install a door (Fig. 17), creating significant alterations to the roof structure's basic structural system.

Fig. 17 An example of an attic conversion for residential use

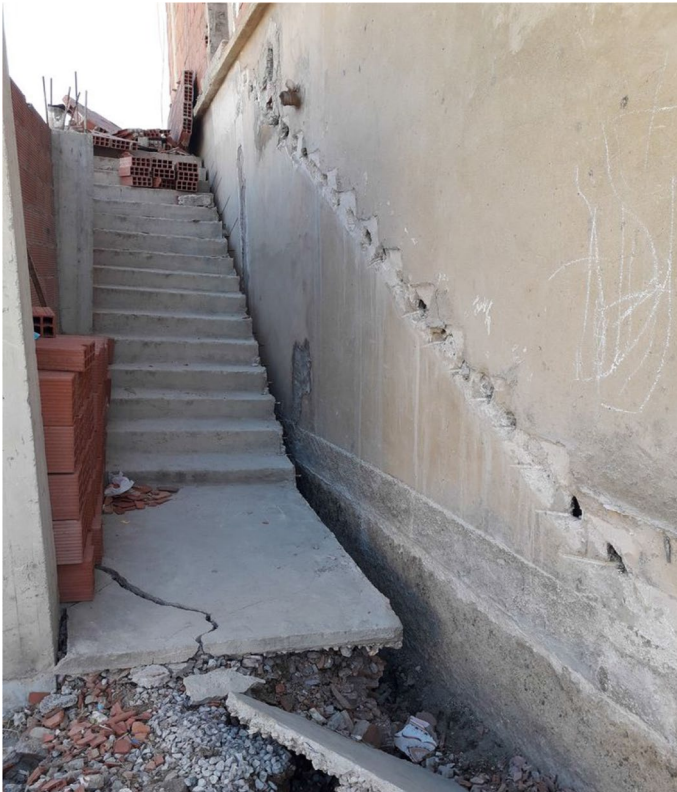
Stairs in residential structures are often positioned in the center of the floor layout, with various residential units on either side. Stairs are not necessarily non-structural features, but in the case of brick structures in Mila, they are not critical for seismic force resistance. Stairs can be monolithic at times, although they are usually fixed to the walls on one side and supported by steel profiles on the other. Many stairs lack a supporting beam and are not monolithic, as seen in Fig. 18 (right). Staircase walls are often thicker and part of a rigid core. The most typical staircase damage is the separation of individual stairs, the falling of plaster (sometimes as thick as 3 cm), and the separation of the stairs from the walls (Fig. 18).

Fig. 18 Typical stairwell damage

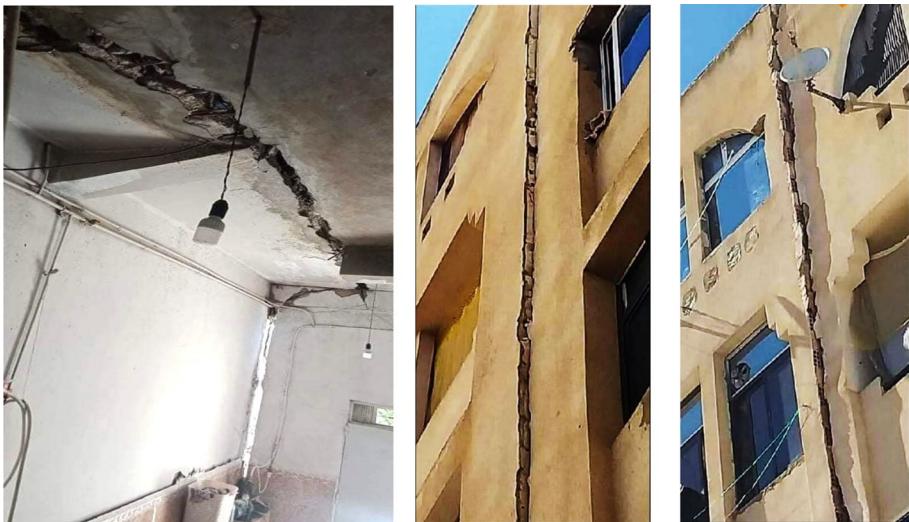
Fig. 19 Typical elevator shaft damage

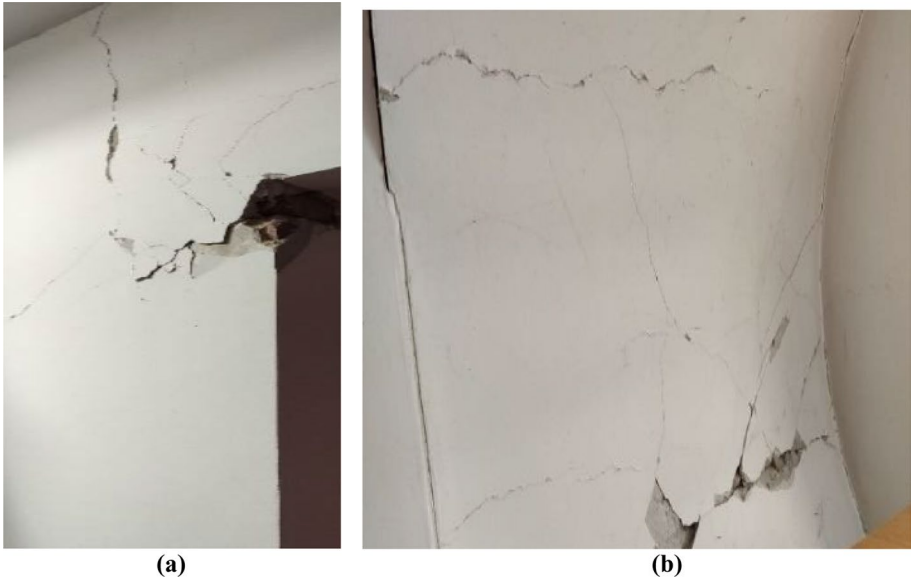
- On all levels, there is apparent damage in the form of cracks in the wall coverings, arches (Fig. 21a), vaults, and ceilings (Fig. 21b);
- Plaster separation and localized damage;
- Structural components (walls, columns, and arches) have minor damage;

Fig. 21 First floor cracks: wall, lintel (a), and ceiling (b)

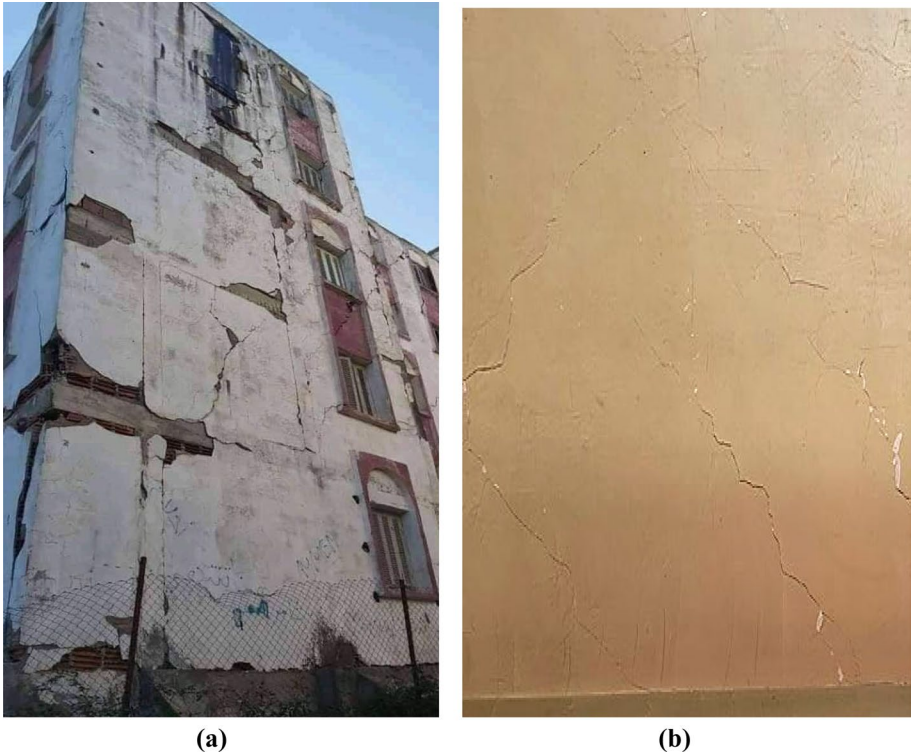
Fig. 22 Exterior a and internal b cracks on the eastern stairwell

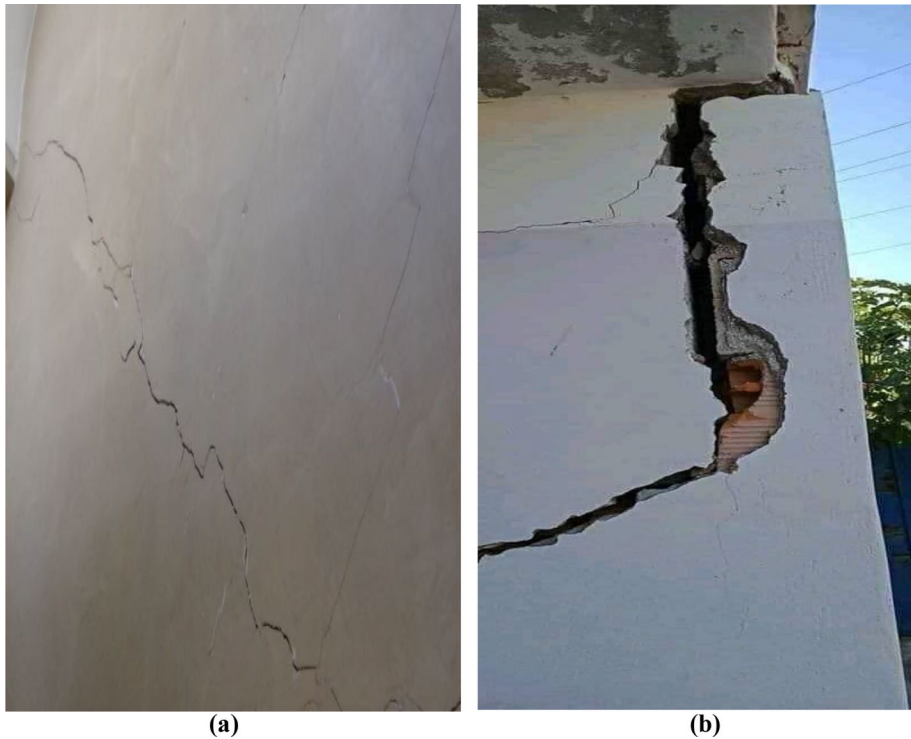
Fig. 23 Exterior **a** and internal **b** diagonal cracks on the central staircase

by tensile strains that run perpendicular to the supporting joint. If such fissures develop deeply enough, they can induce hinge formation and, as a result, loss of stability. However, the defects found in the studied structure are superficial and mostly concentrated in the plaster. Minor local damage occurred to the structural elements (walls, columns, and arches). Diagonal fractures on load-bearing walls may be seen in the center core of the structure, where the main stairway is located, and in the eastern part of the building. These fissures can also be noticed on the building's north side. All the floors show visible damage, such as cracks and crumbling plaster on the walls. Minor local damage to the first-floor walls, as well as cracks on the partition walls and ceiling connectors, may be seen.

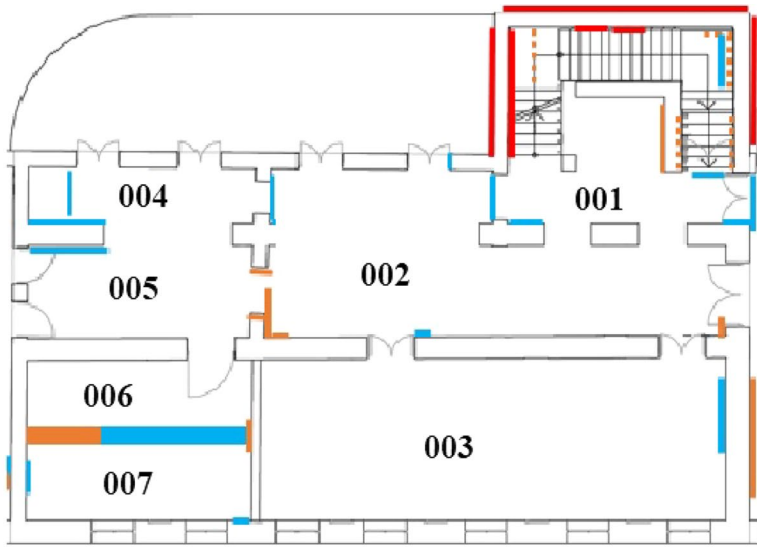
Fig. 24 Damage pattern and shear strength-testing locations on the building’s ground floor

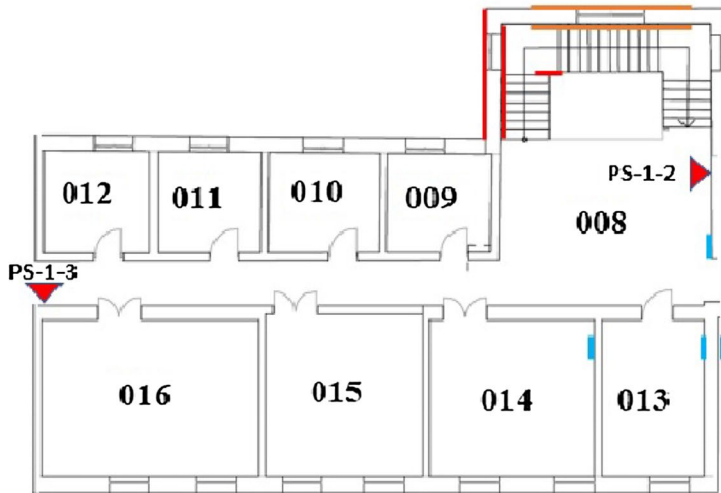
Fig. 25 Damage pattern and shear strength-testing locations on the first level of the structure

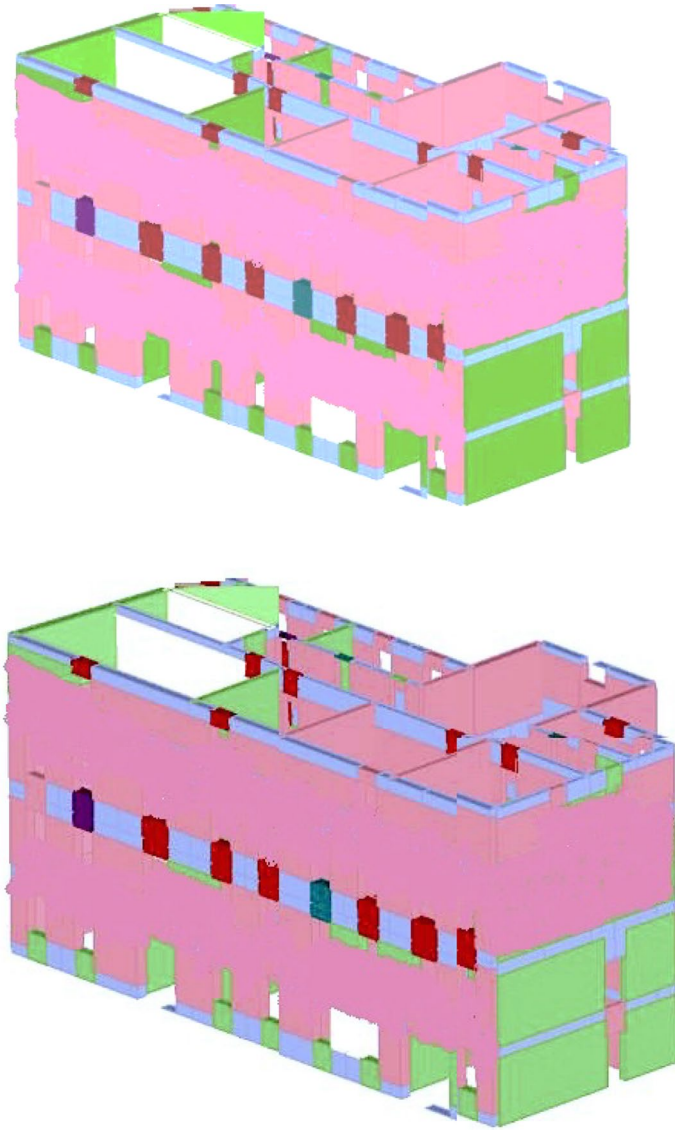
Fig. 32 Damage at maximum displacement capacity for x-direction pushover. Yellow: shear damage, red: bending damage

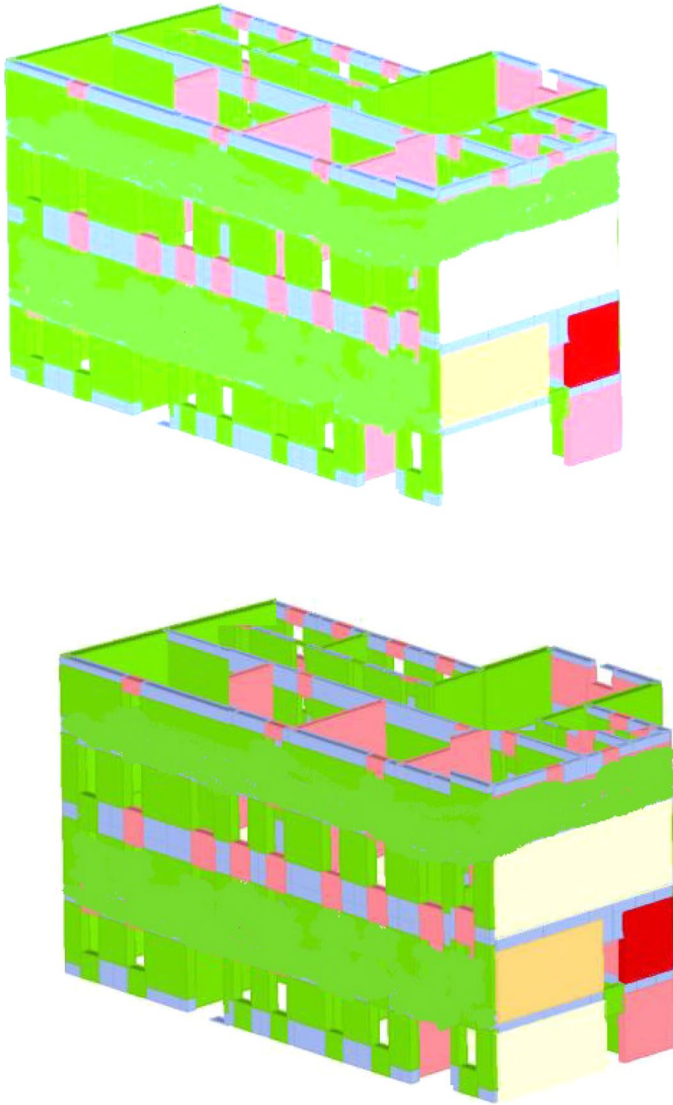
Fig. 33 Damage at maximum displacement capacity for y-direction pushover. Yellow: shear damage, red: bending damage

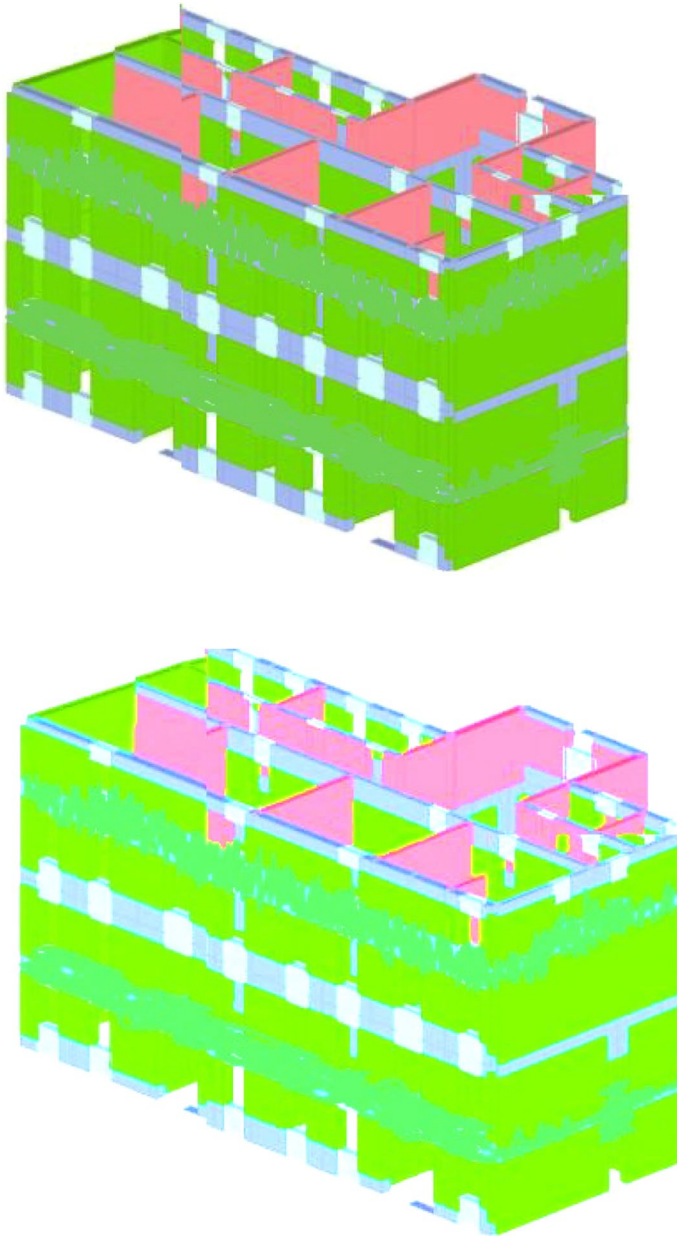
A study of the walls out-of-plane bending must then be performed. This explains the earthquake activity that occurs perpendicular to the walls. The investigation is carried out for the limited situation that is on the verge of collapsing. Acceleration for a 475-year return period is used. If a wall's MRd/MEd ratio is greater than or equal to 1.0, it is considered to have passed the out-of-plane bending test. In Fig. 34, the walls that failed the examination are shown in red.

Fig. 34 Out-of-plane bending findings. Red: bending damage
