Field reconnaissance on seismic performance and functionality of Turkish industrial facilities affected by the 2023 Kahramanmaraş earthquake sequence

Gulsah Sagbas¹ · Ramin Sheikhi Garjan¹ · Kerem Sarikaya¹ · Derya Deniz¹

Abstract

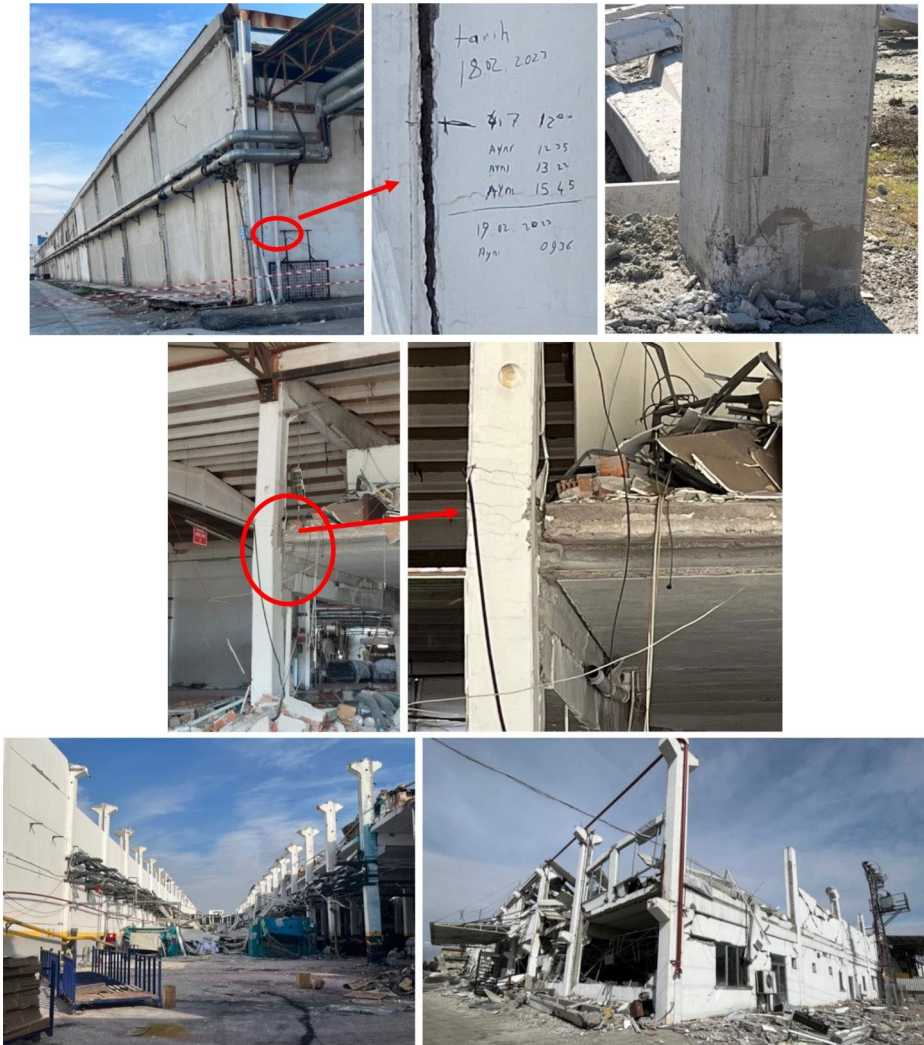
During the inspections, certain precast RC columns were found to have flexural cracks at the base (see Fig. 6-top; where a lateral deflection of 4.7 cm was measured at one-fourth height of the column with respect to ground) or at lateral supports (see Fig. 6- middle), indicating the energy dissipation against the earthquake demands, but the number of these columns was low. In contrast, multiple incidents of partial or total roof collapses were detected in the inspected facilities in Hatay and Kahramanmaras, including the recently constructed post-2015 facilities in Turkoglu OIZ, without showing any hinging at the column base (see Fig. 6-bottom). The main reason was due to loss of connection support at the column-roof beam, which resulted in rotation or collapse of the main roof beams in these systems (see Fig. 7-top). This is a very common damage pattern that has been seen in several recent earthquakes, such as the 1999 Kocaeli earthquake (Erdik 2001) and the 2012 Emilia earthquake

Fig. 6 Plastic hinges and flexural cracks observed at the column bases (top) and lateral support (middle); and complete collapses of roof systems together with main and supporting beams (bottom)

sequence (Liberatore et al. 2013; Belleri et al. 2014). It shows that these connections were insufficient to support the seismic displacement demands associated with the structure's high flexibility, which comes from the tall cantilever columns. Insufficient anchorage in the dowels and improper grouting around them (see Fig. 7) can all contribute to beam-column connection failures, which can lead to roof beams falling from support systems and eventually leading to roof collapses for precast concrete structures. These factors, as well as smaller corbel dimensions that support the roof beams, poor detailing or preexisting deterioration or corrosion at the column corbel-beam connection, may also play a role.

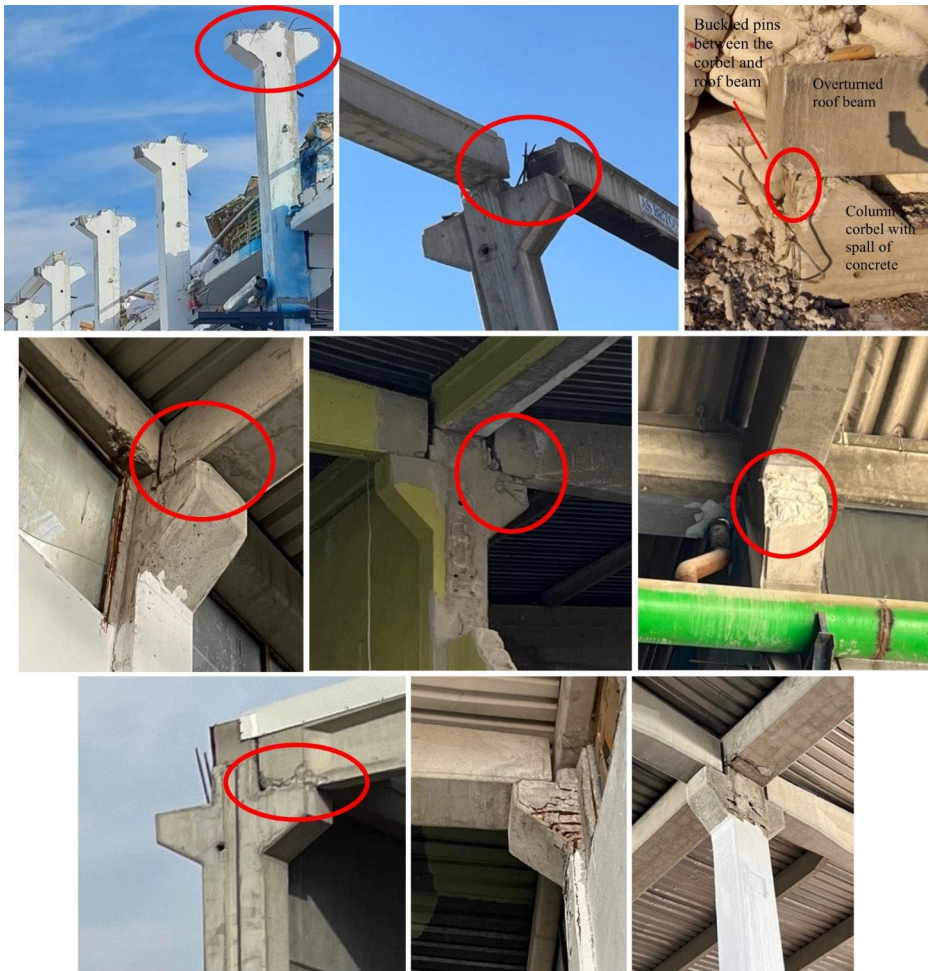
Fig. 7 Examples of pin failures on precast reinforced concrete industrial facilities located in Turkoglu (top); shear cracks and/or spalled concrete at corbels or roof beam ends observed in Adana, Nurdagi, Iskenderun, Turkoglu respectively (middle part from left to right and bottom-left); and severe corrosions observed on the elements (bottom-middle and right)

force reduction factors R to the lower values of 3 (without any shear walls), which was the same in TBEC 2007, but 5 in TBEC 1998. The design concepts for precast reinforced concrete structures were not even taken into consideration by the codes before 1998 (TEC 1975). This is because precast systems were initially utilized in Turkiye around 1965, and their application in industrial buildings increased after the 1980s (Bekiroglu 2006). These facts all may explain why some pre-2000 or even older buildings performed poorly and didn't dissipate enough seismic energy and failed in brittle mode.

2015). Furthermore, strong vertical accelerations may contribute to the collapses of heavy roof systems by causing shear cracks and concrete spalls at roof beam ends or corbels, as a result of continuous poundings between them during the earthquake sequence (see Fig. 7-middle).

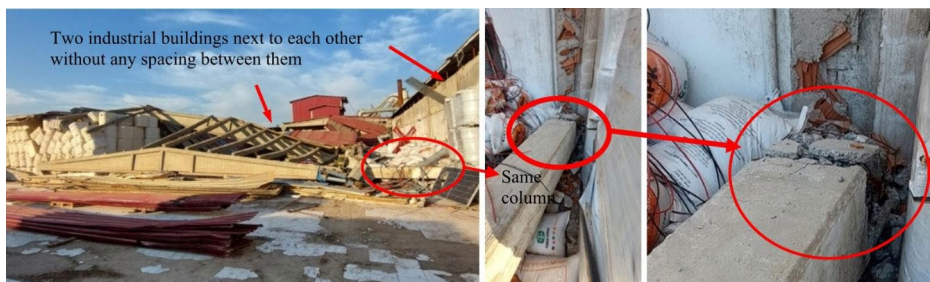
Lastly, as observed during the inspections, the adjacent industrial facility structures were often not constructed with a proper spacing (i.e., seismic construction joint), even these spacings are required in current or prior Turkish seismic design codes (TEC 1975; TBEC 2019). This spacing is very significant as it allows both structures to deform freely without damaging each other under seismic excitations. The effect of one building hitting the adjacent one during seismic excitation is called pounding effect. This effect was observed in a factory in Kahramanmaraş, where pounding of one building caused the other one to completely collapse (see Fig. 8).

Fig. 8 Complete collapse of a precast RC industrial building in Turkoglu, as result of pounding effect

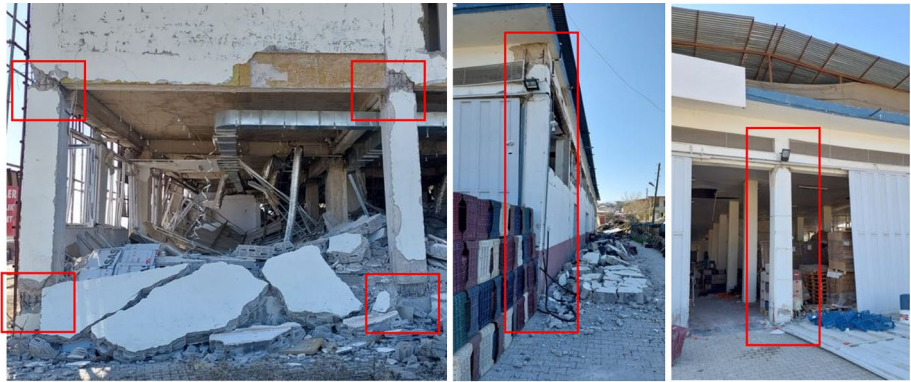
Fig. 9 Severely damaged reinforced concrete facilities with significant lateral drifts and plastic hinges at column ends: in Turkoglu (left) and Antakya (middle and right)

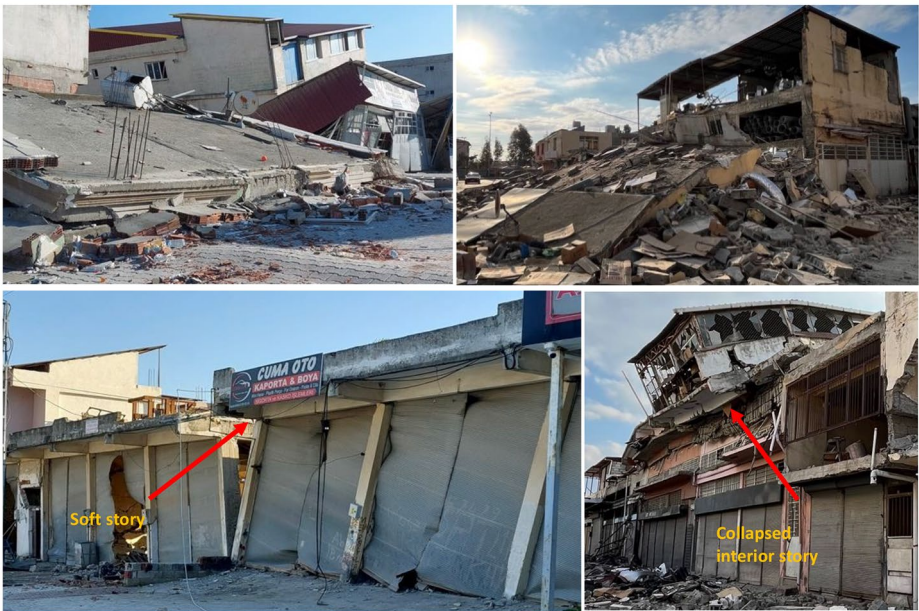
Fig. 10 Several collapsed reinforced concrete facilities at small industrial sites due to weak column-strong beam failures: in Antakya (left) and Iskenderun (right)

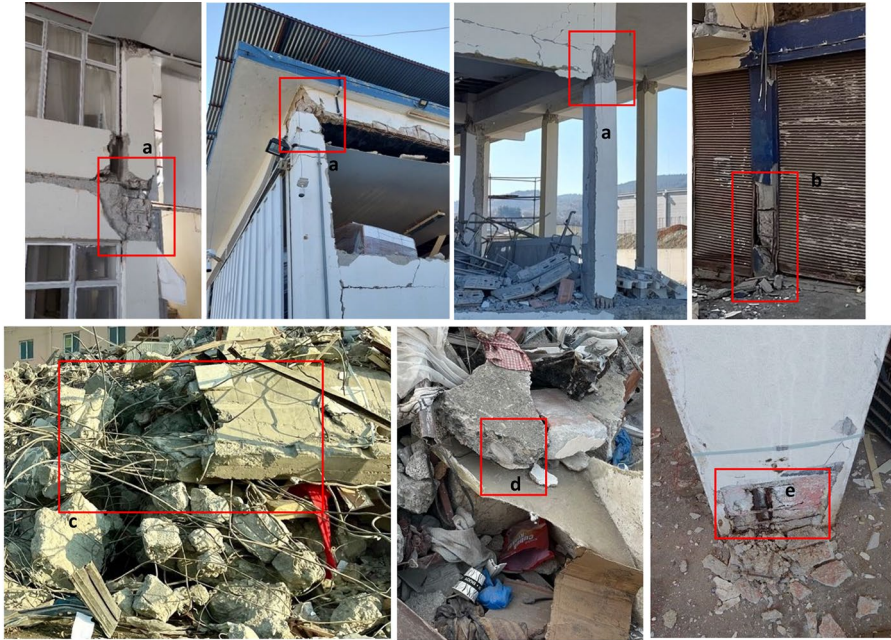
and exposing reinforcement (see Fig. 11e). The corrosion in reinforcement causes the bars to lose its layers, usually resulting in loss of reinforcement area and significant reductions in bonding between reinforcement and concrete (Broomfield 2002).

Poor reinforcement detailing was another significant issue observed for RC industrial buildings on the site, including insufficient reinforcement ratio, poor anchorages of reinforcement, and improper confinement of column and beam elements. Figure 11b shows an example of improper column confinement, where spacing of stirrups is up to 25 to 30 cm,

significantly reducing the shear capacity of the columns. Another example in Fig. 11a shows lack of confinement or poor confinement at the beam-column joints, resulting in weak connections, therefore preventing to follow strong column-weak beam principles.

Fig. 11 Several failure reasons identified for the inspected RC facilities, such as (a) weak connections due to poor reinforcement detailing, (b) shear failures at the column ends due to large stirrup spacing (20–30 cm), (c) use of plain reinforcement, (d) use of improper aggregates in concrete structural elements, and (e) spalled concrete covers of columns due to severe corrosion

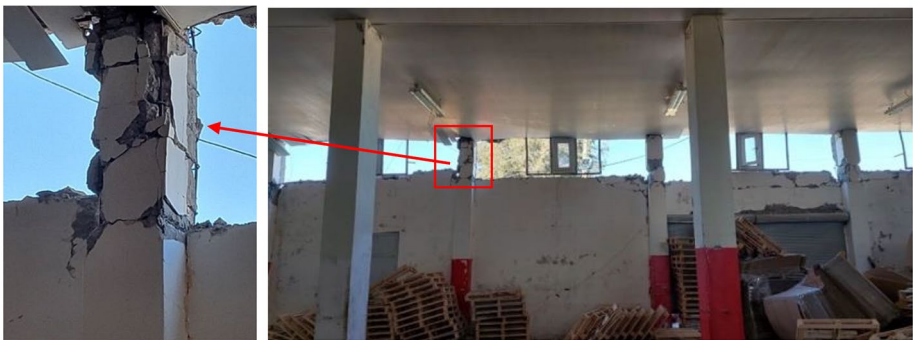
In addition, the short column effect was often observed at many inspected facilities. Fig. 12 shows one instance in which the columns near the windows suffered extensive shear fractures. The infill walls under the windows most likely restricted the columns' lateral

Fig. 12 Short column effects caused by the infill walls for a RC facility in Antakya (built in the 1970s)

displacements, limiting the effective length of the column to window height and increasing its lateral stiffness and therefore shear demands, which resulted in the column shear failures in Fig. 12.

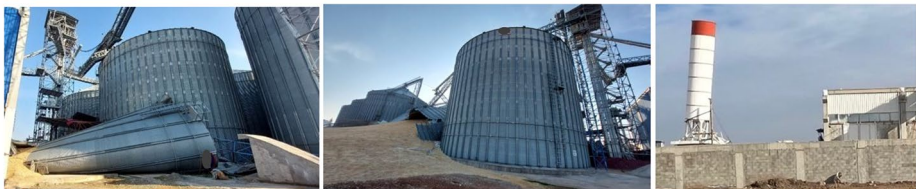
Fig. 13 Severely damaged or collapsed silos in Turkoglu, Kahramanmaras

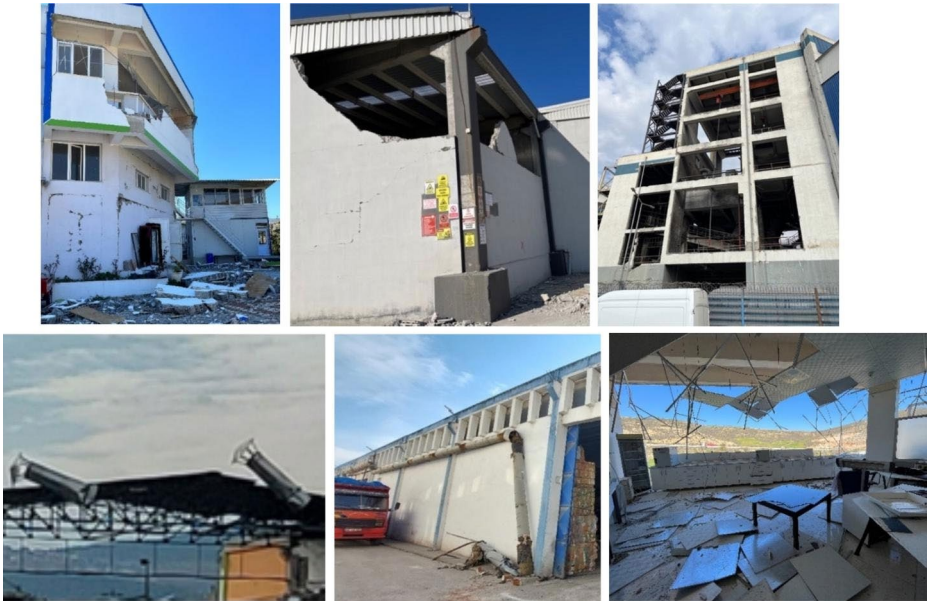
Most of the visited facilities' claddings (typically autoclaved aerated concrete masonry or hollow clay brick walls) were severely damaged due to failures in-plane and out-of-plane directions, including diagonal cracking within the infill walls, crushing at the corners, and partial or complete collapses. There was little or no connection found between the cladding systems and the structural components, increasing the possibility of partial or entire cladding panel failures.

Fig. 14 Cladding/facade damages observed at the facilities in Antakya, Turkoglu, and Iskenderun (top, from left to right); and other observed nonstructural building damages such as overturned chimneys in Turkoglu, broken pipelines in Dulkadiroglu, and fallen ceiling panels in Antakya (bottom, from left to right)

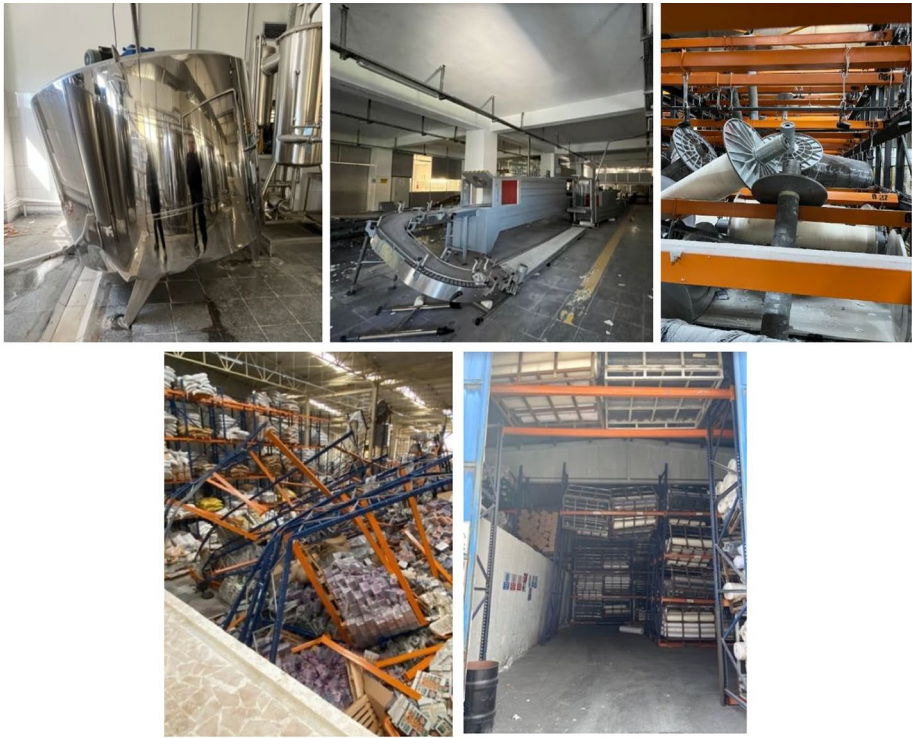
Furthermore, overloaded storage racks were detected in a chemical industry in Adana, where several racks badly bowed even at lower magnitudes of seismic accelerations (see Table 5). In addition, pipelines were seen often missing seismic connection details in several of the sites surveyed, causing them to break away from their connections or to slide entirely off the wall attachment. All of these findings indicate that losses may have been greatly minimized if modest but appropriate retrofit procedures (such as anchoring and bracing) had been implemented to decrease the risk of nonstructural seismic damage.

Fig. 15 Tipped over production equipment in a food processing plant in Antakya (top-left and middle); damage on a thread reel system in a textile factory in Dulkadiroglu (top-right); and buckled storage racks in a food depot in Antakya (bottom-left) and in a textile depot in Dulkadiroglu (bottom-right)

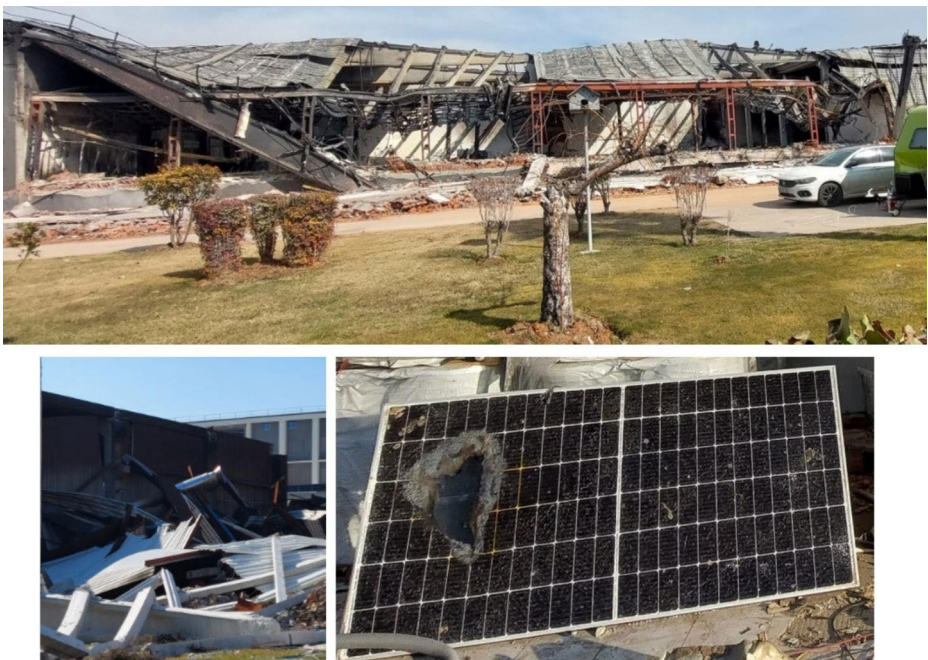
The 2023 Kahramanmaraş earthquake sequence was also a multi-hazard event, including fires following earthquakes (FFE). The reconnaissance team observed three obvious FFE cases in industrial facilities. The first one is a textile precast-RC framed factory, with an interior steel truss system to carry nonstructural equipment, near Kahramanmaraş International Airport. The factory following the FFE incident is seen in Fig. 17 (top), with the majority of the structure destroyed. According to the representative, the source of the incident was a probable spark of an electric arc during the first earthquake, which ignited the paint-based substances inside the facility. The fire lasted for hours and could not be extinguished immediately since water was ineffective in extinguishing the paint-based fire. While all steel components in Fig. 17 (top) seemed to be considerably bowed, precast RC roof components appeared to collapse mostly owing to pin failures at the ends, with some column failures also noted, most likely due to high bending demands at the base. Concrete elements are generally more resistant to fires, until the concrete cover spalls and heat spreads into the reinforcement inside (KCFD 1995; Chen et al. 2004). As a result, this fact shows how the heat was so extreme that it caused the facility to collapse completely under the FFE.

The second FFE example spotted by the reconnaissance team was a textile plant in Turkoglu OIZ, which experienced a similar roof collapse due to the fire that followed the earthquake. Figure 17 (bottom-left) shows the plant with dark-colored burnt building components and panels, which were most likely previously damaged by the earthquake, making them more vulnerable to FFE.

Fig. 17 Incidents of fires following earthquakes observed in Dulkadiroglu (top) and Turkoglu (bottom)
