Investigation of RC structure damages after February 6, 2023, Kahramanmaraş earthquake in the Hatay region

Talha Polat Doğan¹ · Hüseyin Kalkan¹ · Ömer Aldemir¹ · Murat Ayhan¹ · Meryem Böcek¹ · Özgür Anıl¹

Abstract

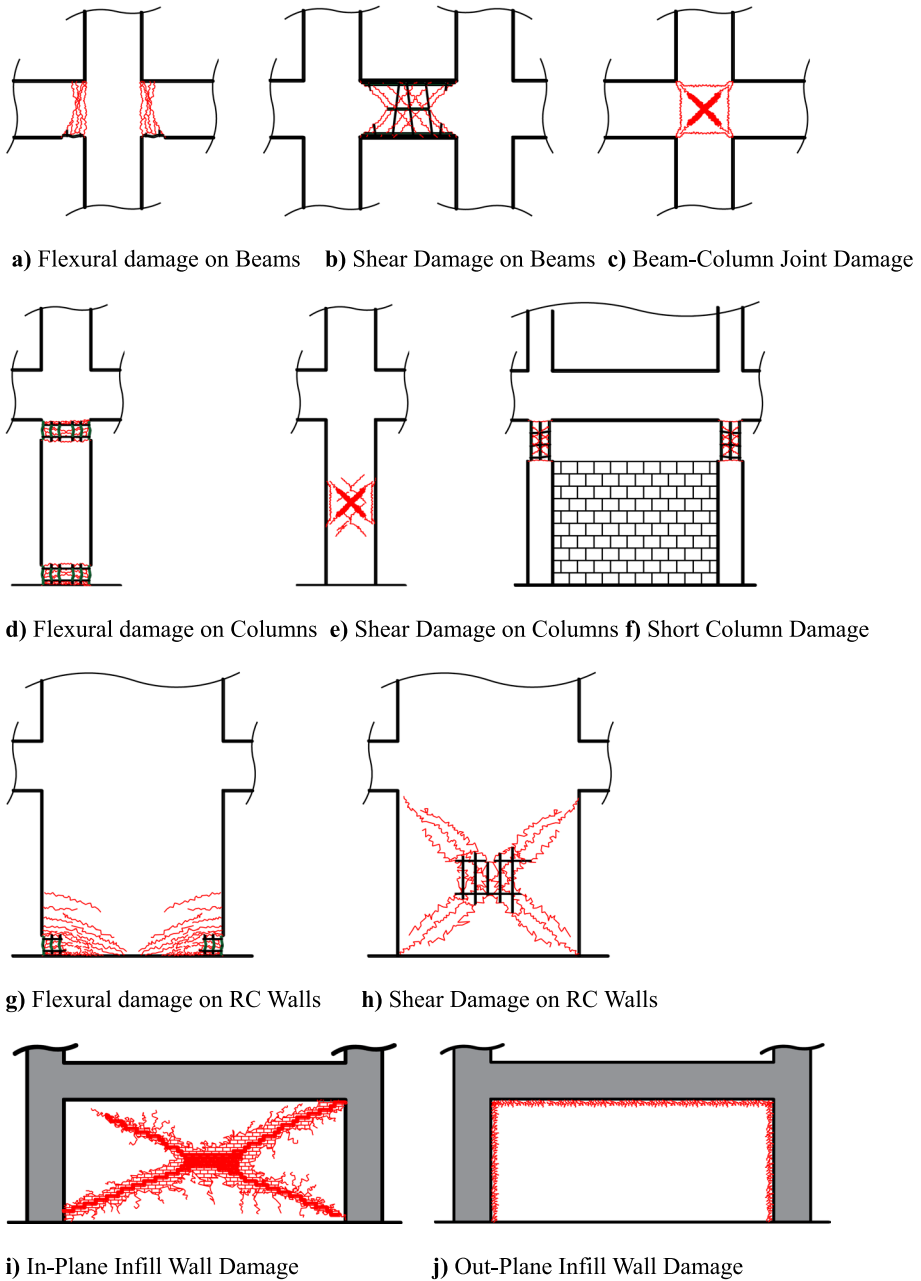
The observations conducted categorized seismic damages in buildings into structural and non-structural damages, as shown in Fig. 5. The buildings in the examined areas were generally constructed in compliance with modern earthquake regulations. Therefore, non-structural damages were minimal or nonexistent, and these types of damages were excluded from the scope of this article.

Fig. 5 Structural and non-structural damages

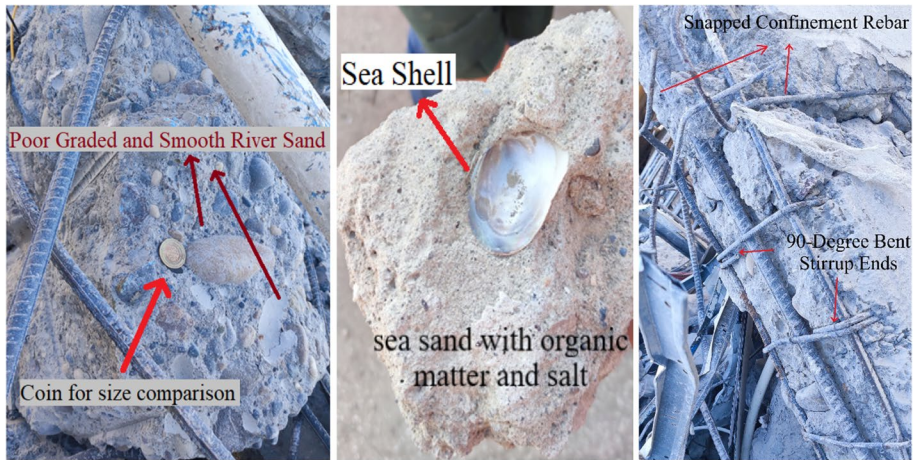
Fig. 6 Material based observed material and manufacturing defects

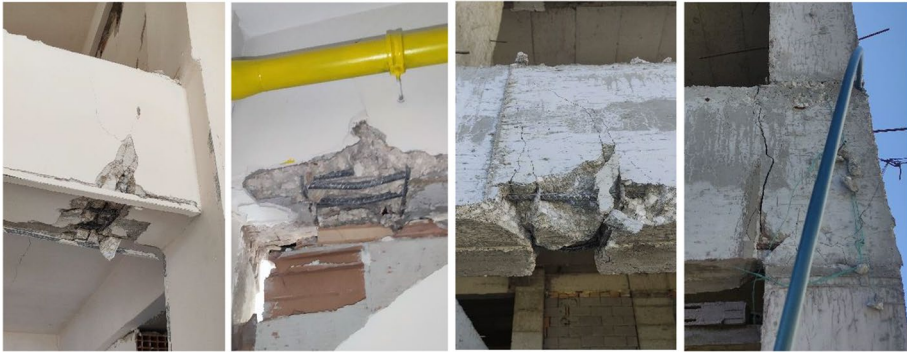
The observed damages in the examined buildings in the disaster-stricken area, as indicated in Table 2, suggest that they generally exhibited ductile behaviour. Among the majority of the intact buildings, flexural damages in beams, as shown in Fig. 8, were frequently observed. However, even in buildings that could be considered "new" shear damages in beams were frequently observed. This can be attributed to architectural reasons and the preference for short beams and diagonal axes in the structural system design, as well as the inadequate use of secondary beams and insufficient confinement, as illustrated in Fig. 9. As a result, shear damages in beams were often observed, even in buildings expected to demonstrate ductile behaviour.

Fig. 8 Flexural damages on beams

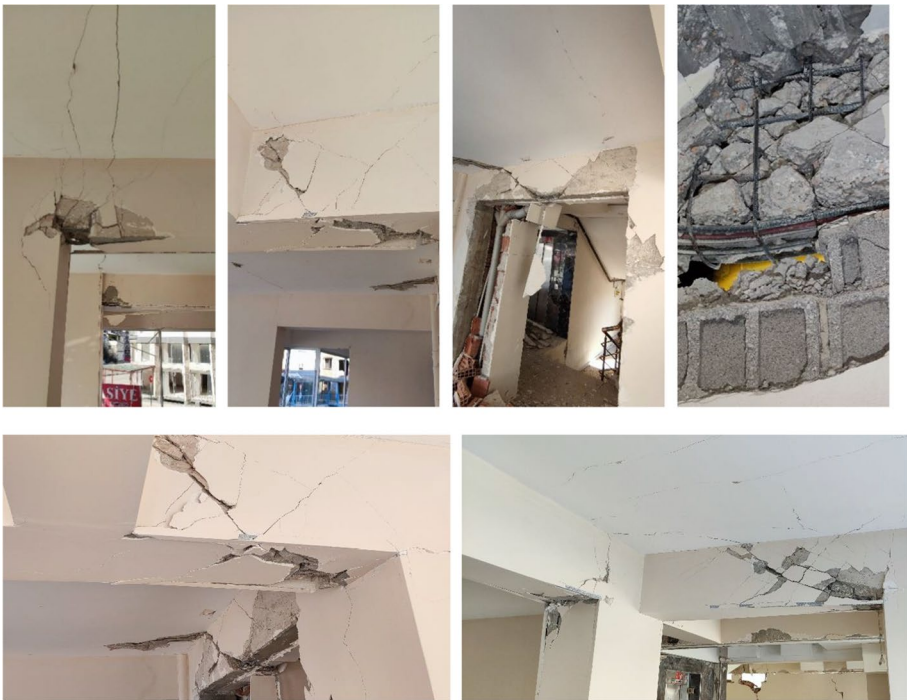
Fig. 9 Shear damages on beams

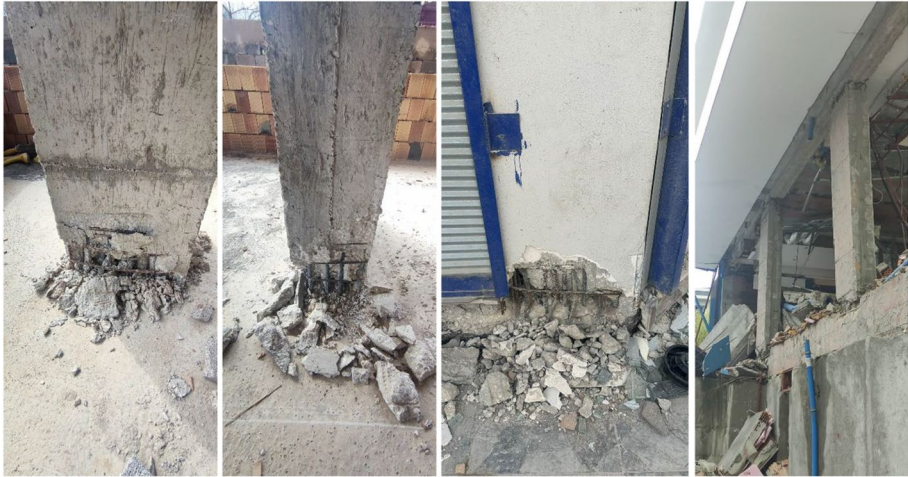
Especially in buildings that have suffered severe damage but have not collapsed partially or completely, plastic hinges have formed at the lower ends of the ground floor columns and sometimes at both ends, as shown in Fig. 10, transitioning the structure

Fig. 10 Flexural damage on columns

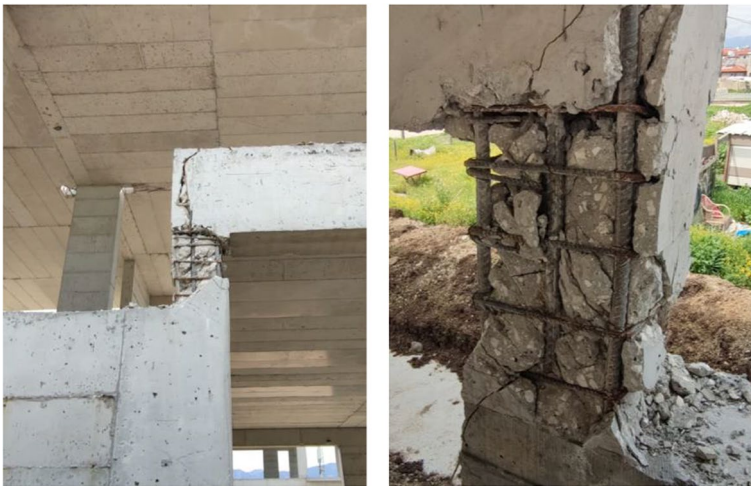
Unlike the bending-damaged columns, in short columns where there is a sufficient amount of longitudinal and shear reinforcement against bending effects, sudden and brittle failure known as short column failure occurs due to errors based on architectural or structural design. Among the examined buildings, in the buildings where this type of damage, as shown in Fig. 11, was observed, almost no other types of damage were found. However, the shear-damaged columns shown in Fig. 12 have only suffered shear damage due to insufficient confinement. These brittle shear failures are generally observed in the ground floors of buildings. Although these buildings have been able to ensure life safety despite having these errors, the reasons for the collapse of the buildings that have collapsed are also related to these damages.

Fig. 11 Short column damage

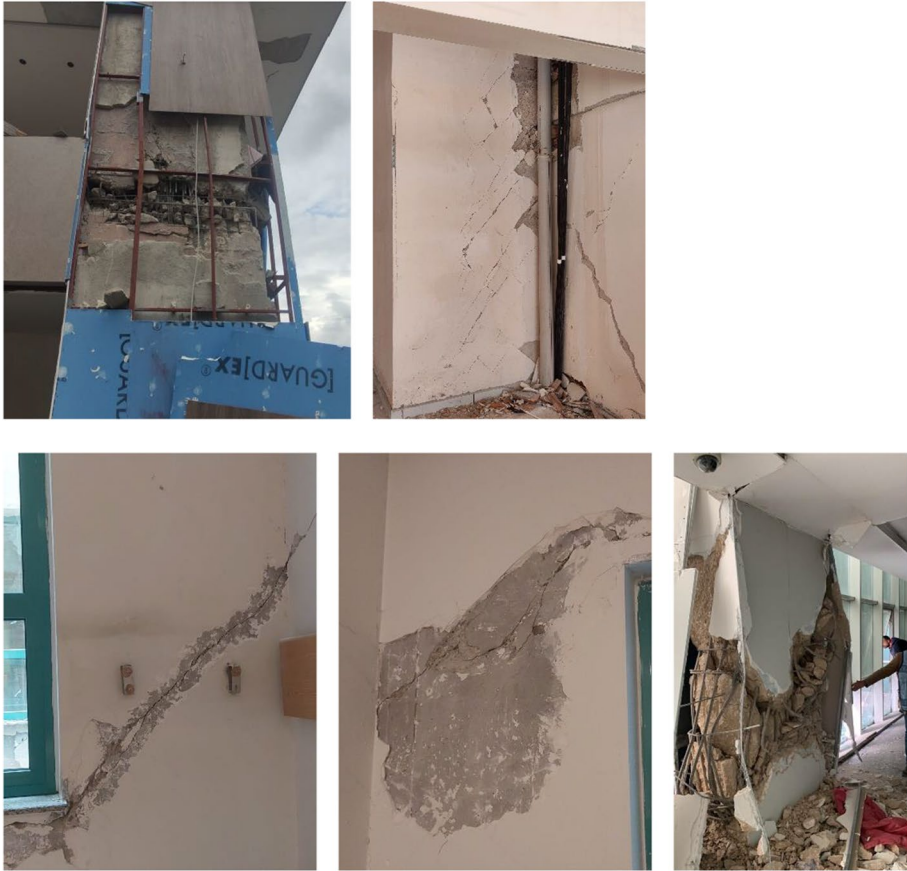
Fig. 12 Shear damage on columns

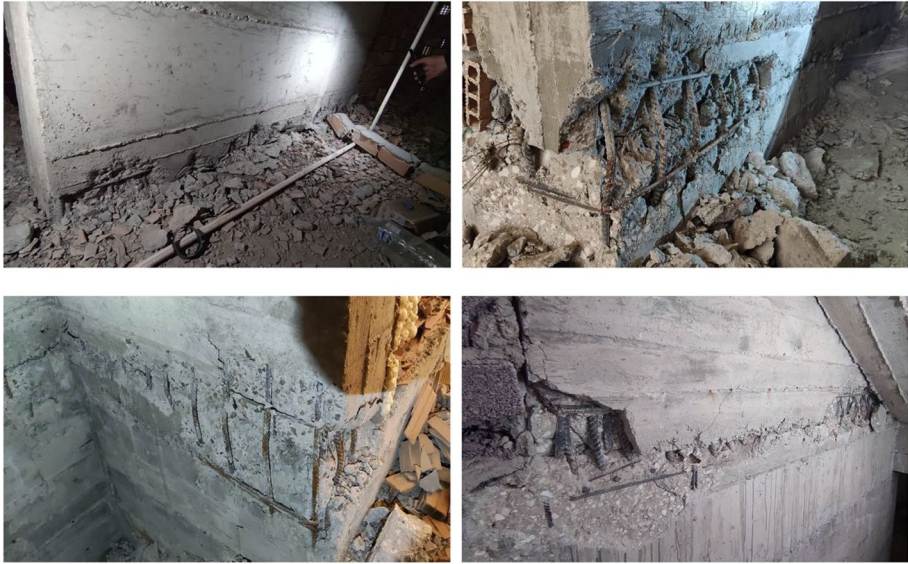
When considering the overall structural systems of the examined buildings, it is observed that reinforced concrete shear walls experience bending or shear damage according to their placement in the floor plans. The provided Fig. 13 illustrates shear walls with flexural damage, which are generally located on the exterior axes of the buildings' floor plans. On the other hand, Fig. 14 displays shear walls with shear damage, typically found on the interior axes of the RC walls. In all damaged RC walls, it has been determined that the confinement reinforcement application was insufficient.

Fig. 13 Flexural damage on RC walls

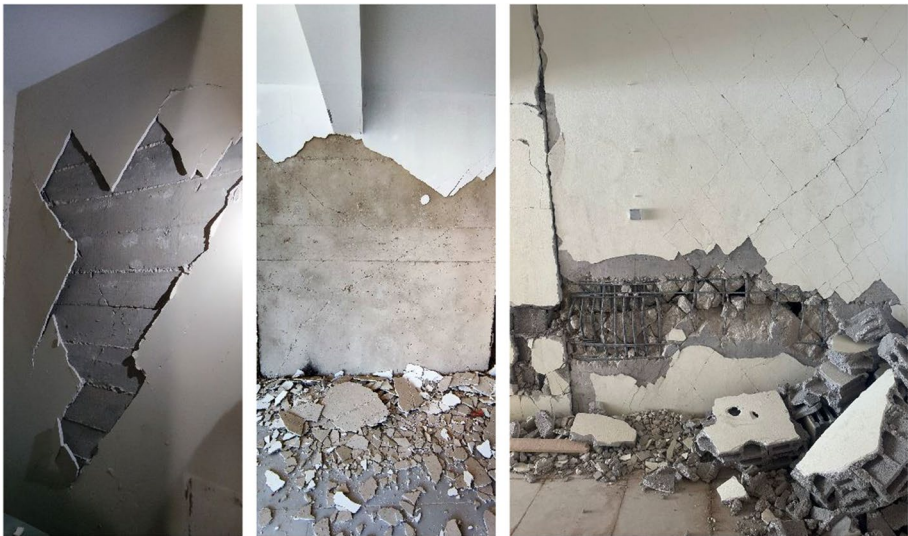
Fig. 14 Shear damage on RC walls

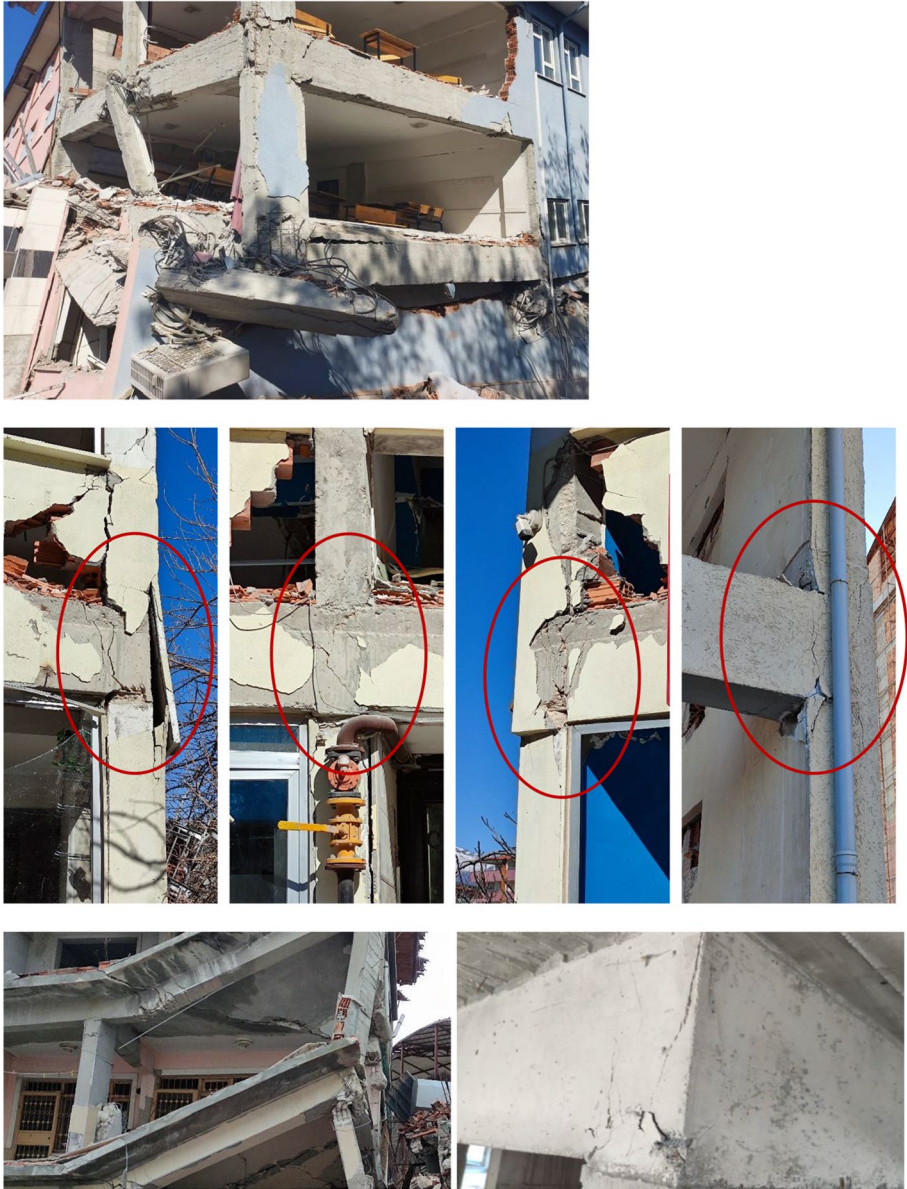
During the field visits, it was observed that the collapsed buildings typically experienced damage at the column-beam connection regions, causing the columns to detach from the frame. The damage in this region was due to shear forces, resulting in brittle failure and the formation of a hinge at the node, leading to the collapse of the building as it transitioned into a mechanism state. In the undamaged buildings as well, damage was observed at the connection regions, as shown in Fig. 15. The connection region damage was predominantly found on the exterior axes of the buildings. In reinforced concrete structures, this region plays a significant role in achieving the intended performance of the building. Among the examined buildings, there is a considerable number of structures that have adequate confinement reinforcement in columns and beams

according to TSC2007 and TBEC2018, but lack sufficient confinement at the column-beam connections, resulting in shear damage in these regions.

Fig.15 Shear damage on beam-column joint

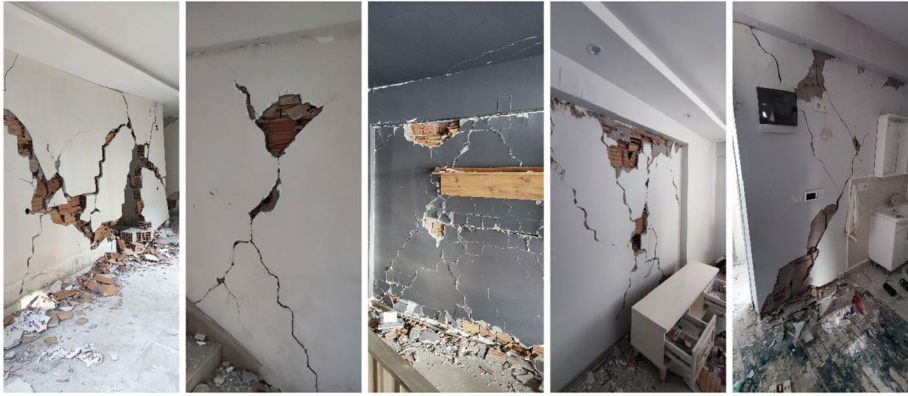
Frequently overlooked in structural system designs, but significantly contributing to the transfer of lateral forces during an earthquake, infill walls have also been observed to sustain damage. Figure 16 illustrates infill walls damaged under in-plane seismic loads. In the earthquake-affected region, it was often observed that during the construction of infill walls, they were not connected to the vertical load-bearing elements on both sides,

Fig. 16 In-plane infill wall damages

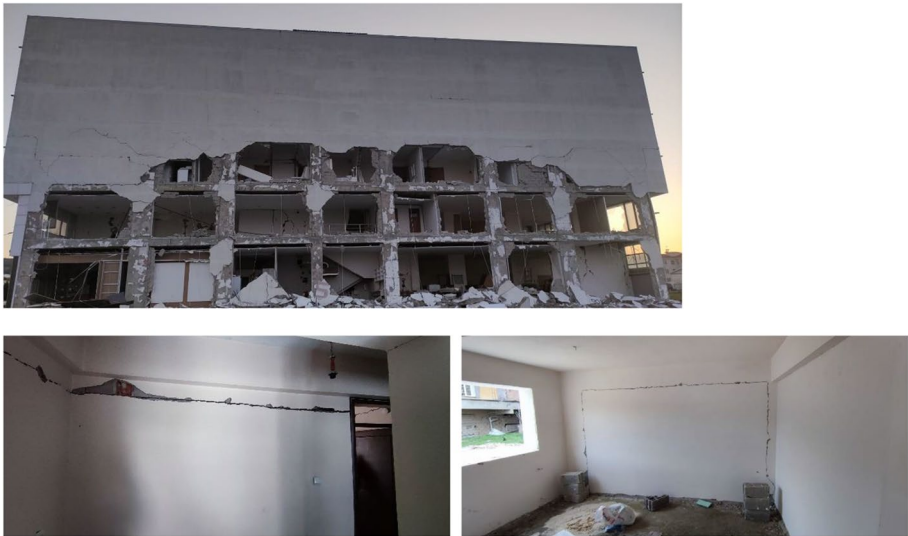
and no compression was applied to the wall under the beam or slab above it, leading to premature failure, out-of-plane damage, or toppling. Figure 17 provides an example of out-of-plane damage illustrating this situation.

Fig. 17 Out-plane infill wall damages
