## 2022 Düzce, Türkiye earthquake: advances in the past 2 decades, lessons learned, and future projections

### Abstract

In the year 1999, two devastating earthquakes ( $M_w$  7.4 Kocaeli earthquake in August and  $M_w$  7.2 Düzce earthquake in November) occurred in Northwest Türkiye. These two earthquakes led to a very large number of casualties and building collapses. When the 1999 earthquakes occurred, most of the structures in the earthquake-impacted region were not designed according to modern seismic design codes. During the 25 years following those earthquakes, there have been significant advances in building construction in the light of earthquake engineering, including adequate seismic codes, new regulations, and effective code enforcement in the earthquake impacted region. These advances have been reflected in the construction of new structures in the region and the retrofitting of existing ones. As a result, 70–80% of the current building stock in Düzce was designed, constructed, or retrofitted after the 1999 earthquakes. Almost 23 years later, in 2022, an  $M_w$  6.1 earthquake occurred in Düzce, with ground shaking close to the seismic design code life safety performa

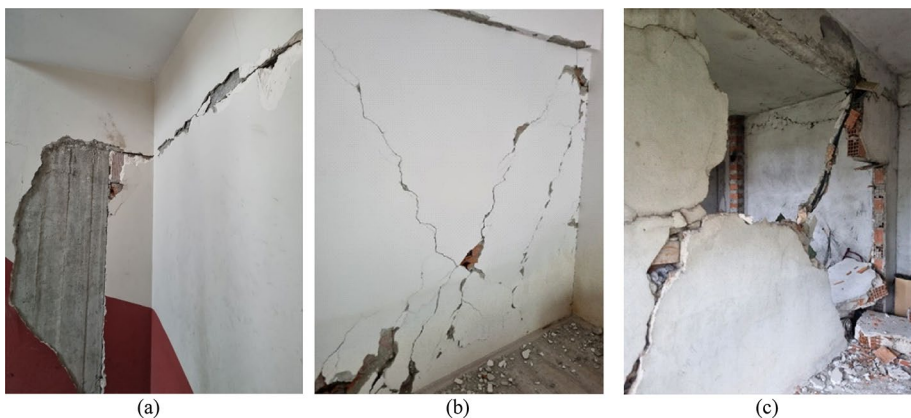
**Fig. 5** Examples of **a** damage at the infill wall/RC frame interface, **b** diagonal cracks in infill walls, and **c** out-of-plane damage of infill walls

For residential buildings, the reported damage was typically localized in the infill walls in the form of in-plane and out-of-plane separations or failures and damage to non-structural components. Figure 5 shows examples of wall separation from the RC frame and diagonal shear failure of infill walls, which were mainly caused by in-plane loading. This type of

damage and diagonal strut in the masonry infill is due to the different deformation patterns of the much stiffer infill wall and the surrounding frame. The first phase of this behavior is cracking at the perimeter of the infill, leading to its separation from the frame (Fig. 5a), which can be followed by damage introduced to the frame members due to the forces transferred by the diagonal strut (Fig. 5b). This separation also makes the infill wall vulnerable to the seismic load perpendicular to the wall (out-of-plane loading). In some cases, in-plane damage weakened the out-of-plane capacity of infill walls, resulting in their out-of-plane failure and/or collapse (Fig. 5c). This kind of failure of infill walls due to the interaction of in-plane and out-of-plane loading has been also observed in other earthquakes (Braga et al. 2011; Marinković et al. 2022) and jeopardizing the escape routes (Lu et al. 2020). In-plane/out-of-plane interaction has been investigated both experimentally (Butenweg et al. 2019) and numerically (Kadysiewski and Mosalam 2009; Mosalam and Günay 2015), with main conclusions that its effects on the reduction of infill wall capacity has to be taken into account.

It is noted that these common types of infill damage documented in Fig. 5 were not major and limited as presented by the ratio of damaged buildings in Table 5. Therefore the 2022 Düzce earthquake is an earthquake where the infill walls contributed to the strength of the buildings in the form of overstrength. The effect of this overstrength on the dynamic response is discussed in the Numerical Simulations section.

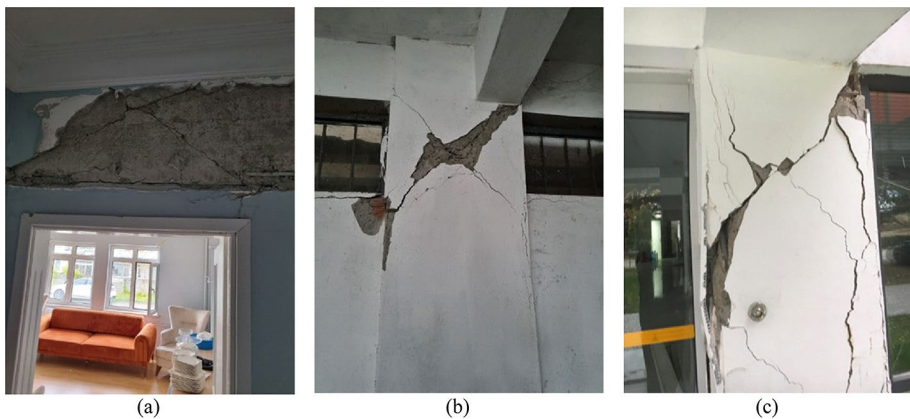
**Fig. 6** Examples of **a** RC beam damage including diagonal cracks, **b** short column damage, and **c** column damage including diagonal cracks

Some representative examples of observed damage in RC beams and columns are shown in Figs. 6. Shear cracks in beams likely occurred due to insufficient spacing and detailing of stirrups. Inadequate reinforcement detailing where bent-up longitudinal bars are often used to provide shear resistance to gravity loads as well as negative moment resistance at supports can be one of the reasons for observed cracks in beams. This was also the case in the 1999 Kocaeli earthquake (Sezen et al. 2000). As mentioned earlier, the majority of the buildings in Düzce are either new or retrofitted buildings, however there is still a small percentage of buildings which experienced these issues and need to be repaired and retrofitted.

Figure 6b and c show typical column shear failures. A “short column” effect (Fig. 6b) occurred in the case of non-structural partial-height masonry infills, when infill walls were constructed not to the full height of the column due to openings, e.g., windows. The infill wall caused a decrease of the effective column height and the corresponding increase of shear forces in the portion of the column which is not in direct contact with the infill.

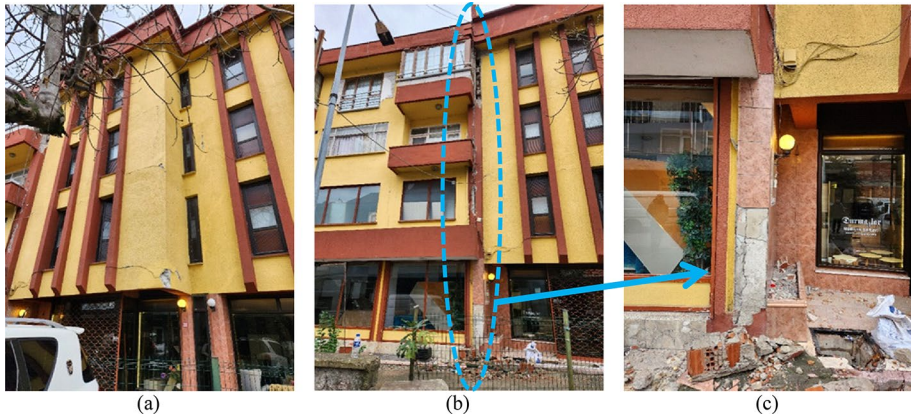
**Fig. 7** Damage to an RC apartment building due to pounding

Several buildings suffered minor damage in the earthquake due to pounding, which was caused by insufficient size or absence of seismic gaps. Figure 7a shows a four-story RC building constructed in 1988. Due to insufficient gap between the two buildings, pounding of the neighboring structures caused damage in the RC columns over the entire height of both buildings, including the parapet wall of the building located on the left in Fig. 7b.

The building shown in Fig. 7a also experienced infill wall damage in the second and third stories above the overhangs.

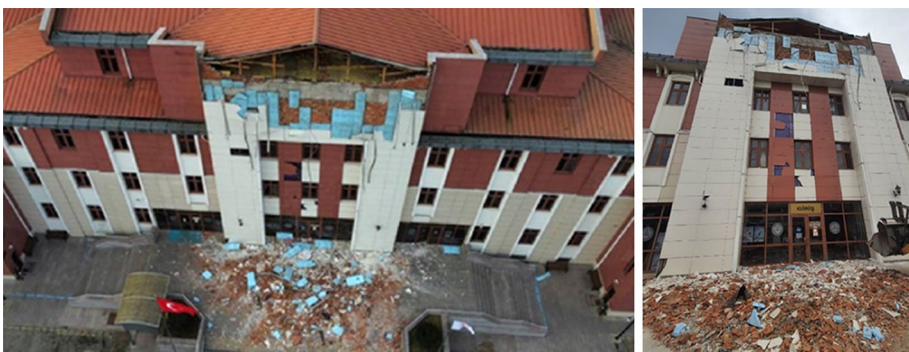
**Fig. 8** Facade damage and gable collapse in the Düzce courthouse (Sources: Deutsche Welle (2022) (left), Aydın Demir (right))

No significant structural damage was observed or reported in the region's government buildings, schools, and hospitals, other than the damage in non-structural elements including infill walls, facades, etc. An example of damage to a government building is provided in Fig. 8. The Düzce courthouse was heavily damaged during the two 1999 earthquakes and therefore demolished 23 years ago. The construction of the new courthouse started in 2006 and was completed in 2008. The façade, including the gable end of the roof, was damaged in the November 23, 2022 earthquake (see Fig. 8). Broken façade materials were a falling hazard near the entrance and could have led to fatalities or injuries if the earthquake did not occur at 4:08 am when no one was in front of the building. This is a reminder that the non-structural component failures not only result in issues regarding functionality or economic loss, but they can lead to injuries or fatalities. Therefore, care should be exercised while designing the non-structural elements, such as façades or suspended ceilings.

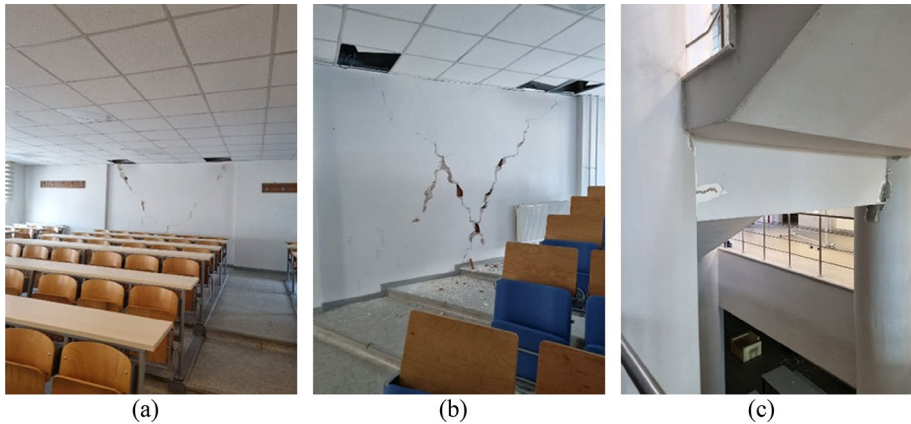
**Fig. 9** Damage to infill walls and stairs in a school in Düzce

Figure 9 shows representative examples of observed damage in school buildings. Typical damage in these multi-story RC structures with unreinforced masonry infill walls include: i) diagonal shear cracks in infill walls and separation from the surrounding beam-column frame (Fig. 9a and b), ii) cracks in the staircases (Fig. 9c), and iii) other non-structural damage including damage to suspended ceilings (Fig. 9b).

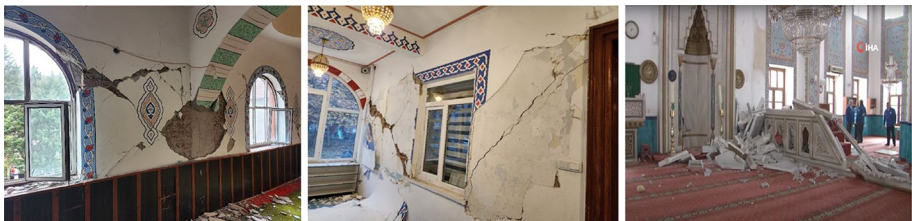
**Fig. 10** Damage on the dome (left) and walls (middle) of Kiremitoğlu mosque, and damage to the interior of Düzce Cedidiye mosque (Anadolu Ajansı 2022)

The November 23, 2022 Düzce earthquake caused substantial damage in multiple mosques, including Kiremitoğlu Mosque in downtown Düzce, Sarıdere Village Mosque in Gölyaka, Cedidiye Mosque in Düzce, Ayşe Metin Neighborhood Mosque in Cumayeri, Yaka Neighborhood Mosque in Cumayeri, and Saz Village in Kaynaşlı. Kiremitoğlu Mosque in downtown Düzce was built in 1968 and includes unreinforced brick masonry load-bearing walls with many window openings. The mosque's central dome experienced a vertical displacement of approximately 100 mm. Major diagonal cracks were observed on the entrance

walls around the windows, as shown in Fig. 10. Figure 10c shows damage to the pulpit inside Düzce Cedidiye mosque. During the November 12, 1999 earthquake two minarets of this mosque collapsed and rebuilt afterwards.

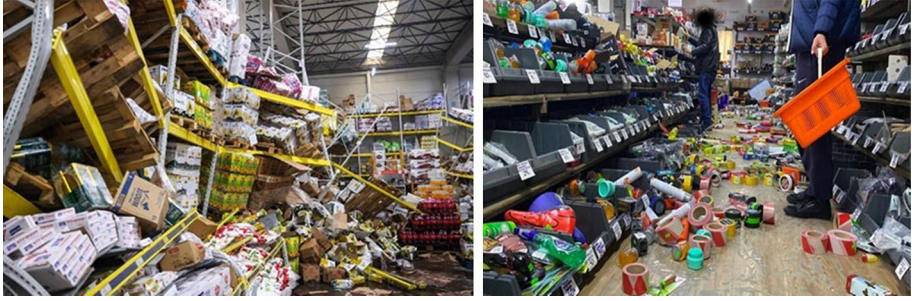
**Fig. 11** Property damage in stores (Sources: Daily Sabah (2022) (left) and Tasdemir (2022) (right))

A significant loss was reported due to non-structural damage in the commercial areas of Gölyaka and Düzce. In most cases, shelves collapsed, or items fell in the stores during the strong shaking as shown in Fig. 11. Although the commercial buildings did not experience severe structural damage during the earthquake, the economic loss due to damage to the assets, goods, and products appeared to be relatively high in certain cases, such as the glass manufacturing factory in Fig. 12. In this factory, significant losses occurred as the vertical stacks of ready-to-ship glass products were shattered. Although there was no reported structural damage in some shops and stores, due to non-structural damage in the area, they had to be closed for a period of time until cleanup was complete.

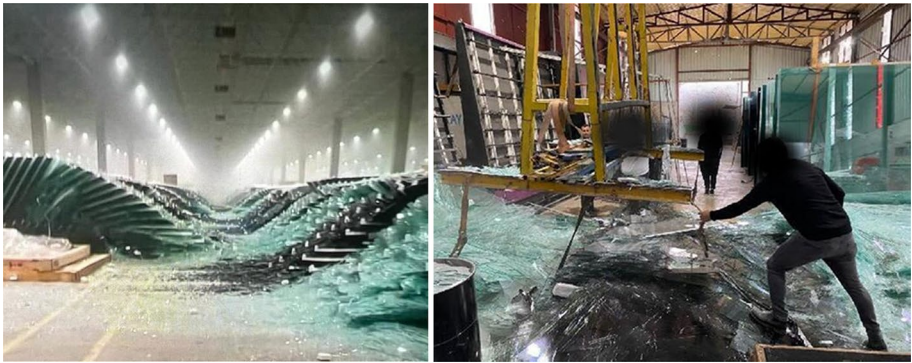
**Fig. 12** Damage in a glass manufacturing facility (Sources: Ensonhaber (2022) (left) and DHA (2022) (right))
