SAFETY, DIAGNOSIS, AND REPAIR

EXPERIENCE GAINED IN APPLIED SYSTEMS

ANALYSIS OF DAMAGED LOAD-BEARING

STRUCTURES OF PROCESS EQUIPMENT

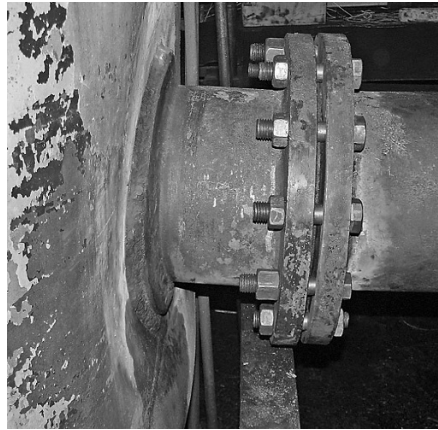
Fig. 2. Depression in region of inlet pipe of filled tank of press.

As a result of failure of the slide valve under the effect of a hydraulic impact in the main line, the inlet pipe of the vessel experiences a failure load, as a result of which the inlet pipe zone of the shell is pressed into the vessel accompanied by the formation of a depression in the shell exhibiting a complex configuration with overall dimensions of the depression 840 × 750 mm and maximum depth 58 mm (Fig. 2).

The following conclusions may be made on the basis of the results. As a consequence of the multidirectional nature of the damage and working loads, the particular damage has led to an insignificant decrease in the bearing capacity, which is partially compensated by the strength factor assumed in the design, as a consequence of which the design collapsing pressure exceeds the nominal working pressure of 0.8 MPa. Thus, the damage to the shell that has arisen with the damaging effect on the inlet pipe in the range of forces being considered here may be assumed to be conditionally safe. The risks associated with the use of the damaged structure must be reduced based on an additional analysis of the remaining life of the damaged structure [6, 7].

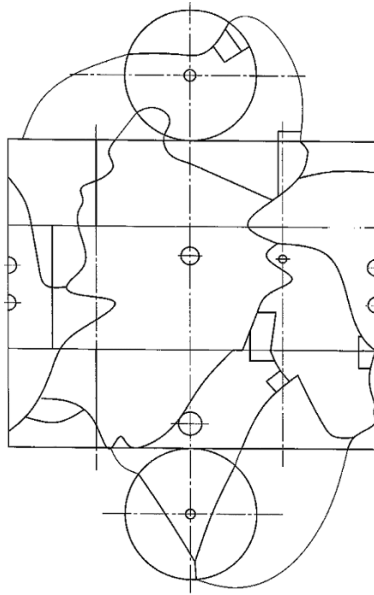
Fig. 3 Development of receiver with fragments found after the failure.

Visual inspection and analysis of the fragments (Fig. 3) showed that failure occurred according to a brittle mechanism accompanied by characteristic morphological failure surfaces.

A broken mechanical technological defect in the form of incomplete fusion, or discontinuity 150 mm in length and 14 mm wide, was discovered in the welded joint between the body of the receiver and the port entrance. The nature of the failure surfaces near the site of incomplete fusion suggests that the defect is the source of the failure. A computational analysis of the risk of the defect with the use of numerical simulation based on the method of finite analysis was undertaken to verify the hypothesis.

Thus, the results of the calculations confirmed that a technological structure defect in the form of incomplete fusion in the welded joint of the body and the port entrance is the source of the failure of the receiver. Redistribution of the stress fields near the site of incomplete fusion as a consequence of temperature stresses caused by a variation of the ambient temperature on the day of the failure was the most likely event, i.e., the actual initiator of the failure of the vessel.
