Post-Earthquake Fire Performance of Buildings: Summary of a Large-Scale Experiment and Conceptual Framework for Integrated Performance-Based Seismic and Fire Design

*Brian J. Meacham**, Department of Fire Protection Engineering, Worcester Polytechnic Institute, 100 Institute Road, Worcester, MA 01609, USA

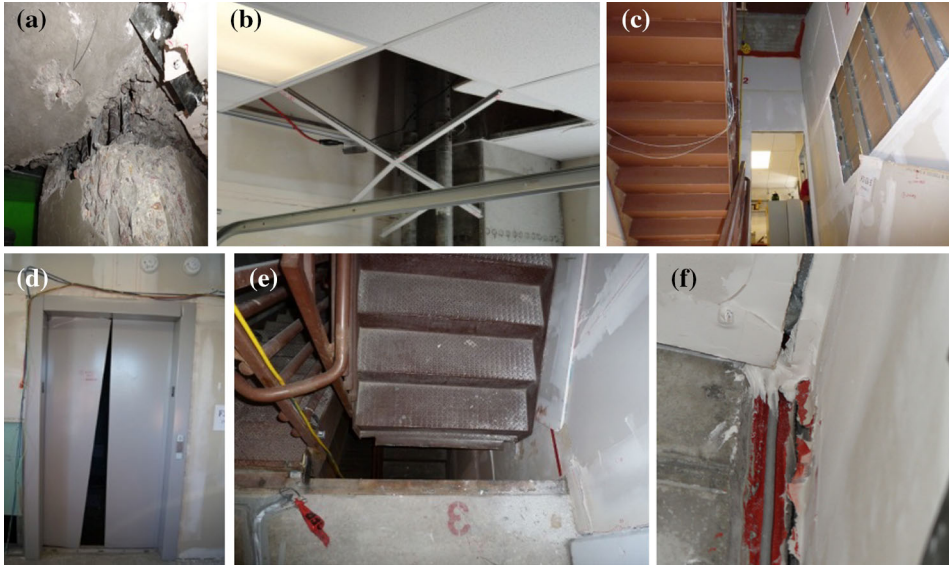
The largest ground motions (FB-5 and FB-6) induced damage to nearly every structural and nonstructural system in the test specimen. Damage to the structural system included densely concentrated cracking in the slabs around columns resulting in punching shear failure, concrete spalling at the base of columns and the ends of beams where the large rotations occurred, as well as fractured and yielded longitudinal rebar in the Floor 2 and Floor 3 frame beams, which required several

floors to be shored up prior to fire testing [20, 24, 25, 28]. Representative damage is shown in Figure 6a. Such damage to the structural systems has obvious concerns for stability of a structure following an earthquake. However, the earthquake-damaged components are more also susceptible to failure in a post-earthquake fire situation. Systems with spalled concrete, exposed or fractured rebar will not have the intended fire resistance and performance during a fire, if such damage was not considered.

Damage to interior partition systems varied widely, with gypsum wallboard being shaken off the walls in some cases, and only cracking and minor openings in joints observed in other locations [20, 23, 25]. Doors in partition walls were in some cases jammed shut, while in others were not able to be closed. Assemblies moving OOP with respect to the direction of motion generally suffered greater damage. The various ceiling systems also exhibited a range of performance, with damage to supports and ceiling tiles on some floors and little damage to systems on others. Damage to interior partitions and ceilings is of particular relevance to fire safety performance, since such systems are integral to fire compartmentation and egress systems. If partition walls and ceiling systems are breached, gaps will allow air to enter compartments, which can enhance burning. Perhaps more importantly the gaps will allow for the spread of smoke and fire, defeating the intended means of protection (compartmentation) and resulting in untenable conditions to develop remote from the fire location. Representative damage is illustrated in Figure 6b.

Figure 6. Examples of damage following FB-6 (a) beam-column connection failure on Floor 2, (b) ceiling damage on Floor 1, (c) loss of gypsum wallboard in stairwell approaching Floor 2, (d) distorted elevator door on Floor 3, (e) stair detached from landing at Floor 3, and (f) gaps in ceiling-wall and wall-column joints on Floor 3.

Testing indicated that for the smaller ground motions (all BI and FB-1 to FB-4), little increase in leakage area resulted. However, as a result of FB-5, the total leakage area in SBR increased by almost 300% as compared with pre-motion baseline, and by almost 900% following FB-6. The type of damage included gaps at joints of up to 12 mm (0.5 in), as illustrated in Figure 6f. While this particular test series was limited in scope due to time and resource constraints, it illustrates the extent of damage which can occur for construction of this type. Significantly larger increases in leakage area could be expected with other systems, such as the drop-in ceiling system installed on Floors 1 and 2 of the test specimen, which had significant failures (e.g., see Figure 6b). Details can be found in [23, 26, 28].

The elevator doors on Floors 2 and 3 were damaged during FB-6, resulting in a triangular-shaped opening on each level of about 0.3 m², rendering it unusable and creating an unprotected opening between floors via the elevator shaft [20, 23, 25, 28]. The stairs became disconnected from the landings at Floors 3 and 4, with handrail weld fractures in some locations. Damage to elevators and stairs have obvious implications for occupant egress and emergency responder access. If a building fire performance analysis does not consider the potential for these systems as unavailable during a post-earthquake fire, egress times and emergency response times can be significantly underestimated, which could have a significant

impact on the prediction of occupant and emergency responder safety. Damage to the elevator door and stairs is shown in Figure 6d, e.

In general, firestop systems worked well. Examples are shown in Figure 10. The only observed problems were associated with fire sealants and similar systems, design for static joints (e.g., wall joints), which moved during the earthquake motion tests (e.g., see Figure 6f).

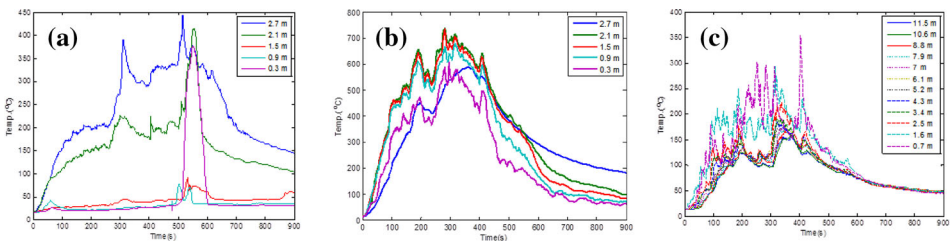
With respect to compartmentation, the primary focus were the SBR and LBR, which were outfit as fire resistive compartments, with fire-rated wall and ceiling assemblies. Following the FB-6 motion test, a gap of about 25 mm had opened along the joint where the separating wall between the SBR and the LBR connected to the exterior wall on the North side. During the LBR-2 fire test (no ventilation openings other than motion-induced gaps: about a 1000 kW fire), smoke and flame was observed extending through this gap from the LBR into to SBR. Fire spread into SBR did not occur due to brevity of the test and the lack of fuel items being present in the SBR. However, given the observed flame extension and measured gas temperatures near the gap in excess of 350°C (662°F) for more than 1 min (Figure 9a), easily ignitable fuels in the vicinity could have been ignited if present [23].

Figure 9. Flame extension from LBR to SBR (a) and temperature profile along gap between LBR and SBR (b) during LBR-2 fire test [23].

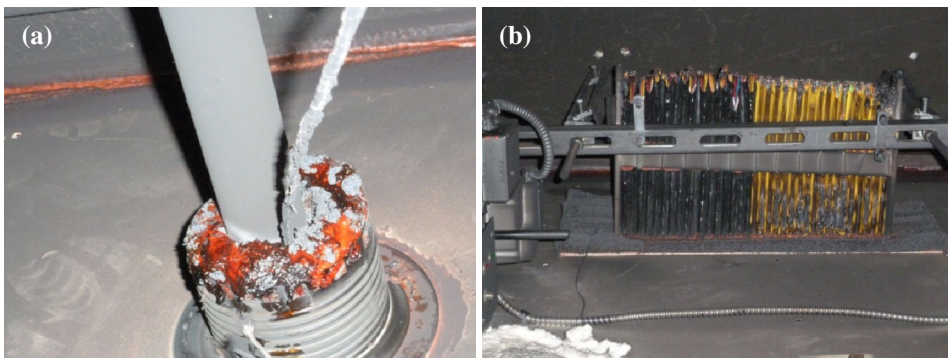
Figure 10. Horizontal pipe firestop in corridor (a) and Cable tray firestop in corridor (b) following ES fire test [23].

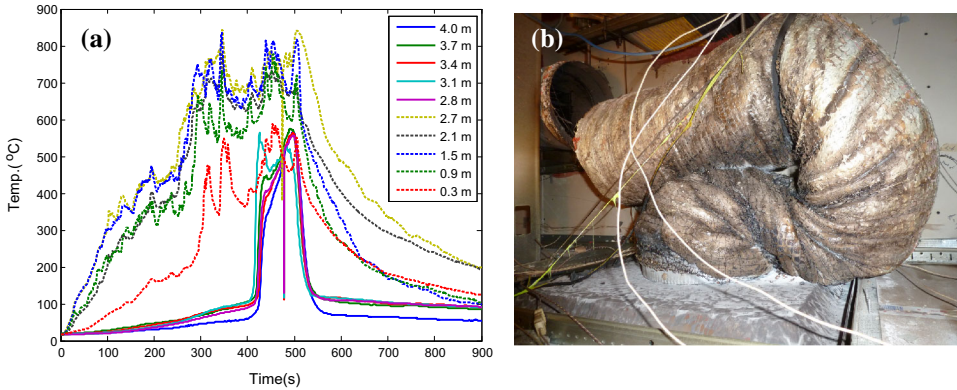
Various components of the mock heating, ventilation and air-condition (HVAC) system were assessed during. In the LBR-2 fire test, in which the upper gas temperature reached over 800°C (1472°F), the flexible duct connecting the ceiling diffuser in LBR to the metal duct and damper at the corridor partition wall was ruptured during the test. The temperature profile and damaged duct are shown in Figure 11. The legend in Figure 11a indicates the heights above the floor surface, with solid and dotted lines for the spaces above and below the ceiling, respectively. Despite the good performance of the fire-rated ceiling assembly during the ground motion tests and the LBR-2 fire test, the failure of the flexible duct during the fire test allowed hot gases into the plenum space.

Figure 11. Temperature increase in the space above LBR ceiling (a) and flexible duct rupture (b) [27].
