Failures Associated with the 2004 Mindulle Typhoon in Taiwan

Jieh-Jiuh Wang · Hoe I. Ling · Andrew Smyth

Abstract On July 2, 2004, a 2000-km southwest air current following the Mindulle Typhoon caused serious damages to infrastructures in Taiwan. The disaster resulted in extensive geological and structural failures, mainly as a result of debris flow. Some of the sites were subjected to types of repeated failures compared to previous typhoons. Some structural failures were attributed to geotechnical failures. It is decided to document and identify causes for some of these major failures triggered by typhoons. The case history showed significant implications to future disaster prevention and management works. New challenges were posed in geotechnical engineering design in encountering rainfall-induced failures.

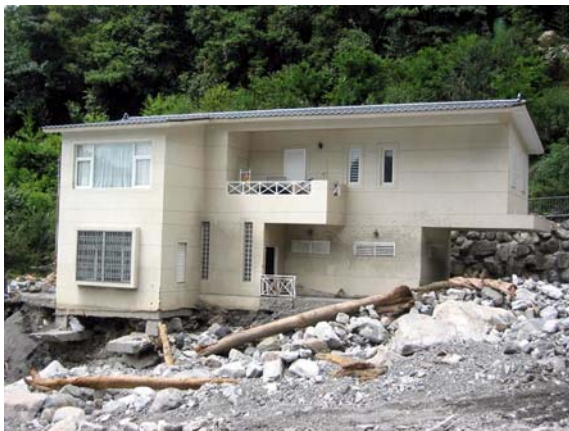
Fig. 4 Failure of foundation

Foundation failure (Fig. 4): There were many factors that led to the failure of foundations, which accordingly resulted in damage of the superstructures. For instance, foundations were vulnerable to landslides and debris flows. Due to the increase in excess pore pressure through rainfall infiltration, the strength of the soil at the foundation decreased. The large and uneven settlements resulted from the loss of bearing capacity. The extent of damage depended on the types of soil and locations.

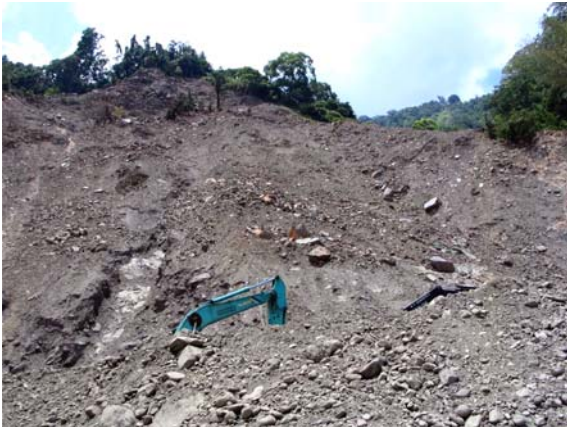
- Translational landslide (Fig. 5): The slides of the dip slope, often occurring among layers of rocks, have caused many tragedies in recent years, especially after heavy downpours. In these cases, the translational landslides were very common since the rainfall was not only torrential in intensity but also lasted for extended period of time.
- Rotational landslide (Fig. 6): This failure involved large scale of soil movement. The

Fig. 5 Translational landslide

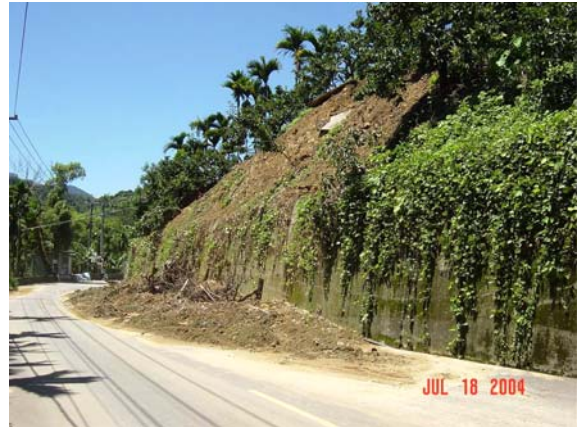
Fig. 7 Surficial slope failure

- Surficial Failures (Fig. 7): Numerous small-scale slope surface failures due to rainfall were seen. These failures were shallow and typically left unrepaired. Exposure of such failures may lead to large-scale failures with time.
- Debris Flow (Fig. 8): The massive mixture of solids and water moved down the streams as viscous fluid. The debris may be very dense, so flows occurred more slowly than water. It is perceived that debris flow is a destructive disaster in Taiwan since there are now up to 1420-documented potential debris flow areas.
- Rock Fall (Fig. 9): The downward movement of rocks that fell off after separating from the

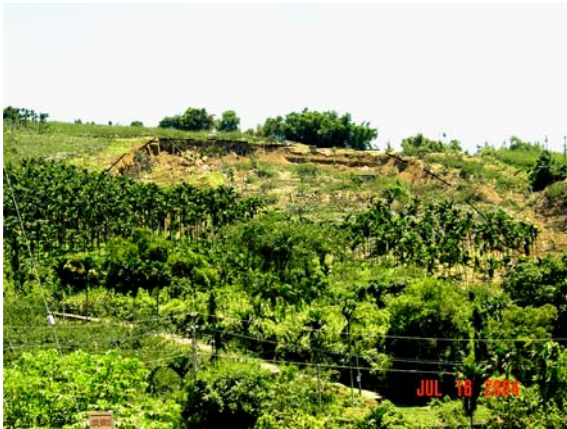
Fig. 6 Rotational landslide

failure as seen in this particular site may lead to catastrophic failure in the events of future typhoons.

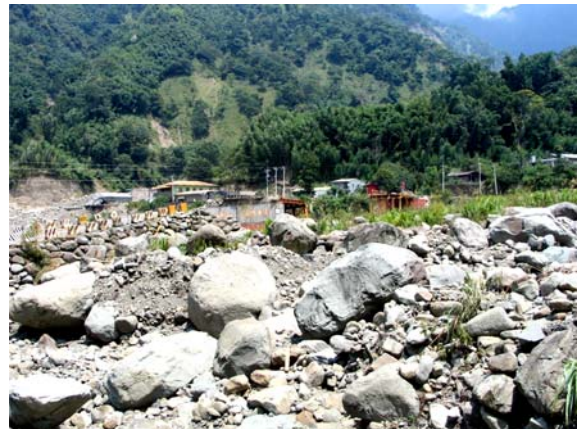
Fig. 8 Debris flow

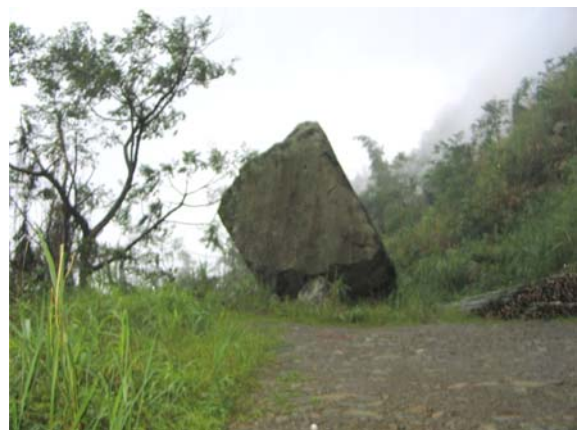
Fig. 9 Rock fall

bedrock. Geological structures in Taiwan are considered young and thus have a high risk of rock falls, and possibly providing sufficient sources of debris flow as they break down and disintegrate. Many near-vertical rock slopes that are susceptible to different types of failures were observed along the major roadways. (Fig. 10)

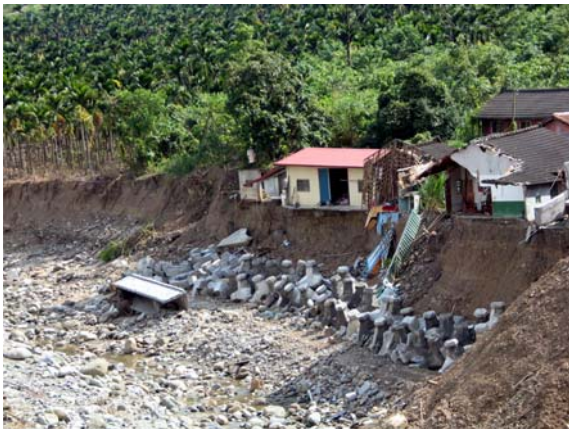
1. **Erosion:** The main factors of flow that affected erosion included the discharge, flow rate, and sections of the channel. After the Mindulle typhoon, heavy rainfall raised the water level rapidly, and then erosion accompanied inasmuch as the soaring flow rate. Erosion increased the angle of the slope to a critical value, while the shear resistance of soil was also reduced in the presence of water flow, thus created unstable slope. The soil strength was reduced and thus the

Fig. 10 Erosion increased the slope angle to critical conditions

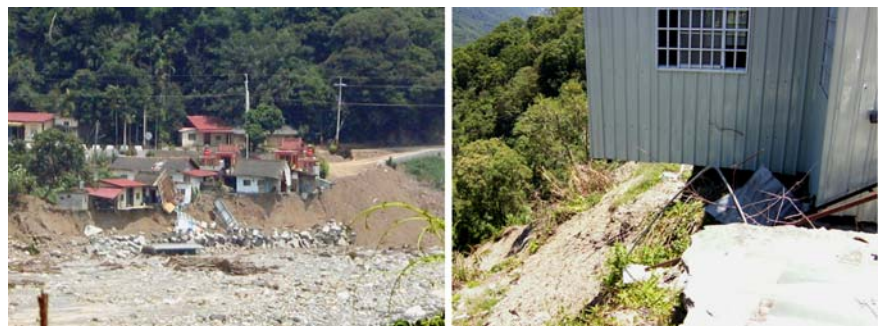
Fig. 11 Scouring and failure of foundations

factor of safety of the slope decreased drastically. Thus, the buildings were washed away by debris flows (Fig. 5), the slope roots were washed out (Figs. 11 and 12), and the roads were destroyed (Fig. 12).

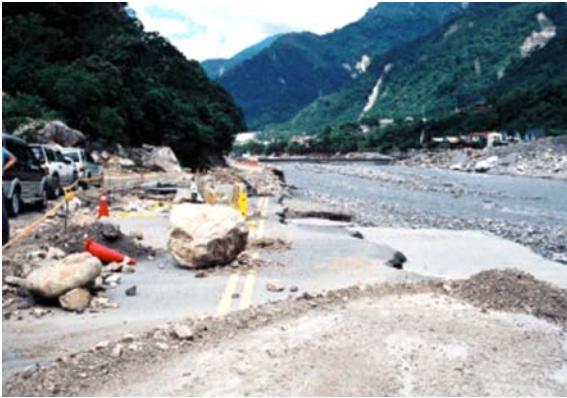
2. **Sediment Deposition:** The flow rate determines the shifting capability of sediments. The distribution of the flow rates varies with depth. Even though the higher flow rate is at the surface, the river bottom possesses slower flow rates due to frictional shear. That is why the observed sediments were deposited at the river bottom (Figs. 12, 19, 20 and 21).

Fig. 12 Roadway failure due to scouring of road base

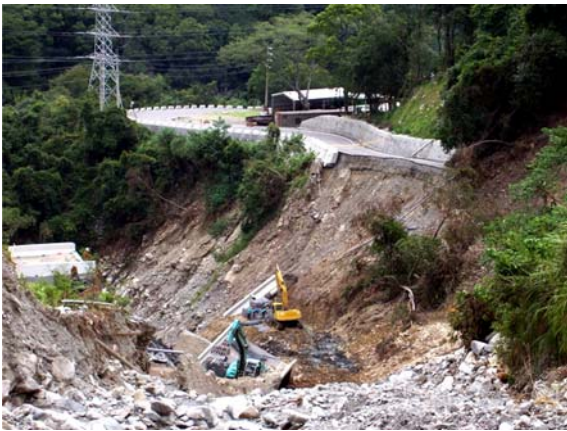
3. **Excess Pore Water Pressure:** The low soil permeability and high intensity of rainfall resulted in a temporary rise of the water table. The cohesive soil beneath the water table became saturated; hence the pore water pressure increased. The increase in the total unit weight of soil due to the permeation of rainfall also promoted the sliding force and thus reduced the factor of safety. As a result, many roads were damaged (Figs. 13 and 18).

Fig. 13 Collapse of bridge and road

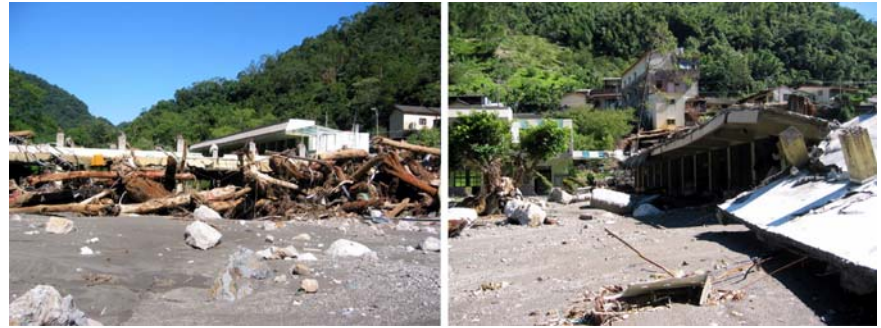
1. Riverside Roads and Erosion: Many expressways and villages are located at riverine areas, some of which are vulnerable to attack. After downpours, water levels rose quickly and flow rates increased dramatically. Gravel and boulders carried by floods led to erosion and transportation of soil particles; thus the foundations under the roads, bridges and building foundations became unstable and collapsed (Figs. 14–16).

In this case, several constructions were unable to withstand the lateral impact from boulders or giant woods. Many riverside buildings were fully destroyed by the lateral forces of floods and their accompanying solids (Fig. 14).

Fig. 14 School buildings damaged by impacts from wood debris carried by flooding river

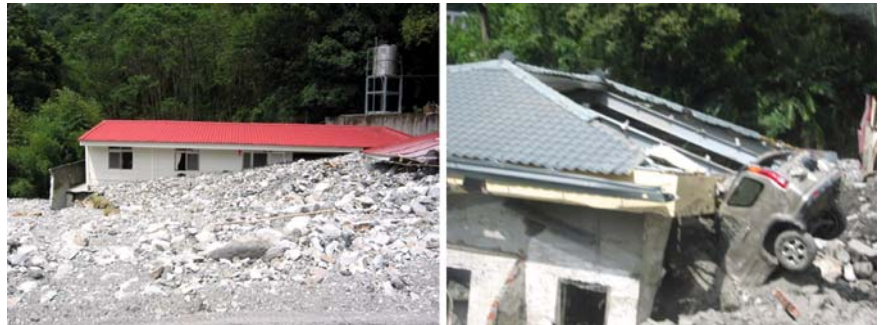
Fig. 15 Building damage—Debris flow has buried buildings and transported large objects

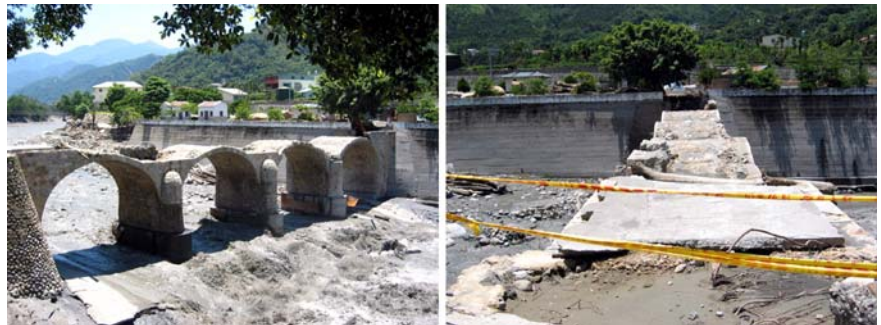
Fig. 16 Bridge damage—Road surface on bridge has been destroyed (much of structure remained intact)

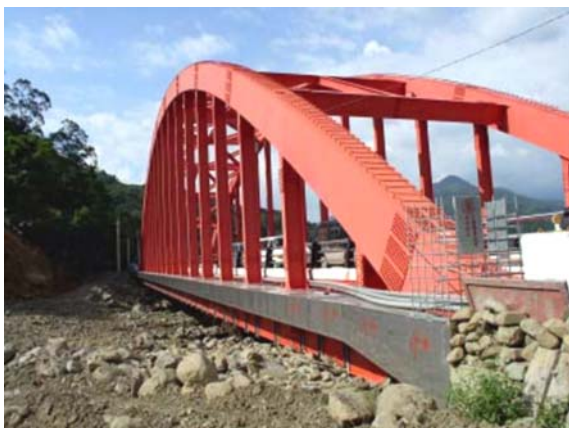
3. Debris Deposits, Lateral impact and Clearance: The river deposited the debris at certain areas. The gravels and boulders piled up and blocked the waterways, thus increased the water level (Figs. 17–20).

The sediments from debris flow raised the riverbed. Insufficient buffer room or clearance beneath the bridge jeopardized the structural safety of bridges. When the rivers overflowed, the bridges not only lost the function but also threatened communities nearby, increasing the regional vulnerability (Figs. 17 and 21).

Fig. 17 Debris-flow deposit up to bottom of new arch-bridge

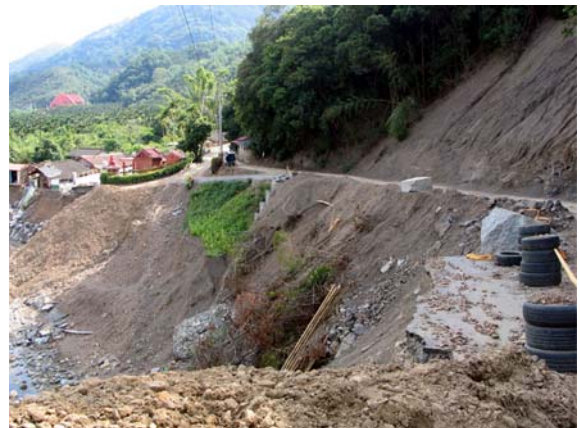
2. Slope Failure: The failure of slope would harm the physical structure sitting upon it, especially since many structures were constructed above the failure surface within the sliding mass (Fig. 18). Similarly, the slope became less stable if the earth, which supported the physical structure, was damaged by the debris of the structure.

Fig. 18 Road damaged by slope failure

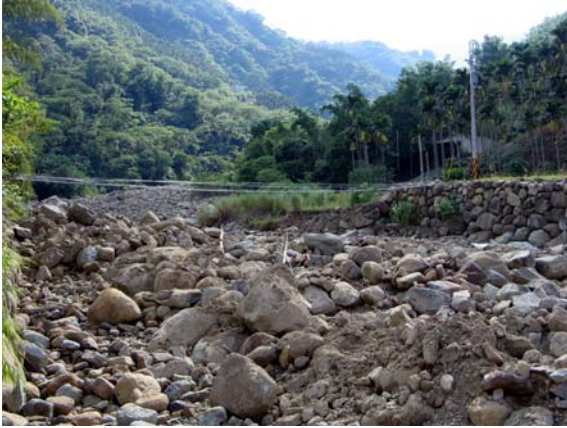
Fig. 19 Debris piled up and blocked waterway

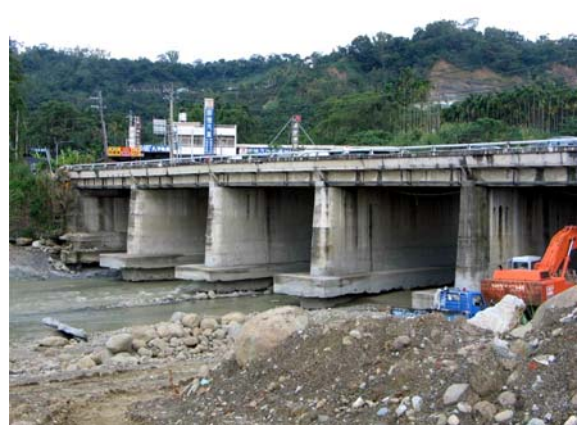
Fig. 22 Approximately 1 meter of bedrock (shale) removed beneath foundation

4. The Scouring of Bridge Foundation: The scouring of bridges is a common problem in Taiwan (Fig. 22). The effects of washout and erosion might have been underestimated. Aside from improving design and monitoring, it revealed the need of deepening and/or protecting the foundations if the situations keep occurring.

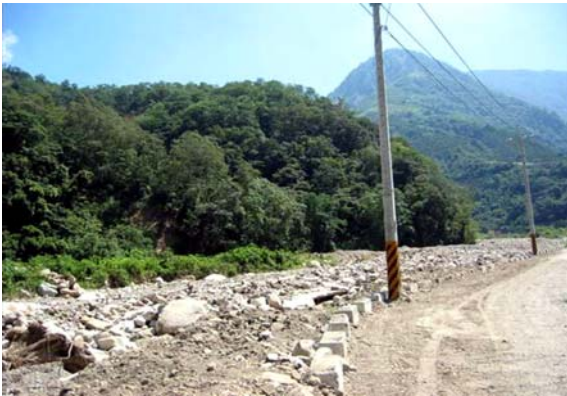
Fig. 20 River channel filled with debris overflowed into adjacent roadway

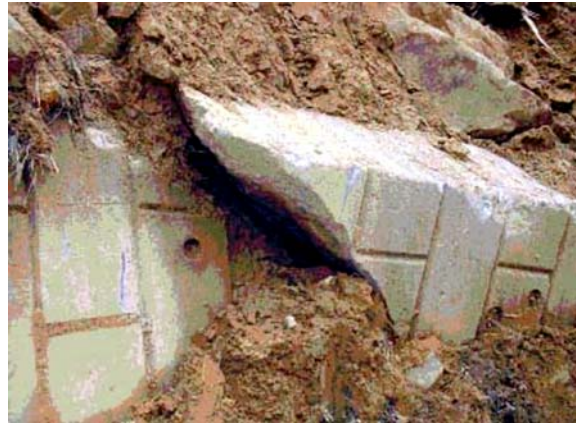
Fig. 23 Detail of failed unreinforced concrete retaining wall

5. Lateral Resistance of the Retaining Walls: In many failure cases, reinforced concrete retaining walls either lacked lateral resisting force or reinforcements (Fig. 23), so that the retaining walls were unable to resist large lateral earth pressure. Several reinforced soil retaining walls with geosynthetic reinforcements were found to have performed well. Some of them were built after failure of conventional retaining walls.
6. Engineering Design Problems and/or Alternative Solutions: Open tunnels, used for protecting the slope and falling rocks, are often located at the sites of falling rocks or sliding zones (Figs. 24–26). Although constructions are often destroyed by debris flows or landslides, the problem may not be related to construction quality but rather

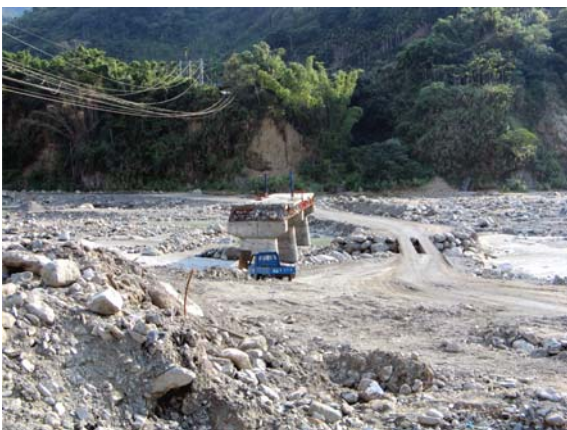
Fig. 21 Bridge lacked lateral resistance. Only three piers remained

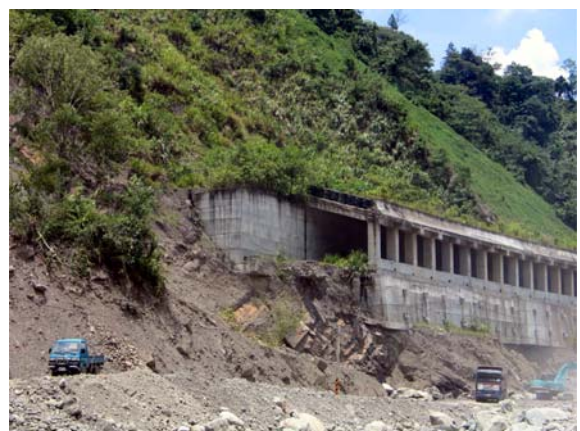
Fig. 24 Open tunnel destroyed by landslides

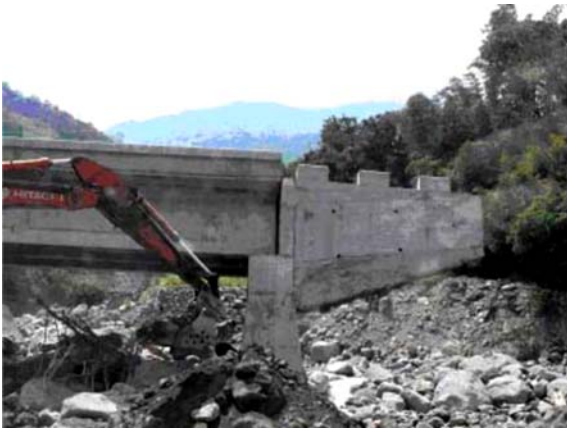
Fig. 25 An example of reinforced concrete abutment with-standing debris flow. Bridge approach has been washed away

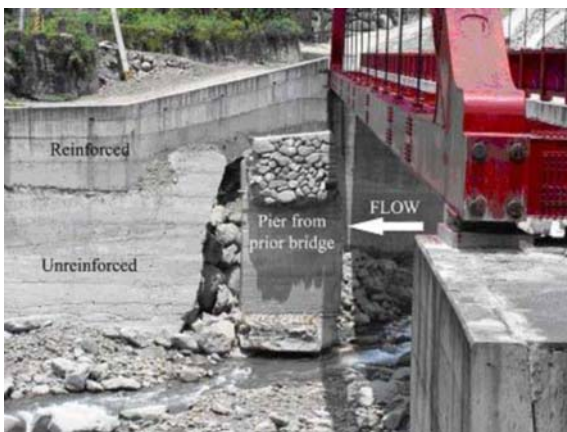
Fig. 26 Abandoned pier arrested debris on unreinforced concrete retaining wall
