A Review of Seismic Damage of Mountain Tunnels and Probable Failure Mechanisms

Nishant Roy · Rajib Sarkar

Keywords Mountain tunnel · Seismic damage · Failure mechanism · Case histories

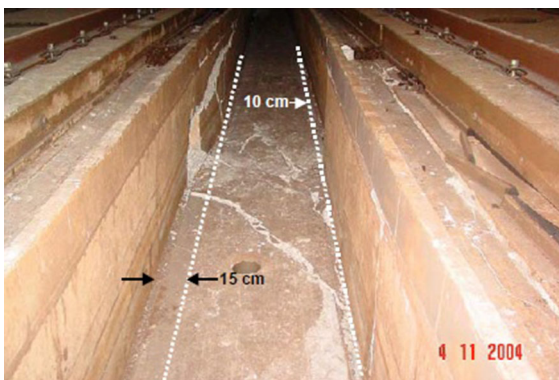
The Uonama tunnel located close to the epicenter (<10 km) suffered maximum damage. The damaged section had an overburden of about 60–100 m. Movement of sidewalls along with development of diagonal cracks was common. At one location, severe damage at the crown leading to lining collapse and exposure of steel reinforcements was observed. As shown in Fig. 1, right lateral shift of about 10–15 cm

Fig. 1 Right lateral shift of about 10–15 cm in Uonama tunnel (Konagai et al. 2005)

of the center ditch along the rails was also observed (Konagai et al. 2005).

Even though landslide was prevalent during the earthquake, it is believed that it was not the major cause as the damaged sections were located at deeper depths. Based on the pattern of cracks observed, it has been concluded that the damage was caused by slipping of a fault segment intersecting the tunnel.

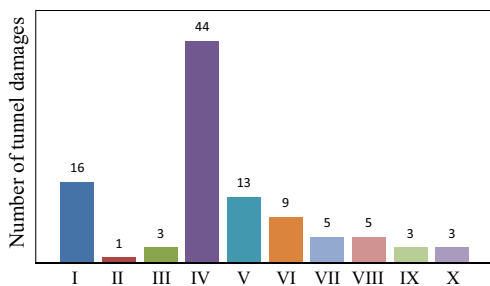
I: Portal failure II: Sheared off lining III: Slope induced failure IV: Lining cracks V: Concrete spalling VI: Water intrusion VII: Exposed reinforcement VIII: Displaced lining IX: Pavement cracks X: Rock falls in unlined section

Fig. 3 Various tunnel damages observed in Chi-Chi (1999) Taiwan earthquake

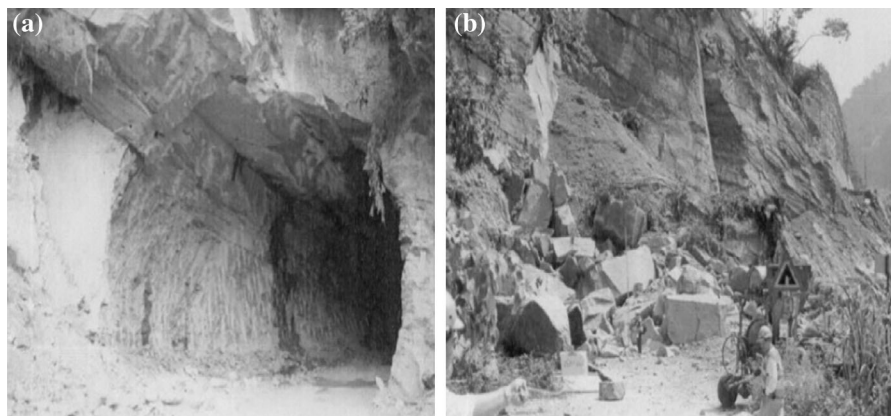
Fig. 4 Damage to Ching-Shue tunnel. **a** Tunnel entrance before the Chi-Chi earthquake. **b** Closure and damage of tunnel entrance due to slope instability (Wang et al. 2001)

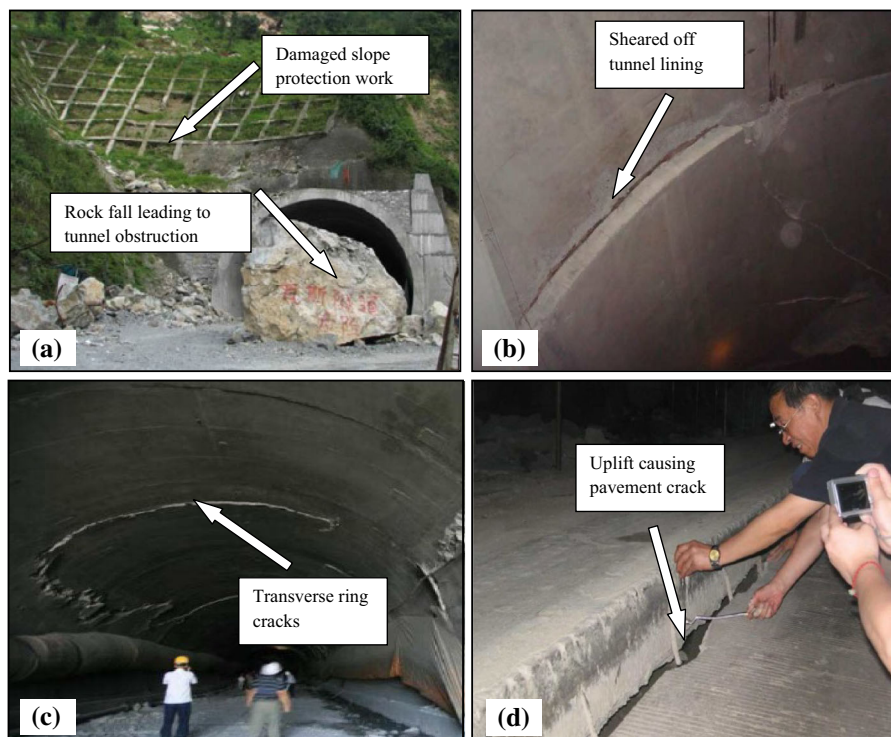
**Fig. 5** Damages at Longxi tunnel during 2008 Wenchuan earthquake (modified after Tao et al. 2011): **a** Rockfall causing obstruction at tunnel entrance, **b** sheared off tunnel lining, **c** transverse ring cracks, **d** pavement cracks due to uplift

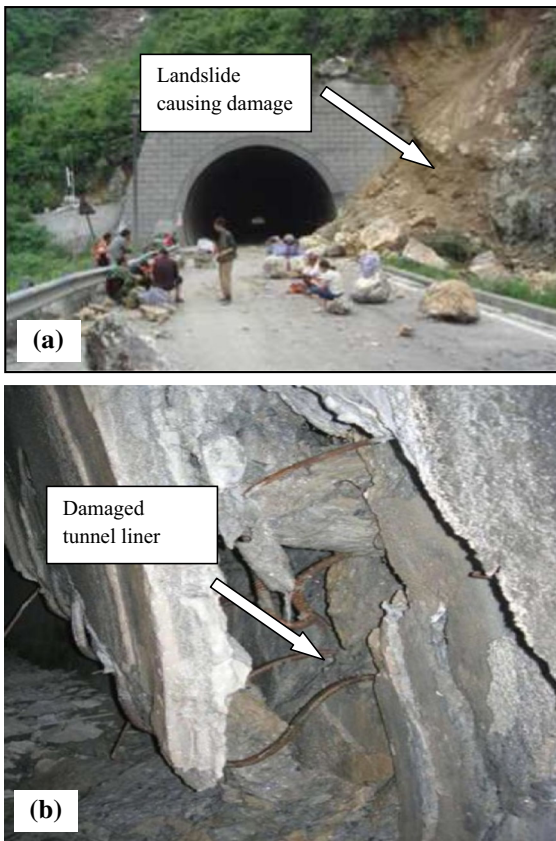
Fig. 6 Damages at Baiyunding tunnel (modified after Tao et al. 2011): **a** portal section damage due to landslide, **b** sheared off tunnel liner

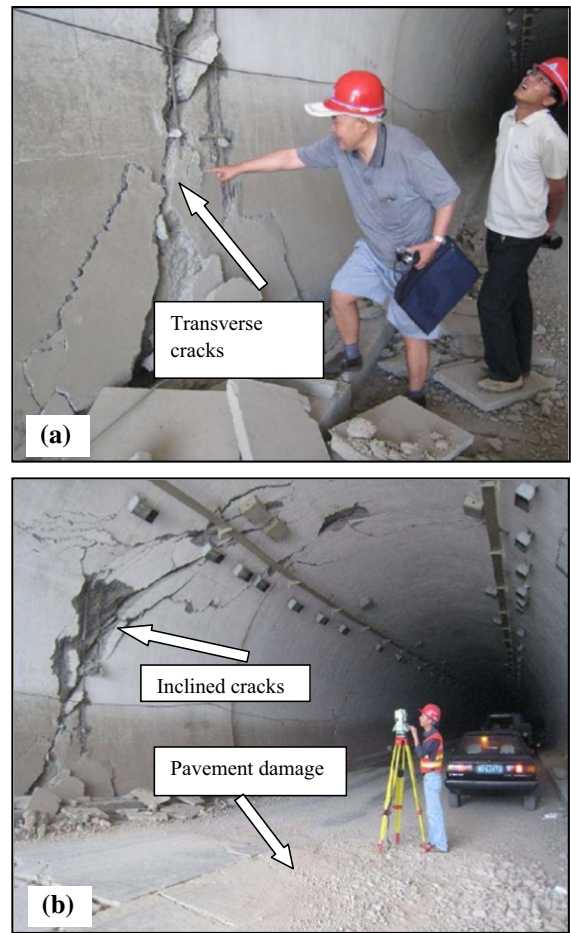
Fig. 7 Damages at Longchi tunnel (modified after Tao et al. 2011): **a** transverse cracking of liner, **b** inclined cracks and pavement damage

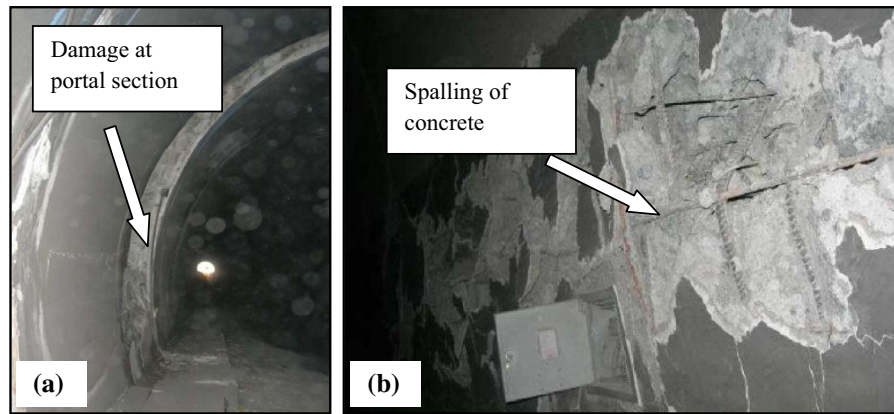
Fig. 8 Damages at Youyi tunnel (modified after Tao et al. 2011): **a** damage at portal section, **b** spalling of concrete from tunnel lining

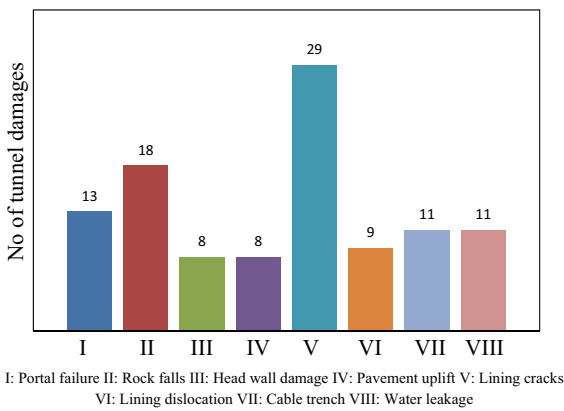
Fig. 9 Various tunnel damages observed in Wenchuan (2008) China earthquake
