Destruction of the 1912 Lenakel Church (Tanna, Vanuatu) in Cyclone Pam, and Thoughts for the Future of the Site

Abstract We report on the destruction of the 1912 Tanna Church by tropical Cyclone Pam, which struck Vanuatu on the 13th March 2015. This building was a very significant prefabricated timber structure that had been archaeologically recorded in great detail. Detailed documentation mitigates to some extent the loss of the physical structure, especially when considered alongside the community's interests in the intangible values of the site. Returning to the site after the building's destruction allowed us to record some new details, and to discuss future heritage plans with representatives from local communities.

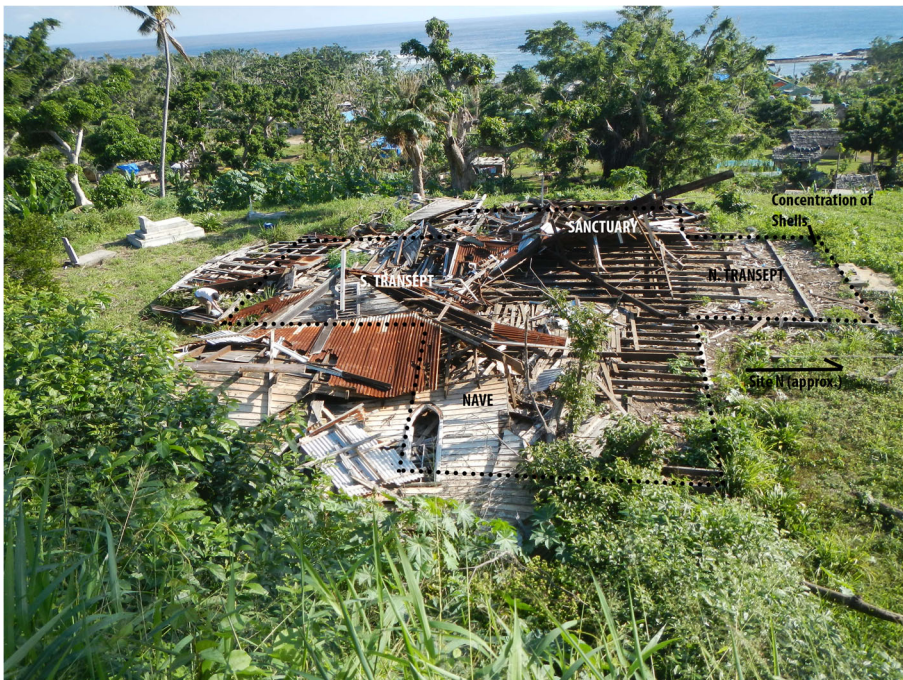
Island, Vanuatu (Flexner et al. 2015). The church, located in Lenakel, west Tanna, was constructed in 1912 from a kit produced by the Sydney firm Saxton and Binns. It was a rare surviving example of this kind of architecture. At the time we noted, “If conservation of the building’s fabric is not carried out very soon, Vanuatu will lose a significant piece of its heritage” (Flexner et al. 2015, p. 283). Often the archaeological recording of standing buildings is reported and the buildings are later damaged or destroyed, either because of natural processes or in the face of development. In the case of the 1912 Lenakel Church, it is with great regret that we report the building was completely destroyed during Tropical Cyclone Pam (Fig. 1). Pam was a category five storm, which struck the islands of southern Vanuatu on 13 March, 2015. The storm caused widespread damage to Tanna especially. The 1912 Lenakel Church had suffered a partial roof collapse after heavy rains in February, and in its already weakened state did not survive sustained winds of up to 280 km/h.

Fig. 1 The 1912 Lenakel Church after Cyclone Pam. The dotted line represents the approximate outline of the church footings. Note how the structure was blown to the south by the strong northerly winds of the cyclone, which reached 280 km/hr

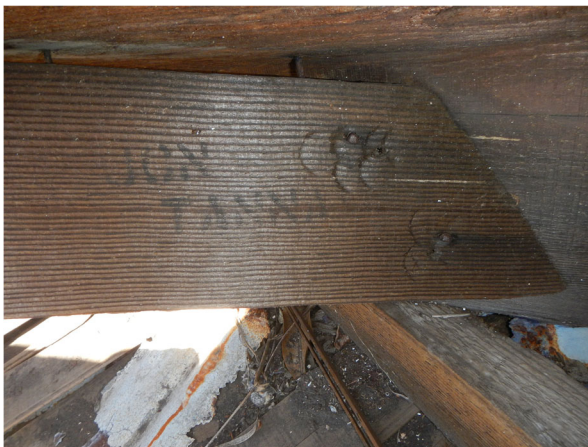
Fig. 2 Previously unseen dispatch marks, such as this were accessible after the building’s destruction. Note also the hammer marks where the nails were driven into this roof rafter

were exposed during the collapse were of mechanically-produced, rhomboidal-headed wire type, found elsewhere in Australasia in the late nineteenth and early twentieth centuries (Varman and Robert 1987; Jones 2012, p. 30). All of this adds to our technical knowledge of the way that the 1912 Lenakel Church was fabricated and constructed.

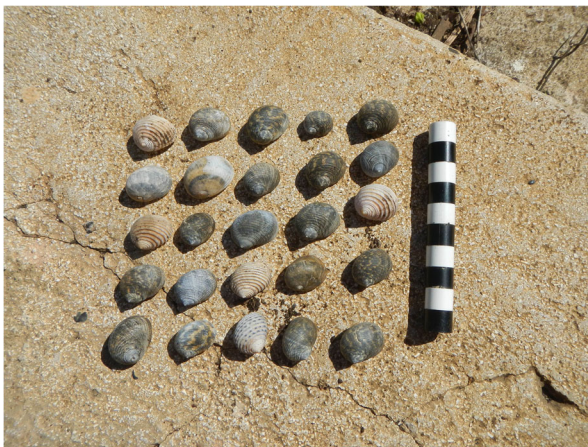
Perhaps more intriguingly, we had noted in our initial survey the presence of marine shells in the corner intersections of the nave and transepts (Flexner et al. 2015, p. 282). Upon returning to the church, more of the footings were exposed, and in the north-western corner of the north transept, on the seaward side closest to the vestry and the pulpit, we found a concentration of at least 25 sea-snail (*Nerita* spp.) shells within a roughly 1 m x 1 m area (Fig. 3). There were additional marine shells and coral pieces along the north wall of the nave as well. The concentration of marine shells in this corner suggests intentional deposition. The shells show no signs of breakage or burning, which would be expected if the shells were left over from the local lime mortar production process, and their location inside the church suggests this is not the case anyway. We interpret this deposit as a ritual offering, perhaps associated with consecration of the church building. The shells were then sealed under the floorboards, which remained mostly intact in this area until the cyclone, resulting in their good preservation.

Fig. 3 A concentration of at least 25 shells of *Nerita* spp., a marine and estuary-dwelling shell, were found in the NW corner of the N Transept (additional shells may be present beyond the ones collected from the surface). This is interpreted as a ritual deposit

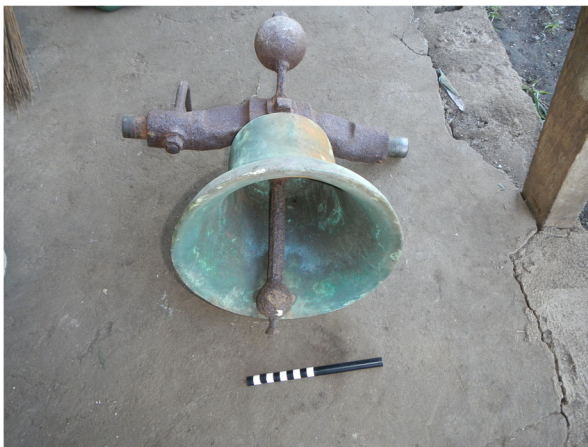
a western perspective, the fabric of the 1912 structure is almost completely lost, though the footings remain relatively intact, and certain elements of the building fabric, such as the church bell (Fig. 4), are being curated by local people in the community. Some of the more intact timbers will also potentially be preserved, though at this time there is no secure structure in Lenakel to house them. At a meeting with west Tanna chiefs, we were told that after the cyclone discussions about a future church building project on the site had passed through the network of local *imwayim* (kava drinking grounds). Even if the physical structure is mostly gone, the affective relationships of Tannese people with *ples* (place; Bonnemaïson 1994, pp. 320–326) mean that the hill on which the 1912 church was built, which was significantly modified by Tannese labour during the construction process (Flexner et al. 2015, pp. 270–271), will remain a part of the network of significant sites on the landscape. Whatever is built on the site in the future, it will maintain the sense of place and connections to people and history on the island. For Tannese people, the physical structure may have been secondary to the people, memories, and ancestors to which it was connected. Heritage significance on the site remains more connected to the “intangible” realm (Smith and Akagawa 2011) above and beyond the historical materiality of the “original” fabric of the 1912 church building itself.

Fig. 4 The church bell, recovered after the destruction of the church building and currently being curated locally in Lenakel. Parts of the original fabric such as this could be incorporated into future building projects on the site
