# Unexpected deposits in the anesthetic circuit: a possible cause of PEEP/Pmax valve malfunction

Takamitsu Ikeda<sup>1</sup> · Ryo Orii<sup>2</sup> · Masaki Iwakiri<sup>1</sup> · Kanji Uchida<sup>1</sup> · Yoshitsugu Yamada<sup>3</sup>

Received: 31 March 2020 / Accepted: 17 July 2020 / Published online: 23 July 2020  
© Springer Nature B.V. 2020

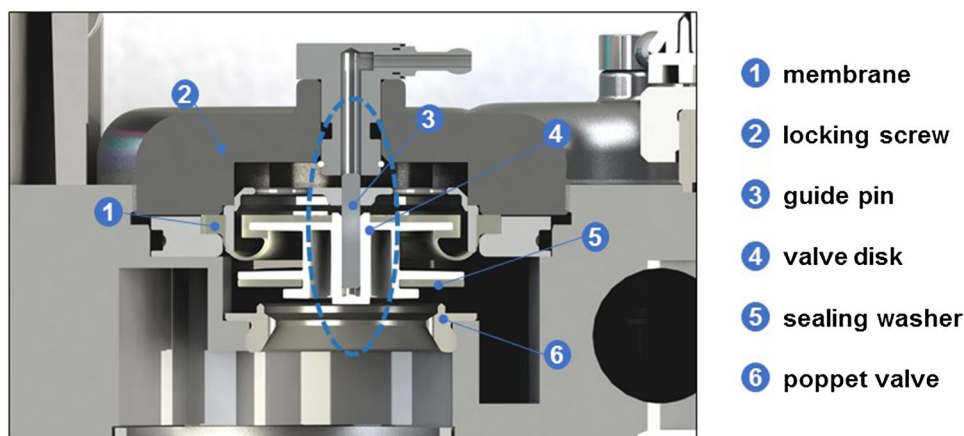
sealing washers; Fig. 1, Nos. 1 and 5, respectively) as a remedy that could restore the ventilator performance to normal. The inspection reports, in combination with other information available from the manufacturer, were reviewed to provide our troubleshooting process. The current investigation was approved by our Institutional Review Board [#2203-(6)].

**Fig. 1** The constituent parts of the internal PEEP/Pmax valve. Discs and diaphragm-like components are layered in a concentric manner with a guide pin at the center ( Source: Dräger Medical Japan)

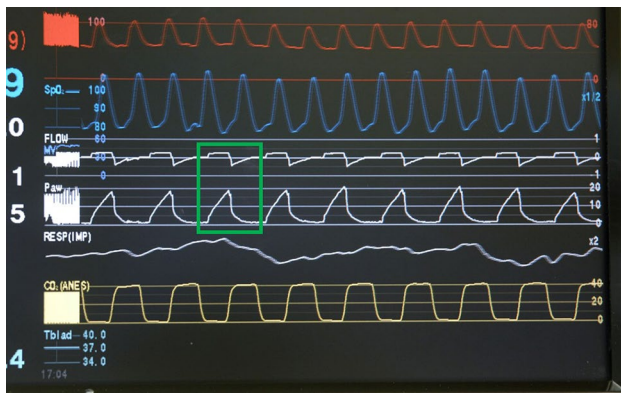
**Fig. 2** Flow and pressure waveforms before application of PEEP. Expiratory flow waveforms can be seen clearly, with airway pressure decreasing to zero shortly after the beginning of the expiratory phase

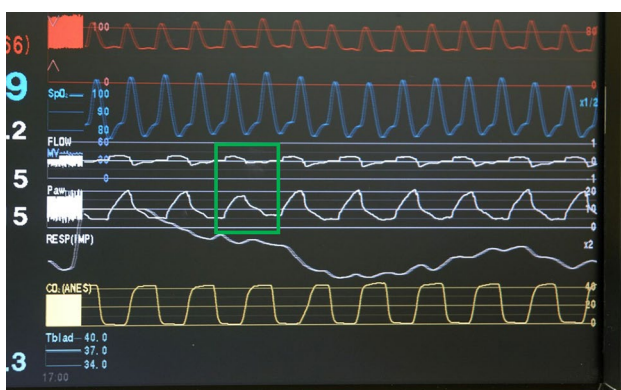
was a decrease in expiratory flow accompanied by a delayed decrease in expiratory airway pressure (Fig. 3). Possible causes of change in pressure and flow waveforms, including asthma attack, bronchospasm, and occlusion or obstruction of the breathing circuit, were quickly ruled out. The waveform returned to normal when PEEP was switched to zero end-expiratory pressure, but the same change was observed upon reapplication of PEEP. Thereafter, we maintained mechanical ventilation without PEEP. The patients recovered from general anesthesia uneventfully.

**Fig. 3** Flow and pressure waveforms after application of PEEP. As compared with Fig. 2, expiratory flow is impaired during almost every respiratory cycle. It takes longer for the pressure to return to the set PEEP during expiration. Note that the picture was taken 3 min after application of a PEEP of 5 cmH<sub>2</sub>O, a time point when a new equilibrium was achieved

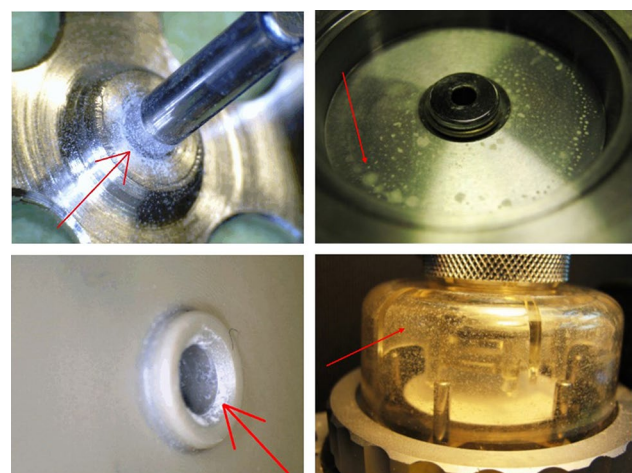
In view of the potential threat to patient safety, we asked Dräger Medical Japan to overhaul the PEEP/Pmax valve and the entire breathing circuit of anesthesia machine No. 2. As the cause remained unidentified, a close investigation was carried out by the head office in Germany. This investigation determined that the PEEP/Pmax valve components, as well as the internal surface of the breathing circuit, were contaminated with large numbers of deposits (Fig. 4). The ventilator performance returned to normal after thoroughly cleaning every constituent part of the valve. Further analysis indicated that the deposits contained calcium that was not derived from the parts used in the manufacture of the Dräger anesthesia workstations. According to the manufacturer, more than 20 similar cases have been reported worldwide since 2006.

**Fig. 4** Deposits found during the investigation by Dräger Medical. White residue was found attached to the PEEP/Pmax valve components (red arrow). The accumulation of contaminating deposits can be a cause of jamming valves

in the PEEP/Pmax valve components. The accumulation of these contaminating deposits could result in excessive friction on the pin and hinder movement of the valve (jamming), causing a higher than intended pressure during expiration (Fig. 6). The application of unintentional PEEP due to jamming valves could be hazardous for patients with unstable hemodynamics during general anesthesia.

Our department provides anesthesia for over 8000 procedures annually to deal with a variety of challenging surgeries that often require long operating times. The calcium found in the deposits might have been derived from the

carbon dioxide (CO<sub>2</sub>) absorbents (Amsorb® Plus, Armstrong Medical), which contain calcium hydroxide that reacts with CO<sub>2</sub>, as well as a lesser amount of calcium chloride and calcium sulphate to make granules harder and more chemically stable [10]. The build-up of contaminating deposits could occur inside the anesthetic circuit gradually over time according to duration and frequency of use of anesthesia workstations.

The accumulation of deposits of unanticipated materials can result in PEEP/Pmax valve malfunction even under regular maintenance [11]. Our maintenance program included scheduled annual testing and inspection of our anesthesia machines and monitors to ensure Pmax and PEEP accuracy as well as lung ventilator performance. The valve components were scheduled to be replaced biennially, followed by evaluation of pressure and flow waveforms during the test operation. Considering that the deposits built up within a year following maintenance, one potential strategy would be to introduce more frequent maintenance cycles in case of unexpected contamination. Replacing the valve components with frequency could also be a possible means of alleviating the problems.

One limitation of the current investigation was that the overhaul of the PEEP/Pmax valve and breathing circuit was carried out in only a single anesthesia workstation. The extent of contamination was not ascertained in other machines, but a careful disassembly and cleaning of the valve would be needed to ensure elimination of deposits if a similar phenomenon should occur again.

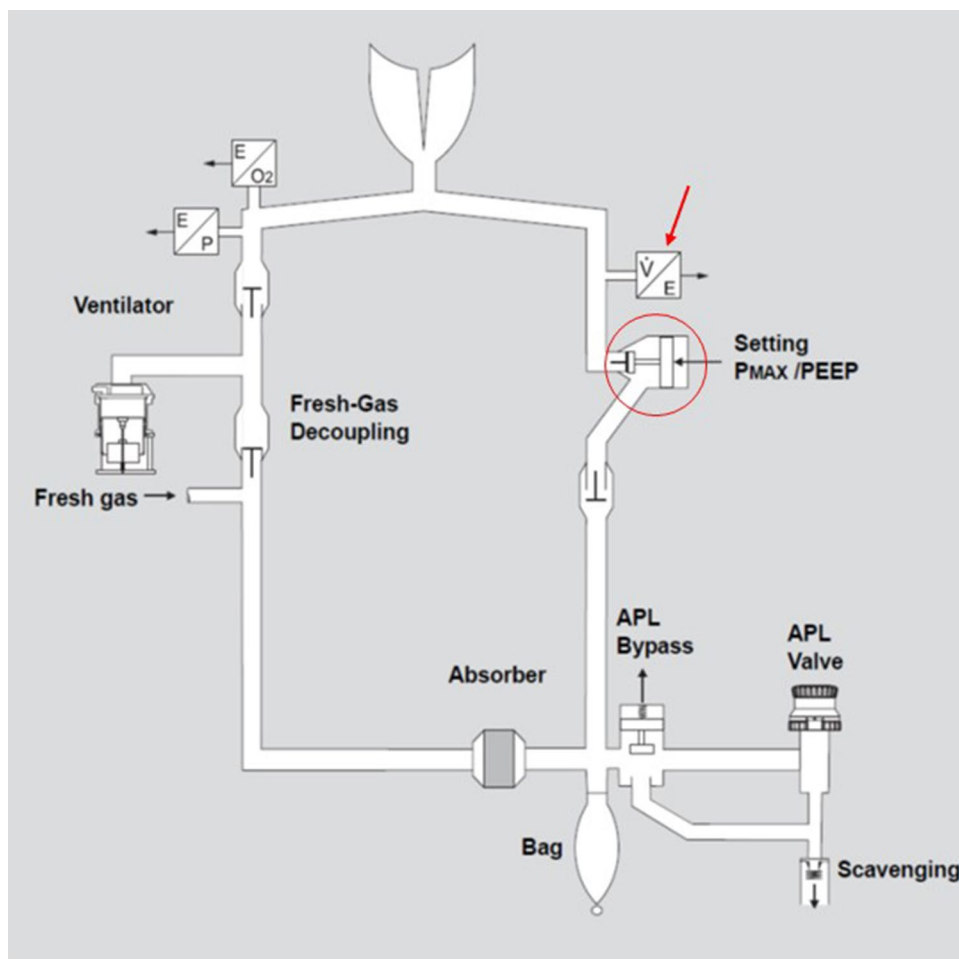
**Fig. 5** Diagram of the Dräger Fabius® GS and Tiro breathing circuit (from the Dräger Fabius® ventilator schematic). On the right is the expiratory limb where the PEEP/Pmax valve (marked as a red circle) and the flow sensor (indicated as a red arrow) are placed (Reproduced with permission of Dräger Medical Japan)

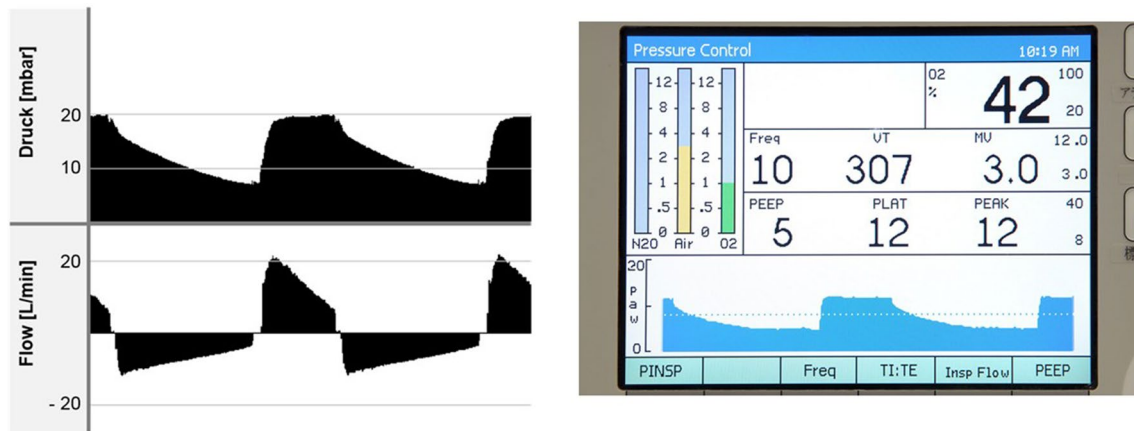
**Fig. 6** Unusual expiratory pressure curve caused by a jamming PEEP/Pmax valve. The left figure shows that expiratory pressure can be higher than the set PEEP as a result of jamming valves (Source:

Dräger Medical Japan). Similar waveforms were observed in our anesthesia workstation, as presented in the right picture
