PHENOMENOLOGICAL MODEL DESCRIBING THE FORMATION OF PEELING DEFECTS ON HOT-ROLLED DUPLEX STAINLESS STEEL 2205

Translated from *Metallovedenie i Termicheskaya Obrabotka Metallov*, No. 1, pp. 29 – 32, January, 2017.

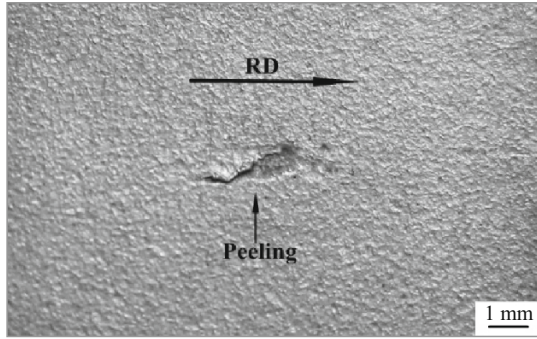
A peeling defect on the surface of a hot-rolled sheet is presented in Fig. 1. Such defects are arranged on the surface of the sheet discretely. The length of a defect is about 1 mm; the width is about 1 mm. Conventionally, we may represent this defect in the form of two parts, i.e., a shallow depression formed as a result of local detachment of a peel and a bridge between the peel and the base metal.

Fig. 1. A peeling defect on the surface of a hot-rolled sheet from steel 2205 (RD is the rolling direction).

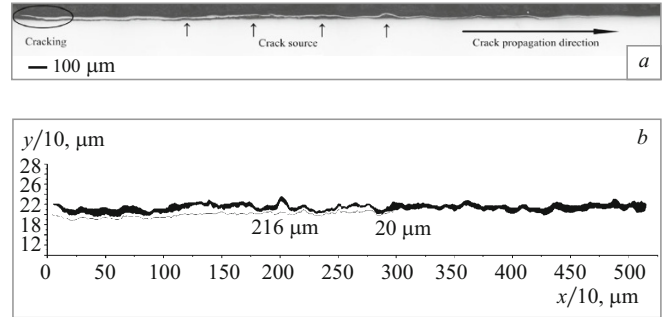
To study the morphology of the defect in cross section, we cut a hot-rolled sheet so that the line of the cut passed through the middle of the defect over the rolling direction. The structure of the specimen is presented in Fig. 2a. It can be seen that a long microcrack has formed between the detached part of the peel and the base metal. In the extreme left-hand position of the defect we can observe detachment from the base metal. In the middle of the defect we can see microscopic discontinuities (bulges), where the metal has obviously been foliated.

Figure 2b presents an image of the defect in a coordinate system where axis X goes along the length of the defect and axis Y goes over the thickness of the sheet. The thick black broken line depicts the contour of the defect and the under-

neath light-gray line depicts the contour of the base metal. In accordance with the graphical representation the defect may be described by the following parameters. The total length of the defect is 5103 μm . The length of the subsurface part of the defect (the left-hand part of the image) is 2980 μm ; the thickness of the defect (the distance between the lower gray line and upper black line, i.e., between the boundary of the base metal and the bottom of the subsurface defect) varies from 20 to 216 μm .

Microscopic bulges appear on the region from 1000 to 3000 μm (Fig. 2*b*), and the contour of the defect has a wavy pattern. This may be connected with the appearance of tensile stresses directed perpendicularly to the surface of the rolled metal. Formation of tensile stresses in the zone of reduced ductility of the metal can cause local fracture, i.e., formation of a microcrack in the regions of active formation of waves. Further development of the microcrack should cause larger-scale foliation, which corresponds to the contour on the region from 0 to 1000 μm (Fig. 2*b*); later on the foliated part of the metal will be detached, which will be observed on the surface of the rolled sheet.

Fig. 2. Morphology of a peeling defect in longitudinal section of a rolled sheet from steel 2205 (unetched specimen, optical microscopy) (a) and its graphical representation in cross section of the sheet (b) (126 μm is the maximum thickness of the defect; 20 μm is the minimum thickness).

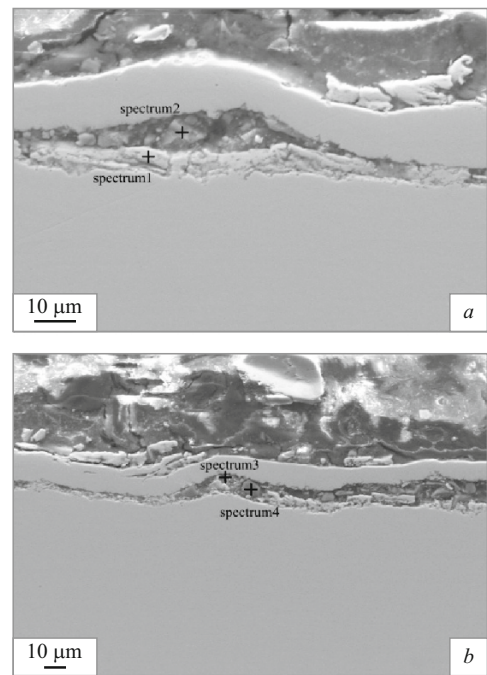
We analyzed the energy spectra of the defect on a longitudinal specimen using a scanning electron microscope. The morphology of the defect is presented in Fig. 3. We observe nonmetallic inclusions in the form of streak precipitates between the defect and the base metal. The results of the analysis of their energy spectra are presented in Table 1. The inclusions contain Mg, Ca, Al, Si, O and other elements. Such elements enter nonmetallic inclusions of types Al_2O_3 and $\text{CaO} - \text{SiO}_2 - \text{Al}_2\text{O}_3 - \text{MgO}$. Accumulation of such inclusions may give rise to micro- and macrofractures in the process of hot rolling due to the reduced ductility of the metal in these zones. Thus, streak precipitates of nonmetallic inclusions may be the most important factor for the appearance of surface defects of the peeling type. In the process of hot rolling such nonmetallic inclusions are chiefly arranged over the direction of the deformation, i.e., in parallel to the surface of the rolled sheet.

Fig. 3. Structure of the surface layer of a rolled sheet from steel 2205 in the region of a peeling surface defect with points of analysis of energy spectra 1, 2, 3, 4 obtained under a scanning electron microscope.

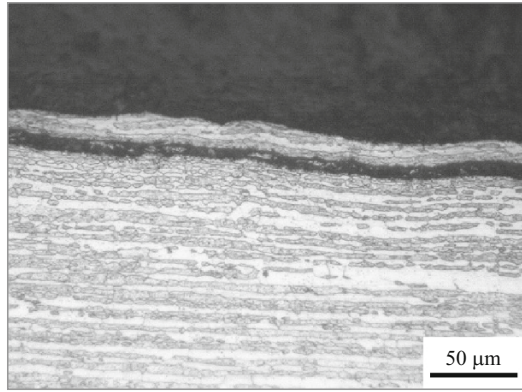
The microstructure in the zone of the defect is presented in Fig. 4. According to the results of the evaluation of the volume fractions of the structural components, the content of austenite is 58.5% and that of ferrite is 41.5%. This proportion of structural components is not optimum for hot deformation. It is known that in hot rolling of a billet, strain develops under the conditions of existence of a double-phase region, i.e., austenite and ferrite. If the proportion of the structural components is not optimum, for example, at an elevated content of austenite, the straining of the austenite and of the

Fig. 4. Microstructure in the zone of a peeling surface defect on steel 2205.

ferrite is hardly coordinated. This may reduce the capacity of the steel for hot plastic deformation, i.e., may give rise to a microcrack at the austenite/ferrite interface. Thus, the interface of the two phases may also be a zone of reduced ductility of the metal and the second cause of the appearance of a peeling defect on the surface. In hot rolling, the boundary between the austenite and the ferrite is also arranged over the direction of the principal strain and in parallel to the surface of the rolled article.

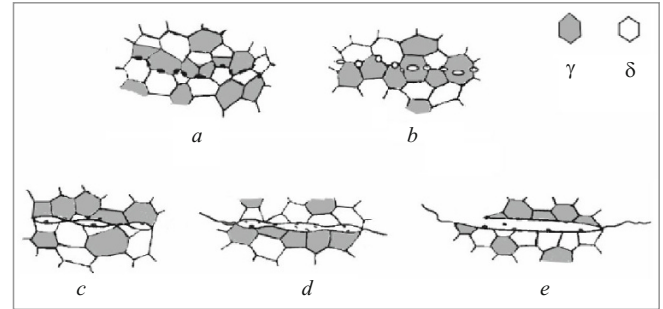
1. Appearance of zones of low ductility in the metal. Such zones contain accumulations of nonmetallic inclusions and phase boundaries near which the content of austenite is not optimum from the standpoint of formation of high process ductility (Fig. 5*a*).

2. Appearance (nucleation) of microcracks. In the zones of low ductility, the strength of cohesion between nonmetallic inclusions and the base metal or austenite and ferrite is reduced, which creates conditions for easy nucleation of microcracks, as it is shown in Fig. 5*b*.

Fig. 5. Scheme of the phenomenological model of formation of defect: *a*) appearance of a zone of low ductility; *b*) nucleation of microcracks; *c*) growth of microcracks; *d*) propagation of microcracks; *e*) formation of peeling defect on the surface of rolled metal.

under rolling, which is perpendicular to the surface of the rolled metal, the microcracks may grow and acquire an oval shape, as in Fig. 5*c*. Individual microscopic bulges appear on the surface of the rolled metal on the corresponding area.

4. Propagation of microcracks. Due to the parallel arrangement of microcracks with respect to the zone of low ductility, they propagate easily over the direction of the deformation, as a result of which the defect is detached from the base metal as is shown in Fig. 5*d*.

5. Formation of a peeling defect on the surface of the rolled metal (Fig. 5*e*).
