# Reconnaissance report on buildings damaged during the Lushan earthquake, April 20, 2013

Feng Xiong · Lingzhi Xie · Qi Ge · Yuxin Pan · Moe Cheung

**Abstract** At 8:02 am on April 20, 2013, an earthquake with a magnitude of seven on the Richter scale occurred in Lushan County, Sichuan Province, China. This paper describes the investigation of the damage to buildings in quake-hit areas. By comparison with “5.12” Wenchuan earthquake that occurred in the same region 5 years ago, the damage modes of the buildings have been analyzed. Public buildings, most of which were reconstructed after the Wenchuan earthquake, exhibited a good performance in regard to the main structures. However, severe damages were identified from non-structural elements. The performance of frame structures supported on rubber isolators was examined, and very few cracks from the infilled walls were observed, unlike the other frame structures. Rural housing suffered extensive damage during this earthquake, due to inadequate structural systems for horizontal-force resistance, lack of construction supervision, and insufficient ground treatment, all of which lead to the tragic destruction. Conclusions were given by

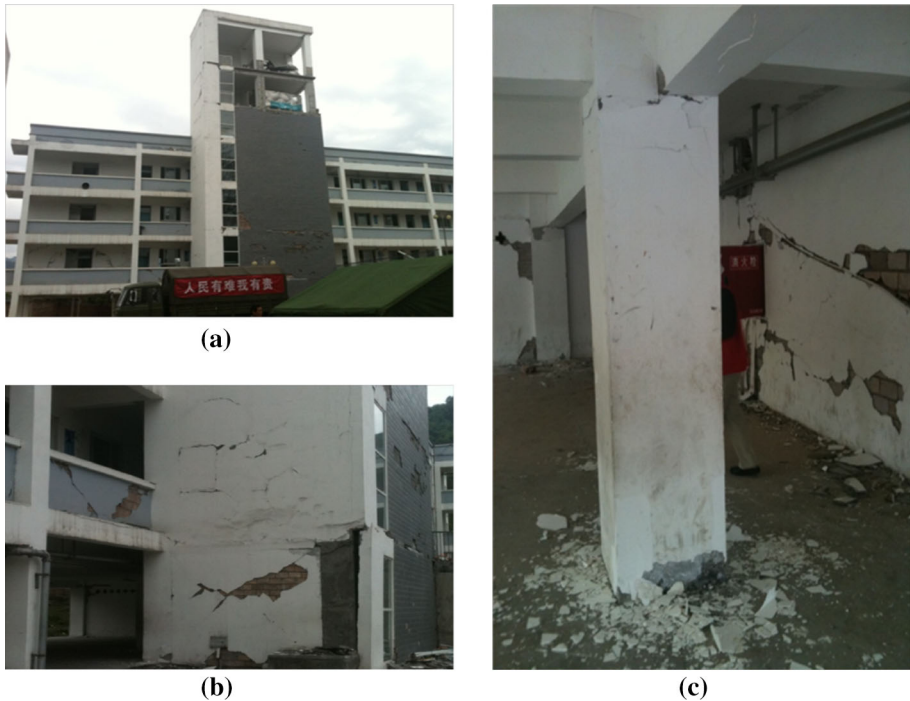
**Fig. 4** Red Cross School in Longxing Village

As shown in Fig. 4, the Red Cross school in Longxing Village was aid-constructed by the Hong Kong Red Cross Organization in 2010 and was located in a ninth-degree zone of this earthquake. The teaching building consisted of a four-story main frame structure and a seven-story tower (Fig. 4a). No partition walls were built on the ground floor, and there were classrooms from the second to the fourth floors. Significant damage could be found in the tower, and the hedge on the top two floors collapsed completely. The water tank on the top floor was badly damaged. The partition and exterior walls cracked extensively and collapsed in parts (Fig. 4b). Cracks occurred in the column heads and foots and formed the typical plastic hinges. Damage on the columns of the ground floor was also observed (Fig. 4c). It can be concluded that the huge seismic intensity (ninth degree) could be a factor causing the column damage. However, the damage to the tower was responsible for the whiplash effect. The slender tower had a very weak lateral stiffness that can be easily damaged during the earthquake. This school had the most severe damage in the reconstruction projects covered in the whole investigation activity. Although the main structure

survived, the complete rehabilitation work is needed, and reconstruction is being considered.

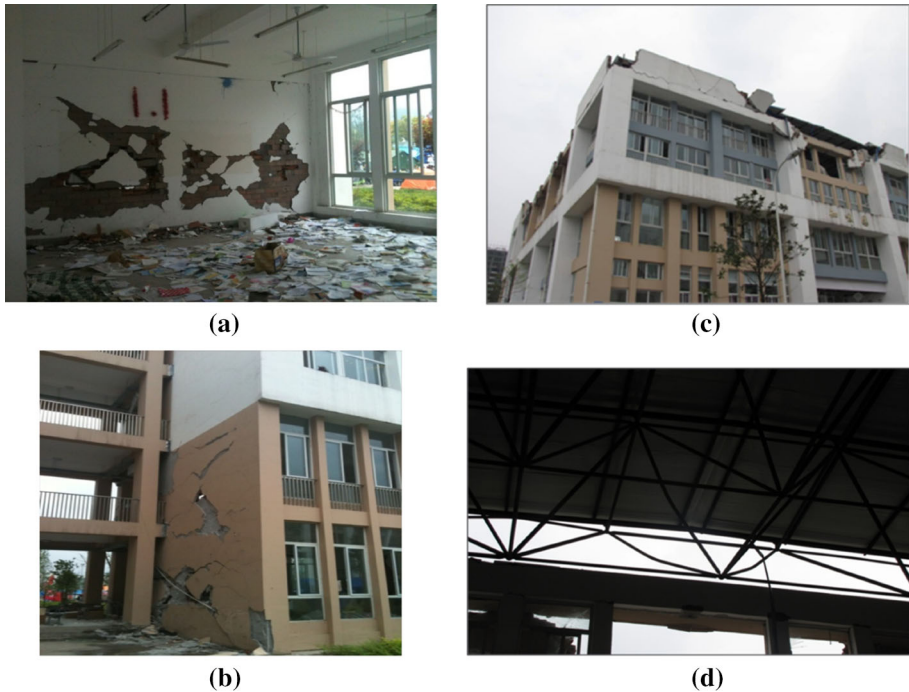
**Fig. 5** Lushan Middle School

The middle school of Lushan is located in a eighth-degree zone and was aid-reconstructed by the Macao Government in May 2012, as shown in Fig. 5. It is primarily composed of a teaching building (10,647 m<sup>2</sup>) and a complex building (2,891 m<sup>2</sup>). Both are frame structures designed for eighth-degree earthquakes. More than 300 students were having classes on April 20, but fortunately, no injuries were identified. The main structure stayed sound after the earthquake, but the infilled walls were badly damaged (Fig. 5a, b), and the parapets on the roof collapsed completely. It could be explained that the high parapet has inadequate anchorage (Fig. 5c). Besides, the complex building used a roof truss structure and a few members buckled (Fig. 5d).

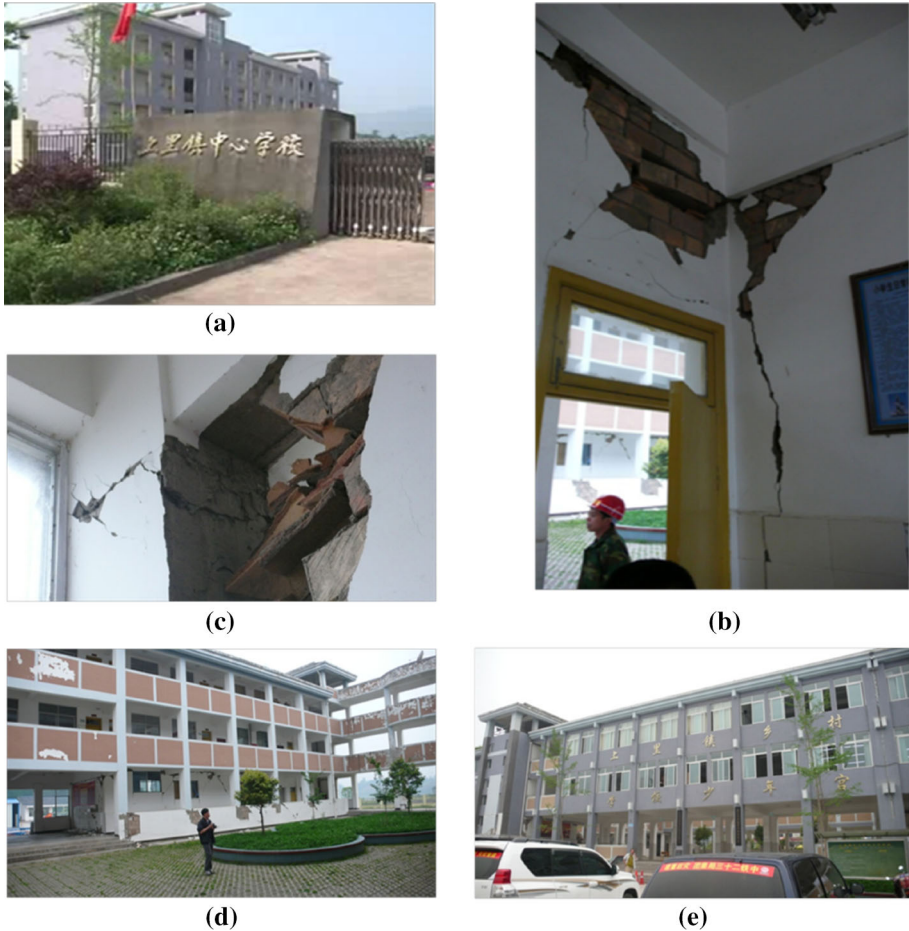
**Fig. 6** Shangli Middle School

The Shangli Middle School also located in the eighth-degree zone was expanded after the Wenchuan earthquake (Fig. 6a). The teaching building was constructed in two phases, the left part was a single-span frame which was built in 2004 and designed by following the old codes, while the right part was a two-span frame which was built in 2011. Since a single-span frame structure is prohibited in the updated design code after the Wenchuan earthquake, one more row of columns was required in order to construct a two-span frame in the new part of the building. The old part was damaged badly in that the infilled walls were totally destroyed, and slight structural damage was also found on the columns (Fig. 6b, c, d). In comparison, the new part of the building worked well with only few cracks on the infilled walls (Fig. 6e). As both parts of the same building exhibited distinct contrasts, it indicates that single-span frame structures have poor performance.

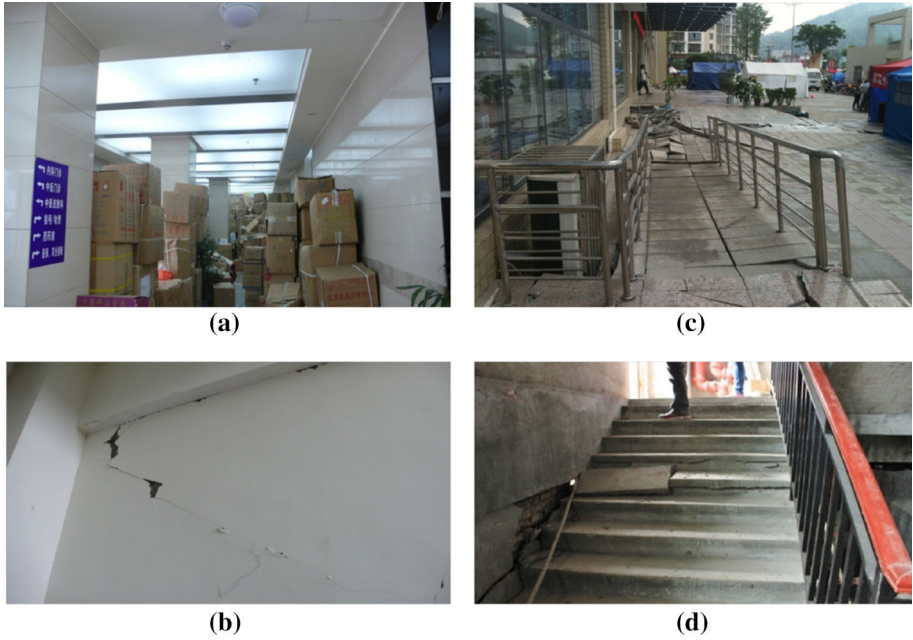
**Fig. 7** New outpatient building complex of Lushan People's hospital

As shown in Fig. 7, the Lushan People's hospital is primarily composed of an outpatient building complex, an old outpatient building, and a hospitalization building. The three buildings were purposely put together to form a shape of “品”, a Chinese character. Among them, the new outpatient building complex (7,995 m<sup>2</sup>) was put into use in 2011, and it has seven stories above the ground and one-story underground. The structure is a frame structure and is supported on rubber isolators; in total, 83 isolators were set for the whole building. After experiencing this 7.0 magnitude earthquake, the isolation system showed excellent performance. Only a few cracks were detected on the infilled walls, and the ceiling stayed intact (Fig. 7a, b). Moreover, no medicine fell from any of the medicine cabinets, demonstrating the small displacement of the superstructure. The pipeline system was relatively good, the elevator and the air condition equipment installed on the top floor remained in normal operation. However, the cover on the isolation gutter surrounding the building was damaged, indicating that the building experienced great horizontal displacement on the base isolation floor (Fig. 7c). In the field investigation, some slight damage corresponding to the isolation floor was found, such as cracks in a staircase over the isolation floor, local damage on pipes without flexible joints (Fig. 7d). It exposed problems in the detailed design of the isolation building, as shown in Fig. 8. Infilled walls on the ground floor were badly damaged, and the ceilings collapsed extensively (Fig. 8a, b). In a sharp contrast, the other two adjacent buildings suffered severe damage. In the hospitalization building, cracks were detected in a few columns (Fig. 8c). After the earthquake, patients were moved out from the hospitalization building and lived in temporary tents due to the significant damage in the building. Reconstruction of the building is being considered.

3. The new outpatient building demonstrated a good example of an isolated building. It is the first new project to experience a real earthquake of 7.0 magnitude. The design should be applied extensively on schools and hospitals. On the other hand, the detailing of isolated buildings needs to be improved, such as the isolation gutters, flexible pipe joints, and structural members passing through the isolation floor. It is necessary to instruct the owners of isolated buildings how to ensure good maintenance and correct use.

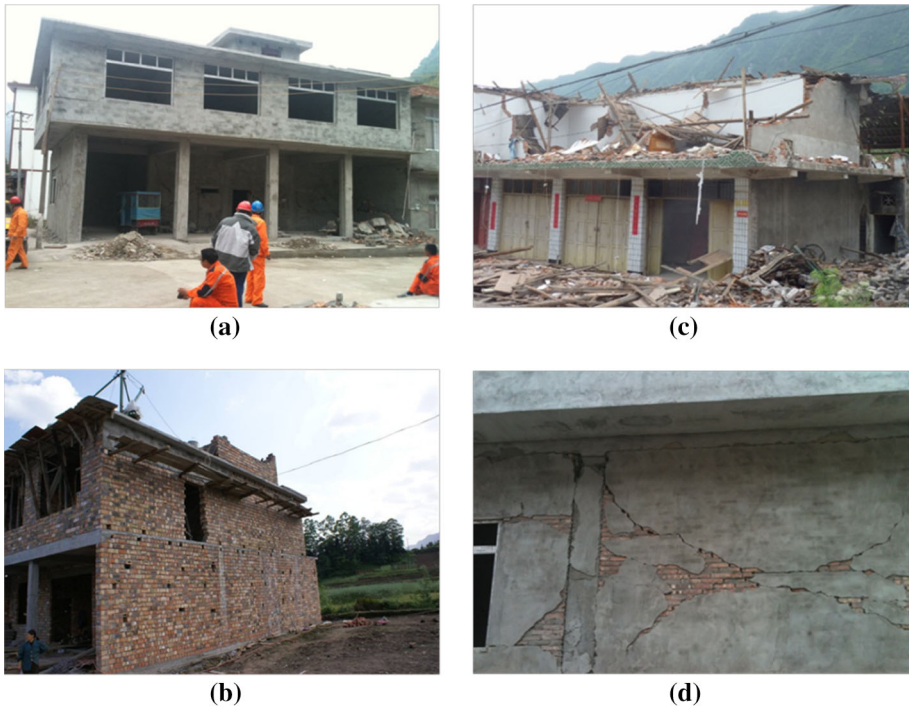
1. Lack of structural systems for horizontal-force resistance. Since there was no strict design for most self-built houses, the structural columns and beams were arranged only to support the upper floor weight without considering the horizontal-force resistance. Figure 9 shows some typical rural houses, in which the whole structure was supported by the weak frame on the ground floor (Fig. 9a). On the ground floor, there were few lateral walls and no front longitudinal wall, while the back longitudinal wall only had a thickness of 120 mm. The column section was insufficient, only 250 mm × 250 mm, and caused the weak lateral stiffness (Fig. 9b). The second floor was of masonry structure without or lacking confining columns and ring beams. When the earthquake occurred, either the columns or infill walls on the ground floor cracked or the masonry

walls on the second floor collapsed (Fig. 9c, d). The confused and poor structural system is the main reason for the severe damage to rural houses.

**Fig. 9** Typical rural house structures and consequent damage

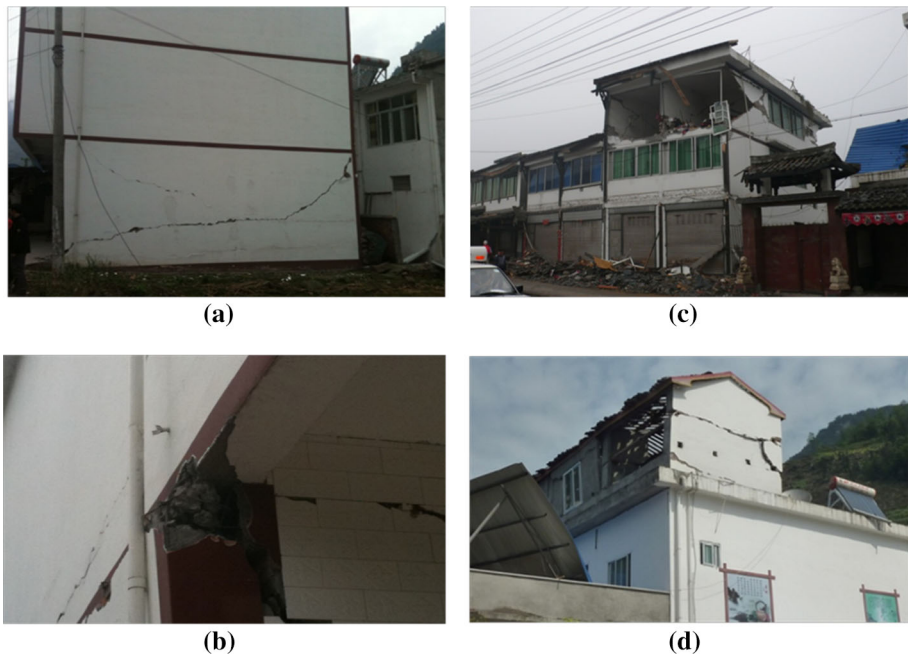
2. Lack of construction supervision resulted in the poor quality of the self-built houses. The strength of the concrete material generally did not satisfy the design standard, and the amount of rebar was less than many of the designs actually required. The structural members were also of poor strength. Therefore, the reinforced concrete members were destroyed extensively in rural houses during the earthquake (Fig. 10a–d). This is rare in public buildings in big cities.

**Fig. 10** Damage modes of self-built houses
