# Seismic intensity map and typical structural damage of 2010 Ms 7.1 Yushu earthquake in China

Maosheng Gong · Shibin Lin · Jingjiang Sun · Shanyou Li · Junwu Dai · Lili Xie

**Keywords** Yushu earthquake · Earthquake disaster survey · Seismic intensity map · Typical structural damage · Structural seismic capacity

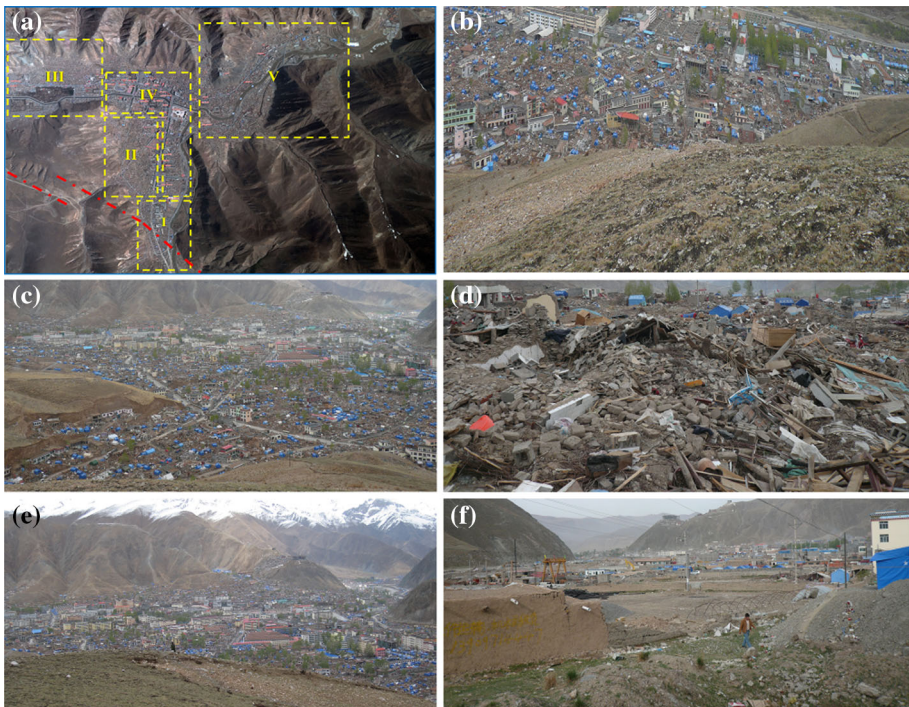
Jiegu Town is located at the area of intersection of the Zhaqu and Baqu Rivers. Along the narrow valleys of these two rivers, Jiegu Town exhibits a T-shaped urban plan, as shown in Fig. 4a. Because of the high population and the considerable number of non-engineered buildings, the damage in this town was more severe than that in other locations. The damage to the southwestern and southern parts of this town was more severe than in the eastern and central parts, as can be seen in Fig. 4; this is due to the proximity of surface ruptures marked by red dashed dotted lines in Fig. 4a.

**Fig. 4** Overview of Yushu Town after the earthquake: **a** remote-sensing image after the earthquake (National Administration of Surveying, Mapping and Geoinformation, 2010), **b** damage to southern part I, **c** damage to southwestern part II, **d** damage to western part III, **e** damage to central part IV, **f** damage to eastern part V

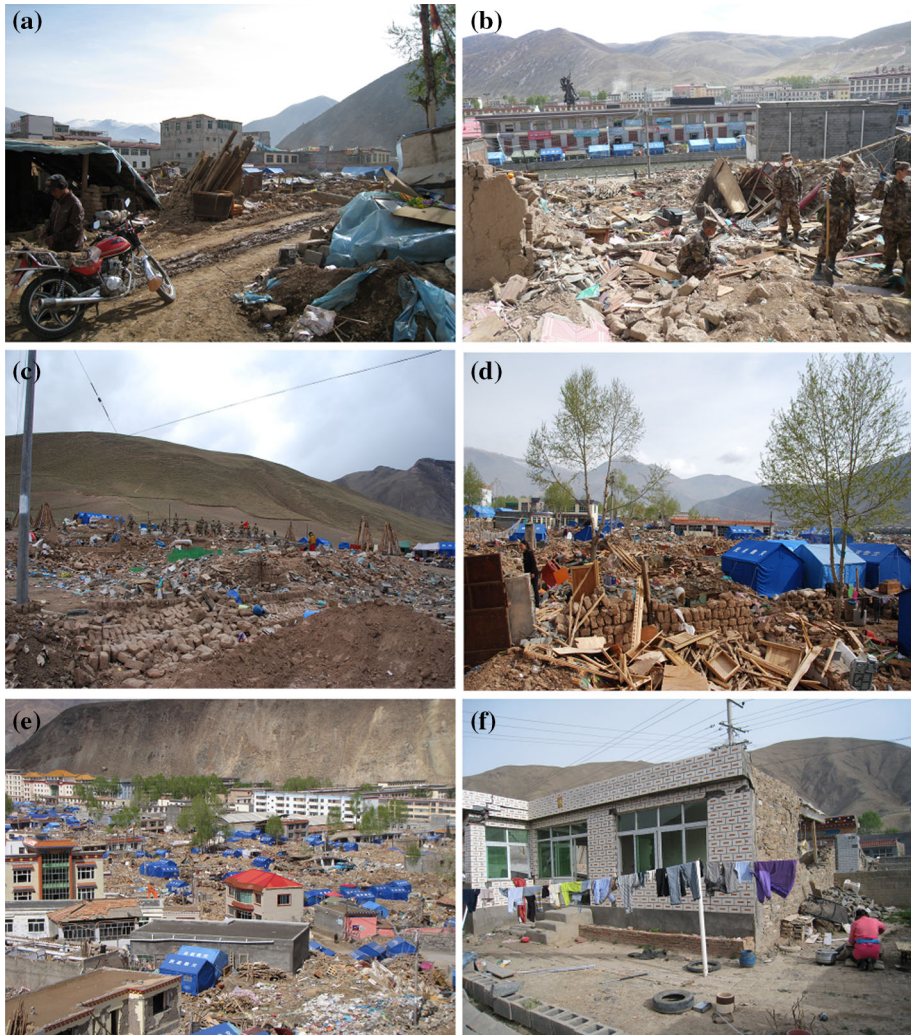
Because of these adverse features, adobe and stone structures are vulnerable to earthquakes. The survey shows that more than 60 % of the adobe and stone structures in Parts I through V of Jiegu Town were completely destroyed in the earthquake, and an additional 30 % sustained severe damage in the form of cracks, partial collapse, and out-of-plane failure of bearing walls, as shown in Fig. 5.

**Fig. 5** **a** Complete destruction of 16 single-story adobe houses with timber roofs near Shengli Road (Part IV), **b** 12 collapsed adobe houses with timber roofs near Hongwei Road (Part V), **c** complete destruction of more than 60 adobe houses with timber roofs in Saiyigou Village (Part II), **d** more than 70 collapsed adobe houses with timber roofs in Shuangyong Lane (Part I), **e** complete destruction of adobe buildings versus standing of other buildings around North Xihang Road (Part II), **f** partially collapsed gables and cracked interior walls in a single-story stone house near Qionglong Road (Part V)

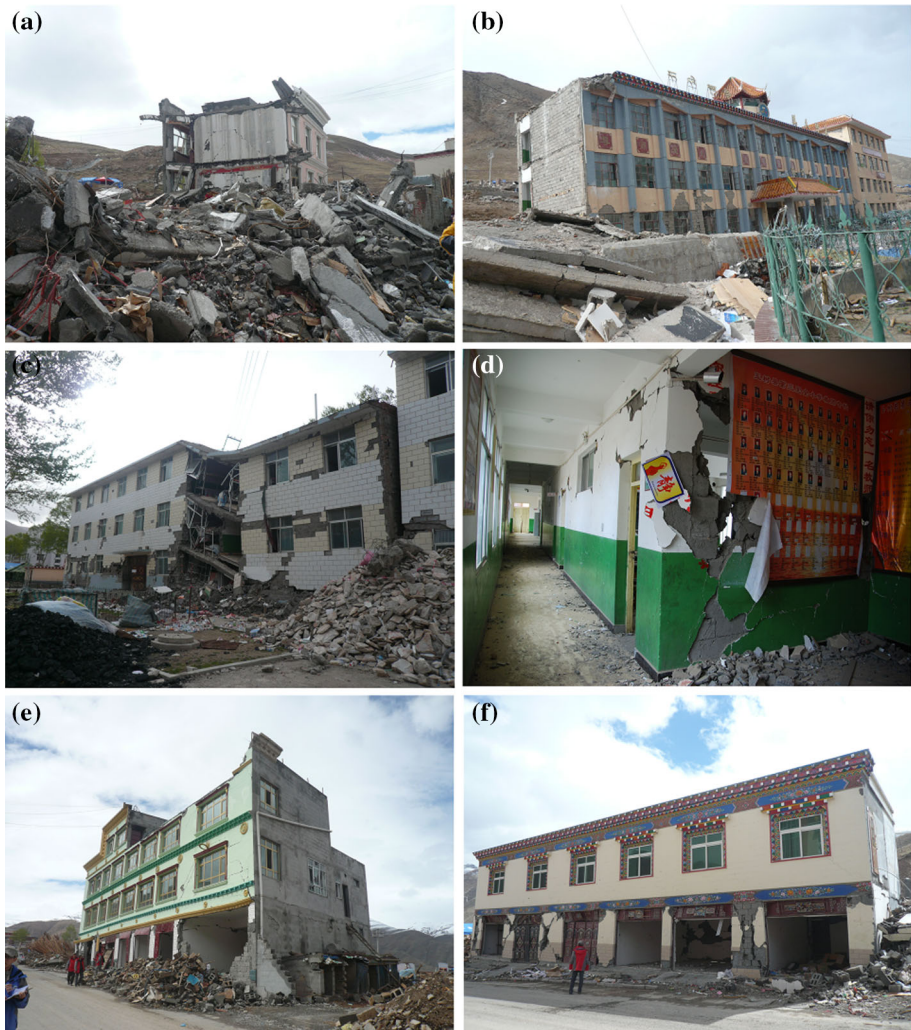
**Fig. 7** **a** A completely collapsed concrete block building near South Xihang Road (Part II), **b** an extensively damaged teaching building in a college (Part III), **c** an extensively damaged male-student dormitory building at a college (Part III), **d** partially destroyed bearing wall on the first floor of an elementary school building (Part III), **e** partially collapsed and cracked bearing walls of a concrete block building near North Xihang Road (Part II), **f** cracked bearing walls at the first story of a concrete block building near West Xihang Road (Part II)

- (3) Hollow concrete block structures without core columns suffered extremely severe damage in the earthquake; therefore, during the design and construction of this type of structure, the structural or core column should be laid out in such a way as to improve the seismic capacity of this structure and make use of the advantages of a hollow concrete block (e.g., low density and high strength).

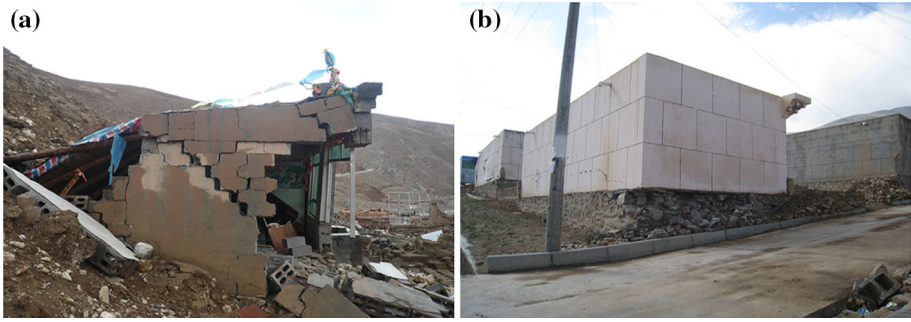
**Fig. 8** **a** A partially collapsed single-story concrete block building caused by failure of a mountain slope (Part II), **b** the crushed foundation of a single-story partially damaged concrete block building (Part II)

- (1) Since site conditions and mountainous topography typically have a significant impact on structural damage, loose soil sites and unstable slopes must be avoided or sufficiently improved. If needed, appropriate measures, such as ground improvement and slope reinforcement, should be taken to deal with unfavorable soil types. Buildings erected on steep slopes with uneven underlying stiffness may suffer structural collapse or severe damage during earthquake shaking, so either the ground should be reconfigured to form a horizontal plane or a special reinforcement should be applied to the first layer. Because a foundation with mud masonry rubble can easily break and cause instability, this type of foundation should also be avoided and replaced by concrete masonry or other affordable solid foundations.

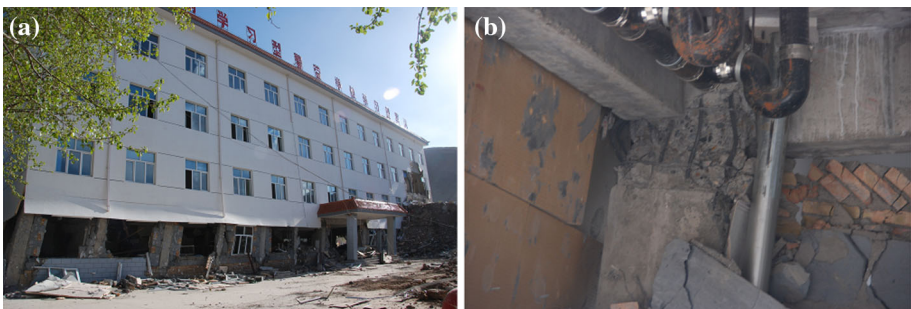
**Fig. 10** A tilting RC frame building of a police station with yielded column ends on the soft first floor and cracked, partially destroyed infill walls (Part I)

- (4) In the Chinese seismic design code, the RC frame structure is expected to achieve a “strong-column weak-beam” yielding mechanism. However, during previous earthquakes in China, including the two recent great earthquakes (2008 Wenchuan and 2010 Yushu), few structures had achieved a desired seismic fortification objective. Especially in the Yushu earthquake, most of the structures incurred column-end damage. Further research is required to determine a yielding mechanism for an RC frame structure that would experience beam damage prior to column damage. A related research topic should focus on the contribution of

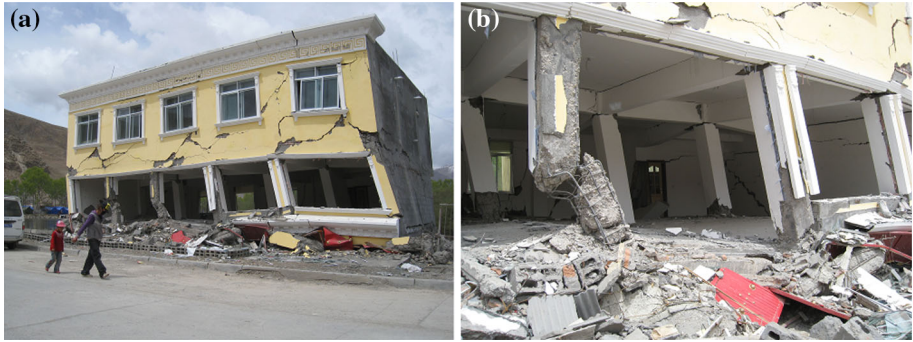
**Fig. 11** A tilting three-story RC frame building at Xinjian Road with a destroyed soft first floor and cracked and broken columns on the second floor (Part III)

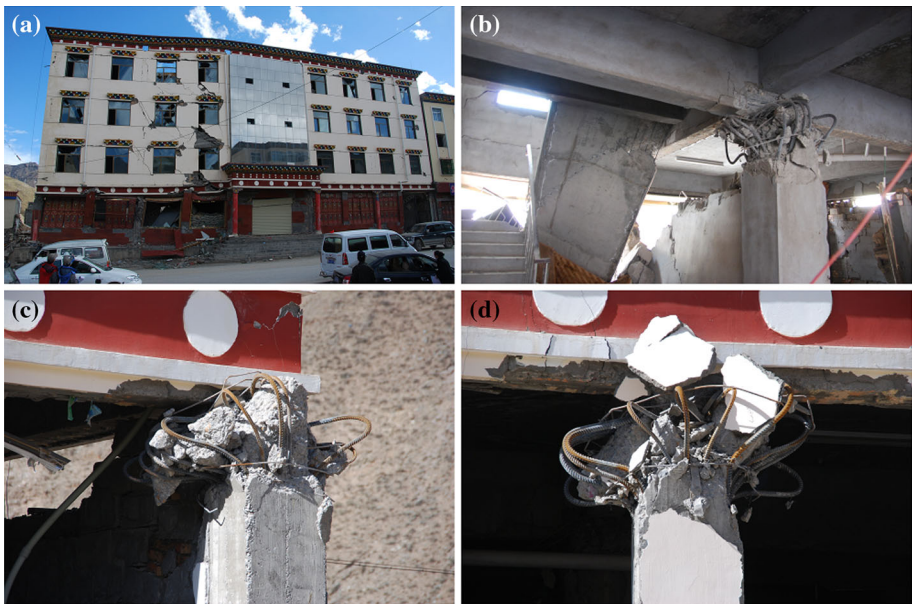
**Fig. 12** A four-story RC frame building near Shangye Road and Baqu River with yielded column ends in the soft first story and cracked infill walls around some upper floor windows (Part IV)

- (5) In the earthquake, the infill walls of RC frame buildings were partially destroyed and exhibited severe cracks and out-of-plane falling. Following corrective analysis and design, when performing seismic-resistant design, the infill walls should be inserted into a simulation model as non-bearing elements appropriately linked to load-bearing elements. A connection between infill walls and main frames to prevent out-of-plane destruction and collapse of the infill walls might also be required.

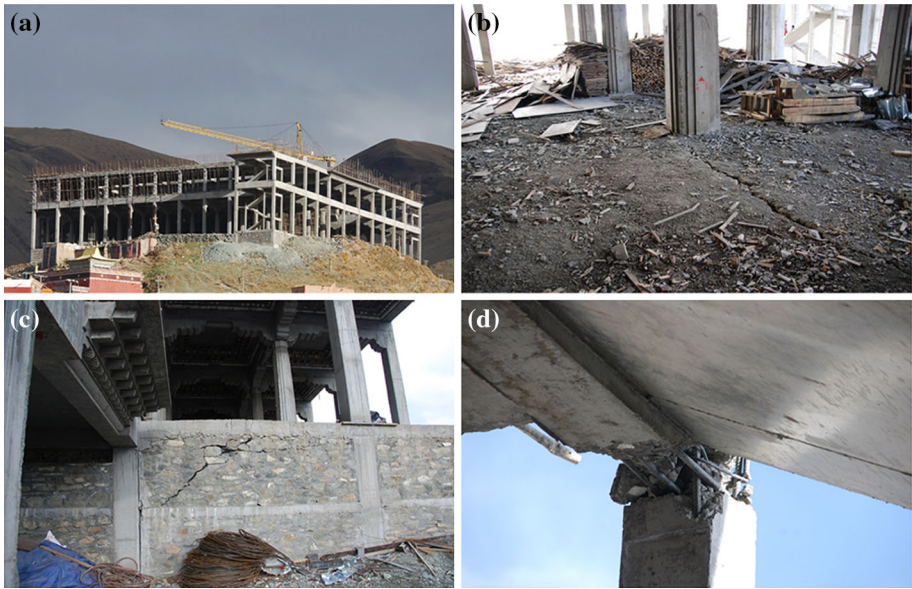
**Fig. 13** An RC frame building under construction at the top of a mountain; it exhibits cracked ground, a partially damaged foundation, and yielded column ends due to the mountain topography and the failure of the slope (Part V)

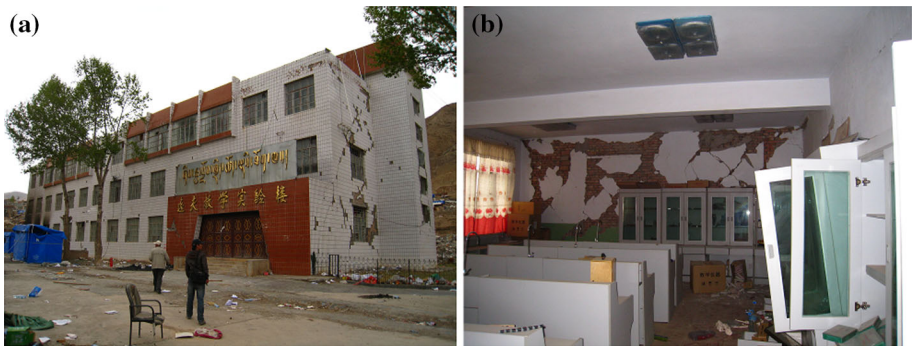
**Fig. 15** A building in a college with X-shaped cracks in bearing walls and severe damage to interior walls (Part III)

- (6) For brick masonry structures, cracking or even collapse of load-bearing walls is a common failure pattern. The survey found, however, that a more thoughtful arrangement of structural columns and belt courses can significantly improve building integrity and reduce collapse probability. The design and construction of the structure should therefore strictly follow the specification. In addition, outer vertical walls, including the walls below and between windows, should together form a lateral force-resisting system. The dimensions of vertical walls can also have a significant impact with respect to damage to them. It is also necessary to take into account the impact of window and door openings on the seismic performance of the whole structure.

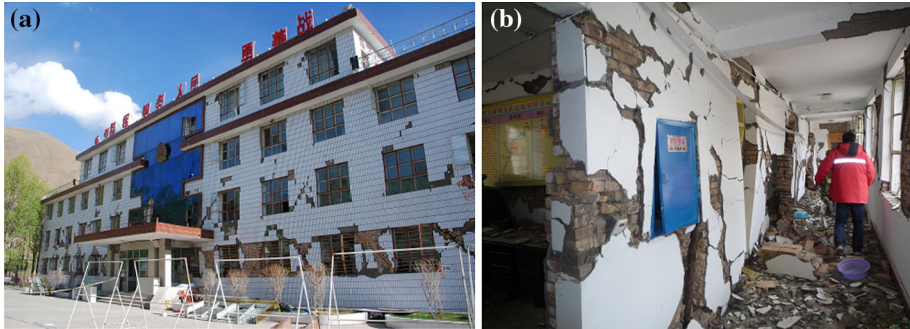
**Fig. 16** X-shaped cracks in bearing walls and cracked and partially destroyed interior longitudinal walls in an office building of a police station constructed without columns and belt courses (Part I)

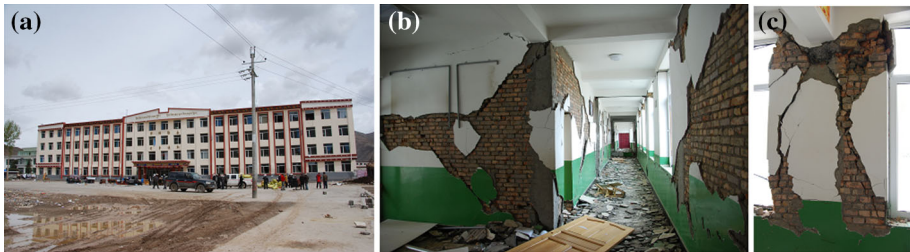
**Fig. 17** X-shaped cracks in most bearing walls, and broken columns on the first floor of a four-story masonry building of Yushu First National Middle School that was constructed using cast slabs, columns, and belt courses (Part IV)

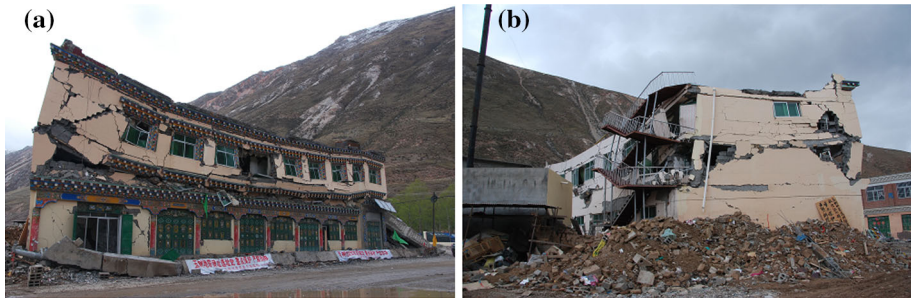
**Fig. 19** Collapsed second floor that was used as a large restaurant in the Gesaer Hotel building (Part I)

floors, especially the second floors, had much more severe damage than the first floors, as shown in Figs. 19 and 20a. A few buildings had completely collapsed first floors and slightly damaged upper floors as shown in Fig. 20b; this was also the most common damage pattern for this type of structure in the 2008 Wenchuan earthquake (Civil and Structural Groups of Tsinghua University, Xinan Jiaotong University, and Beijing Jiaotong University 2008; He et al. 2011a, b).

- (7) For bottom frame structures, several buildings had severe damage on floors with low stiffness, and some even experienced entire floor collapse. The damage in several earthquakes indicates that this kind of structure is inappropriate for high-seismic-intensity areas.

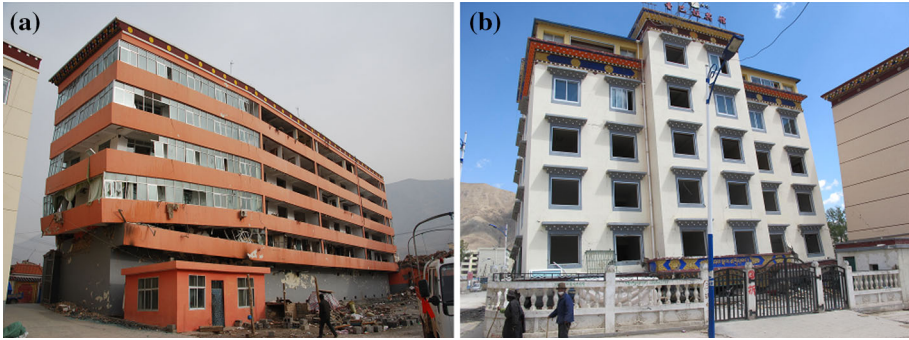
**Fig. 20** **a** Partially destroyed second floor in a building of Yushu Construction Company that has an RC frame for the first floor and masonry structure at upper floors (Part IV), **b** the six-story Xiangbala Hotel at Mengtong Road with a completely destroyed soft first floor and slightly damaged upper stories (Part IV)
