# Landslide Hazard in the Nainital township, Kumaun Himalaya, India: the case of September 2014 Balia Nala landslide

**Abstract** Nainital township located in the Kumaun Lesser Himalaya is known to be vulnerable to landslides since past, and it has been reported that half of the area of the township is covered with debris generated by landslide. A disastrous landslide in the Rais Hotel locality on the right side of the Balia Nala struck during September 2014 after the excessive rainfall. Geologically, the area dominantly comprises limestone with shale and slate which are highly crushed and weathered due to the presence of the Nainital Lake Fault that extends into Balia Nala as Balia Nala Fault. Ground-penetrating radar study depicts that these rocks are overlain by thin debris cover of the order of 5–10 m. The geotechnical studies confirm these rocks and the overlying soil as having very low strength. The landslide has triggered because of the excessive rainfall in the area. It has been observed that rainfall in the area has increased since 2010. An increase in more than 100 % intensity of rainfall during the monsoon from an average 33 mm per day (1995–2013) to 68 mm per day in 20

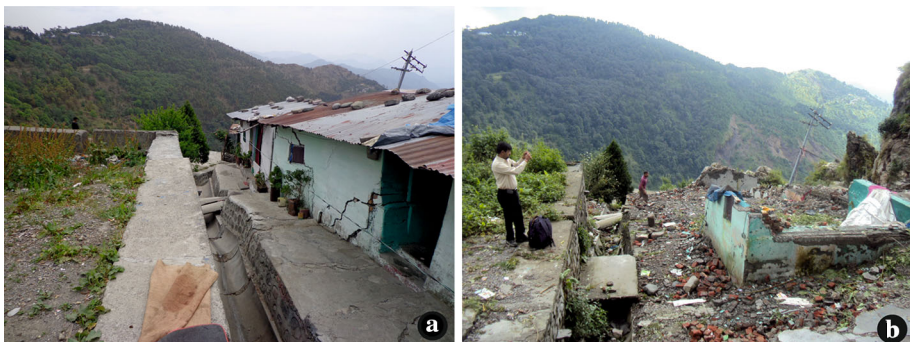
A landslide had occurred on 10 September 2014 in the Rais Hotel colony locality after the continuous rainfall. The slide had damaged about 20 m stretch of the concrete footpath connecting GIC–Krishnapur and washed away about 360 m<sup>2</sup> retaining wall on the slope (Fig. 1c). Prior to the occurrence of landslide in the area, cracks in the houses and on the ground have been observed, clearly indicating that the slopes were moving slowly (Fig. 4).

**Fig. 4** **a** Cracks on the walls of the houses located adjacent to the GIC playground before the occurrence of September 2014 Rais Hotel colony landslide and **b** subsidence of the area and damage to the houses after the occurrence of September 2014 Rais Hotel colony landslide

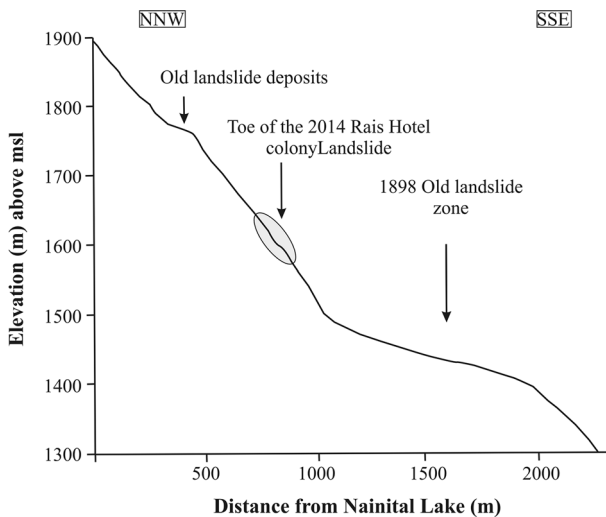
(Fig. 5). A major knickpoint has been observed at an elevation of about 1500 m above msl, where the channel gradient drops to about 5°, which continues till 1400 m, and further downstream the channel gradient again increases to about 20°. The gentle gradient in the zone between 1400 and 1500 m above msl has been well correlated with a landslide that occurred on the left bank of slope in the Kailakhan region in 1898, depositing 5.5 million tons of debris into the Nala (Middlemiss 1898). Another small nickpoint in the profile has been observed at about 1770 m above msl. This is also related to the landslide along the Nala. The overall steep gradient of the Balia Nala is mainly because of the active movement of the Balia Nala Fault as has been evidenced by the continuous widening of cracks on the walls of the houses located on either sides of the Balia Nala (Fig. 6).

**Fig. 5** Longitudinal profile along the Balia Nala indicating very steep channel gradient and old landslide deposits

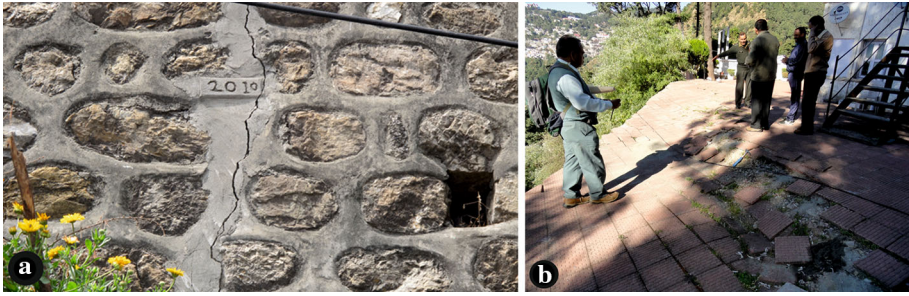
**Fig. 6** **a** Cracks surfaced again and in continuously widening on the retaining wall in a school building that was repaired in 2010 and **b** tiles of the floor have been uprooted in a zone of about 2 m width and more than 50 m length in the Kailakhan region on the left flank of the Balia Nala

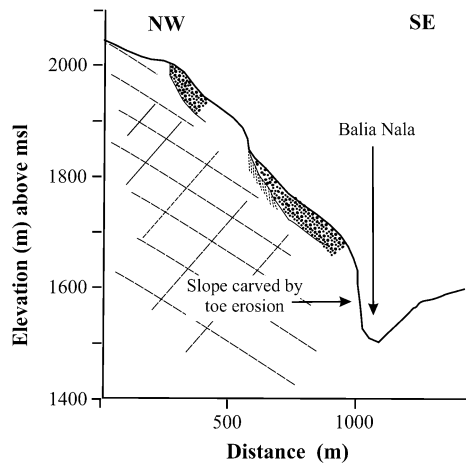
Figure 7 depicts the cross section along the Rais Hotel locality landslide that occurred on 12 September 2014. The crown of the landslide is located at 1872 m. The main scarp of the landslide is about 225 m high. The slide is located on a small spur, and the general hill slope is very steep with an angle of about 70° towards south-eastern side. The slide is being widened along both sides as well as progressing in the upward direction as indicated by the cracks on the slope and in the houses. The slide has partially damaged about 20 houses located in the vicinity and has endangered all the houses in the locality (Fig. 8a). Cracks have also been observed in the building of the Govt. Inter College, located on the crown portion of the landslide.

**Fig. 7** Cross section of the Rais Hotel colony landslide that struck in the Nainital township in September 2014

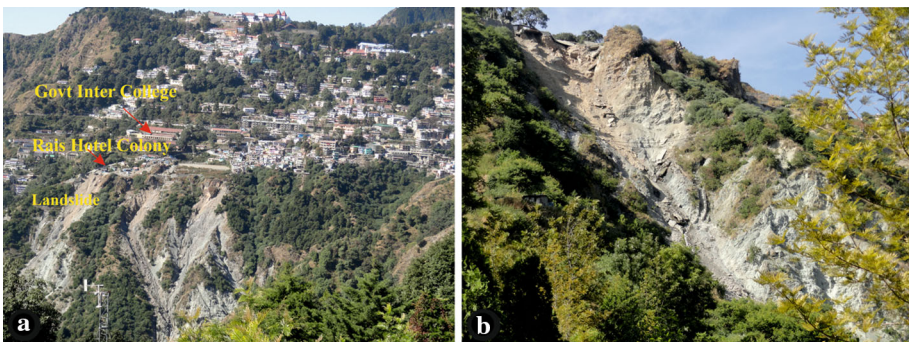
The entire slope in the landslide zone in the upper part is made up of weathered limestone and dolomitic limestone, whereas the lower slopes towards the Balia Nala are made up of black carbonaceous slate. The slates are highly weathered and leached with white and yellow encrustation. These are covered with thin veneer of debris constituting mainly pebble- and cobble-size limestone, sandstone and slate embedded in sand–silt–clay matrix (Fig. 8b). The rocks exposed in the landslide zone dip towards NE at an angle of about 35° (towards up-drainage direction). The slope towards the lower slope near the Balia Nala is being continuously eroded by the Nala and is thus very steep of the order of 80°–85°.

**Fig. 8** **a** Panoramic view of the Rais Hotel colony landslide that has damaged about 20 houses and is endangering the entire Rais Hotel locality including the GIC, **b** main body of the landslide depicting weathered rocks in landslide zone and is covered with thin veneer of sediments

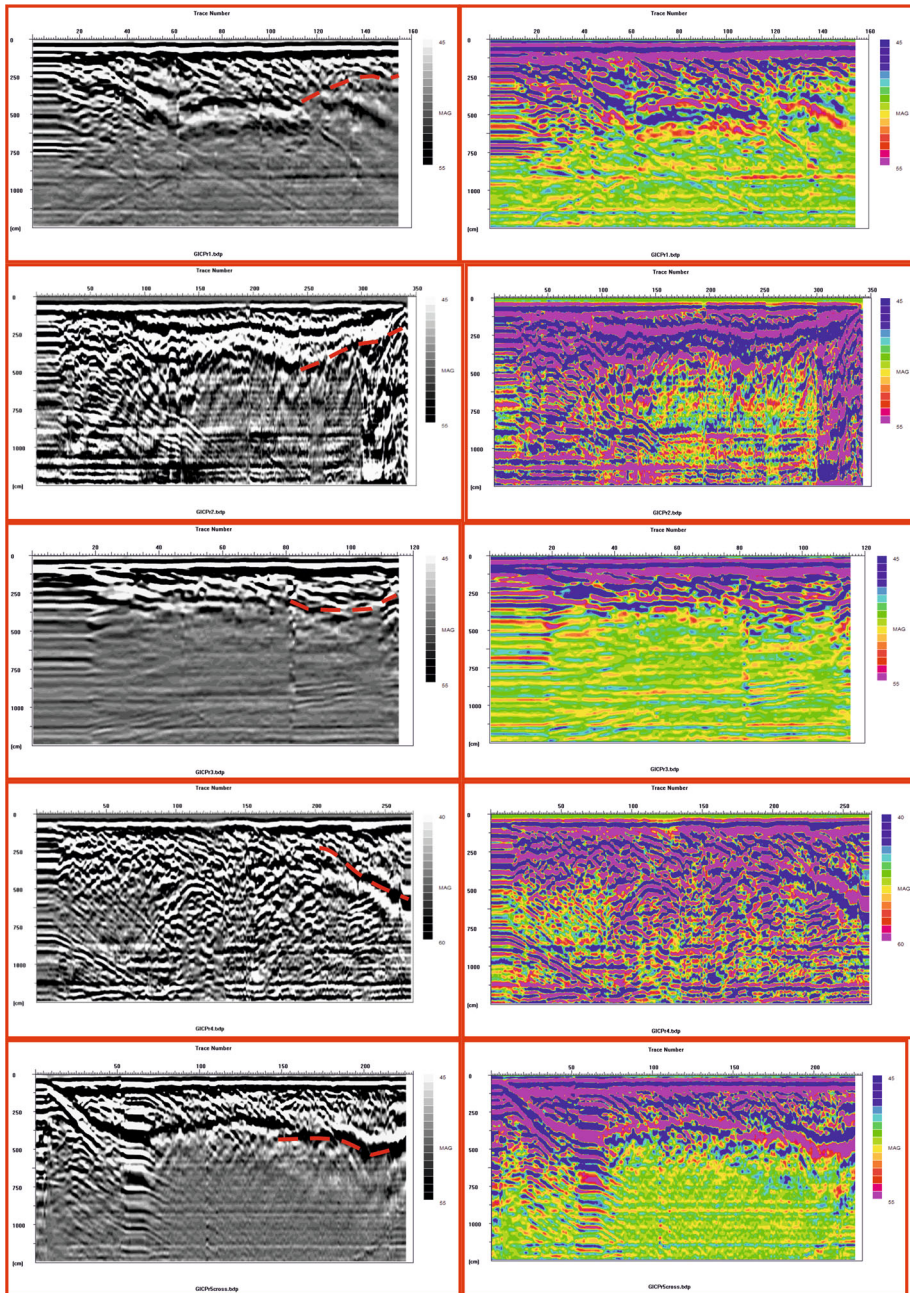
**Fig. 10** GPR profiling along lines 1–6 on the Rais Hotel colony playground (refer to Fig. 9). *Red dotted line* indicates the interface of the rock and overburden

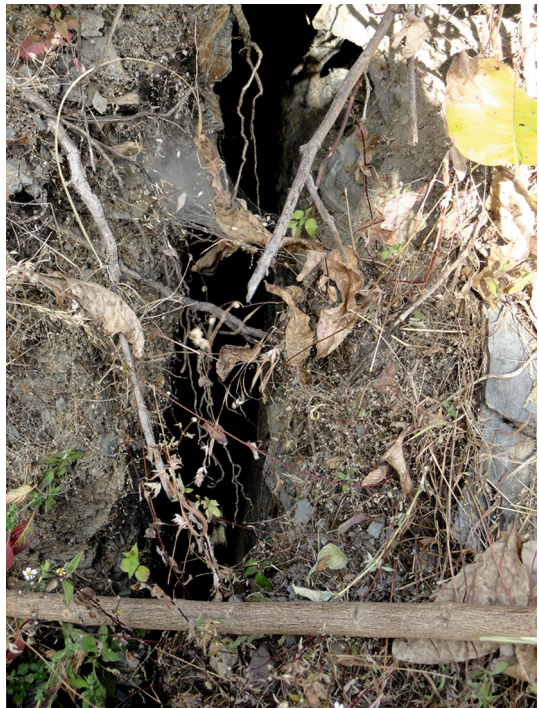
**Fig. 11** Open cavities in the rock slope on the lower valley slope indicating that the slope may fail in future

noted to be widened with time (Fig. 4a). Further downhill on the slope, open cracks and cavities in the slope have been observed (Fig. 11), indicating the probability of future hazard. The area at the lower elevation is being monitored for its surface movement using GPS, and it has been observed that the area is sliding slowly at a rate varying between 10 and 60 cm/year (Kotlia et al. 2009). Cracks have also been noted on the left bank of Balia Nala in the Kailakhan area. These cracks were noted at different elevations, prominently at about 1898, 1929 and 1950 m above msl, running along ESE–WNW direction. This side of the Balia Nala is occupied by the army camp, and at the ridge top, Nainital Halipad is located. Thus, landslides at the lower elevation (Fig. 12) are posing serious threat to the Halipad and the army set up in the area.

It is therefore utmost important to take immediate preventing measures in the form of construction of proper drainage network on the slopes so that ingress of water into the slope is minimum.

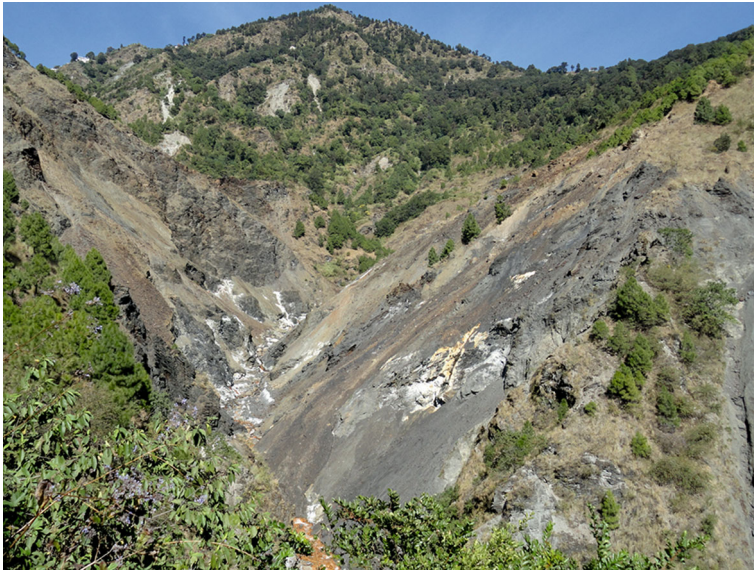
**Fig. 12** Highly sheared and weathered rocks on both sides of the Balia Nala due to the Nainital Fault, here referred to as Balia Nala Fault
