Seismic damage to schools subjected to Nepal earthquakes, 2015

Keywords Nepal earthquake 2015 · School · Directivity effect · Site effect · Earthquake sequence

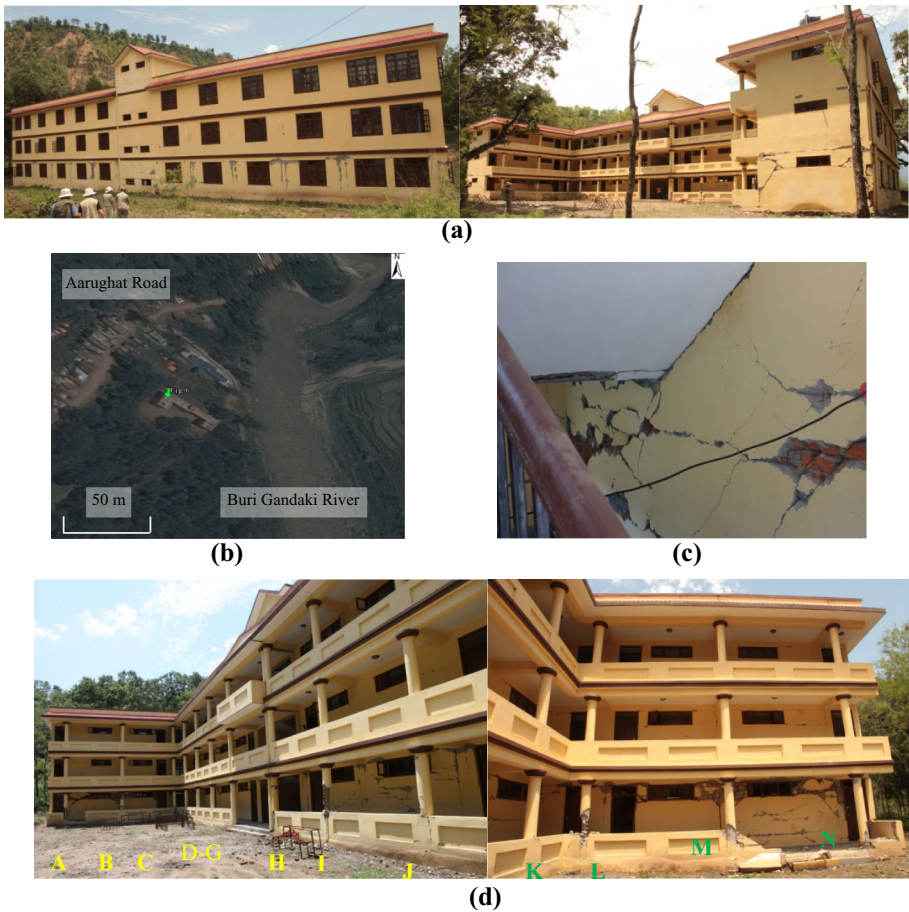
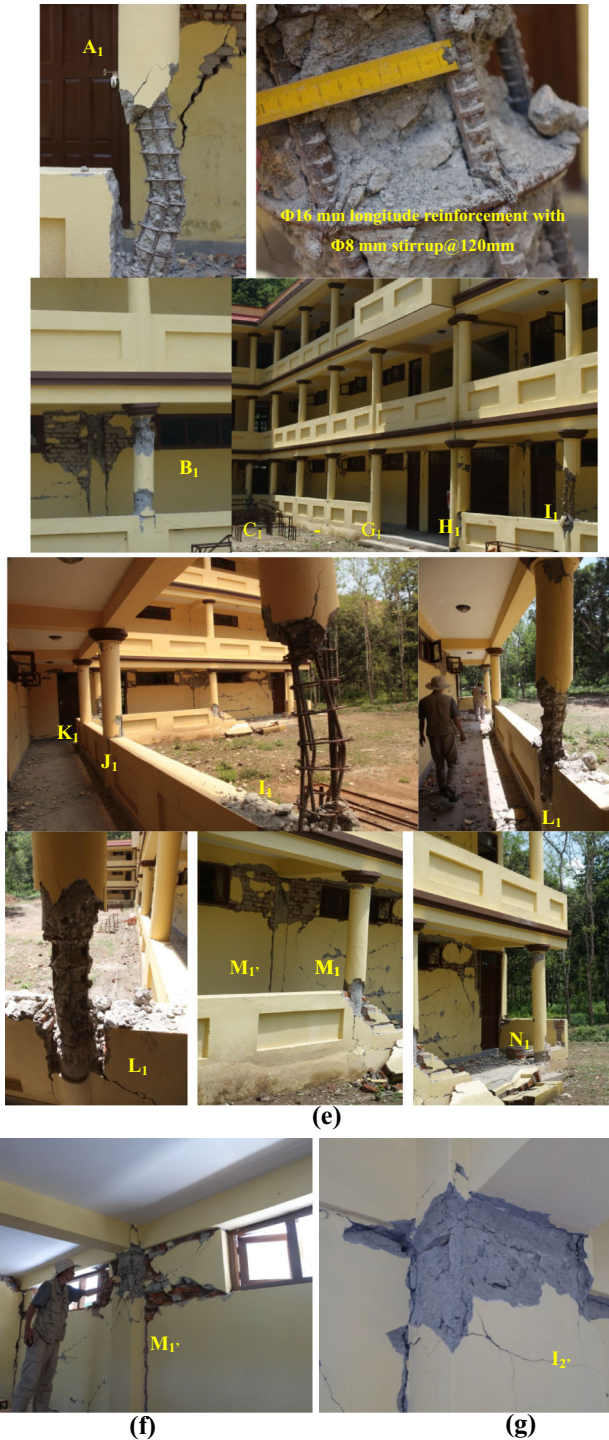
A university with a three-storey (partial four-storey) RC frame built in August 2012 was found on the large flat lower terrace between the Arughat road and Buri Gandaki River in the Aruchanaute Gorkha Gandaki district (Fig. 6a). The topography map is captured from Google Earth as shown in Fig. 6b. The structure showed many typical types of damage, such as the short column effect due to the sudden change in the lateral stiffness supplied by the half-height walls in the corridors, X cracks between holes in the masonry walls and the existence of a weak floor (the bottom floor) due to the failure of the ‘weak beam/slab, strong column design’ in realising the shared energy absorption amongst the structural components of all floors. The masonry wall of the staircase connecting the first and second floors had a severe crack, as shown in Fig. 6c. Based on the state of the seismic damage to the bottom floor, the possibility of collapse if a strong aftershock hit this area was high. Thus, the university was graded as ‘dangerous’ after inspection by the Nepal government, so it could no longer be used as a refuge until it was repaired.

There were 14 columns along the corridor for each floor with the interval distance around 5 m, marked A through N as shown in Fig. 6d. The subscript following the letter indicates the floor to which it belongs, e.g. A₂ stands for a column on the second floor, whilst M₁ stands for the column next to and in the same cross section with M₁. All of the columns were inspected carefully and are shown in Fig. 6d, e. Column A₁ failed due to constraint by the adjacent half-height wall, which induced a shear force and bending

moment at the column’s lower section. The exposed longitudinal reinforcement bar had a diameter of 16 mm with $\Phi 8$ mm stirrup @ 120 mm. Column B₁ suffered less damage, but the upper and lower concrete cover broke off due to the short column effect. Columns C₁ through G₁ were almost intact; damages were found in the corner columns C₁ and D₁. However, on the symmetrical side, H₁ had moderate damage at its connection to the half-height masonry wall. The concrete of column I₁ was reduced to rubble, leaving its yielded reinforcement bars twisted. J₁ and K₁ had only slight damage. Column L₁ at the inner corner also had severe damage. Columns M₁ and N₁ had less damage, probably due to the early out-of-plane collapse of the adjacent masonry walls. The inside view of the columns on the first and second floors (Fig. 6f, g) shows the great variation in the seismic damage intensity, which indicates that the structure member of the higher storey did not share

Fig. 6 Seismic damage to a three-storey university with a reinforced concrete (RC) frame. **a** Overview (*left* north elevation; *right* south elevation). **b** Nearby topological information. **c** Wall of the staircase between first and second floors. **d** South elevation and damage to 14 columns (A through N) of the corridors on the first floor. **e** Seismic damage to 11 columns along the corridor of the first floor. **f** Inside a classroom on the first floor in the same cross section as column M1. **g** Column of a classroom on the second floor in the same cross section with column 12

However, the different seismic intensities experienced by columns F_1 and G_1 and H_1 and I_1 could be due to the local adverse site configuration (the detail site configuration report is not available until now), the live load distribution or the local defect of the columns. It is worth noting that the columns H_1 and I_1 were closer to the river, and the columns F_1 and G_1 were close to the higher terrace (by about 5 m) as shown in Fig. 6b.

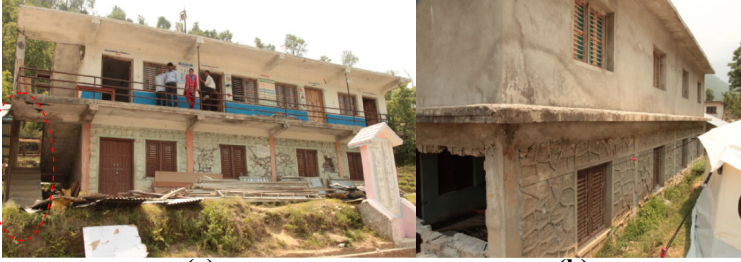
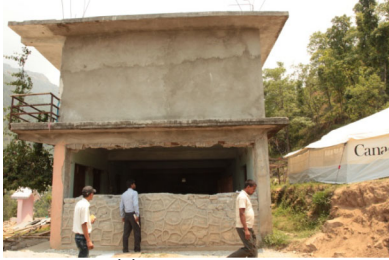
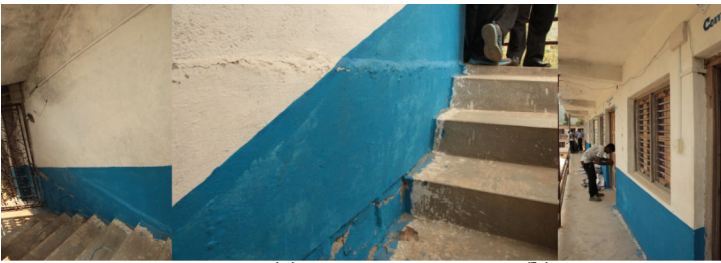
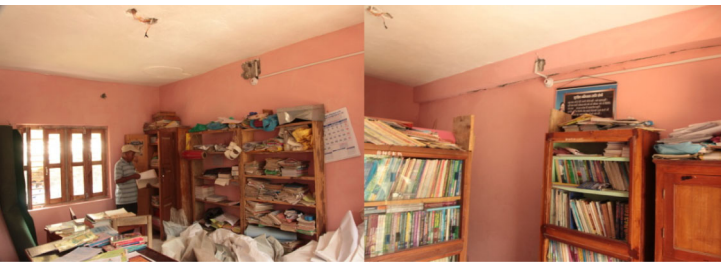
Located on a small hilltop (estimated to be 40 m higher than the hill foot; see Fig. 7a–d), this school suffered moderate damage to its stone masonry walls. The masonry walls of the first floor had severe damage, whilst those on the second floor had only slight damage at the joint of the masonry wall and the RC frame, as shown in Fig. 7g–i. The outer cement belt net enhanced the wall's bonding strength (Fig. 7a, b, e, f). The out-of-plane collapse of the masonry wall was due to the heavyweight of the rock with the limited bonding strength (Fig. 7c). However, the RC column suffered limited damage (Fig. 7a, b, e). One additional defect is shown in Fig. 7a: there was no column beneath the slab of the first floor near the staircase. Although it did not lead to significant damage to the upper structure due to the lightweight above under moderate seismic input, this situation should be avoided to prevent partial collapse. The staircase was almost intact; cracks were found at the joint of the stair step and the masonry wall supporting it.

◀ **Fig. 7** Seismic damage to Shree Bhumeswory Higher Secondary School, Muktitar, Sindhupalchok. **a** South elevation (note the absence of the column underneath). **b** North elevation. **c** East elevation. **d** West elevation. **f** Crack in the masonry outer wall. **g** Inside view from the east elevation collapsed wall. **h** Staircase. **i** South face of the second floor. **j** Second floor inside view, slightly damaged (no apparent cracks)

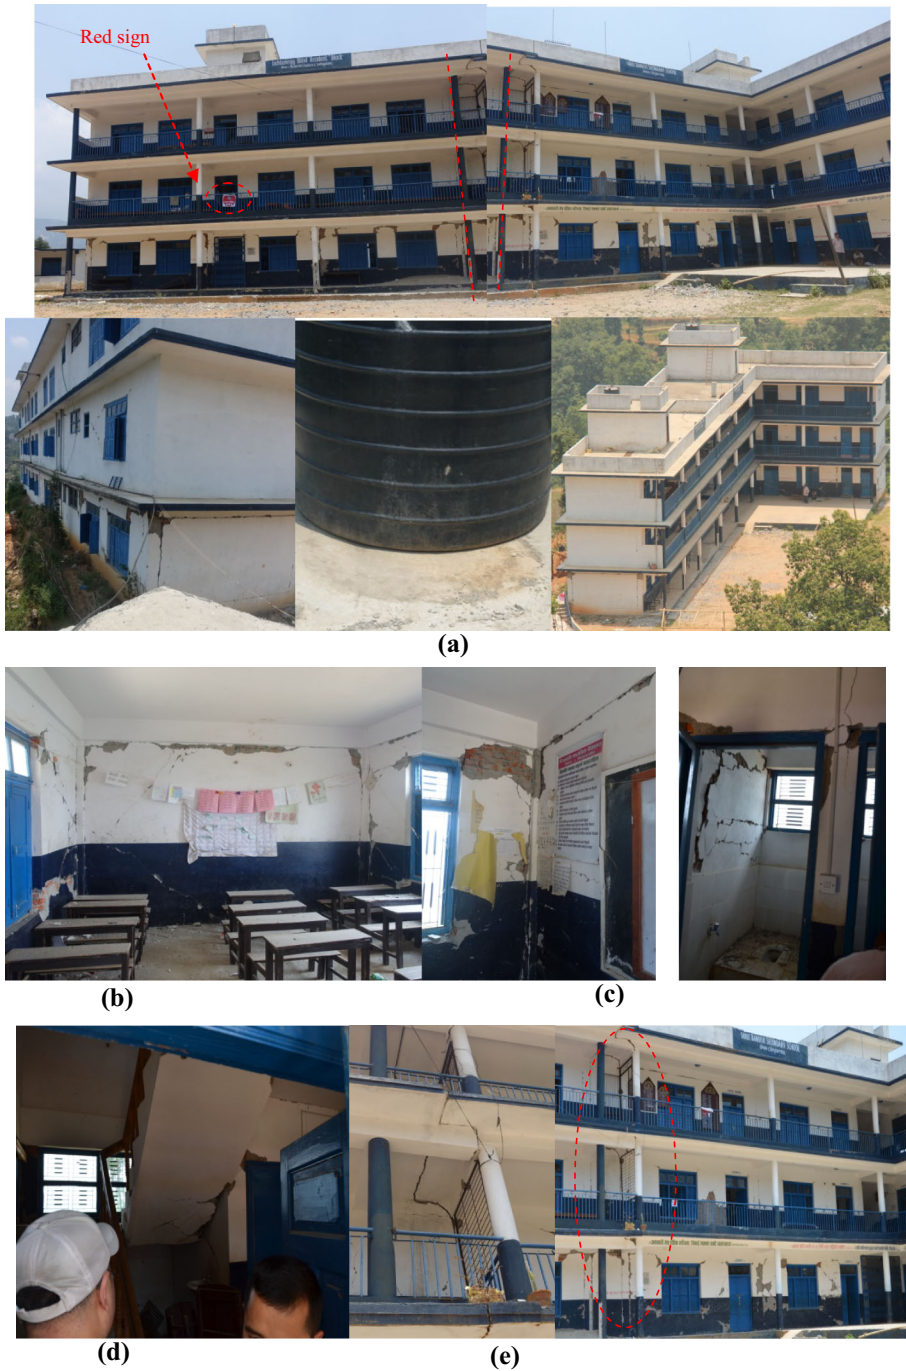
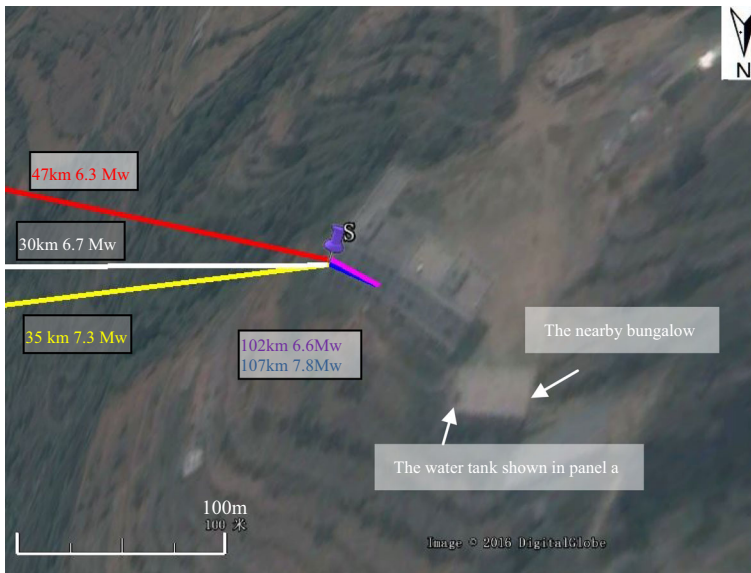
This three-floor RC frame located at Chautara 8, Sindhupalchok, was constructed with financial assistance from Germany and Austria in November 2012 (Fig. 8a). The connection between the masonry wall and the RC frame at the corner had an apparent crack along the interface of the frame and the masonry wall, as shown in the lower left panel of Fig. 8a. The small water tank on the roof of a nearby bungalow (Fig. 8f shows relative positions of the two buildings) had moved about 17 cm, as measured from the stamp shown in the lower middle panel of Fig. 8a. The inner masonry walls of the first floor between the holes (window or door) had developed slight or moderate diagonal cracks (Fig. 8b, c). The wall and the ladder of the staircase connecting the first and second floors had moderate cracks, as shown in Fig. 8d. The damage to the seismic joint is circled in Fig. 8e. The sharp turn of the crack path might indicate the reinforcement configuration or the position of the slab connection (left panel in Fig. 8e). After inspection, the structure could have been graded as moderately damaged in our opinion; however, it was classified as uninhabitable (red sign for danger shown in Fig. 8a) by the Nepal government to prevent the casualties that could result from a collapse.

Fig. 8 Seismic damage to Shree Bandevi Secondary School. **a** Overview (*upper panels* are connected at *red dashed lines*). **b** The inner wall had light to moderate damage. **c** Crack between the window hole and the toilet door on the first floor. **d** Severe damages to the staircase connecting the first and second floor. **e** Large relative movement at the seismic joint. **f** The topographic map from the Google Earth

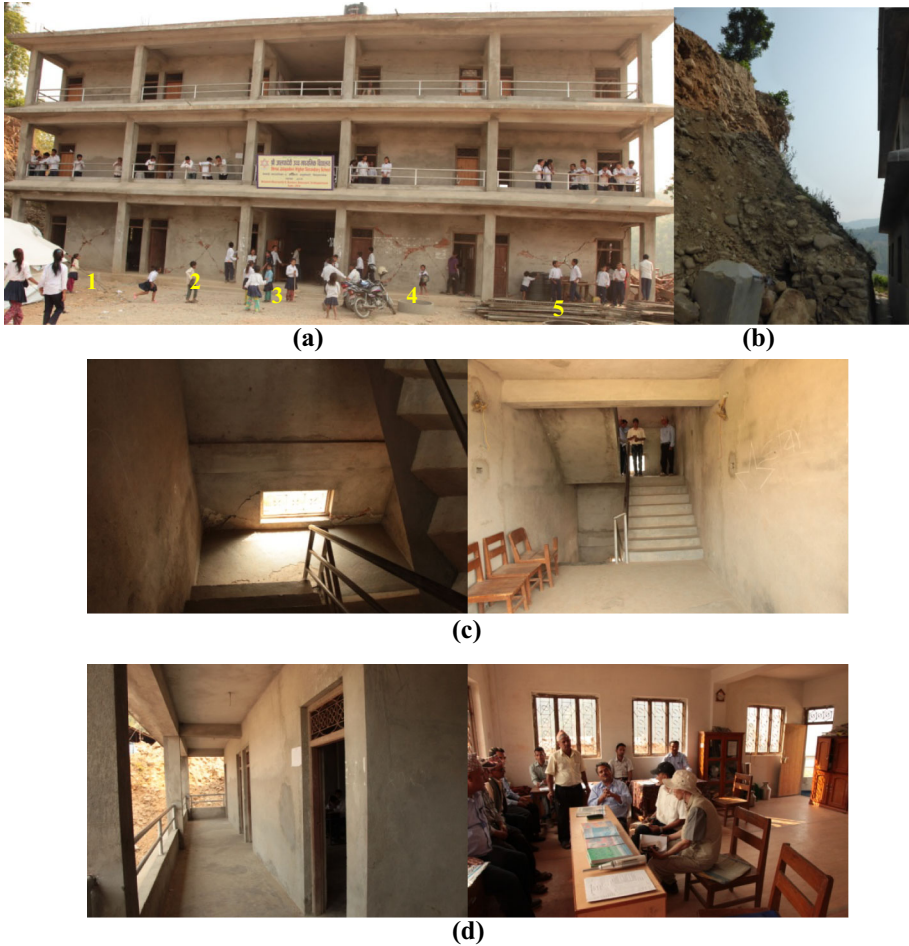
This school, located at Melamchi Municipality-8, Bansbari, Bahunipati, Sindhupalchok, had a regular design, as shown in Figs. 9 and 10. Damage was found only in the masonry walls of the first floor and the landing of the staircase connecting the first and second floors. It was interesting to find that the back side of the structure had no apparent damage. Only the front side of the masonry wall showed severe cracking (Fig. 9a), possibly because of

the differing lengths of the holes in the front and back elevations. On the back side, many windows divided the masonry wall into small pieces, thus reducing the in-plane stiffness, whilst the front wall had a longer cross section, which made it stiffer and resulted in more severe damage than that seen on the back side.

Fig. 9 Seismic damage to Shree Jalapadevi Secondary School. **a** Overview. **b** Hill to the *left* of the building. **c** A small crack developed diagonally at the corner of the windows in the staircase connecting the first and second floors. **d** No damage was observed on the second floor

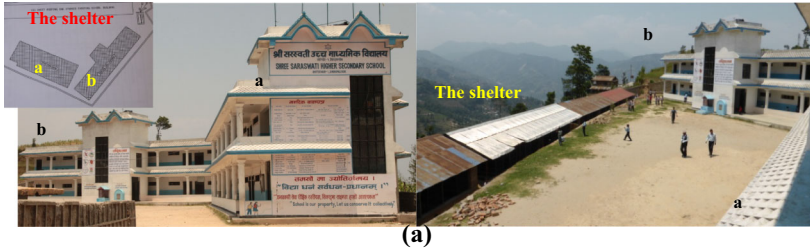
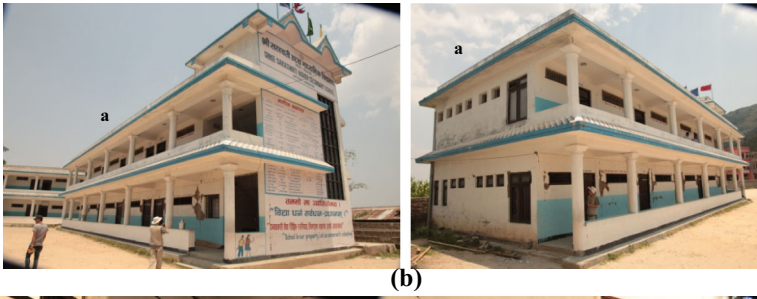
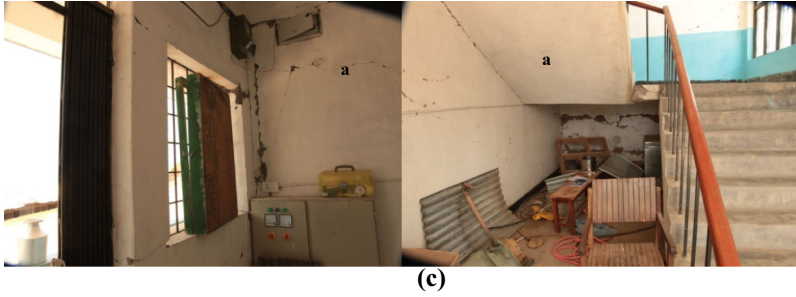
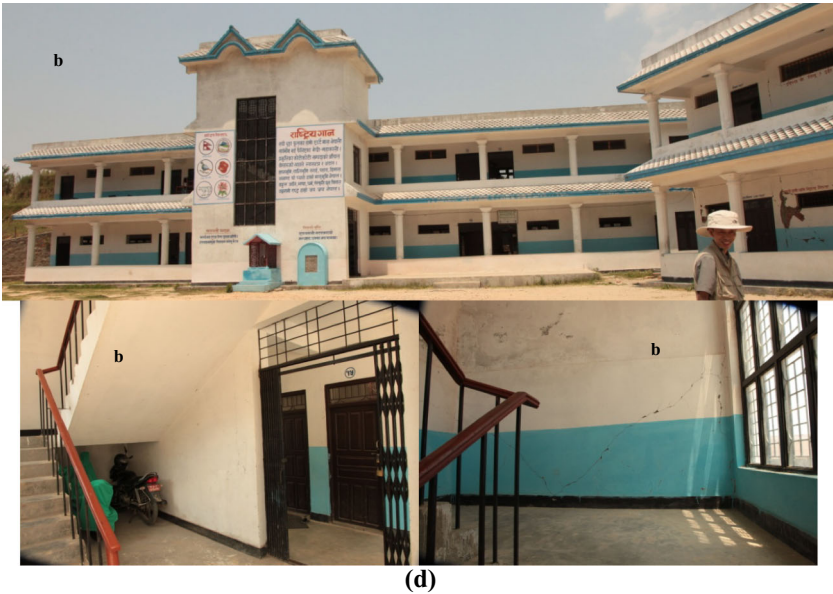
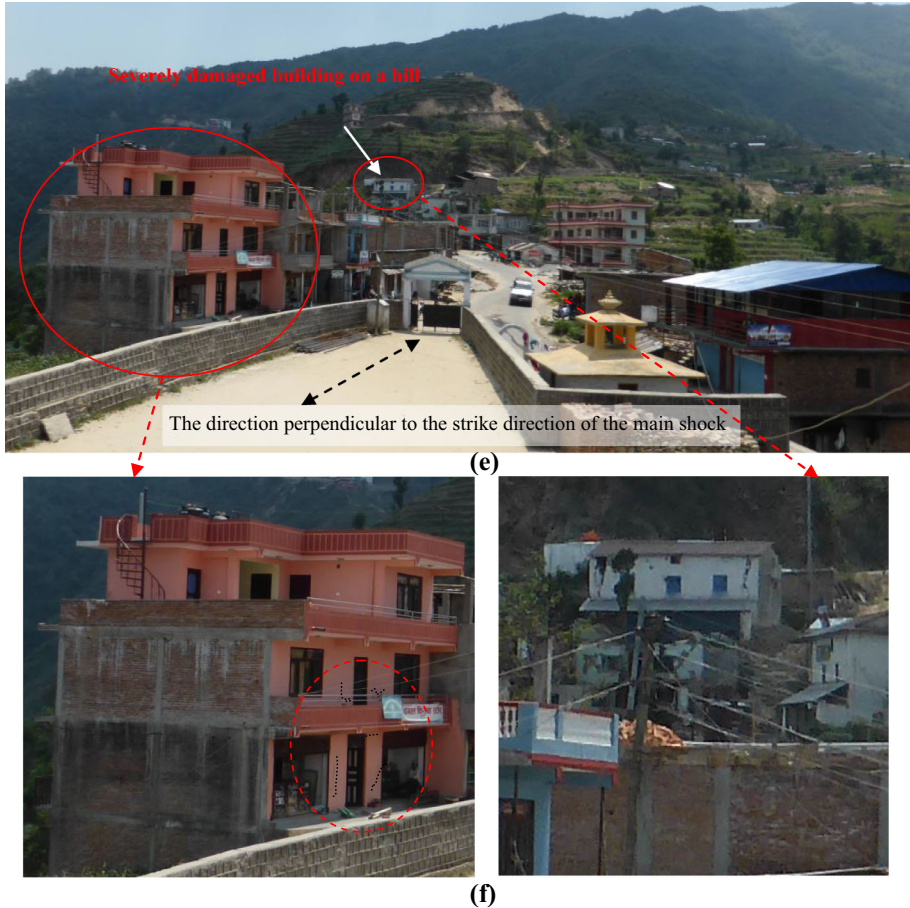
The characteristic of this school that distinguishes it from the others is that the seismic damage intensity of the school building differed greatly along the main shock's strike direction and the perpendicular direction. The school located at a small hill with around 10 m attitude difference from the hill foot (Fig. 10f). The amplification effect due to higher altitude is well known and verified by comparing with surrounding buildings shown in Fig. 10e, f. The nearby house with red circle is almost intact with visible crack perpendicular to the strike direction of the main shock. Another two floor masonry house on a hill has much severer damages.

The early built Building a has much severe damages along the longitudinal direction, even though there are also many holes in the transverse direction as shown in Fig. 10b, c. It is interesting to find that the transverse direction of Building a coincides with the strike direction of the main shock. One possible reason could be the forward-directivity effect of the input seismic wave. The forward-directivity effect is generated when the velocity of fault rupture is close to the shear-wave propagation velocity. As the rupture front propagates from the hypocenter, the amplitude and the energy of a shear-wave front are accumulated by the shear waves travelling ahead of the rupture front. When a site is located along the fault and the earthquake wave propagates towards the site, the arrival wave front is seen to have a large pulse of motion (a shock wave effect) (Bray and Rodriguez-Marek 2004). Two rupture directivity effects are well known: a change in the magnitude of shaking and the difference in the magnitude of shaking on the two horizontal components oriented perpendicular (larger) and parallel (smaller) to the strike of the fault (Abrahamson 2000).

This proposal is further verified by the inspecting result of Building b, which is perpendicular to Building a. It is found that the longitudinal outer walls of the first floor of Building b do not even have visible cracks; only the wall on the platform of the staircase connecting the first and second floors has a minor crack in the transverse direction (the

◀ **Fig. 10** Seismic damage to Shree Saraswati Higher Secondary School. **a** Overview. **b** Cracks were found at the corner of the door and window holes on the first floor of Building **a**. **c** Damage to the staircase connecting the first and second floors of Building **a**. **d** Limited damage was found in the staircase of Building **b**. **e** View along the longitudinal axis of and from Building **a** to the entrance. **f** Details of the circled building in **e**

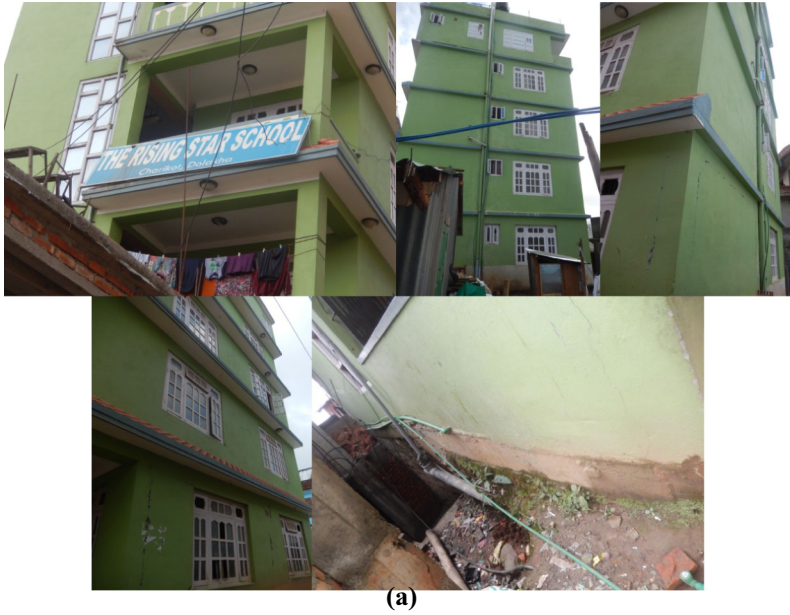
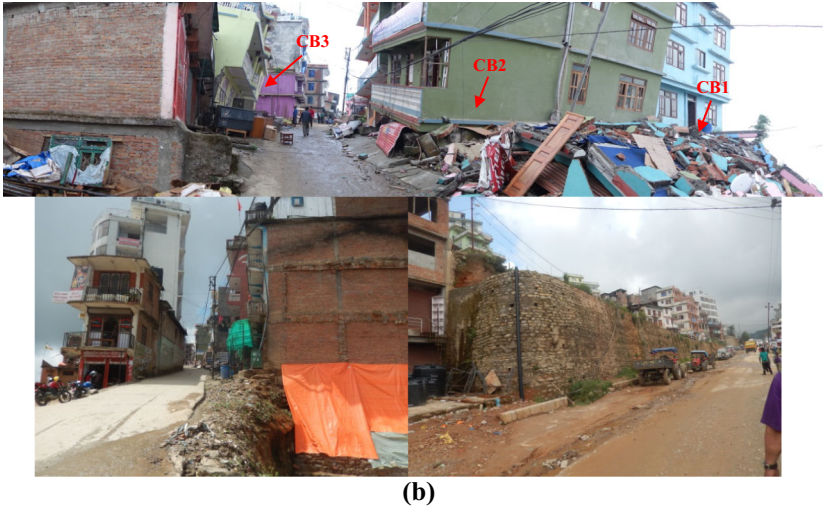
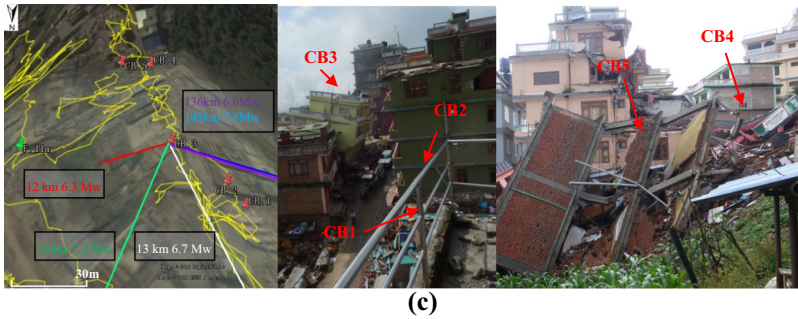
Rising Star School was a five-storey RC frame at Charikot as shown in Fig. 13. No severe damage was found in this building; only minor cracks were observed at the joint between the RC frame and the masonry wall on the first floor. However, only 100 m from this location, five collapsed and severely damaged similar RC frames were found within an area of 100×50 m (Fig. 13c). It was told by the local residents that the main shock only damaged most of the buildings. However, the aftershock on May 12 completely destroyed the damaged building as shown in Fig. 13. The reason for this big difference could be the

characteristics of the site configuration. The school is located on relatively flat ground, whilst the collapsed or severely damaged RC frames were located on a suddenly raised divide. The narrow divide might have amplified the long-period component of the seismic input due to its slender shape, which was probably close to the natural period of the RC frame, thus resulting in severe damage. In addition, the foundations of the RC frames on the narrow divide were bounded asymmetrically due to the limited land. Most of the collapsed buildings climbed up a cliff or stood narrowly from the cliff edge. The unequal swing forces during the load cycling of the earthquake tended to push the RC frames into the weaker bounding direction, causing a great amount of tilt or even collapse.

◀ **Fig. 13** Seismic damage intensity differed greatly between different RC frames in close proximity, one on flat ground and the others located on a suddenly raised narrow divide. **a** The school is on relatively flat ground and suffered minor damage. **b** Assembly of collapsed RC frames nearby, located on a suddenly raised narrow divide (CB indicates collapsed buildings on the ridge of the narrow divide). **c** The relative positions of these two locations and geological information around the two sites

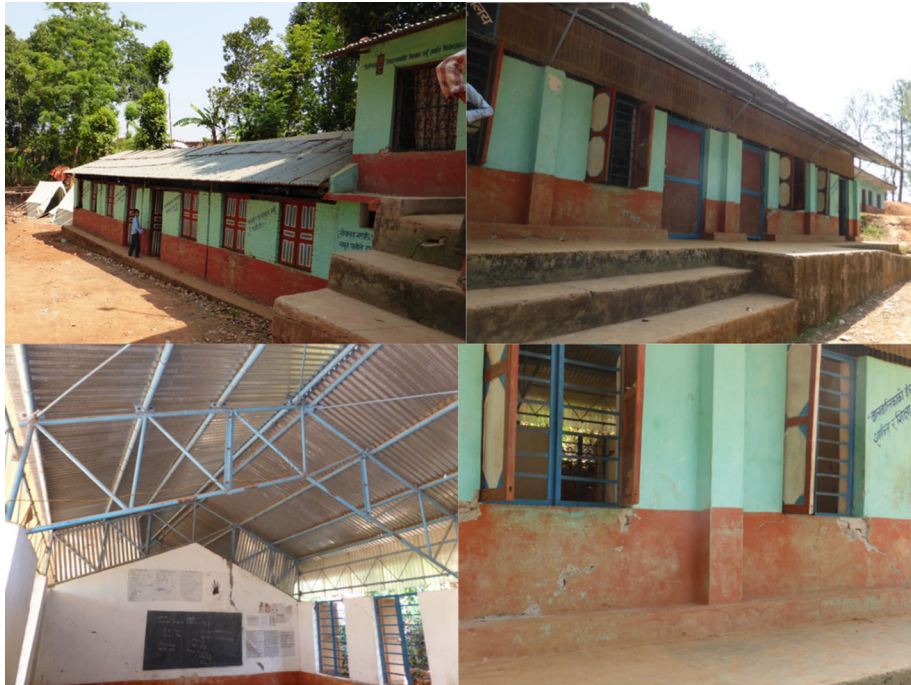
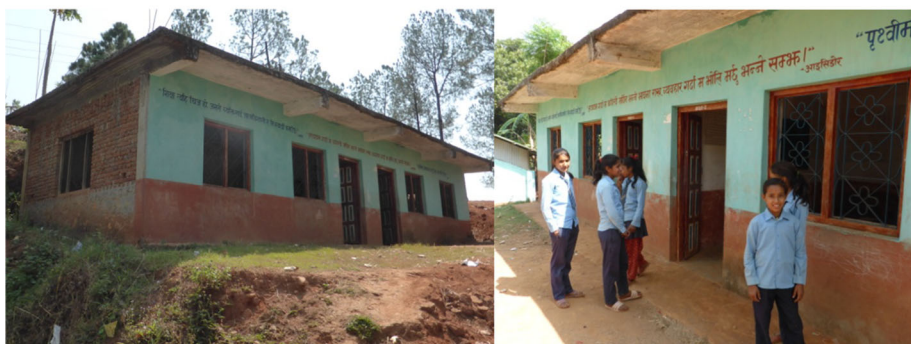
bungalow with an RC roof. The former had severe cracks in the masonry walls (Fig. 14a), whilst the latter was almost intact (Fig. 14b). The reason for the greater damage intensity of the former could have resulted from the lower constraint at the top of the wall because no ring beam or slab was present there and the light steel frame roof could neither provide sufficient stiffness to constrain the out-of-plane movement of the masonry walls nor coordinate the structure to resist the seismic load as a entirety. Thus, localised damage appeared, as shown in Fig. 14a.

Fig. 14 Seismic damage to Popakar Elementary School, including one RC bungalow and one masonry structure. **a** The masonry structure with a light steel frame roof has an apparent crack next to the window and door holes and inside walls. **b** The RC frame bungalow suffered no damage

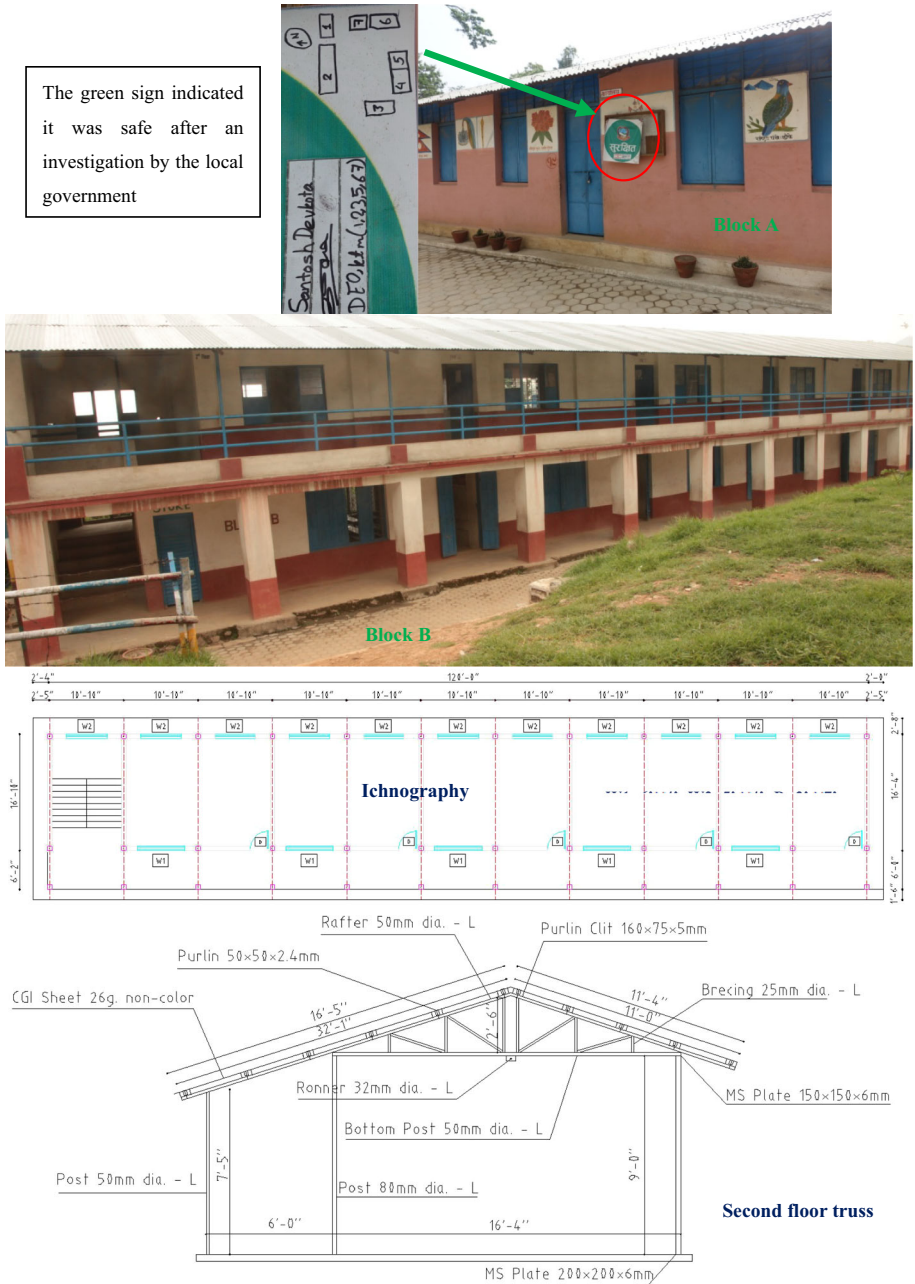
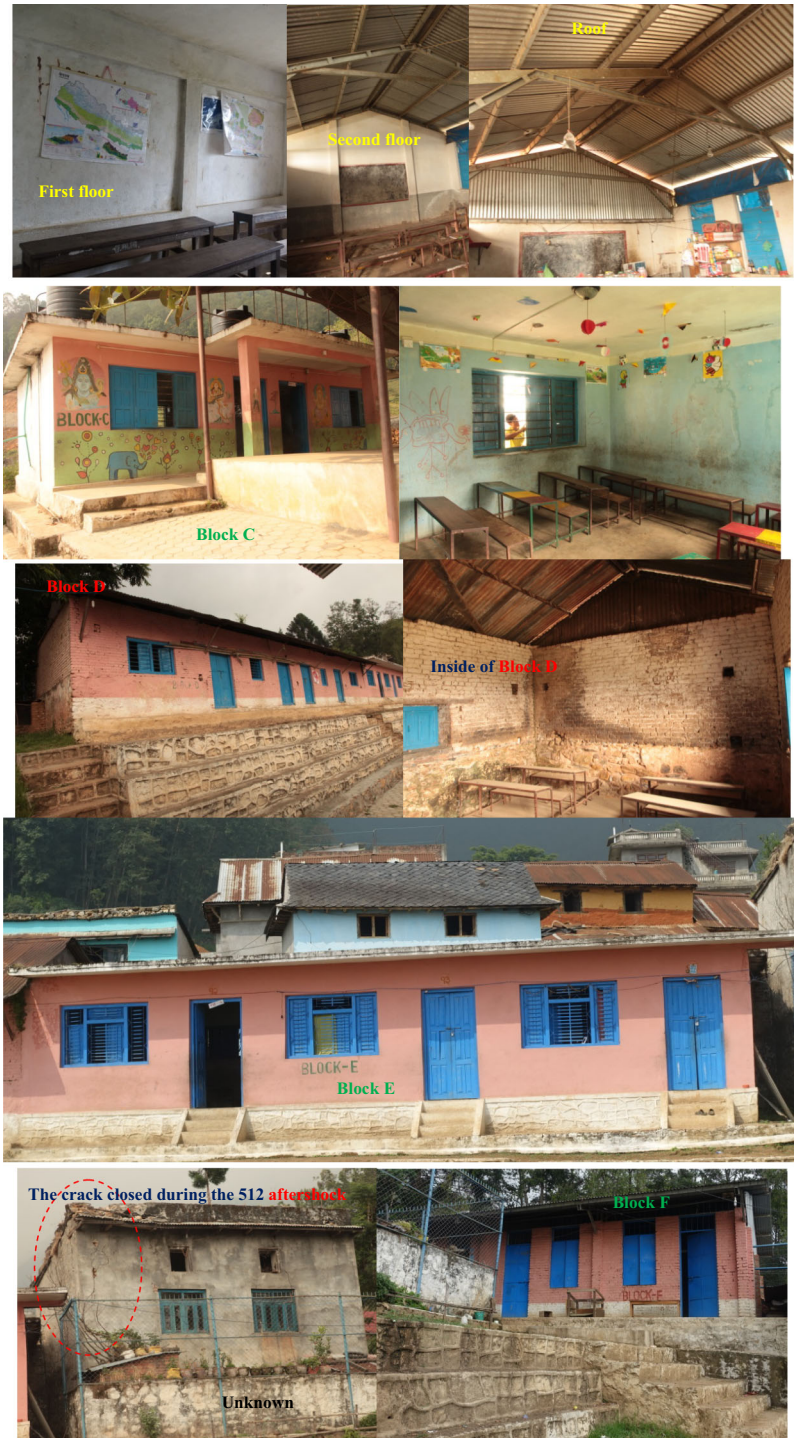
Fig. 15 Seismic damage to one RC bungalow and one masonry structure at Thankot Chundevi Secondary School

seismic damage intensity was low; however, like the damage at Popakar Elementary School, the masonry building with the light steel frame roof had the worst damage, followed by the two-storey RC frame with the masonry wall. The RC bungalow with the RC

roof was almost intact, with only a minor crack at the corner of the roof. Details of the seismic damage are shown in Fig. 15. There was a green sign at block A, indicating the ichnographic layout of seven school buildings and the status evaluation results from the local government. However, we only found six class buildings, blocks A to F, and building 6 marked on the green sign could not be identified. By comparison, buildings 1–5 clearly corresponded with blocks A–E, and building 7 corresponded with block F. The uncertainty did not cause us any trouble because only one building with a red sign was clearly marked on block D. All others were evaluated as safe by the local government.

We were interested to see that an old RC frame was severely damaged during the main shock, but the crack closed during the aftershock, leading to no further damage (see the bottom left panel of Fig. 15, marked unknown). This was just a happy coincidence.

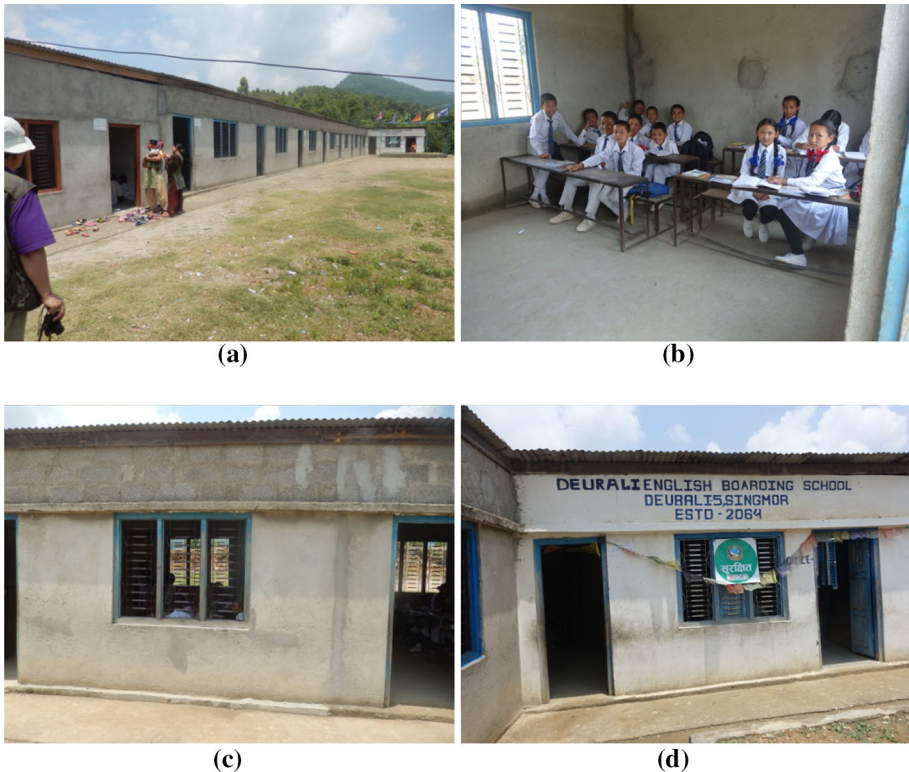
Fig. 16 Seismic damage to Deurali English Boarding School, constructed of light brick cement-bonded masonry. **a** Outside view. **b** Inside view. **c** Light brick over the heavy brick. **d** The school was verified to be safe as marked by the *green sign*

This cement-bonded masonry bungalow was located at Deurali-5, Singmor, ESTD—2064, on a hilltop. It had only minor cracks around the window and door holes (Fig. 16a), which had already been fixed by filling with cement, as shown in Fig. 16b. One typical difference from the other masonry structures we encountered is that a large lightweight masonry block was used for the wall above the window and door lintels (Fig. 16c). A timber frame

covered with a lightweight CGI sheet was used for the roof. Clearly, the construction philosophy was for the local artisans to use a lighter superstructure for safety. The building was graded as safe by the local government (Fig. 16d).

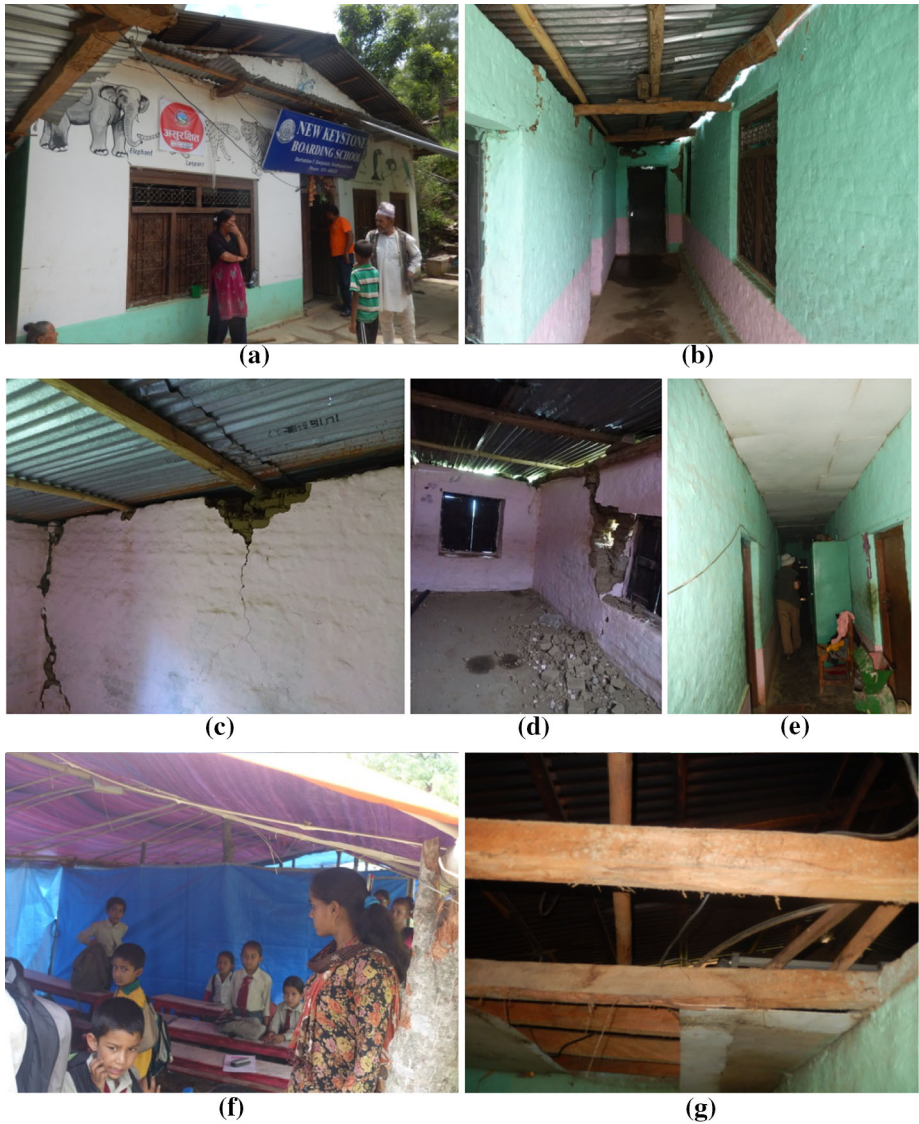
Fig. 17 Seismic damage to New Keystone Boarding School, constructed of low-strength cement-bonded masonry with simple timber frame roof with light corrugated plate. **a** School name. **b** The corridor. **c** Cracks of the wall under beam. **d** Severe cracks at the windows hole. **e** The corridor viewed from the opposite direction. **f** Temporary tents for teaching. **g** Electricity wires arranged around timber frame

This aged cement-bonded masonry bungalow was located at Barhabise-7, Sanipalati, Sindhupalchok district (Fig. 17a). Although it was regarded as cement-bonded masonry, the aged cement was weak, as shown in Fig. 17. Severely damaged and partially collapsed masonry walls were observed (Fig. 17b–e). Even with a simple timber frame supporting the light CGI sheet, the joint area of the wall and the timber beam still had a large crack (Fig. 17c). All crew members had been transferred to temporary tents outside the damaged school (Fig. 17f). It is worth noting that the electrical wires were arranged through the timber frame as shown in Fig. 17g, which might have caused a fire hazard.

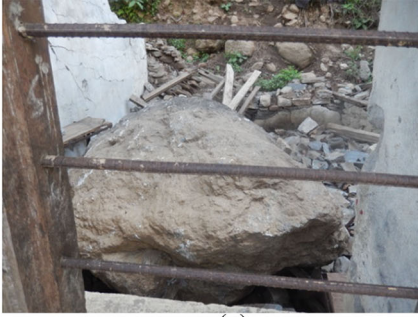
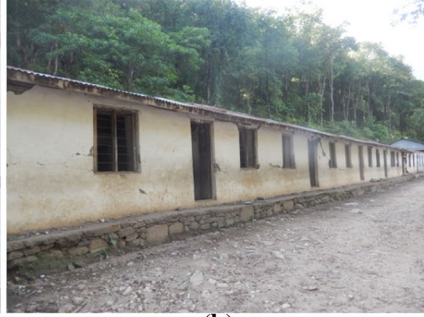
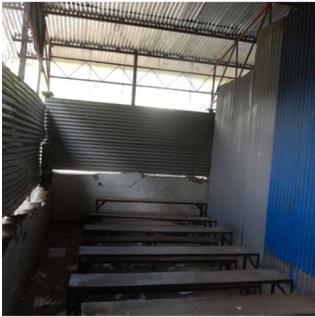
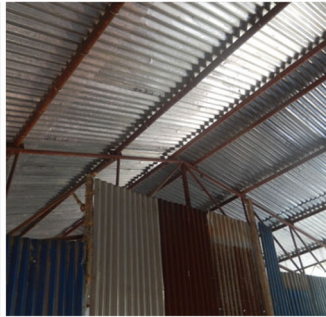
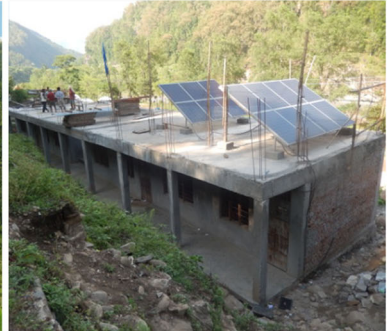
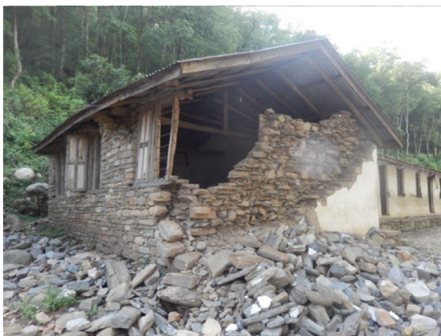
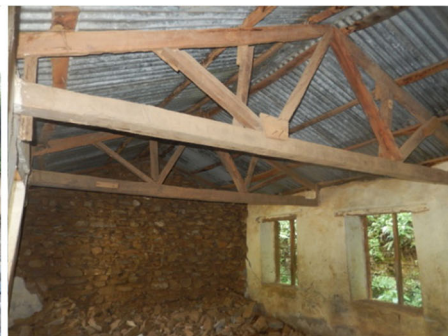
◀ **Fig. 18** Seismic damage to Thumo Gorka area due to landslide, rock falls and strong ground motion. **a** Rockfalls knocked into the classroom. **b** The school located near the hill foot. **c** The temporary school made of simple frame. **d** Light CGI sheet as roof. **e** The other side of the classroom. **f** Nearby landslide on a river. **g** Nearby landslide on the hill. **h** The nearby cement bonded masonry was intact. **i** Timber frame with collapsed wall of heavy stone. **j** Timber roof frame

masonry with a timber frame roof (Fig. 18i, j), the newly built RC frame with cement-bonded masonry (Fig. 18h) had no apparent damage even though it was only less than 20 m away.

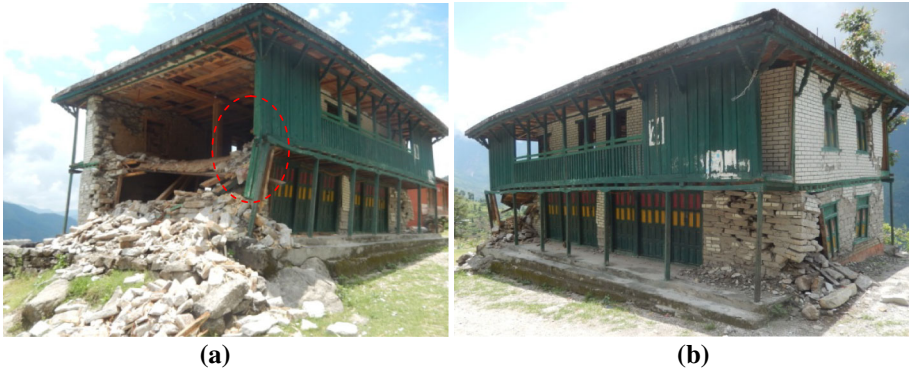
Fig. 19 Seismic damage to Thumo Gorka area due to landslide, rock falls and strong ground motion. **a** Out of plane collapse of masonry wall. **b** The view of the other corner

The small elementary school at Karthali Sindhupalchok was a two-storey timber-framed building with mud-bonded stone masonry. It stood only about 3 m away from the cliff edge. The wall of one side partially collapsed due to its heavyweight and the low constraint of the out-of-plane direction (Fig. 19a). The timber column at the corner also tended to break at the top of the ground floor (Fig. 19a, marked by red dashed-line circle). The other side partially collapsed at the ground floor (Fig. 19b), and a diagonal crack developed from

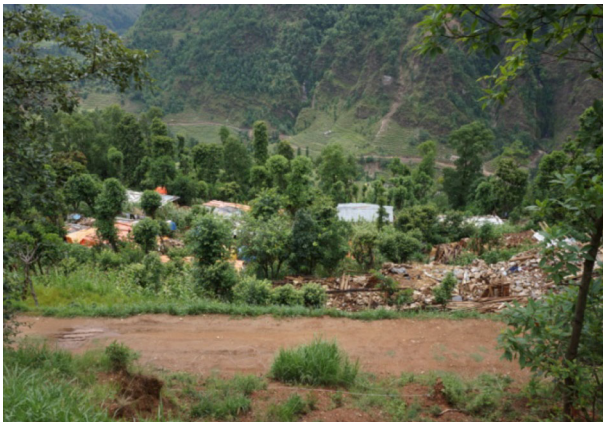
Fig. 24 A completely collapsed stone masonry structure at the school gate (facing west)

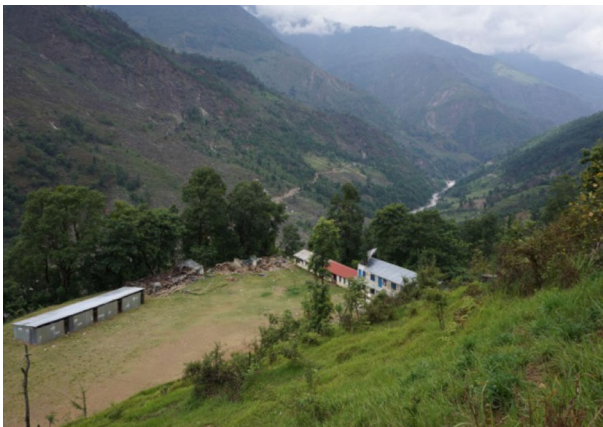
Fig. 25 School houses were severely damaged (facing west)

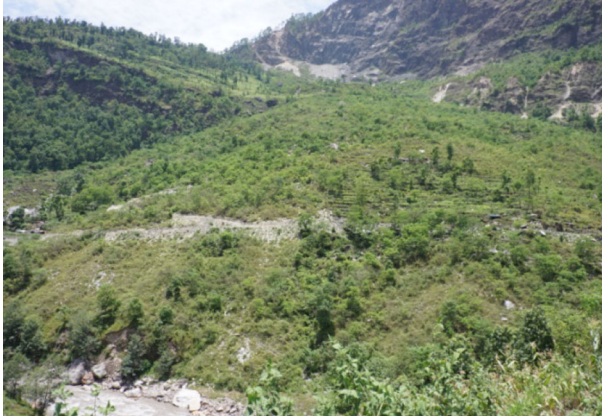
Fig. 26 Large developed ancient landslide body to the west of the main trench (facing west)

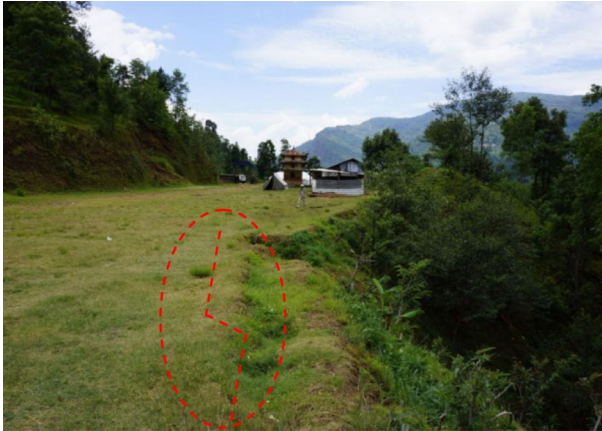
Fig. 27 Land rupture near the south cliff of the school (facing south)
