Mechanism and future risk of slope instability induced by extreme rainfall event in Izu Oshima Island, Japan

Abstract

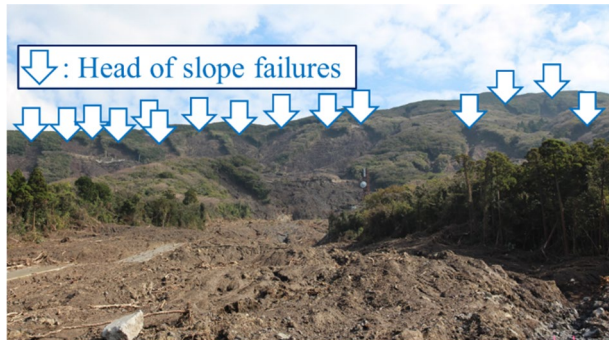
Figure 5 demonstrates the view of the slope after the 2013 disaster. It is evident that many small earth flows merged to form a big one. Moreover, the initiation points were situated at the nick points of the volcanic slope where the slope is retrogressing toward the mountain. Noteworthy was that the nick points were situated slightly above the alignment of a motorway. Figure 6 exhibits one of the initiation points of the slope failure. Obviously, the depth of shear failure was shallow here. Shear failure developed above the interface between volcanic ash sand and less pervious loess soil underneath (Wang et al. 2019). Therefore, the slope disaster in 2013 was a part of the natural process in which mountain slope is eroded and disappears after a long time. After the initiation of instability, small failure mass merged with one another as travelling downward, eroded the slope surface and trees on the way (Fig. 7), increased the size and devastated the human community at the bottom (Fig. 8).

Fig. 5 View of failed slope on the western side of Mihara Yama Volcano

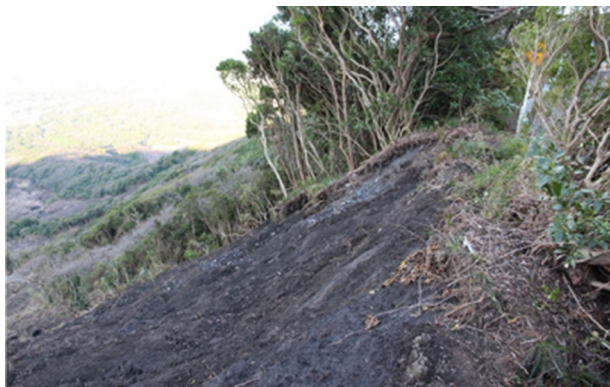
Fig. 6 Shallow shear failure at the initiation of slope instability

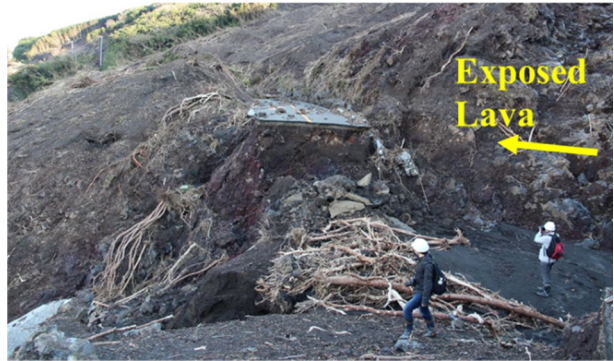
Fig. 7 Eroded surface in the middle of the mountain slope

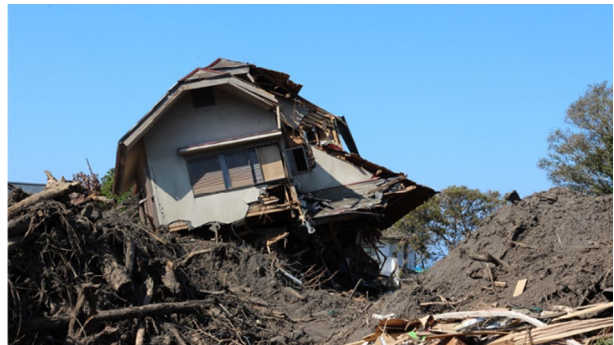
Fig. 8 Destroyed human community at the base of the slope

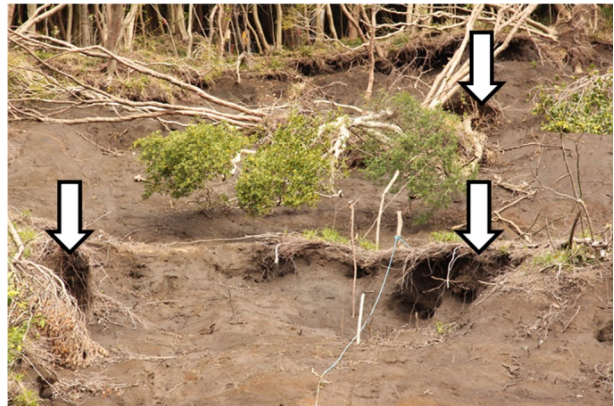
and associated slope failure were the extremely rare and severe events. One of the interesting findings in the disaster area is the existence of many piping holes (Fig. 9) through which a big amount of groundwater was ejected from the volcanic subsoil. There are different opinions about the creation of those piping holes; high groundwater pressure removed the surface material to trigger the slope failure, or falling-down of the surface material triggered water ejection. Rainfall-induced slope disaster in this island has been called “byaku” by local people. According to Tsuiki (1961), “byaku” means flow of debris and water triggered by ejection of groundwater (through piping holes).

Fig. 9 Piping holes at the head scarp of the failed slope

Figure 9 suggests that water ejected from the underlying soil affected the initiation of slope instability. It was thus thought that high pore water pressure in subsoil played a chief role in the triggering mechanism of slope disaster. In this regard, this chapter examines the possibility of upward flow of groundwater through lava into surface soil. In extreme events, rainwater that infiltrates from the upper parts of the Mihara Yama

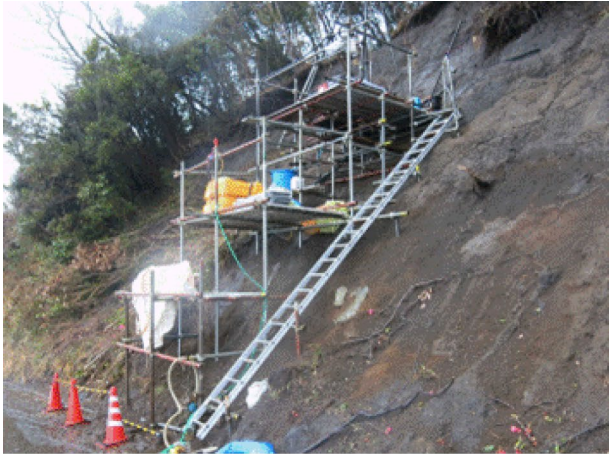
(a) Borehole site B

Figure 12 illustrates the situation of the points B and B' that are located below the top scarp of failure and beside a slope failure, respectively. B was on the failed slope, while B' was on a stable ground. By comparing these two sites, it was expected to find the reason why one part of the mountain slope was stable, while other part was not. Figure 13 compares the obtained subsurface profiles. The autobrecciated lava is a material that is formed by quick cooling and volume contraction. Within the range of drilling (down to 10 m depth), B' site has a thicker lava layer than B that is within the slope failure. Another point is that the unstable slope at B consists of interbedding different materials in which scoria and gravel appear more pervious than lava.

Fig. 12 Situation near boreholes B and B' during the subsurface investigation

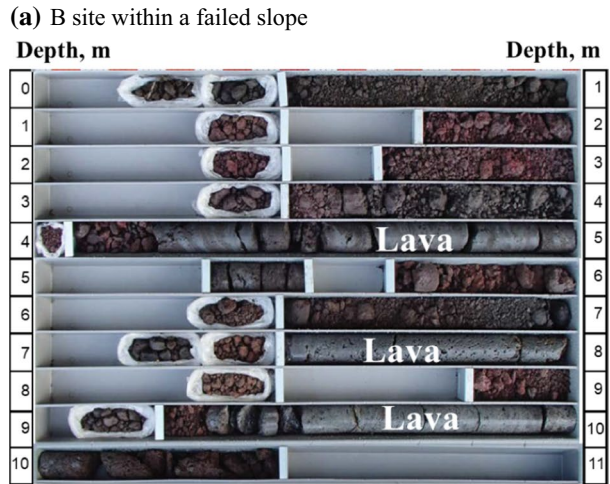
Photographs of drilled samples from B (failed slope) and B' (no failure) are compared in Fig. 14. Therein, the shallow parts are composed of fractured and highly pervious materials. At B in Fig. 14a, the material from GL–1 m to –3 m is called autobrecciated lava. Although it is named "lava," its appearance is similar to that of highly pervious gravel. Below 3.5 m, the profile in Fig. 14a is made of interbedding lava and gravelly materials. The top lava layer contains many fissures, but two more lava layers at lower elevations appear more continuous and less pervious. The profile at B' is characterized by a thicker lava layer from GL–5 m to –10 m; see Fig. 14b. Note, however, that this continuous lava layer has many cracks and appears to be pervious.

Fig. 14 Comparison of core samples obtained at sites with B and without B' slope failure

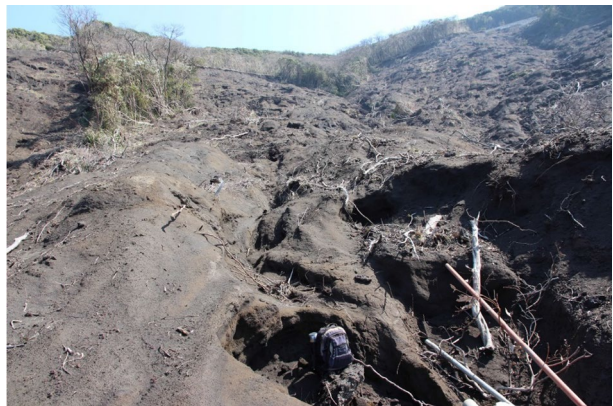
The borehole site C is located on a small mound within the damaged slope (Fig. 11). Herein, the original surface material had been removed by the soil flow and a lava layer was exposed at the surface (Fig. 15). The stratigraphy at C (Fig. 16) appears similar to that of the site B' (Fig. 13) where no failure happened. Note that ABL (autobrecciated lava) in Fig. 17 is a lava that was broken into small pieces during cooling. It is interesting that standard penetration resistance in ABL is quite variable, possibly depending on the extent of breakage and grain size.

Fig. 15 Situation around bore-hole C

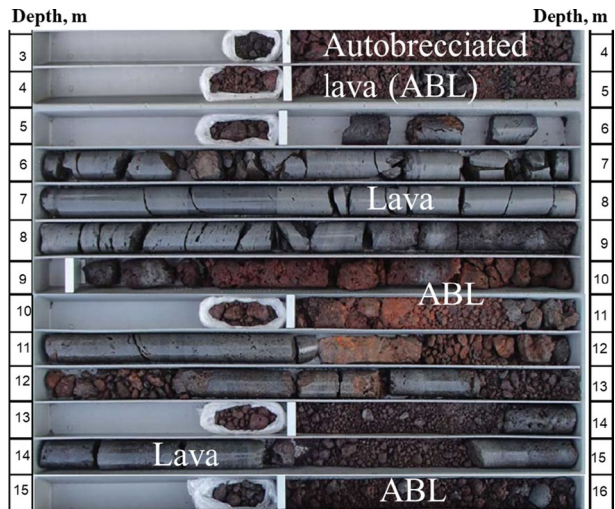
Fig. 17 Appearance of lava collected from depth 6–9 m of Site C

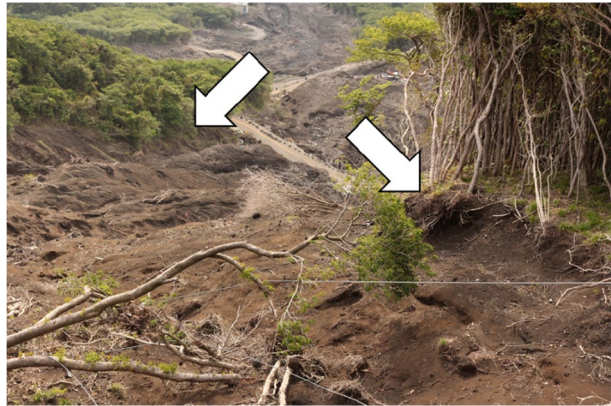
Figure 5 shows that a substantial portion of the slope remained intact at the high elevation after the disaster (Fig. 18). Hence, the most important problem when community reconstruction was discussed after the disaster was the possibility of further slope failure in the coming years. To handle this problem, the authors borrowed more borehole data at the middle height of the slope from the Tokyo Metropolitan Government and interpreted them together with their own data at point C. The location of those boreholes is illustrated in Fig. 11, Nos. 8–20. After their interpretation, Fig. 19 is drawn. Prior to addressing its significance, the post-disaster situation at several borehole sites is picked up to illustrate that there were two different damage types as stated in the following sections.

Fig. 18 Remaining parts of the disaster slope (view from the top)

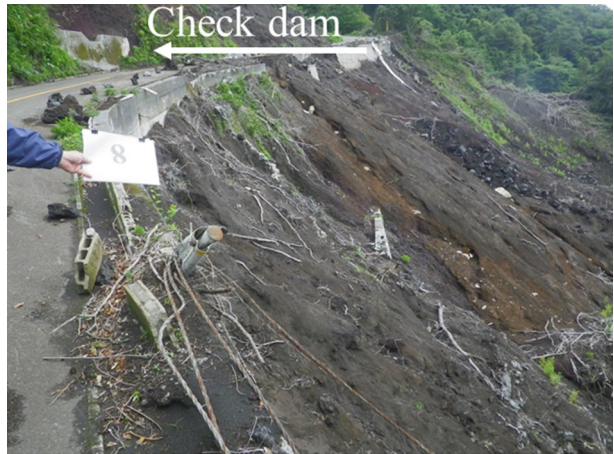
At No. 8 site (Fig. 20), the surface soil and vegetation were lost by erosion but the road structure as well as a check dam in the top-left background remained intact. This implies that the slope did not fail by shear. This site is, therefore, called erosion-dominated.

Fig. 20 Post-disaster situation at borehole site No. 8

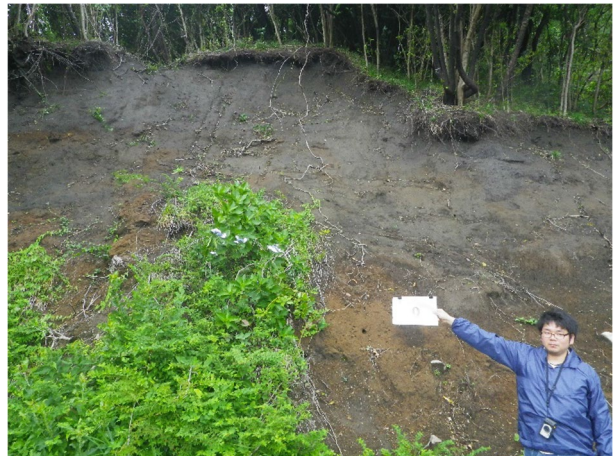
On the mountain side of the No. 9 site was a head scarp as shown in Fig. 21. Therefore, this site failed by shear failure mechanism. No piping hole was found here, and there is no idea about the effect of pore water pressure on shear failure.

Fig. 21 Post-disaster situation at borehole site No. 9

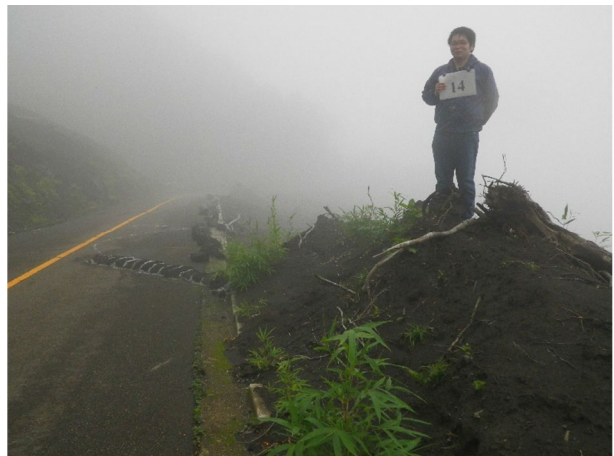
This site was affected by erosion. The person in Fig. 22 is standing on a mound that survived the disaster. Thus, no shear failure happened here.

Fig. 22 Post-disaster situation at borehole site No. 14

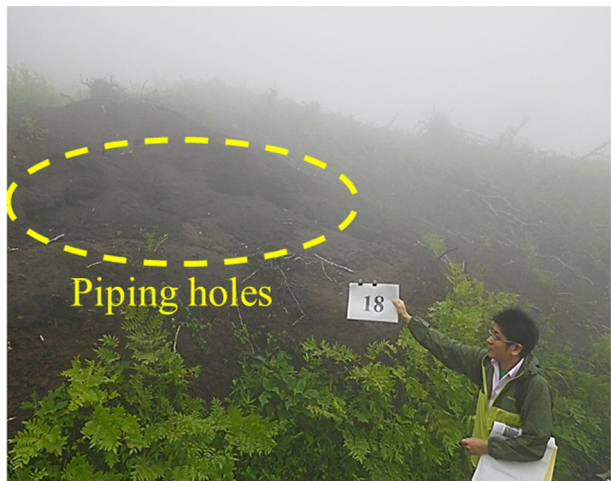
In Fig. 23, there are many piping holes in the head scarp behind this site. It is inferred therefore that effective stress here was reduced by water ejection and that shear failure triggered the slope disaster herein.

Fig. 23 Post-disaster situation at borehole site No. 18 (this photograph was taken during foggy hour of the day)

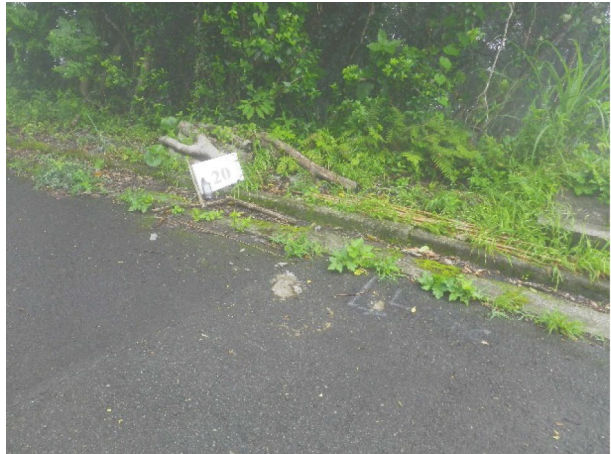
(a) Exact site

The exact site of this borehole is located on an intact ground (Fig. 24a). However, there was a head scarp of failure accompanied by a piping hole within 1 m distance (Fig. 24b). Therefore, this site should be considered to have failed by shear mechanism.

Fig. 24 Post-disaster situation at borehole site No. 20

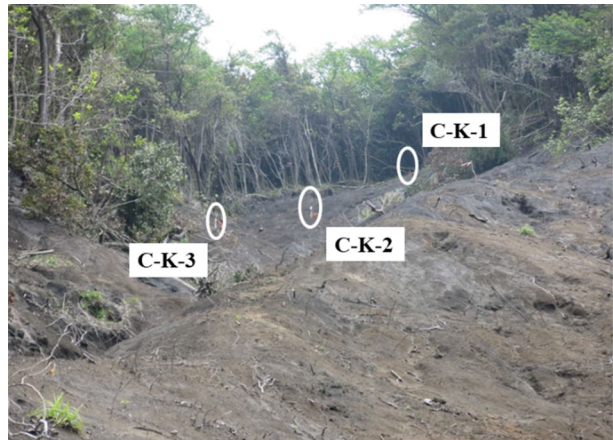
Figure 35 illustrates one of the monitored sites that appeared more likely to fail soon than others, which is namely the slope C at the bottom of Fig. 11. The tilting angle of the device was recorded in 2014 as shown in Fig. 36a. Herein, the tilting angle made noticeable increase twice, in May and in October. The event in May occurred without rain, and it was supposed that the device tilted due to such a local disturbance as animal action (Fig. 36b). Therefore, no risk of slope failure was considered. In contrast, the October event occurred after typhoon No. 18 “Phanfone” brought precipitation of 162.5 mm on October 5 and 93.0 mm on 6 at JMA Oshima Station (Fig. 36c); effects of antecedent rainfall on slope instability. Therefore, attention was paid to the rate of tilting which is the key precursor data for safety judgment. Although an alert was prepared when the rate exceeded the warning criterion of 0.1 deg/h for a short while (Fig. 36d), this critical situation did not last for a long time and no slope failure happened.

Fig. 35 Installation of tiltmeters for early warning of slope failure (photograph taken in 2014 by looking up from the slope bottom)

After the disaster, efforts were initiated to remove debris from the destroyed community and reconstruct infrastructures therein. In this stage, one of the most important issues was the risk of further slope failure and Fig. 19 is the authors’ suggestion to the local community, further disaster being unlikely on the remaining “ridge” subsurface topography. To ascertain the safety of reconstruction activities, the authors installed an inexpensive early warning system in which tilting angle of sensors was monitored and interpreted. It has been a practice that a warning message is issued if the rate of tilting exceeds 0.1 degree/h. For

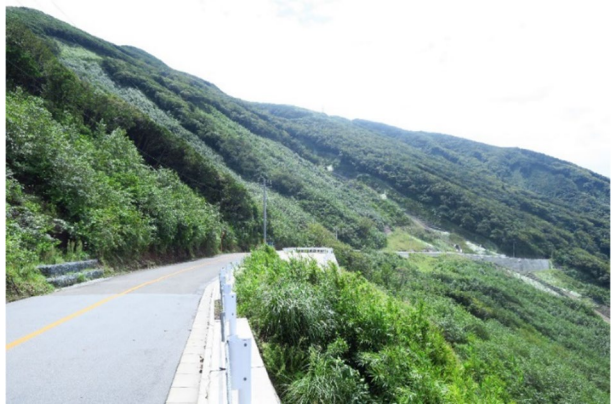
The studied slope has been stable to date. On September 11, 2018, almost 5 years after the disaster, the first author visited the site and inspected the situation. It was found that the affected slope had been recovered by greening and that no serious slope failure had happened since 2013 (Fig. 37). The slope C of monitoring in Fig. 35 had maintained its stability for 6 years after the disaster (Fig. 38). Thus, the implication of Fig. 19 was confirmed to be reasonable.

Fig. 37 Intact situation of the failed slope on September 11, 2018 (same site as in Fig. 20)

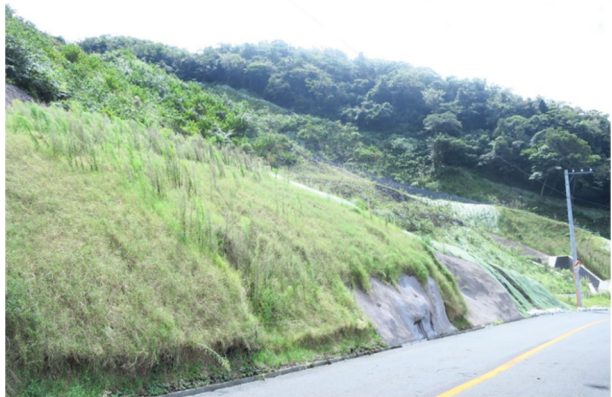
Fig. 38 Intact situation of the monitored slope on September 11, 2018
