Group-occurring landslides and debris flows caused by the continuous heavy rainfall in June 2019 in Mibei Village, Longchuan County, Guangdong Province, China

Abstract

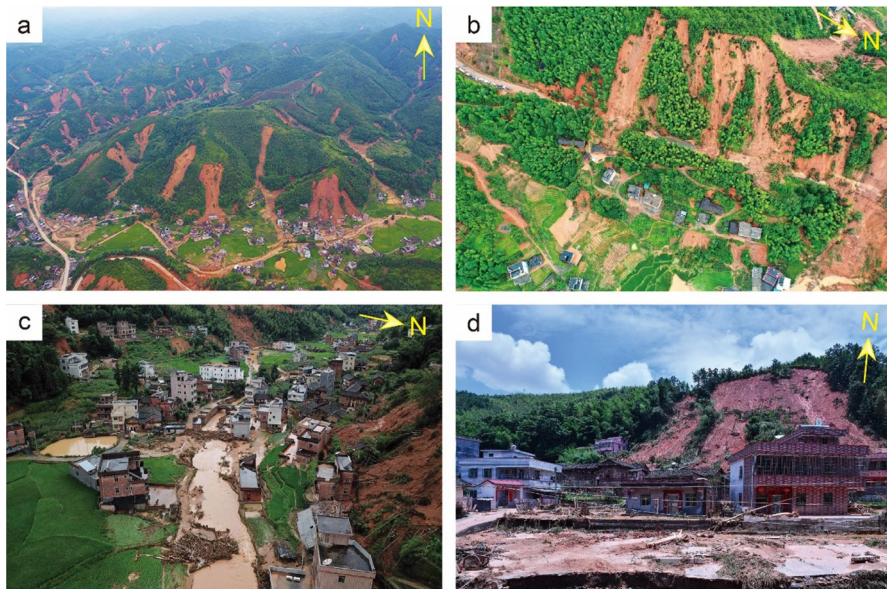
Fig. 1 Post-disaster photographs of Mibei Village (June 13, 2019). **a** Aerial view of Mibei Village after the disaster (provided by Hua Zhang); **b** the landslide characteristics along X158 road (provided by Xiangtao Zhang); **c** buried roads, river, farmland (provided by Mingming Tang); **d** the damage of landslide to houses (provided by Wei Xie)

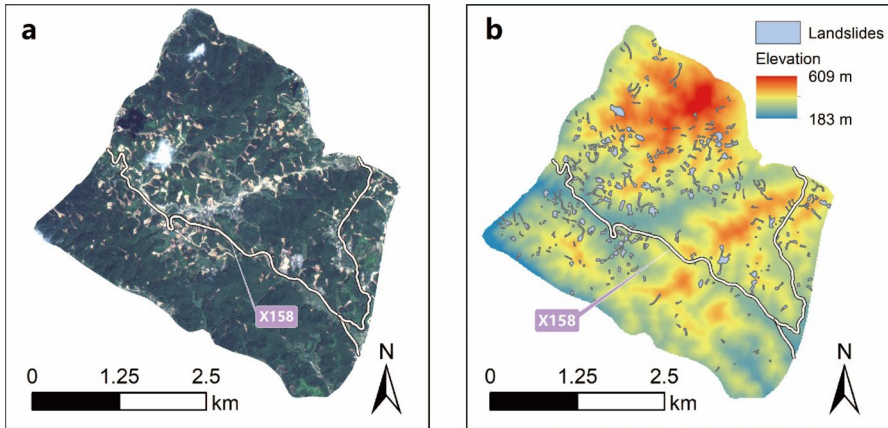
The study area is 14.76 km², and 327 landslides are interpreted by post-disaster high-resolution optical satellite remote sensing images (Fig. 4). The total area of landslide scar is $75.25 \times 10^4 \text{m}^2$, accounting for 5.1% of the study area. Figure 4b shows that the landslides are mainly distributed in the north of the Mibei River and along the X158 road. Among them, 86 landslides (accounts for 26.3%) are adjacent to roads and houses, causing traffic interruption and house damage, which are the leading cause of economic losses. According to the statistical analysis of the landslide scar area, the landslide scar area percentages of less than 5000m² and 10000m² were 87.46% ($n=286$) and 96.94% ($n=317$), respectively. There are 10 landslides with an area of more than 10000m², which are distributed along the X158 road ($n=4$) and in the valley ($n=6$).

Fig. 4 **a** Remote sensing image of the study area taken by Gaofen-1 on August 24th, 2019; **b** spatial distribution of landslides interpreted by remote sensing image

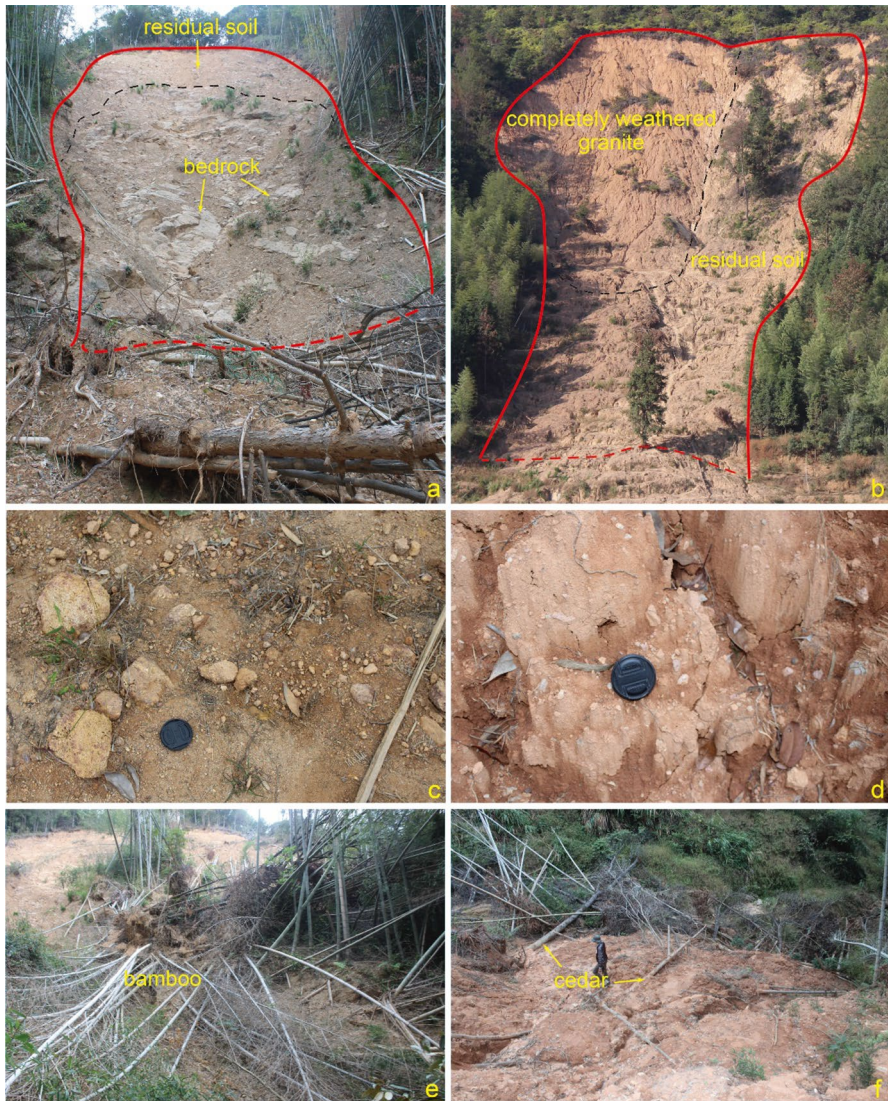
There are two types of sliding bed exposed after the occurrence of a large number of landslides, i.e., completely weathered granite and moderately strong weathered granite. Combined with the characteristics of the slope structure near the landslide area, the study area's slope structure can be summarized into two types. The first kind of slope structure is composed of moderately strong weathered granite and granite residual soil with a thickness of 1–2 m. The sliding surface mainly develops along with the interface between bedrock and covering layer for the landslides under this kind of slope structure. The material composition of landslide mass is primarily composed of fine-grained components, with a small amount of gravel carried away from the moderately strong weathered granite. The diameter of gravel is 5–20 cm. After the landslide, the bedrock (moderately strong weathered granite) was exposed in the middle and front edge of the slope; (Fig. 6a, c). The second type of slope structure is composed of moderately strong weathered granite, completely weathered granite, and granite residual soil. The thickness of granite residual soil is 1.5–3 m, and the typical thickness of completely weathered granite is 3–6 m, but the thickness of partial completely weathered granite can reach more than 12 m. There is no outcrop of moderately strong weathered bedrock in the slope area. Under this kind of slope structure, the sliding surface develops along with the interface between granite residual soil and completely weathered granite, and locally cuts into completely weathered layer. The landslide mass is mainly composed of fine-grained components with a small amount of breccia with particle size less than 2 cm (Fig. 6b, d).

Also, due to the very high growth density of bamboo and cedar in the study area, plant roots and stems mixed with loose landslide accumulation in the process of landslide movement. During the investigation, many plant debris were found in the landslide accumulation, with a maximum diameter of 20 cm and a maximum length of 5 m. Plant debris has an individual impact on the movement and accumulation of landslides, as shown in Fig. 6e, f.

Fig. 6 Structural characteristics and material composition of typical landslides

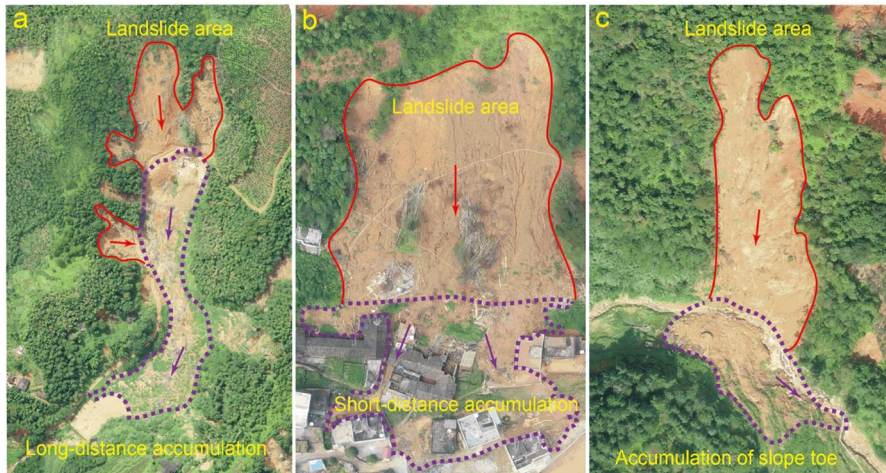
1. Long-distance accumulation (Fig. 7a)

Fig. 7 Plane characteristics of landslide accumulation (digital orthophoto map)

2. Short-distance accumulation (Fig. 7b)

3. Accumulation of slope toe (Fig. 7c)

The landslides are mainly distributed on both sides of the V-type gully. After the landslide mass lost its stability, it stroked the slope on the opposite bank through a straight path and then stopped. Loose accumulation of landslides blocked the gully channel. However, since the landslide movement path is nearly vertical to the gully flow direction, the potential energy provided by the gully cannot be converted into the kinetic energy of the continuous landslide. The gully channel is blocked by landslide mass, and the increasing flow with

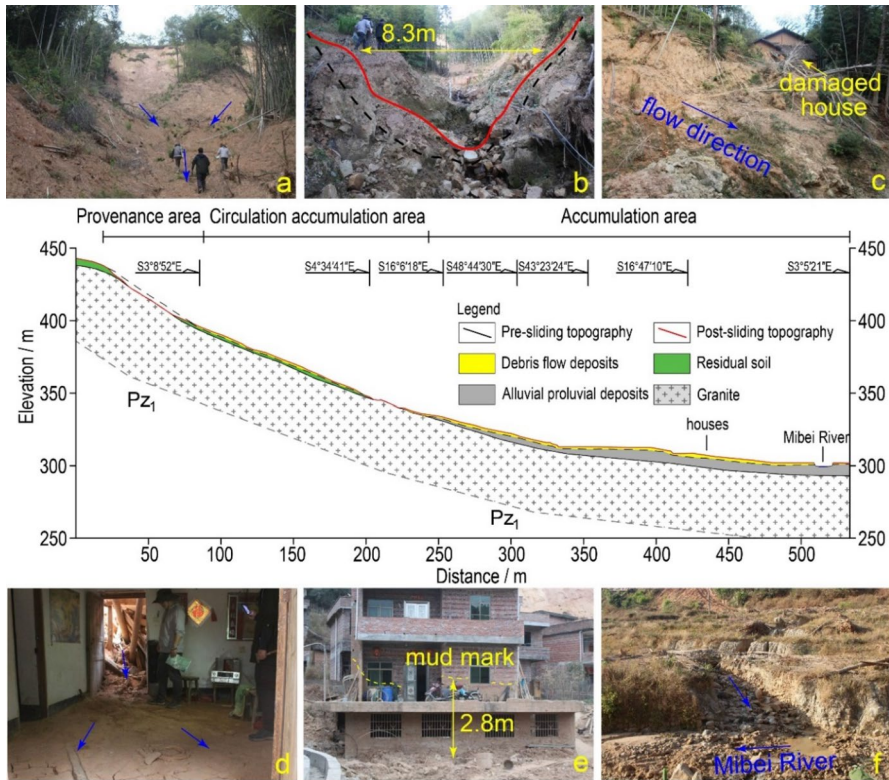
The formation of debris flow is closely related to rainfall, terrain topography, slope structure, and physical and mechanical properties of rock and soil. The substance source of this kind of small debris flows is distributed in gully source slope. Rainfall is the direct triggering factor of slope instability. The mechanism of slope instability caused by rain will not be described here. After the slope is unstable, the landslide mass will have a movement distance under the gravitational potential energy. However, due to the pore water content not reaching saturation at this stage, the loose landslide mass is scattered and accumulated,

Fig. 12 Characteristics of typical debris flow in the study area. **a** Characteristics of debris flow provenance area; **b** characteristics of debris flow gully; **c** damage of debris flow to gully slope; **d** houses damaged by debris flow in the middle of the gully; **e** houses affected by debris flow accumulation at gully mouth; **f** accumulation characteristics of debris flow at gully mouth

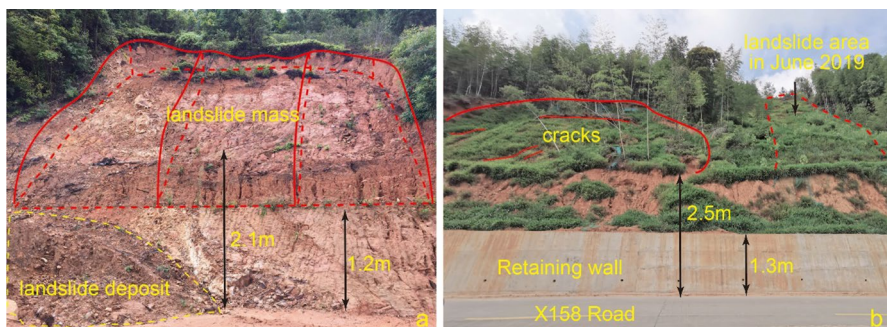
The X158 road in the study area passes through the low mountain and hilly, and the slope is excavated because of the terrain, to form the excavation slope with the height of 2–15 m, and the terrain slope is generally 40°–50° in a straight line. Due to the low frequency of local geological hazards, most of these excavated slopes are not timely and effectively supported. In the excavated surface, the boundary between granite residual soil and completely weathered granite is clear, providing good free space conditions for sliding out along the interface of granite eluvium and the completely weathered layer in Fig. 13a. The group-occurring landslide hazards in the study area also provide a warning for the later engineering construction. The rainfall in the study area has the peak characteristics over the years, which does not rule out the recurrence of continuous heavy rainfall again. The future engineering activities should fully consider the slope structure characteristics, evaluate the stability of the excavation slope, and timely and effective support should be carried out for the excavation slope with the risk of instability to reduce the landslide hazards caused by rainfall in the future.

After the disaster occurred in June 2019, the local Government repaired the X158 road in time to keep the lifeline unobstructed. Retaining walls with a height of about 1.3 m were built for the crucial slopes along the road, and vegetation greening was adopted for the

Fig. 13 Characteristics of landslide hazard caused by engineering activities

slope surface. After the rainy season of 2020, the front edge of the retaining slope along the X158 road appears new deformation signs, and even locally sliding failure occurs, as shown in Fig. 13b. Through investigation and analysis, it is found that the support measures are not reasonable. The excavation slope reveals granite residual soil and completely weathered granite, while the height of the retaining wall is lower than the boundary of granite eluvium and completely weathered layer. The sliding surface of shallow landslide mainly develops along with the interface of granite eluvium and completely weathered layer, so the retaining wall does not play its full role. It is suggested that before adopting retaining walls and other types of supporting measures in later engineering construction, the structural characteristics of the slope should be fully identified, and the corresponding size design should be carried out to avoid similar situations.
