RC structural damages observed after October 30, 2020, Seferihisar—İZMİR earthquake and analytical evaluation of existing sample RC buildings

M. Koçer¹ · A. Ünal¹

Received: 18 December 2021 / Accepted: 7 February 2023 / Published online: 19 February 2023
© The Author(s), under exclusive licence to Springer Nature B.V. 2023

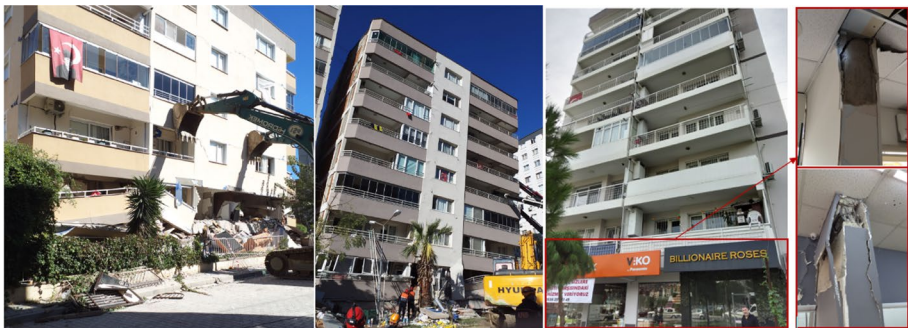
The information determined by the investigations performed on the heavily damaged buildings in the İzmir earthquake has showed that these buildings had non-ductile reinforced concrete frames. Since the ground floors of the buildings on the main street were designed as workplaces, the height of the ground floor of most of the buildings is high with soft and weak story irregularities. Glass walls were used instead of the infill walls at the ground floors since the buildings were used as workplaces, which affects the non-ductile frames' strength and stiffness between the floors resulting in the danger of sudden collapse of the buildings. For the buildings with infill walls, the infill walls are only considered in the vertical load effect, and additionally they gain lateral drift stiffness to the buildings by protecting their completeness up to a definite level of earthquake force. In an analytical model with soft and weak story irregularity according to the acceleration records of İzmir earthquake, the removal of the infill walls at the ground floors increased the ground floor drift ratio of the building by 12.5 times (Koçer et al. 2018a, 2018b). Accordingly, hinges occur at the column ends of the ground floor of the building without any damage at the upper floors, and the load-carrying capacity of the building decreases. Thus, the building cannot absorb the accumulated earthquake energy by presenting a non-ductile behavior. In Fig. 9, some buildings having no infill wall but soft story mechanism at the ground floors can be seen with large plastic deformations developed at the ground floor column ends.

Fig. 9 The building examples damaged due to weak and soft story irregularity (image by authors and (AFAD 2021))

In the light of the information obtained from the previous earthquakes, some improvements related to the infill walls were made in TEC-2018. For instance, two different relative story drift ratio formulations have been presented according to the infill walls' jointed or jointless connection to the reinforced concrete frame. Here, the relative story drifts of the partition walls formed with jointless connection have been limited by reducing two times in comparison with the partition walls formed with jointed connections.

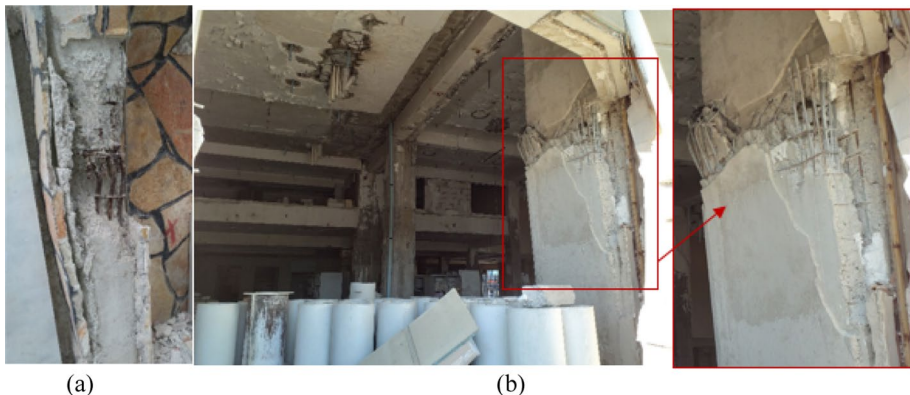
The lap splices were at the lower and middle regions of the columns according to TEC-2007 and earlier regulations that the lap splice length was required to be the same as the coupling length (Eq. 1) (TS 500–2000 2000) if it is at the middle and 1.5 times of the coupling length if it is at the lower region. According to TEC-2018 Regulation, the lap splice is allowed only at the middle region of the column. At these regions, stirrup confinement is compulsory in both regulations. The site observations in the earthquake area showed that the stirrup confinements have not been applied on the columns in accordance with the regulations. Furthermore, it was seen for the lap splices applied at the middle regions of the columns, if the stirrup confinement was not made with appropriate rate and length, buckling occurred in the longitudinal reinforcement at the lower end of the lap splice due to the variation encountered in the axial stiffness of the column (Fig. 10.a). In Fig. 10.b, a reinforced shear wall designed as shear wall and damaged during the earthquake is shown. The ribbed reinforcement was used at the shear wall boundary zones, while unribbed reinforcement at the middle regions. In addition, no stirrups were used in the shear wall boundary zones, and unribbed and hookless stirrups were used in the whole shear wall cross-section. Moreover, the lap splices at the longitudinal reinforcements of the shear wall were produced at the middle region of the shear wall, and no stirrup confinement was made. For this reason, damage is concentrated at the lap splice region during the earthquake, and the lap splices in this region were stripped.

Fig. 10 Column and shear wall damages (image by authors and (AFAD 2021))

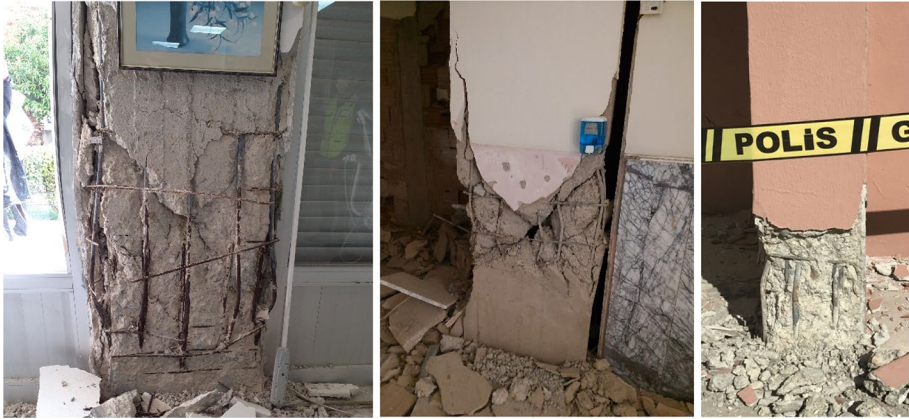
In Fig. 11, the damages that occurred at the columns in which stirrup confinement has not been done at the lower region of the column were pictured, which were frequently met during the investigations carried out in the earthquake region. Not having any detailing of the reinforced concrete members according to TEC-1997 Earthquake Code is the common feature of these damaged buildings. The damage levels were high due to unribbed reinforcement and poor quality concrete production for the longitudinal reinforcements. In addition, the stirrup confinement and hookless horizontal reinforcement production caused

Fig. 11 Column damages (image by authors and (AFAD 2021))

the unfastening and then buckling of the longitudinal reinforcement; corrosion damage occurred due to the concrete quality and caused the coupling unfastening in the members.

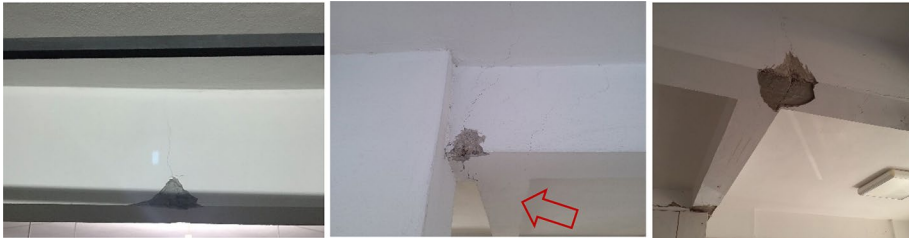
Fig. 12 Secondary beam damages (image by authors and (AFAD 2021))

While examining the earthquake damages on the reinforced concrete buildings, besides the hinging formation at the beams due to the lateral effect of earthquake, the vertical earthquake effects that are not so much considered in building design also causes various damages on the buildings. Due to the vertical earthquake effect of İzmir earthquake, some of the buildings with long beam spans faced with cracks which usually occurred at the center points of the beams where more bending takes place (Fig. 12.a). On the other hand, in some buildings due to the architectural reasons, the secondary beams can be made which starts from a column and connected to a beam with no column or not starting from a column but placed between two beams vertically. When the lateral earthquake forces affect the building, the secondary beams transfer loads from the nodal points they are connected to the main beams; in this case, this means a single load acting from nodal point to the main beam that can cause damages at these regions. Since there is no restriction about the secondary beams in current and former regulations in Turkey, the construction of this type of beams in buildings still continues. In Fig. 12.b,c., some of the damages that occurred on the main beams due to secondary beams in İzmir earthquake are shown.

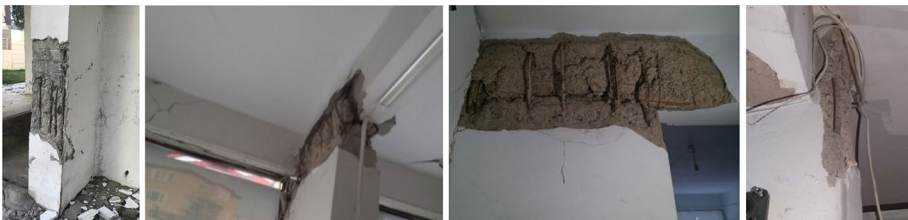
One type of the widespread damages experienced in the İzmir earthquake was the damages observed at the column-beam connections (Bursa Technical University 2020). The main reason of these damages was not keeping the installation of stirrups throughout the column length at the column-beam connection zone. The provision and details of stirrup application at the column-beam connections have been explained comprehensively in all the today's and past regulations. According to TEC-1975 regulations, the amount of stirrups applied for the unit length of the column-beam connection zone should not be less than the amount of stirrups applied for the unit length of the middle zone of the column. There were two conditions in question for the confined and unconfined column conditions in TEC-1997, TEC-2007 and TEC-2018 regulations. In confined connections, at least 40% of the amount of stirrups existing at the confinement zone of the lower column will be used throughout the connection zone. However, the diameter of the stirrup will not be less than 8 mm, and their spacings will not exceed 150 mm. In the unconfined connections, at least 60% of the amount of stirrups existing at the confinement zone of the lower column will be used throughout the connection zone. Here, the diameter of the stirrup will not be less than 8 mm, and their spacings will not exceed 100 mm. Despite the provisions about the column-beam connection zones defined in all these regulations, the requirements for these regions have not been applied in most of the buildings. Since stirrups have not been used in column-beam connection zones, damages are concentrated at these regions. Furthermore, due to the lateral stiffness of beam larger than the lateral drift stiffness of column, the damages were concentrated at the column-beam joints during the lateral load transfer to the columns together with the lateral effect of the earthquake. In order to avoid the possible shear forces that can occur due to this reason, stirrups should be applied to the column-beam connection zones and possible damages should be prevented. Since no stirrups have been used at the column-beam connection zones of some buildings, during the İzmir earthquake, the longitudinal reinforcements at these zones were buckled and columns lost their load-bearing capacities (Fig. 13 a,b,c). In addition to this, it is a possible condition that the width of the beam is less than the width of the column at the nodal point at which the beam is connected to the column. Also under this condition, the stirrup application should continue throughout the column. However, as seen in Fig. 13d, this condition has not been taken into consideration in some buildings, and the buckling of the longitudinal reinforcement of the columns caused damages at the column-beam connection zones.

Fig. 13 Column-beam connection zone damages (image by authors and (AFAD 2021))

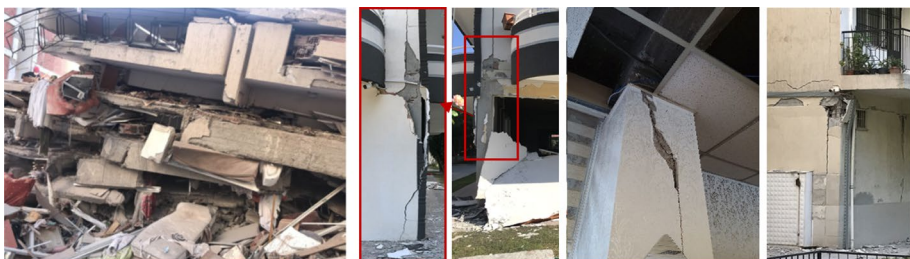
The energy of the earthquake should be consumed by various mechanisms in destructive earthquakes. For instance, the hinging is desired to occur at the beam ends in order to provide the building to consume the energy of the earthquake by presenting a ductile behavior during the earthquake. For this reason, today's construction regulations include some conditions for plastic hinges to occur at the beams instead of columns. The most important one of them is that the sum of the moments of the load-carrying capacity of the columns connected at each column-beam nodal point should be at least 20% greater than the sum of the moments of the beam cross-sections' load-carrying capacity obtained on the column face at the same nodal point. In many of the buildings collapsed or heavily damaged in the earthquake occurred in İzmir on October 30, 2020, the floors were collapsed one on the top of the other just like a pancake due to strong beam–weak column production besides the low lateral drift stiffness (Fig. 14a). The strong beam–weak column damages experienced in the İzmir earthquake are shown in Fig. 14b, c

Fig. 14 Strong beam–weak column formation (image by authors and (AFAD 2021; TEC 2018))

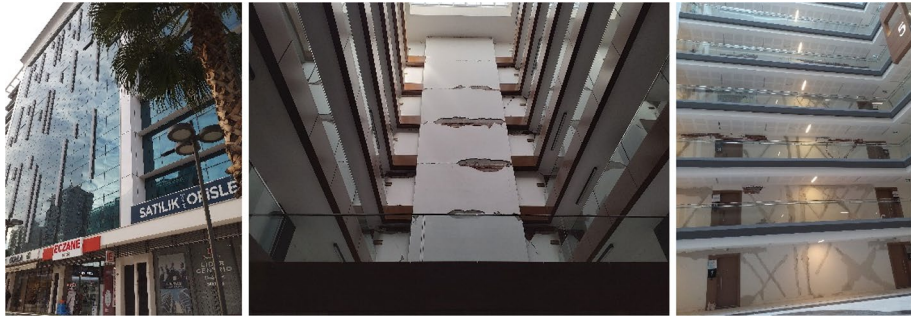
As seen in Fig. 15, during the earthquake, no damage was observed on the reinforced concrete frame system of the building designed in ductile shear wall + frame system according to TEC 2007 Earthquake Code. This building is located in the Bayraklı District where the buildings collapsed or heavily damaged during the İzmir earthquake were concentrated. The building with its ductile load-bearing system contributed against the earthquake loads during the oscillations of the earthquake due to the contribution of walls to the lateral drift stiffness. However, this building that can be considered as luxury category in terms of building usage quality faced with partition wall damage that cannot be expected in this level of earthquakes. Hence, it is concluded that the aforementioned building had insufficient drift controls in the design or insufficient amount of shear wall cross-sectional areas (Fig. 15).

Fig. 15 Infill wall damage (image by authors and (AFAD 2021))

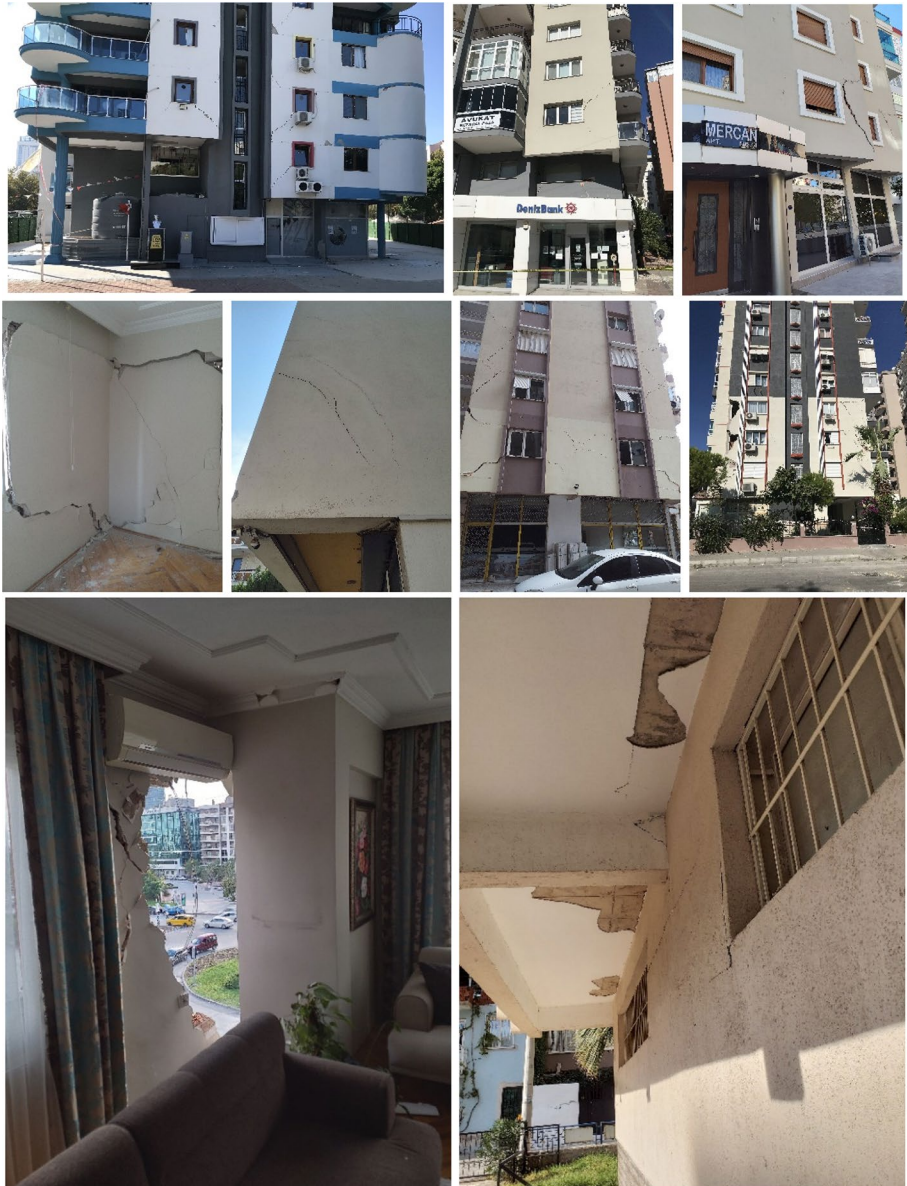
the earthquakes on the overhangs of the buildings due to the vertical earthquake acceleration depending on the lengths of the overhangs. Owing to the damages occurred on the overhangs during the previous earthquakes, various studies were carried out and vertical acceleration spectrum was firstly included to the current earthquake regulation (TEC 2018; Arslan et al. 2013; Tan et al. 2008; Inel et al. 2013). According to the current regulation, the vertical earthquake analysis became obligatory for the beam members exceeding 5 m cantilever span or 20 m horizontal span. For the buildings not having the above-mentioned problems, the vertical earthquake acceleration is taken into consideration by adding the 2/3 ratio of the short-period horizontal acceleration to the dead load. The observed earthquake damages occurred at the overhangs constructed for architectural concerns during the İzmir earthquake are shown in Fig. 16. The overhang walls of the damaged buildings were separated from the main frame or fell down from the out-of-plane facade.

Fig. 16 Overhang damages (image by authors and (AFAD 2021))

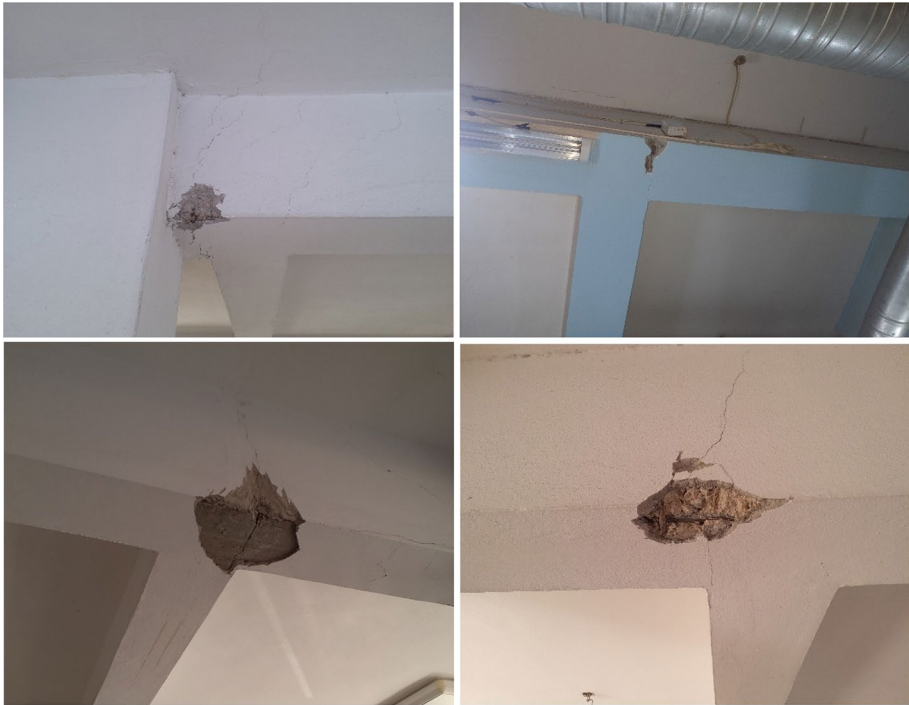
One of the damages caused by horizontal and vertical earthquake acceleration in structures is secondary beam damage. This structural defect, which is generally seen in buildings, was also observed in the on-site investigations after the earthquake in İzmir. The effect of the high-order shear force in the secondary beam region and the vertical dynamic effect caused the shear damage to intensify in the beam with low stiffness. Photographs of this damage are given in Fig. 17. As it can be seen in Fig. 17, the cracks in the beams with a greater span from the main beam on which the secondary beam rests extended to the slab. While the magnitude of the horizontal acceleration to which the structures are exposed during the earthquake is in the order of 0.179 g, the magnitude of the vertical acceleration is almost half (0.08 g). Since this vertical effect is also considerably high, it caused such damages to both the overhangs and the secondary beams in the buildings.

Fig. 17 Secondary beam damages (image by authors and (AFAD 2021))

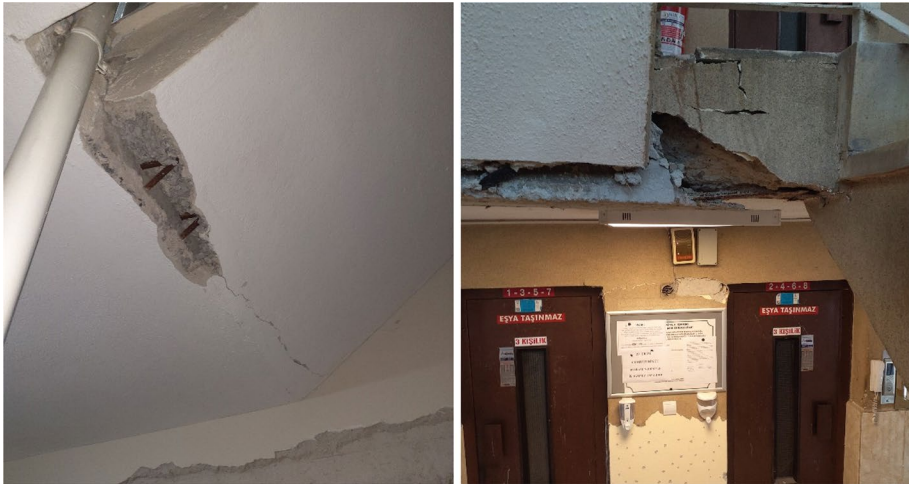
with simple support. Since the tension in the support region is on the upper side, if the compression region is not sufficiently equipped, tensile stresses occur in these regions during earthquakes and such damages are observed. This type of damage is shown in Fig. 18. As can be seen from these photographs, structural damages generally occurred at the bottom of the area where the staircase was supported on the slab.

Fig. 18 Staircase damages (image by authors and (AFAD 2021))

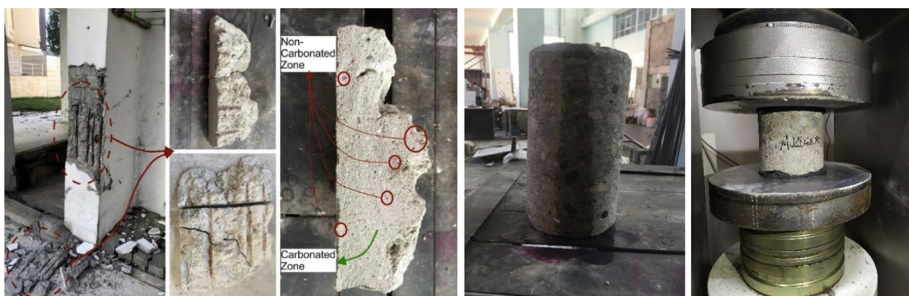
Furthermore, the carbonation depth for the core sample obtained from the representative building was measured, and similarly the carbonation effect on the entire core sample was observed. After the compression test applied on the core sample, a low strength value of 14.6 MPa was obtained, since the entire cross-section was completely affected from the carbonation depth (200 mm). Similar results for the relationship between the compressive strength of concrete and carbonation were also obtained in the related studies (Khan and Lynsdale 2002; Kim et al. 2009). The pictures of the buildings faced with corrosion damages are given in Fig. 20.

Fig. 19 Determination of carbonation depth and core compression test

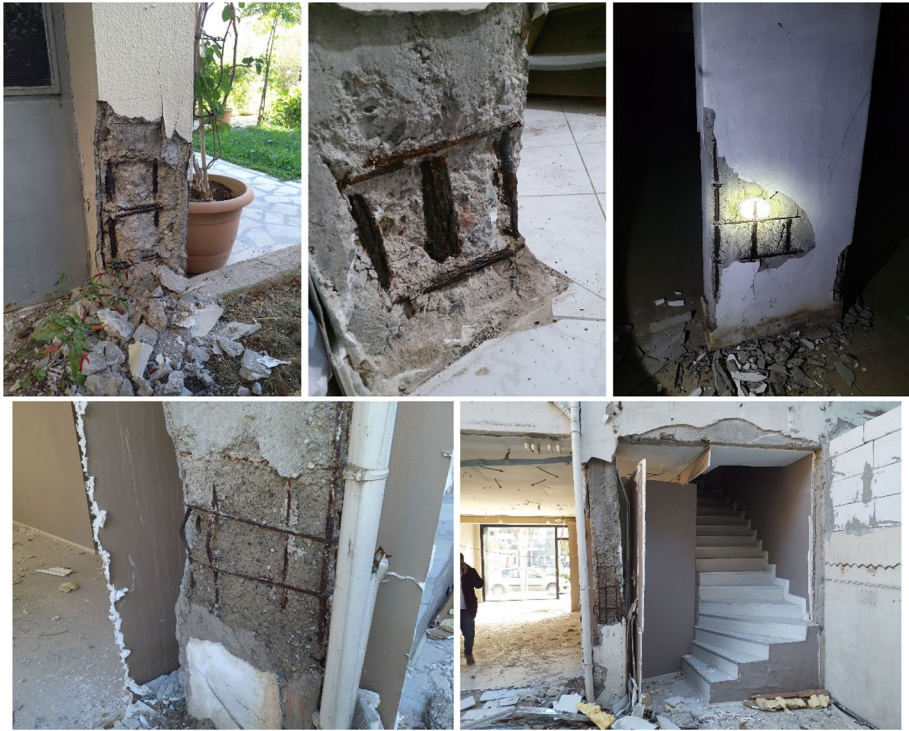
Corrosion is one of the basic problems of the buildings existing in the marine climate regions. Corrosion damage was observed in general of the buildings damaged in the İzmir earthquake. The common features of the buildings faced with corrosion damage are poor quality concrete class, concrete cover insufficiency or carbonating problem arising from the use of aggregate and sand obtained from sea in the concrete production. Since one of the primary reasons of the corrosion formation at the reinforced concrete members is the carbonation of the concrete, the depth of carbonation should be measured. In this study, concrete samples and core samples were taken from a representative building and carbonation depths were measured, because the reason for some of the damages occurred in İzmir earthquake was thought to be corrosion. The concrete specimens taken from the columns of the aforementioned building were cut, and their surfaces were cleaned. Then, the carbonation depth was determined by spraying phenolphthalein indicator on the cut and cleaned concrete specimens. After the phenolphthalein indicator comes into contact with the concrete surface, the color of the non-carbonated concrete surfaces turns into purple while carbonated concrete surfaces show no color change. In Fig. 19, the carbonation depth was measured by taking the concrete cover layer from the representative building in İzmir Bayraklı Region and cutting the cover layer in the direction of the cross-section. As seen from the figure, entire section except a few number of spots has been carbonated, and carbonation has become effective in the entire concrete cover. The reinforcements of this column have been corroded, and their cross-sections have been considerably decreased due to carbonation effect.

Fig. 20 Corrosion damages (image by authors and (AFAD 2021))
