Effects of the February 6, 2023, Kahramanmaraş earthquake on structures in Kahramanmaraş city

Abstract

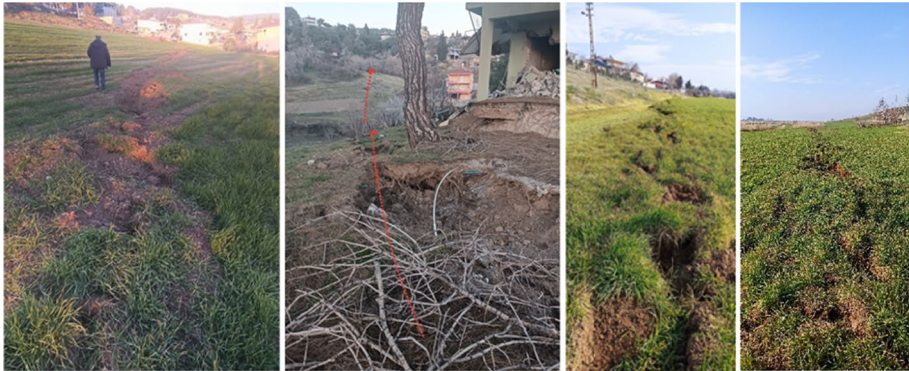
Fig. 8 Surface fractures observed in Çiğli and Kuyumcular villages

Earthquakes cause damage to the ground surface as well as structural damage. Ground damage was observed extensively in Çiğli Village, 12 km from the epicenter, and Kuyumcular Village, 18 km from the earthquake epicenter. Cracks were formed in the land and the fault progressed in a traceable direction in a certain direction. Fault outcrops are shown in Fig. 8.

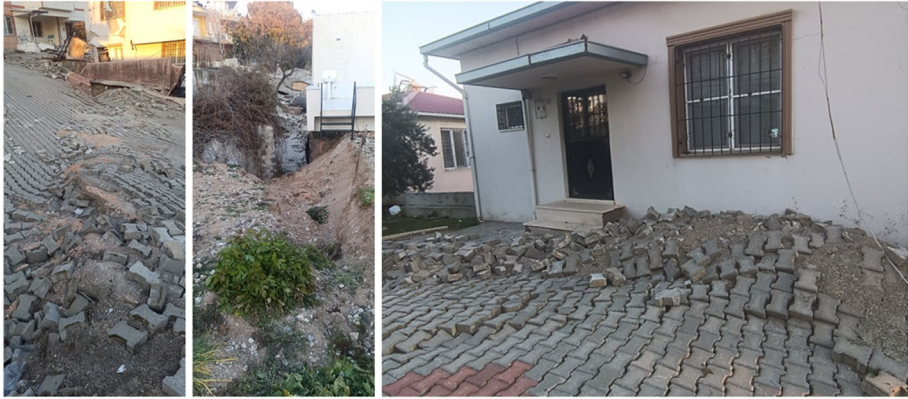
Kahramanmaraş Çiğli village was one of the places most affected by the earthquake. The effects of the fractures, which reached 2 m in width and observed in the center of Çiğli village with approximately 350 households, one of the villages most of which were destroyed in the earthquakes, are shown in Fig. 9.

Fig. 9 Damages caused by the earthquake in Çiğli village center

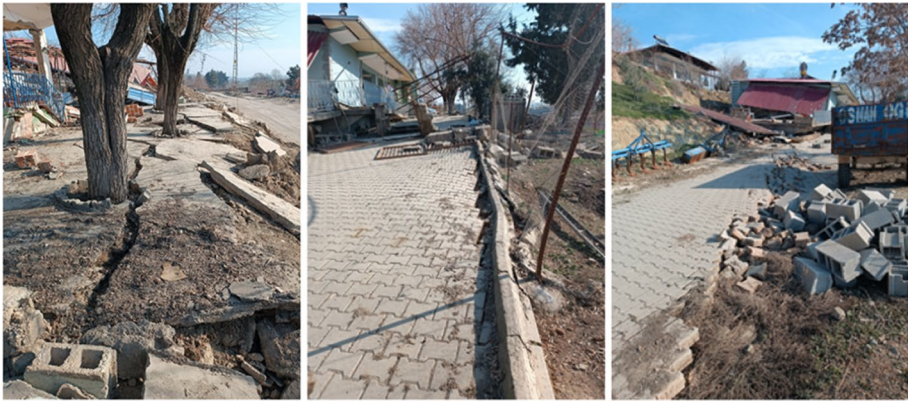
Kahramanmaraş Kuyumcular village, which is one of the villages in the direction of its fault line like Çiğli village, was one of the places most affected by the earthquake. Only 3 houses survived in the village where there are 40 houses. The damage to the roads at the village entrance and inside the village or the closure of the roads due to collapsed buildings caused delays in aid and intervention. The surface damages observed in Kuyumcular village are shown in Fig. 10.

Fig. 10 Earthquake-induced surface damage in Kuyumcular village

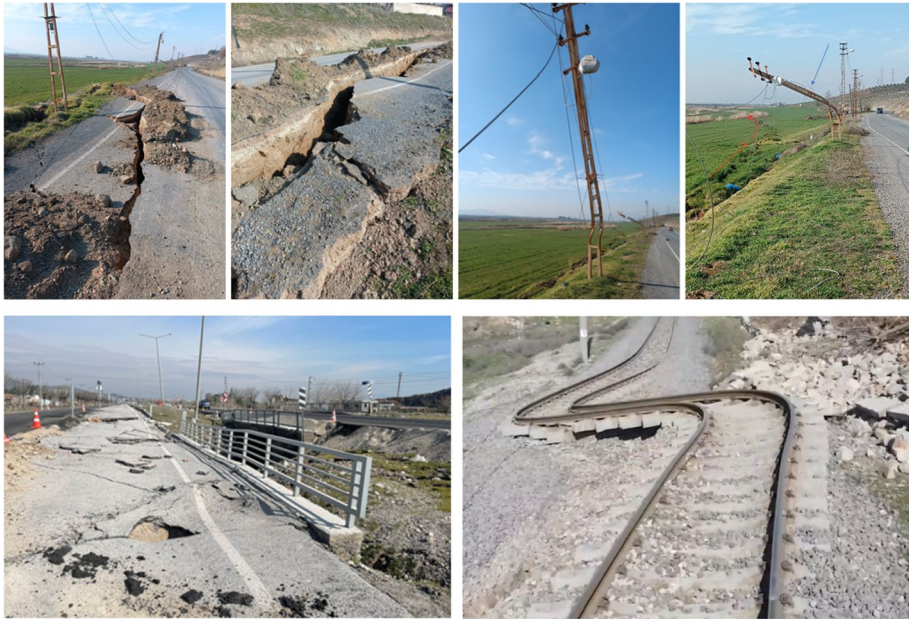
Fig. 11 Damages in transportation and communication facilities after the earthquake (Kahramanmaraş)

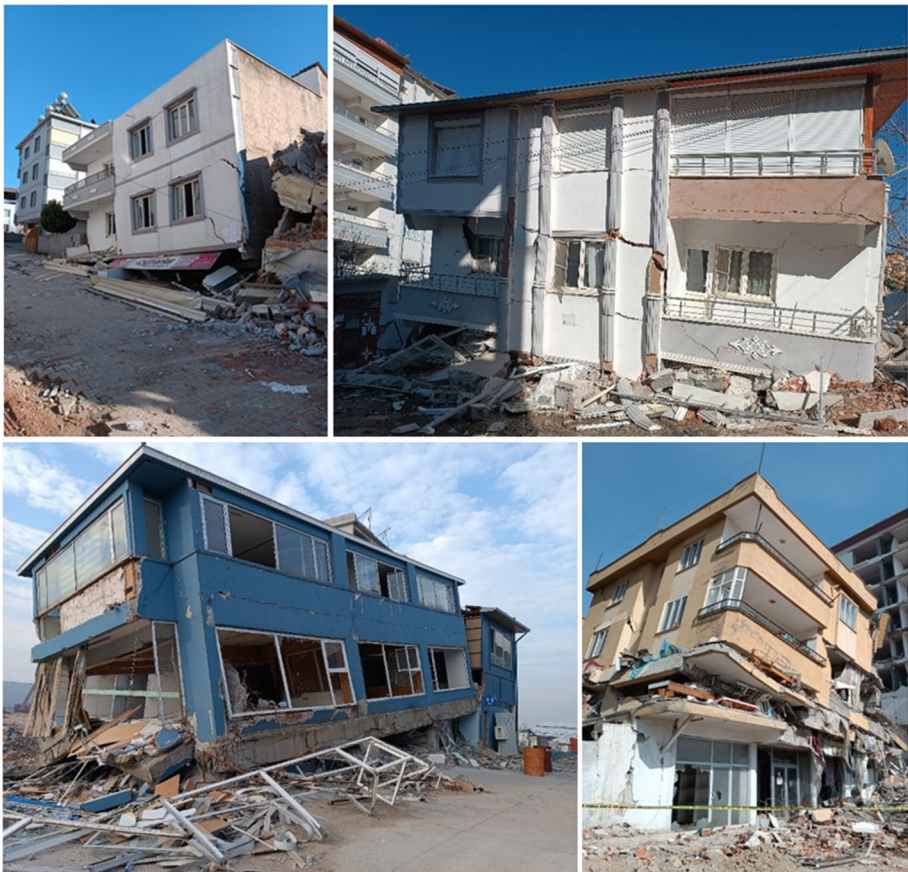
Soft/weak story is an important irregularity that must be avoided due to capacity design. Totally collapse occurs especially with the hinging of ground story columns. Damages observed in reinforced concrete structures in previous earthquakes have also been observed widely in Kahramanmaraş and its districts. One of these damages is the formation of soft/weak story due to the difference in strength and stiffness between floors. A sample of such

damage is shown in Fig. 13. This type of irregularity, which is frequently encountered in residential buildings, is caused by the fact that the entrance floors of the buildings are high and the infill walls are not made in order to make the buildings more functional for commercial purposes, causing more horizontal displacement of the lower floors during the earthquake. As a result, the carrier system is severely damaged. In short, the difference in strength and/or stiffness between floors in the building is the main reason for such damages.

Fig. 13 Buildings collapsed as a result of soft/weak story mechanism

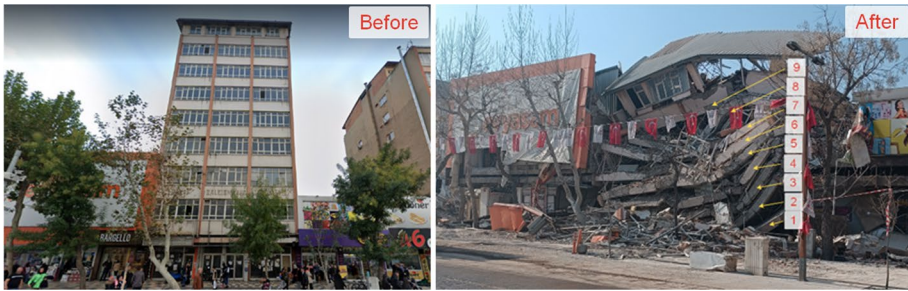
Fig. 14 Sample of pancake total collapse

collapses in the form of stacking of floors called "pancakes." As a result of the articulation of the columns in the building, all floors collapsed by piling on top of each other.

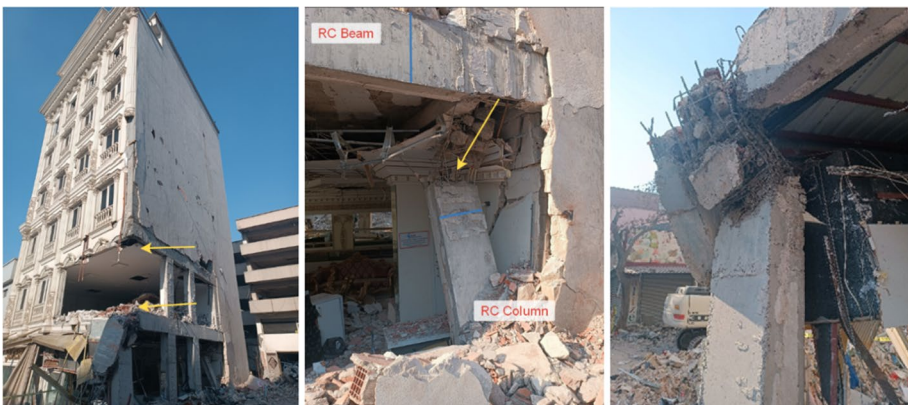
Fig. 15 Examples of RC columns heavily damaged by the impact of pounding

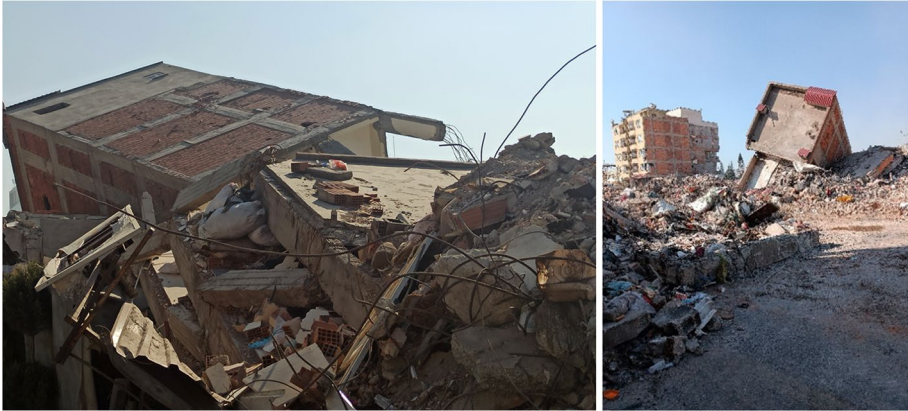
Fig. 16 Example of a building collapsing to the side

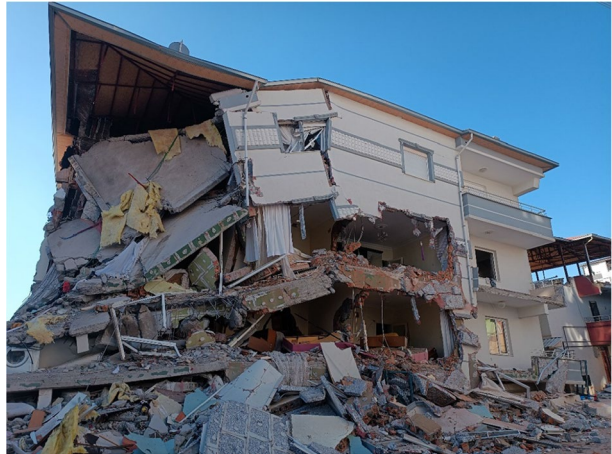
An example of damage in the type of partial collapse of the RC structure in the vertical direction is shown in Fig. 17. Vertical collapse or heavy damage occurred in the same area on each floor of the building. Torsion effect, plastic hinge starting at ground floor columns

Fig. 17 The collapse of a part of the structure in the vertical direction

and continuing to upper floors, beam-column discontinuities, strong beam-weak column, and low-strength reinforced concrete are among the main causes of this type of damage.

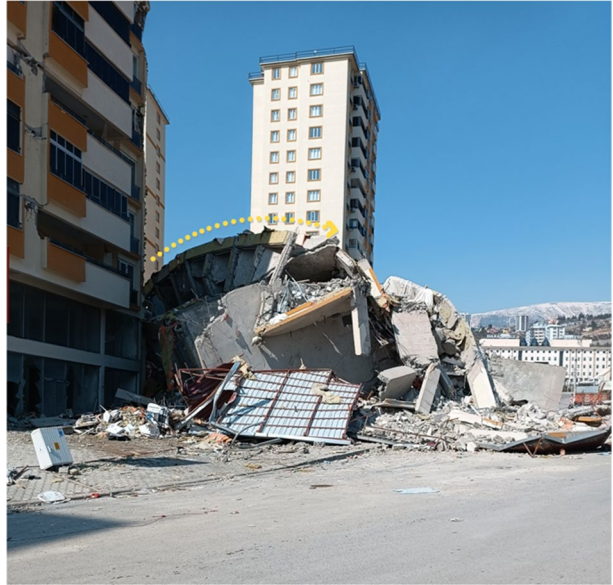
The collapse mechanism in the form of lateral collapse is caused by the formation of plastic hinges primarily in the columns, insufficient reinforcement, low-strength material, and RC frame insufficiency. An example of this damage mechanism is shown in Fig. 18. The main reason for this damage, which can classify as slumping damage, is that the system reaches the lateral collapse mechanism as a result of the formation of plastic hinges in the columns (construction of strong beams, weak columns, not paying attention to the confinement of stirrups, poor concrete quality).

Fig. 18 Lateral collapse (accordion) damages

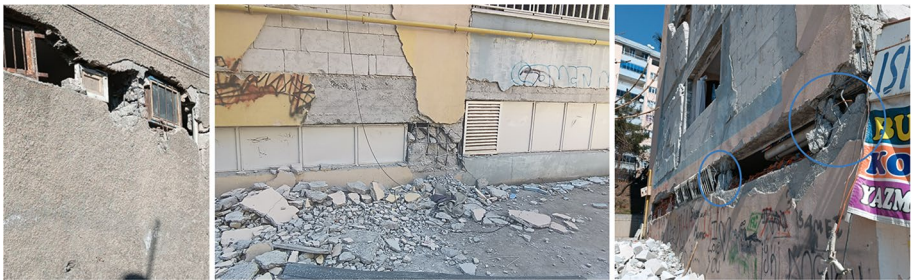
Short column formation is a structural weakness situation specified in TBEC-2018, and sudden shear damage occurs, especially in ground floor columns. Short column damage caused by the change of column height due to different reasons in the building has also been observed widely. Short column damage, especially due to the use of band-type windows, is shown in Fig. 19. In this case, buckling problems in longitudinal reinforcement were clearly observed as a result of crushing in low-strength core concrete. Short columns,

Fig. 19 Short column damages due to band-type windows

which are created in the design phase or later in building structures, are structural elements with high rigidity and low ductility. Due to their high rigidity, they are exposed to small displacements despite large horizontal forces during earthquakes. This situation causes the columns to collapse by losing strength due to shear failure.

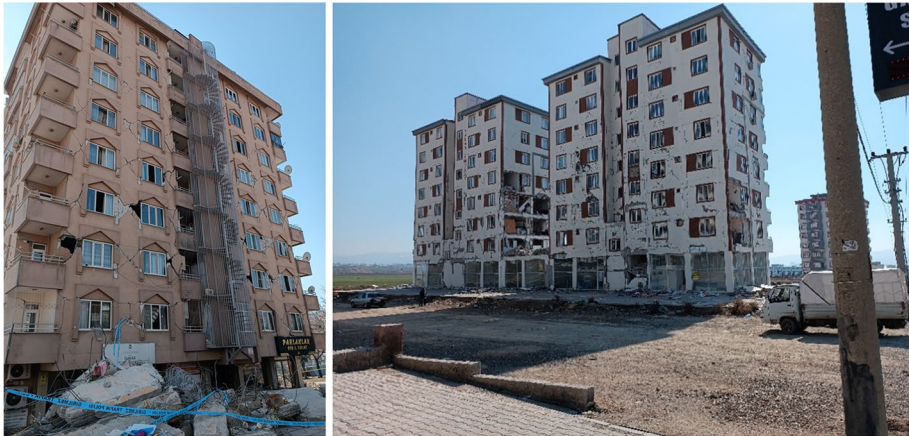
Infill wall placement, if done properly, is a great gain for structural performance. Otherwise, a soft and weak story situation may be triggered and building torsion may occur. In addition, displacement controls for the frames must be made separately depending on whether these elements are adjacent to the frame or separate in the design. In RC structures, X-shaped shear cracks are commonly encountered in the infill walls, which are built to separate spaces and due to external effects, have low shear and tensile stress capacity. Such damage is shown in Fig. 20. In addition, out-of-plane failure-type damages were observed on these walls with insufficient connections.

Fig. 20 Examples of infill wall damage

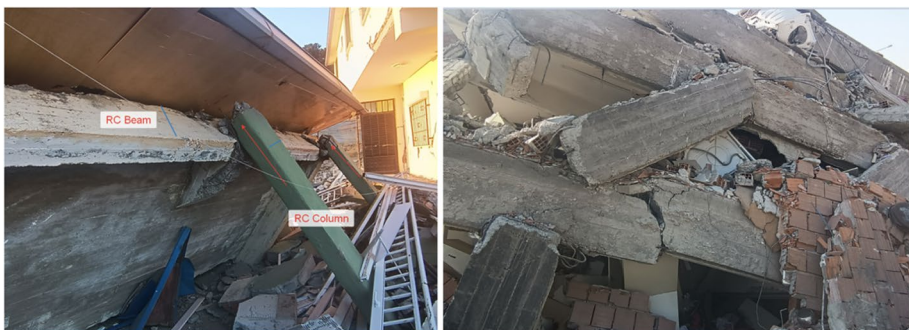
of load-bearing elements with each other has an important place in earthquake-resistant building design specifications. The load-bearing structural elements with size compatibility between them perform the load transfer in a healthier way. Columns are recommended to be stronger than beams in earthquake design codes. Because the beams only carry self-weight together with the loads coming from the slabs and walls on the floors they are located. However, in addition to all these loads, the columns also carry self-weight and the loads coming from the upper floors. In this case, the hinges are formed at the upper ends of the columns, causing the columns to separate from the beams, resulting in damage (Fig. 21).

Fig. 21 Damages caused by strong beams and weak columns

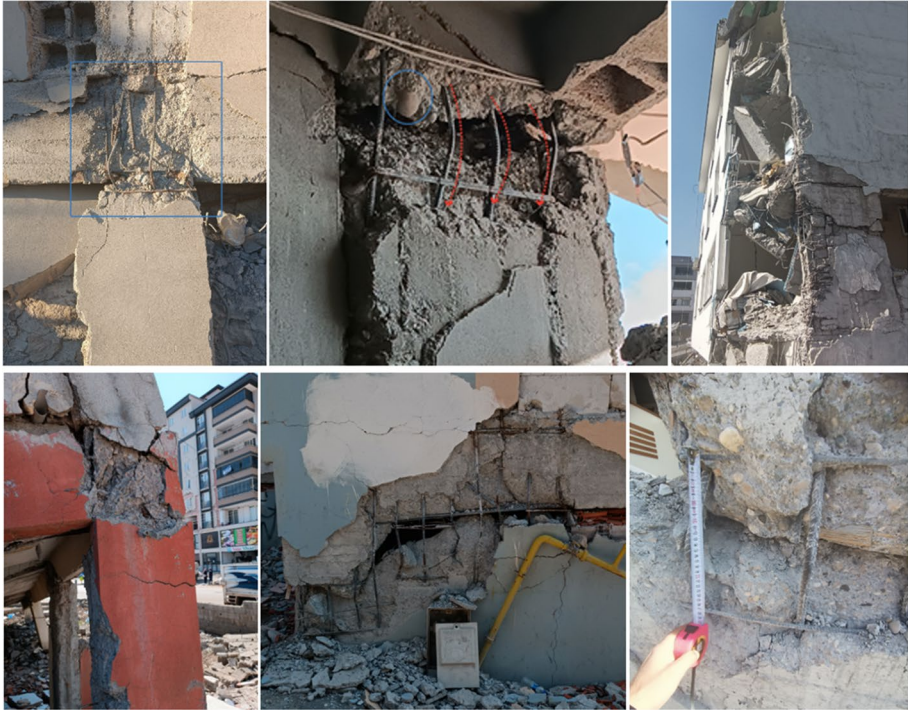
Structural member detailing must comply with TBEC-2018. Inadequate or unsuitable use of reinforcements used to resist tensile stresses in reinforced concrete buildings at column-beam joints and poor workmanship also cause structural damage at various levels. In such damages, the concrete cover is damaged first, followed by a buckling of the longitudinal reinforcements, where inadequate transverse reinforcement is not used. (Fig. 22).

Fig. 22 Damages due to low-strength concrete and lack of reinforcement

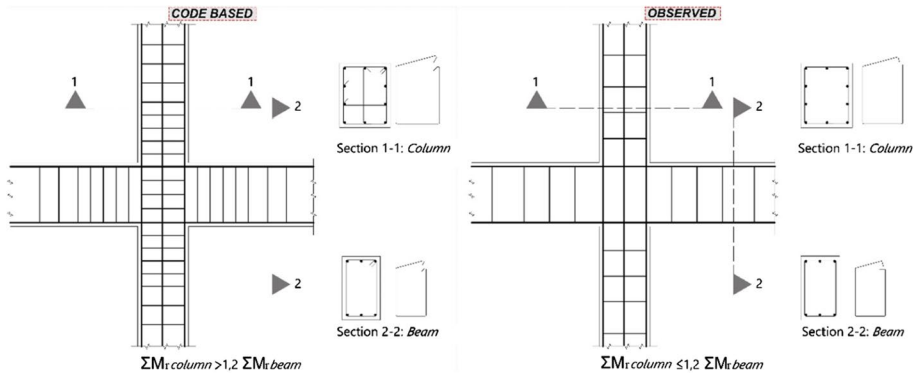
Fig. 24 Comparison of the reinforcement detail according to the code and observed in the field

As seen in Fig. 24, it is seen that the transverse reinforcement gaps in the beam-column joint, confinement, and middle region are exceeded. It has been observed that in some regions of the columns, the transverse reinforcements are not used at all. In addition, it has been determined that the special earthquake stirrups, which are obligatory in TBEC-2018, are not used at all. In addition to these, the transverse rebar's fixed to the longitudinal rebar at 90° instead of 135° . This prevented the transverse and longitudinal reinforcements from working together during the earthquake and caused them to separate from each other. In addition, although a strong column-weak beam is foreseen in the regulation, the weak column-strong beam is created in practice. A comparison of the code and observed conditions in the field of all these cases is shown schematically in Fig. 24.

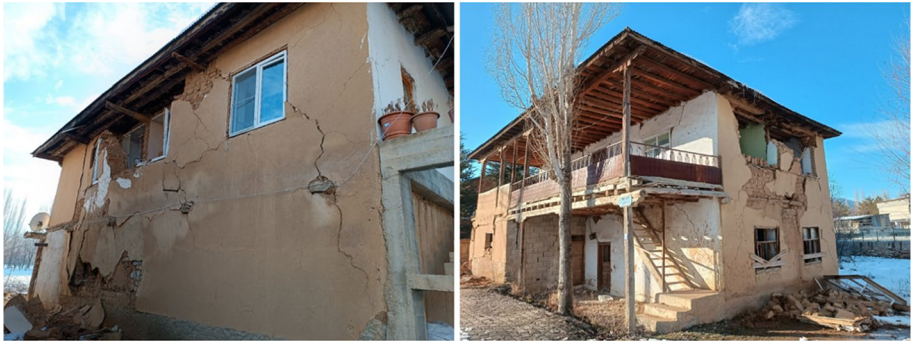
different levels due to the separation of the load-bearing wall corners, and damage to the non-structural building members. One of the frequently encountered problems in masonry structures under the effect of seismic load is cracking in window openings. These cracks often involve weaker sections such as corners or junctions of structural members. In the examinations made after the earthquakes, it was observed that most of the masonry structures in Kahramanmaraş were structurally damaged due to cracks in these regions. These findings play an important role in better understanding the behavior of masonry structures in earthquakes and determining the measures to be taken to strengthen the structures. Damages caused by window openings are shown in Fig. 26.

Fig. 26 Damages caused by window openings

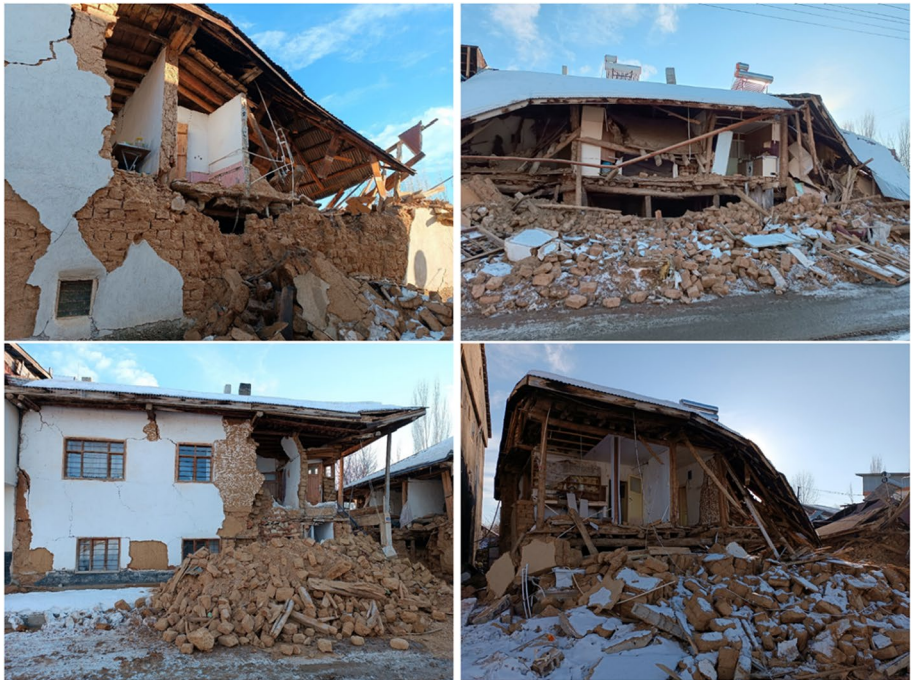
Fig. 27 Out-of-plane movement damages load-bearing walls

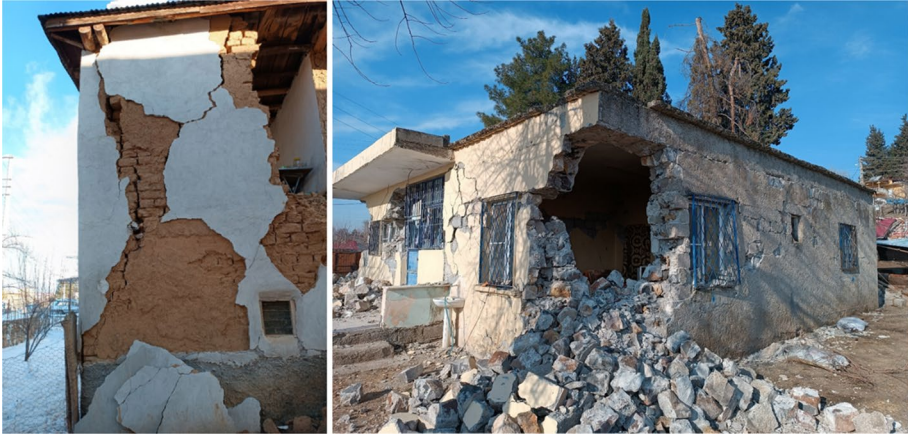
clamping at the corner points of the load-bearing walls is the main reason for this damage. Especially as a result of the concentration of horizontal loads at these points and exceeding the bearing capacity, cracks or separations can be seen at the wall joints or corners. Examples of such damage are shown in Fig. 28.

Fig. 28 Splitting damage at the wall corners

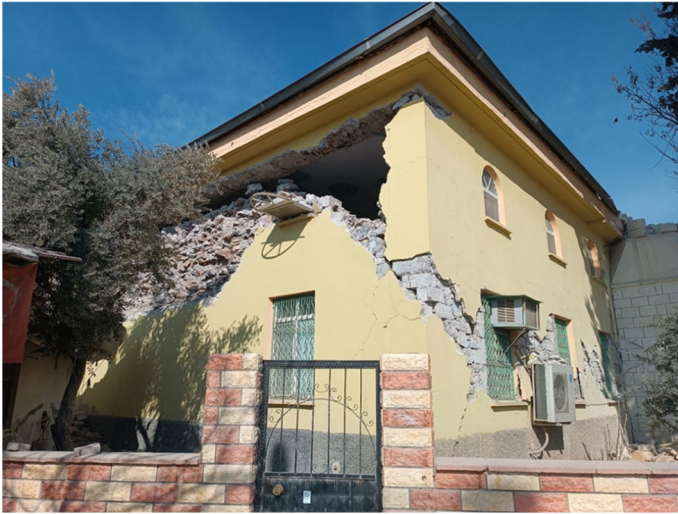
Examples of damaged structures containing mixed materials are shown in Fig. 29. This type of damage was caused by the lack of sufficient connections during the layering of different wall materials.

Fig. 29 Damages caused by the use of different wall materials and insufficient connection

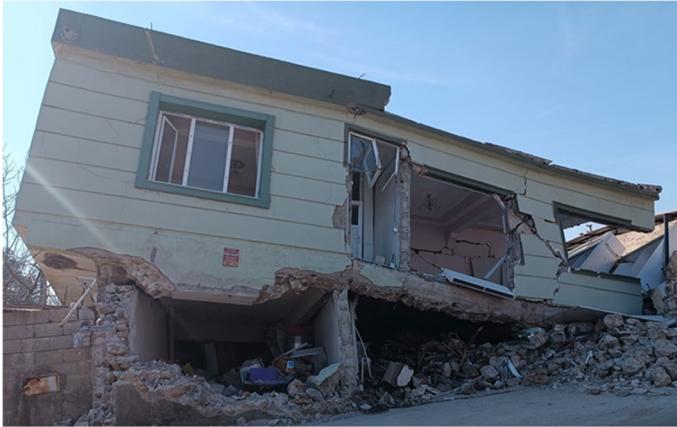
Damages were also observed in the confined masonry structures. The difference in strength/rigidity between floors was caused by the soft-story mechanism. An example of such damage is shown in Fig. 30. Since the gap between the load-bearing walls on the left side of the building is less than on the right side of the building, the building has reached the collapse mechanism from the right side.

Fig. 30 Soft-story damage in a confined masonry structure

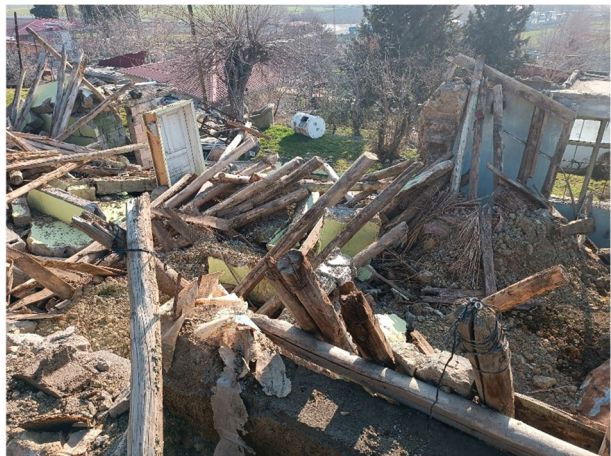
with the roof and have poor in-plane/out-of-plane rigidity, cannot transfer the load correctly, experience a sudden loss of strength and the walls collapse together with the roof. In buildings with heavy earthen roofs, the rate of destruction is higher when combined with factors such as the use of materials with low strength, the inability to provide the necessary and sufficient connection between the walls, and the excess of door and window openings. Examples of damage that caused the total collapse of the structure as a result of additional earthquake forces due to heavy earthen roofs are shown in Fig. 31.

Fig. 31 Heavy damage due to heavy earthen roofs

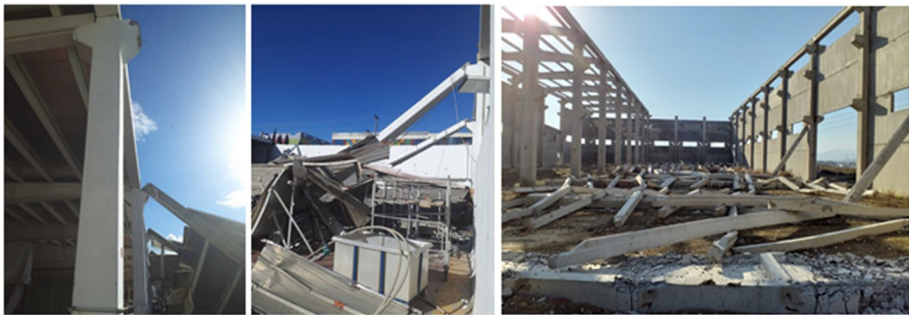
Fig. 33 Examples of industrial structures after the failure of the pinned beam-column connection

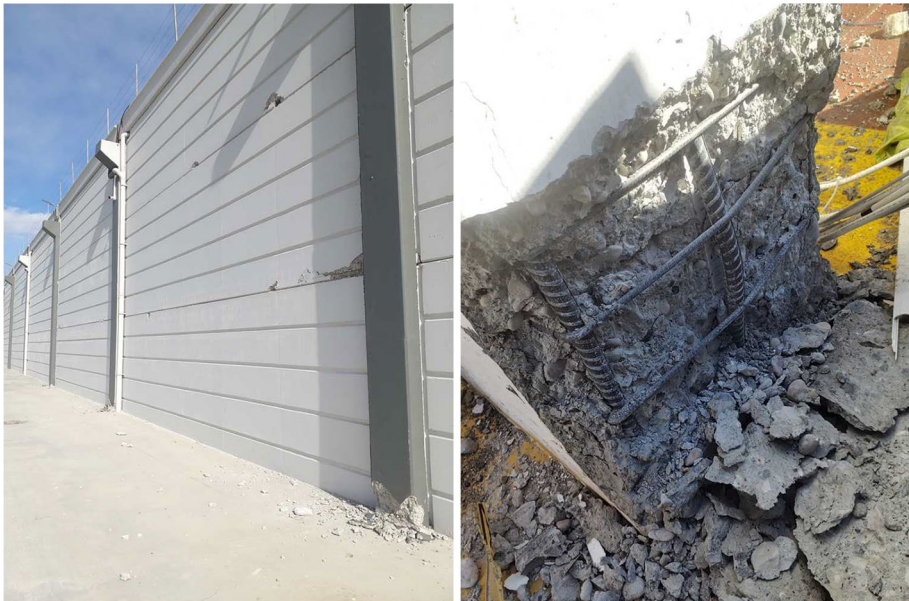
Fig. 34 Plastic hinges formed at the base of the column

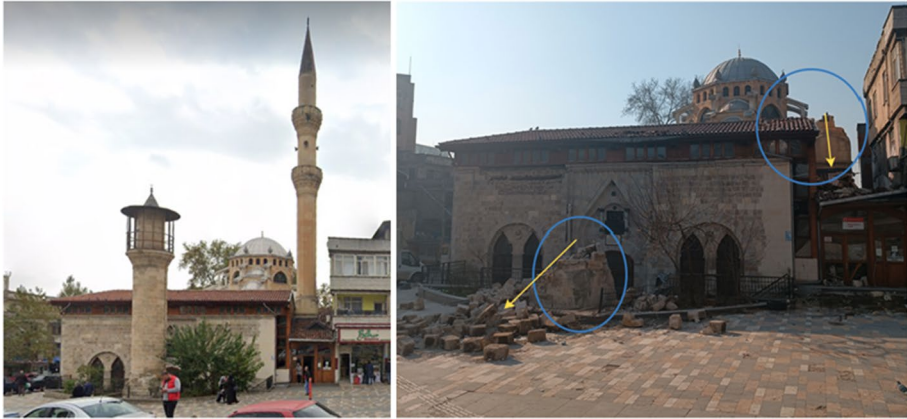
Fig. 35 Arasa Mosque and its minaret before the earthquake (google earth), after the earthquake (by authors)

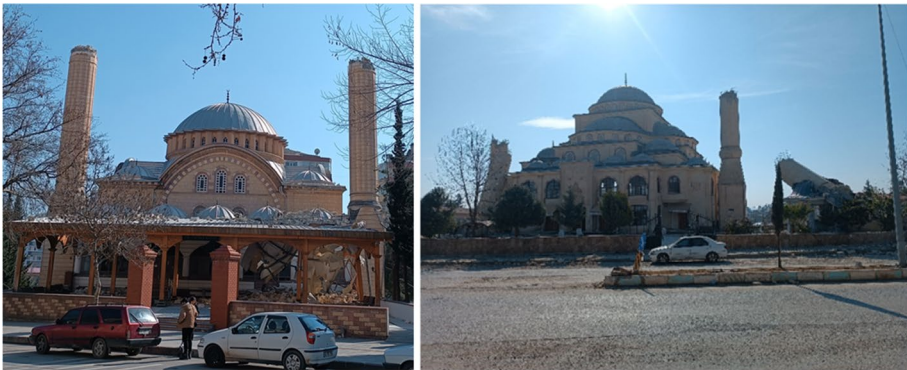
Fig. 36 Examples of minarets damage

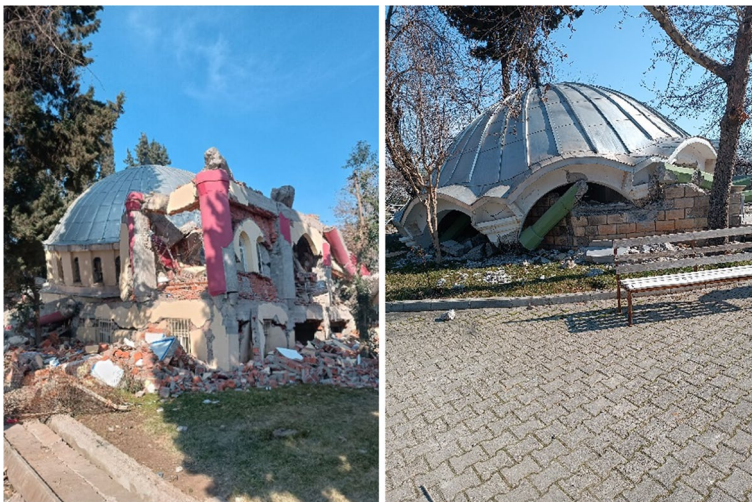
Fig. 37 The partial and total collapse of the mosque and its Shadirvan
