# Evaluation of the seismic response of reinforced concrete buildings in the light of lessons learned from the February 6, 2023, Kahramanmaraş, Türkiye earthquake sequences

Burak Yön<sup>1</sup> · İbrahim Özgür Dedeoğlu<sup>2</sup> · Musa Yetkin<sup>3</sup> · Hakan Erkek<sup>4</sup> · Yusuf Calayır<sup>5</sup>

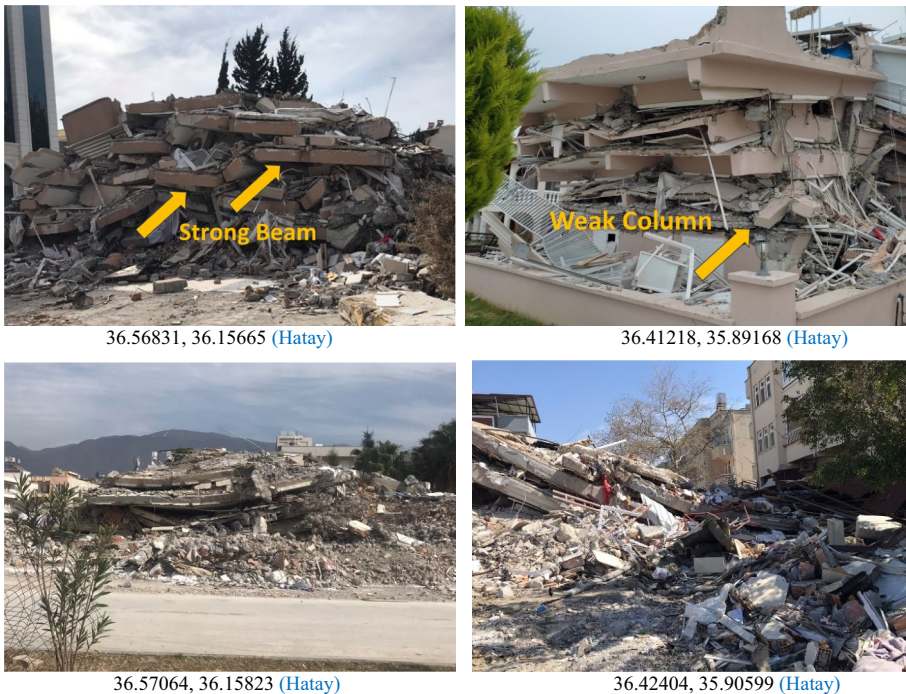
collapses, failing to demonstrate any inelastic behaviour. Axial load represents a significant factor influencing ductility. The axial load on beams is significantly less than that on columns. Consequently, it is more straightforward to guarantee ductility in beams than in columns. It is therefore recommended that columns be constructed with greater strength than beams and that plastic joints be formed in beams rather than columns. By the TEC-2007 and TBEC-2018, the bearing capacity of columns joining at a node must be a minimum of 20% greater than the bearing strength of beams joining at the same node. However, it was observed that this design was not implemented in earthquake-prone zones, resulting in the collapse of numerous structures. Figure 14 illustrates the phenomenon of a strong beam-weak column in earthquake areas.

Fig. 14 Strong beam-weak column mechanism in the earthquake area

Damage type	Recommendation/Solution
Strong beam-weak column	The bearing capacity of columns joining at a node be at least 20% greater than the bearing strength of beams joining at the same node
Soft story-weak story mechanism	It would be to consider the drift of the floors relative to each other rather than the peak displacement in the design. To increase the stiffness of this floor, reinforced concrete shear walls should be used or column sizes should be increased. In addition, applications such as mezzanine floors should be avoided
Pounding effect	The minimum space should be left between adjacent buildings according to the peak displacements obtained as a result of analyses given in the earthquake codes
Short column damage	Short columns should be avoided in buildings as much as possible. Where it is necessary to construct short columns, closely spaced stirrups should be used to increase the shear safety of these columns. The sides of the columns should be walled or crushable material should be placed

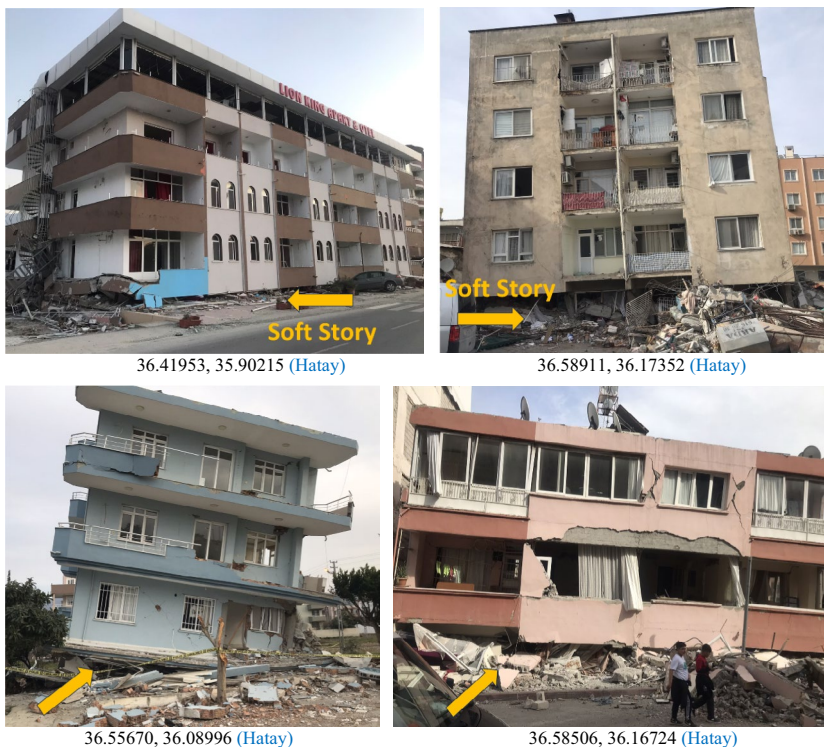
The soft-story mechanism is a type of brittle failure that often occurs after earthquakes. In these buildings, where the ground floor is designed as a commercial space, the height of this floor is higher than the other floors. In addition, the use of insufficient reinforced concrete shear walls or thick columns on this floor to ensure that the front façade of the commercial space remains open, and the lack of infill walls, are other factors that reduce the stiffness of this floor. Due to this incorrect design, the stiffness of this floor is quite low compared to other floors. In the serviceability limit state assumed for the slab and beam in the design, cracks may occur in the relevant elements. However, the low-stiffness vertical members on this floor may collapse without cracking in the same limit state. A second

Fig. 15 Soft-story mechanism in earthquake areas

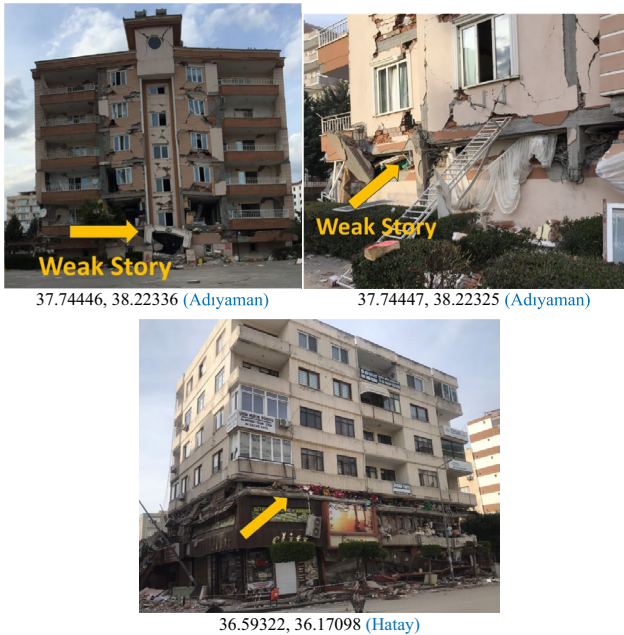
Another type of damage observed in seismic regions is that of a weak floor mechanism. This type of damage, which causes brittle fracture, is primarily caused by the abrupt reduction in the size of columns and reinforced concrete shear walls between floors, or the removal of these structural elements. However, the omission or subsequent removal of infill walls to create large spaces between floors represents another significant cause of damage. Such errors result in a reduction in the effective shear areas of the structural members on the floor in question. Consequently, the floor, which has been weakened by the earthquake, enters a state of collapse. Figure 16 illustrates the mechanism of weak-story failure in seismic zones.

**Fig. 16** Weak-story failure mechanism in the earthquake areas

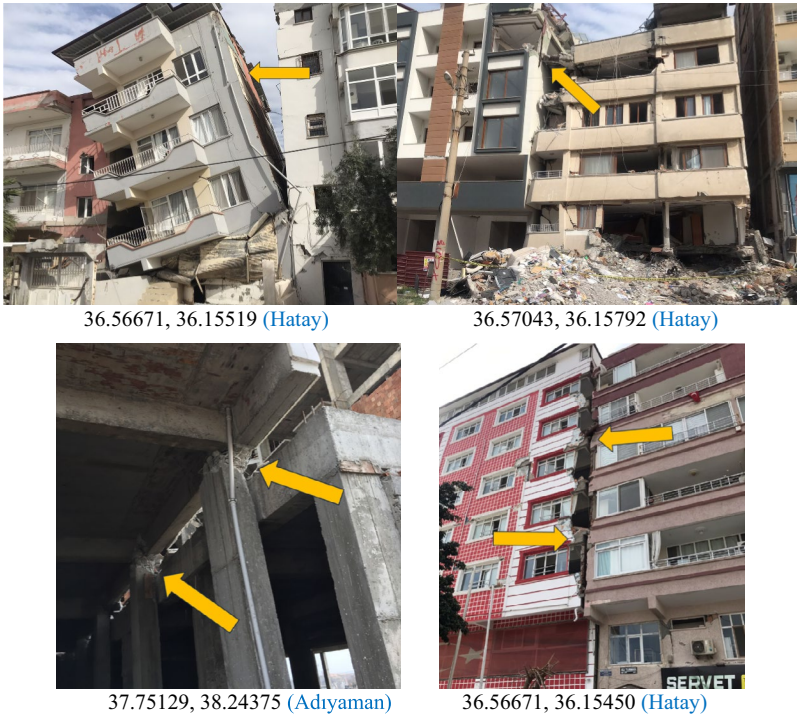
the earthquake. Due to this pounding effect, buildings with weak rigidity can be severely damaged or go into collapse mode. TBEC-2018 (2018) offers two approaches to the minimum amount of space that should be left between adjacent buildings to prevent a collision, and the amount of space is determined according to the unfavourable one of these two approaches. In the first approach, the minimum size of gaps should be 30 mm up to 6 m in height, and from thereon, a minimum of 10 mm should be added for each 3 m height increment. In the second approach, the amount of gap is determined depending on the  $\alpha$  parameter. If the floor slabs of neighbouring buildings are at the same level on all floors,  $\alpha = 0.25(R/I)$  should be taken, and if the floors of neighbouring buildings are at different levels,  $\alpha = 0.50(R/I)$  should be taken for the whole building. In these equations, the factor of the structural behavior and building important coefficient is shown by  $R$  and  $I$ , respectively. During the field study, it was observed that there was insufficient space between the buildings, which resulted in significant damage to the structures (Fig. 17).

Fig. 17 Pounding effect

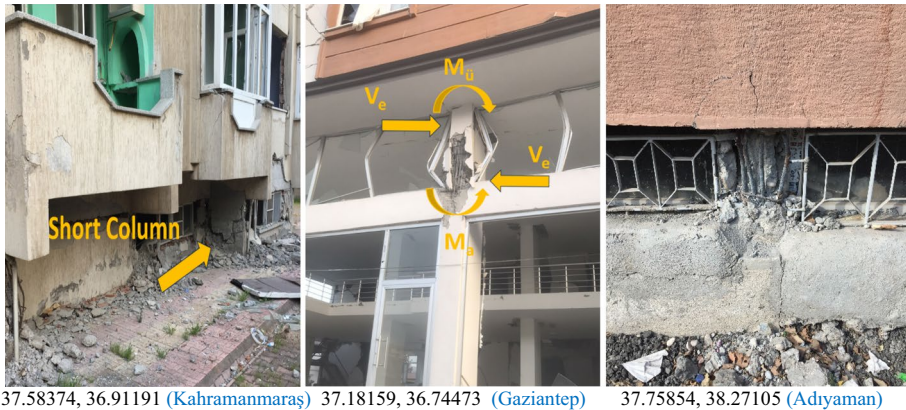
where  $M_a$  and  $M_u$  are the end moments obtained by multiplying the bearing capacity moment at the lower and upper ends of the short column by the coefficient of 1.4.  $l_n$  is the length of the short column,  $V_r$  is the shear strength of the column cross-section,  $A_w$  is the effective body area of the column cross-section, and  $f_{ck}$  is the characteristic compressive strength of the concrete. During the field study, no special stirrup details were found to meet the earthquake shear force of short columns. For this reason, these structures were severely damaged (Fig. 18).

**Fig. 18** Short column damages

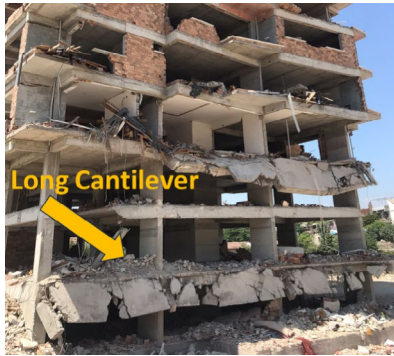
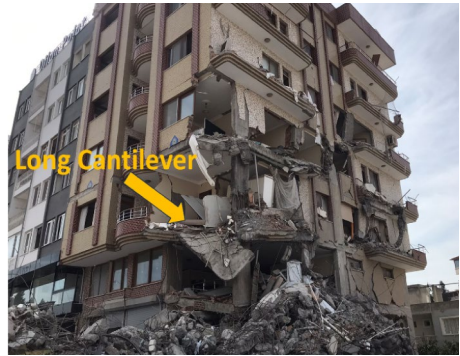
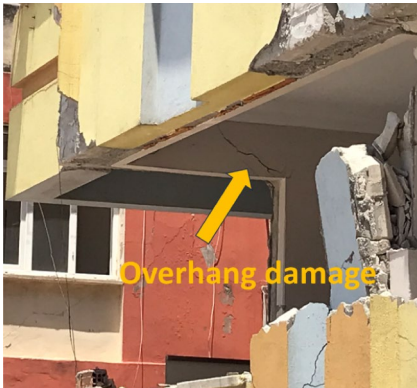
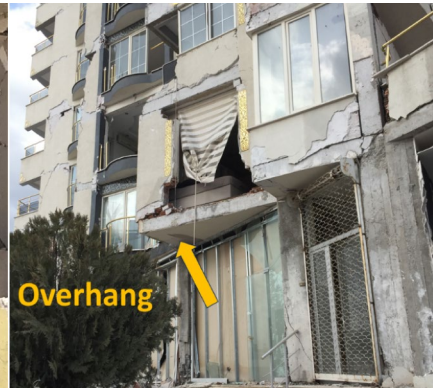
Buildings with long cantilever balconies and heavy closed overhangs are greatly affected by the vertical acceleration of the earthquake. With the vertical movement of the earthquake, large moments occur in the built-in support of the console. Long consoles that are not detailed according to this effect go into collapse mode. In closed cantilevered

structures, external infill walls may be damaged in-plane or out-of-plane as a result of vertical movement. Considering the effect of the vertical component of the earthquake in the design of structures and representing this effect with the vertical elastic design spectrum has become possible with TBEC-2018 (2018). Unfortunately, before this date, buildings were designed only for the horizontal earthquake effect, without taking into account its vertical component effect. Despite this, serious damage was observed in buildings with cantilever balconies and closed exits that are new or under construction in the earthquake region (Fig. 19). TBEC-2018 has made it mandatory to use the vertical elastic design spectrum in the design of the structures given below (2018):

**Fig. 19** Long Cantilever and Overhang damages

However, the authors recommend that vertical acceleration should be taken into account in all building designs.

Long cantilever and overhangs	The vertical elastic design spectrum should be considered in the design of structures and cantilevers should be detailed in this effect
Short beam damages	Reinforcement detailing of these beams should not be done as in classical beam design. Special reinforcement detailing must be done to prevent damage to these beams
Buckling damage	The buckling effect should be considered in the design by the designer
Torsion effect	To protect against additional torsional moments in buildings, great care should be taken in the placement of reinforced concrete walls and columns
Material quality	Buildings must be constructed to the minimum concrete strength required by earthquake codes. Control should be ensured at every stage of the building's construction
Insufficient transverse reinforcement	Special seismic cross ties and hooks should be bent 135° in all seismic zones
Compressive failure due to over reinforcement	The limits on the use of reinforcement required by TBEC-2018 to ensure ductility in beam and column designs must be complied with

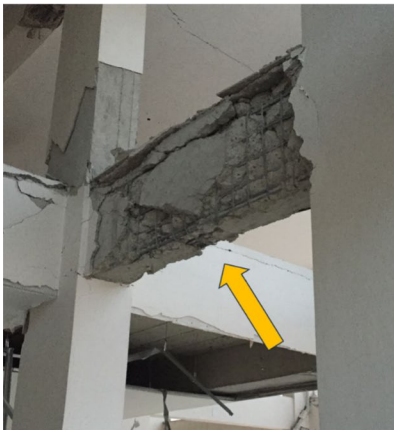
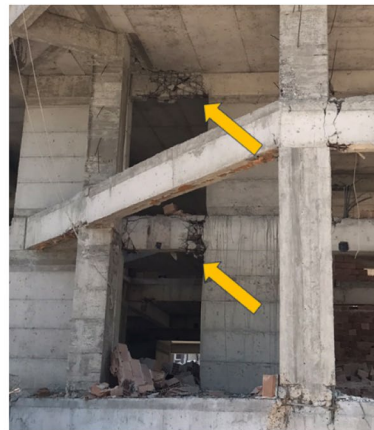
It may be necessary to create openings in reinforced concrete shear walls for reasons such as doors, windows, etc. Consequently, hollow shear wall systems are formed. While a shear wall without openings shows bending behaviour, due to the openings opened in the wall, this behaviour exhibits shear behaviour depending on the opening ratio. In hollow shear wall systems, column stiffnesses will be considerably higher than beam stiffnesses. Since hollow shear elements are very rigid under earthquake forces, they do not create double curvature. Double curvature deformation occurs in the beams. Thus, the tie beams are under the influence of both bending and shearing. This causes serious damage to the short beams. This type of damage has been observed in the region affected by the earthquake. Figure 20 illustrates the damage sustained by the short beam damages. Reinforcement detailing of these beams should not be done as in classical beam design. Special

**Fig. 20** Short beam damages

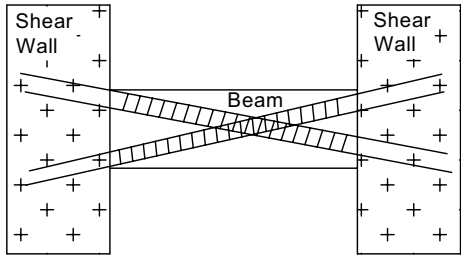
**Fig. 21** Special detailing of the short beams

reinforcement detailing be employed to prevent damage to these beams. Figure 21 illustrates the specific reinforcement detailing of the tie beams.

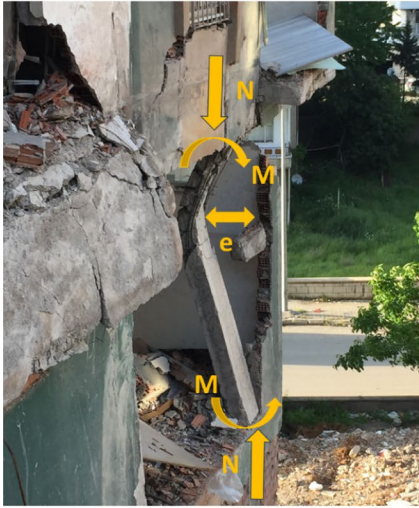
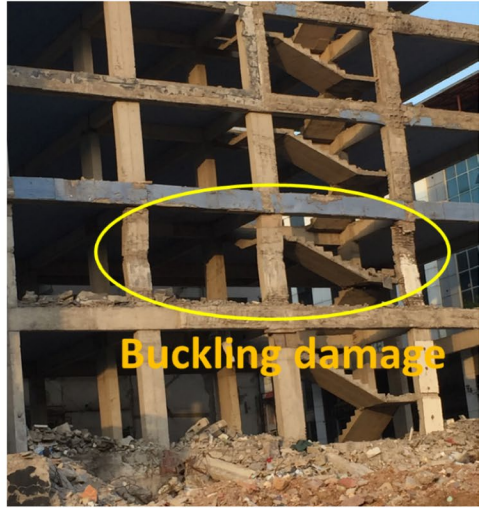
**Fig. 22** Buckling damage

The buckling of reinforced concrete columns is influenced by many factors. The aforementioned factors include the dimensions of the column cross-section, the length of the column, the support conditions at both ends of the column, the single and double curvature of the column in systems where slip is prevented, and the quality and wrapping effect of the material. The behaviour of thick columns and slender columns is quite different from each other. In thick columns, fracture occurs in the form of buckling of reinforcement and crushing of concrete, while in slender columns, it occurs in the form of stability fracture (buckling along the column). In slender columns, vertical load also becomes important due to increased lateral translation due to horizontal forces, and the columns break under the effect of second-order moments. In observations made in earthquake regions, columns subjected to buckling damage were found. These damages are presented in Fig. 22. When this figure is examined, it is seen that in addition to the Moment ( $M$ ), the column is subjected to

an additional second-order moment of the normal force  $(N) \times e$ . As a result of this effect, the columns were severely damaged.

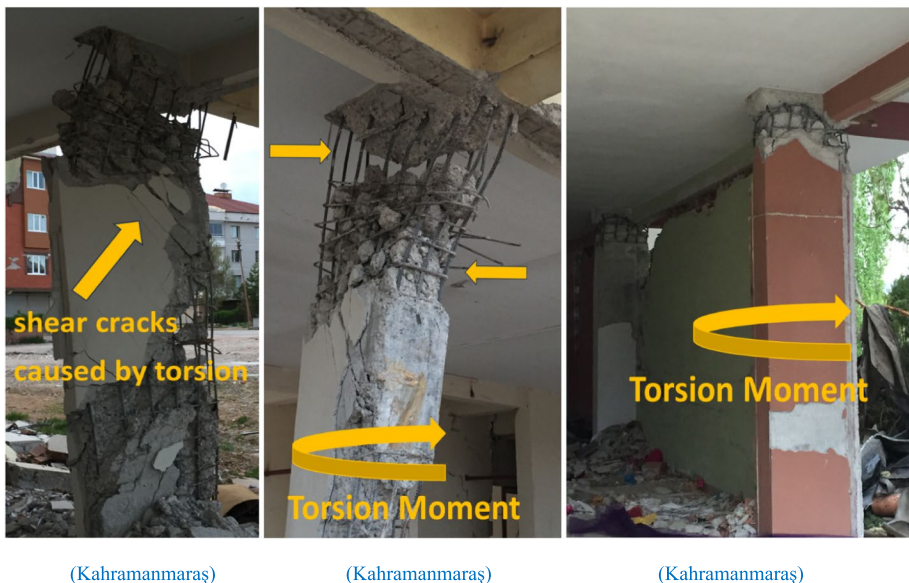
Torsion represents a significant source of stress on buildings during seismic events. As reinforced concrete walls are not placed in a regular pattern, the centre of mass and the centre of rigidity of the structure move away from each other. The centre of stiffness displaces the area in which the reinforced concrete walls are concentrated. Depending on the distance between the two centres, additional torsional moments occur in the structure. These moments, which are not taken into account in cross-section calculations, force the columns to rotate and cause brittle fractures. During the examination carried out in the earthquake area, the structures damaged due to torsion are noteworthy. Figure 23 shows the damage caused by the torsion effect. To be protected from additional torsional moments in buildings, great attention should be paid to the placement of reinforced concrete walls and columns. These elements should be placed considering their rigidity. However, the positions of columns and shear walls should not be changed randomly during the construction phase of the building. Changes that will increase or decrease the rigidity of columns and walls should be avoided.

Fig. 23 Torsion damage

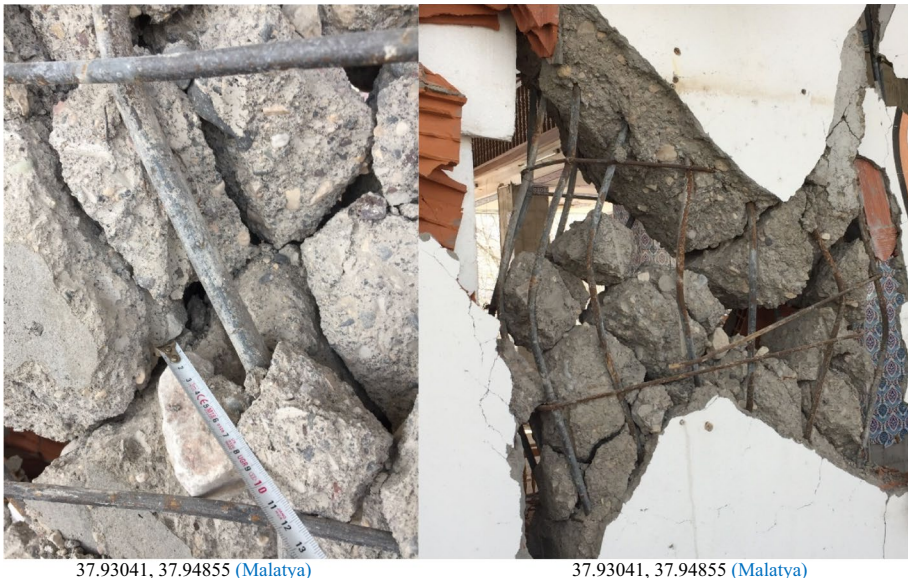
strength instead of smooth surface reinforcement with 220 MPa yield strength in buildings constructed after the 1999 Kocaeli earthquake. However, while the minimum concrete compressive strength was stated to be 20 MPa in the TEC-2007, the earthquake code renewed in TBEC-2018 required the minimum concrete compressive strength to be 25 MPa. Observations made in the earthquake area showed that the concrete strength of most of the heavily damaged old buildings was between 6–10 MPa and their reinforcements had flat surfaces. Due to this feature of the reinforcement used, it was determined that there was no adherence between the reinforcement and the concrete, and the reinforcement was stripped from the concrete (Fig. 24). It has been observed that the concrete strength in new buildings is relatively higher than in old buildings, but remains below the concrete strength specified in the codes. It was determined that the placement of the concrete was not particularly taken into consideration and there were gaps in the concrete (Fig. 25). It has been determined that there are segregations in structural elements caused by concrete pouring. As a result of our observations, it was concluded that the supervision in newly constructed buildings is still inadequate, additional water is used to settle the concrete between the reinforcement, the concrete is placed without using a vibrator, and no curing process after concrete pouring.

Fig. 24 Material quality of old buildings

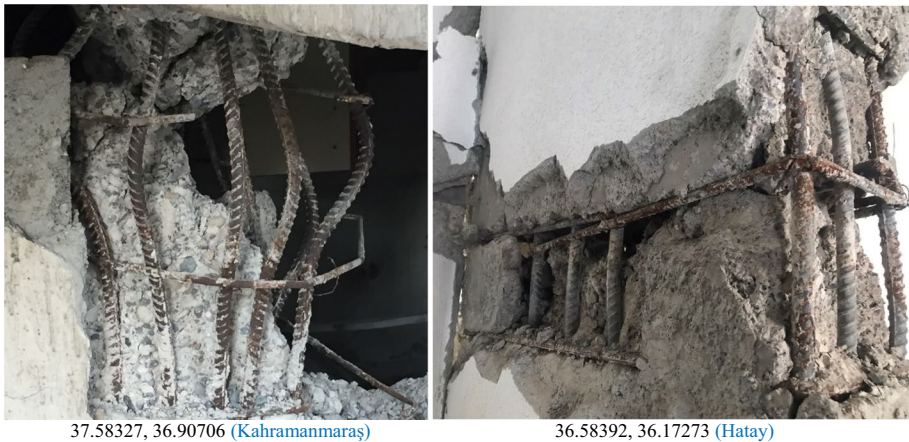
**Fig. 25** Material quality of new buildings

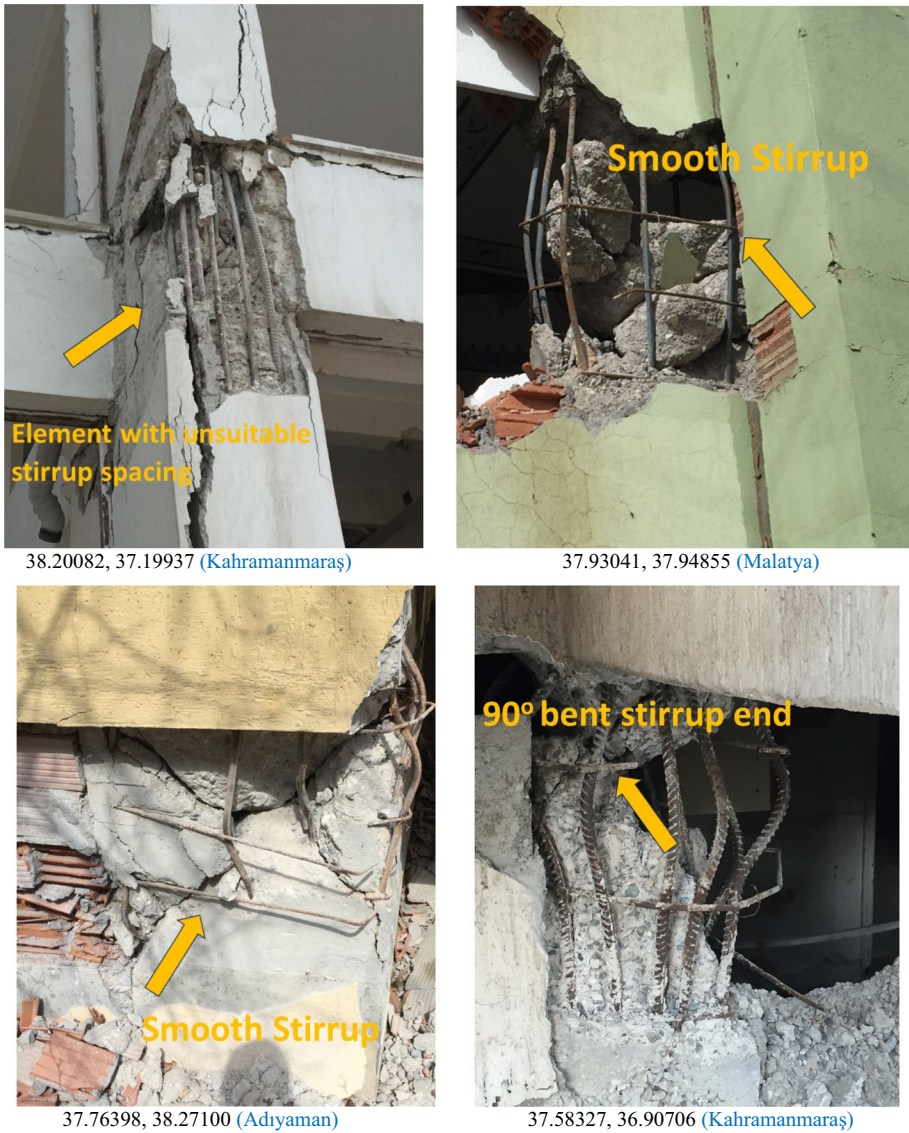
buildings. This can be attributed to various factors, including inadequate inspection procedures, design errors, and negligence on the part of construction workers. In the field studies carried out in the earthquake zone, it was observed that plastic joints occurred and appropriate stirrup tightening was not made in the column end areas that required special detailing. In addition, as a result of using flat-surface transverse reinforcement and not bending the ends of the stirrups, serious shear damage occurred in the structural elements. In field studies, it was determined that the stirrup spacing, which was expected to be between 5–10 cm in the column end regions, was between 20–40 cm. Additionally, it was observed that in large columns, a single stirrup was made surrounding the reinforcement. For this reason, the longitudinal reinforcements were buckled and serious shear damage occurred in the core concrete. Turkish Earthquake Codes (1997 (TEC 1997, Onat 2022), 2007, and 2018) require that special seismic cross ties and hooks should be bent  $135^\circ$  in all seismic zones. Figure 26 illustrates the structural elements that failed due to inadequate transverse reinforcement, improper hooks, and smooth bars.

Fig. 26 Inadequate transverse reinforcement, improper hooks, and smooth bars

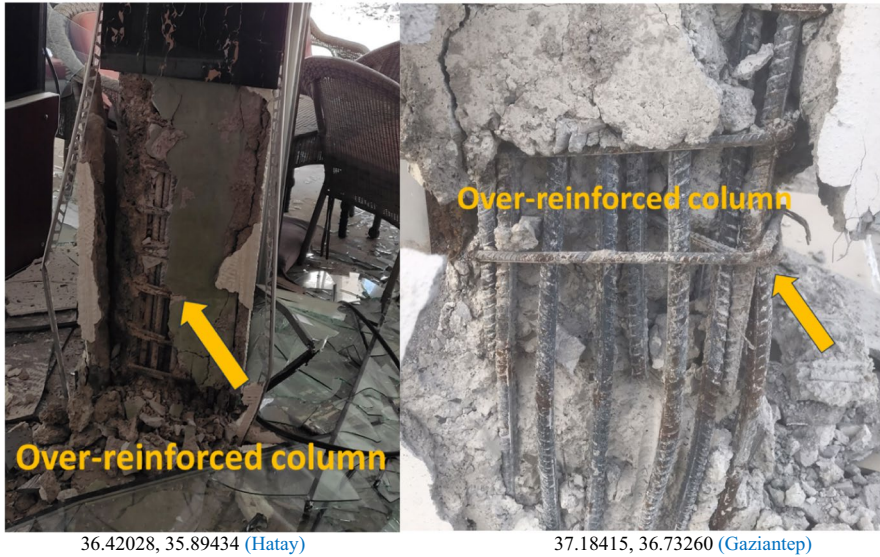
The Turkish Earthquake Codes impose minimum and maximum limitations on the use of reinforcement to ensure ductility in beam and column designs. The maximum limit is for the element to exhibit ductile fracture behaviour without undergoing compression failure. When the reinforcement ratio in the elements is higher than the balanced reinforcement, the concrete is crushed without the reinforcement flowing during the fracture. This situation causes compression fracture, which is a brittle fracture. In the field studies made after the earthquake, it was determined that the reinforcement did not flow in the elements where the reinforcement ratio was too high, whereas the core concrete was crushed and broken. Figure 27 illustrates the phenomenon of compression fracture.

**Fig. 27** Compression failure in columns due to excessive reinforcement

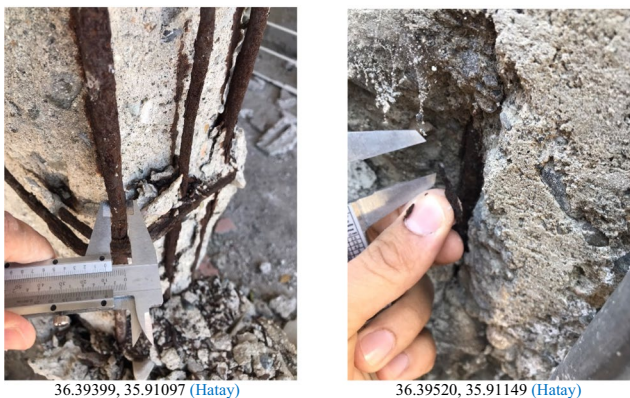
Basements and ground floors of buildings are more affected by groundwater and rainwater. Especially the reinforcement of structural elements with poor external insulation and inadequate concrete cover are subject to corrosion for various reasons. As a result of corrosion, reinforcement loses its properties and begins to flake over time. This results in a loss of functionality for the reinforcement and a reduction in the bearing capacity of the structural elements. Many structural elements with corroded reinforcement were found in

**Fig. 28** Corroded reinforcement

the earthquake zone (Fig. 28). Maintenance and repair processes must be continued after the construction of reinforced concrete buildings to eliminate factors that cause damage, such as corrosion.

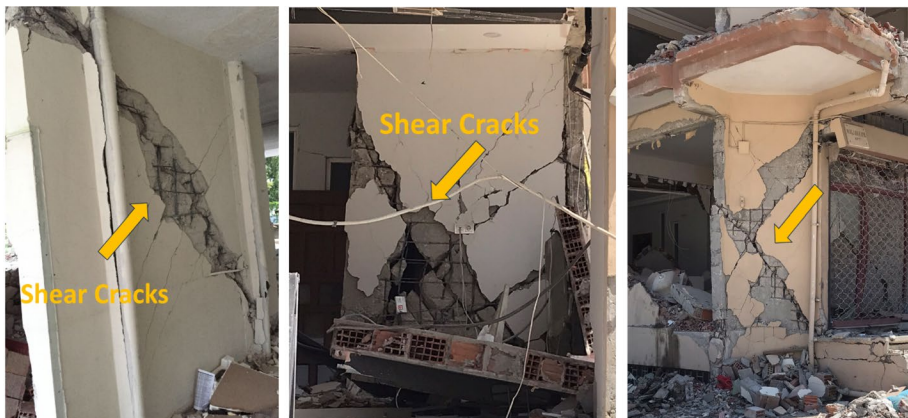
force especially stress the end areas of the walls and the areas close to the foundation. For this reason, when detailing wall element reinforcement, attention should be paid to the end zones and critical height. Examinations carried out in the earthquake area showed that the damaged shear walls were exposed to large shear forces. It was determined that the shear wall end zone was not made in the damaged shear wall elements and there was no appropriate reinforcement detailing. It was also observed that the buildings with fewer shear walls than required were insufficient to resist the earthquake forces. Shear wall damages for these types of buildings are presented in Fig. 29.

Fig. 29 Shear wall damages

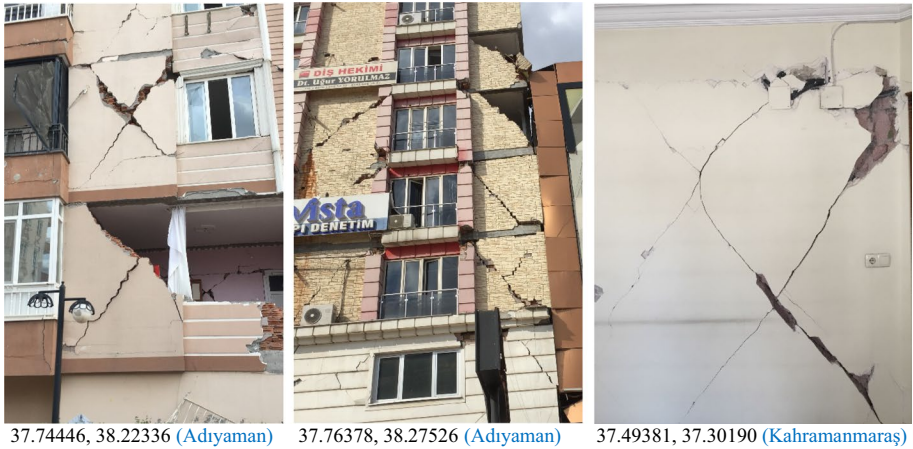
**Fig. 30** In-plane damage to infill walls

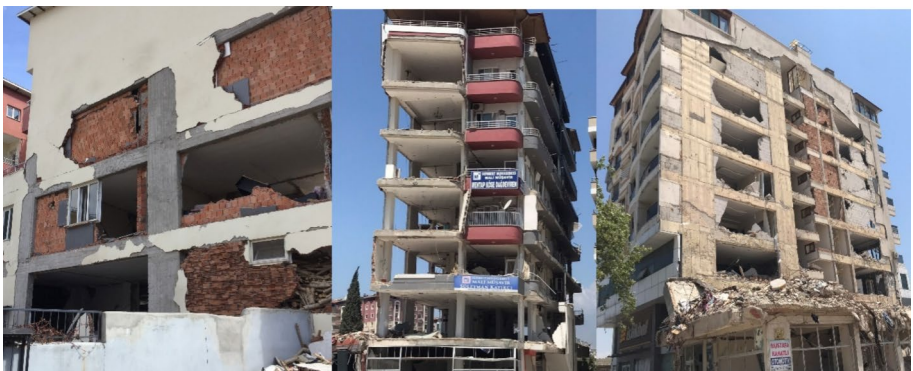
Infill wall damage may also manifest as out-of-plane wall damage. The exterior walls of some buildings in Türkiye are constructed with two layers to provide heat and sound insulation. In this application, which is done by placing insulation material between two walls, the outermost wall layer falls out of its plane due to the earthquake effect, due to the lack of connection elements between the walls and insufficient mortar. In addition, increasing space widths for architectural reasons leads to the construction of higher and wider walls. These weak walls, which have low thickness, do not have beams between

the walls and are anchored to the frames only with mortar, easily toppling out of their planes. Figure 31 demonstrates the out-of-plane damages in infill walls.

**Fig. 31** Out-of-plane damages to infill walls

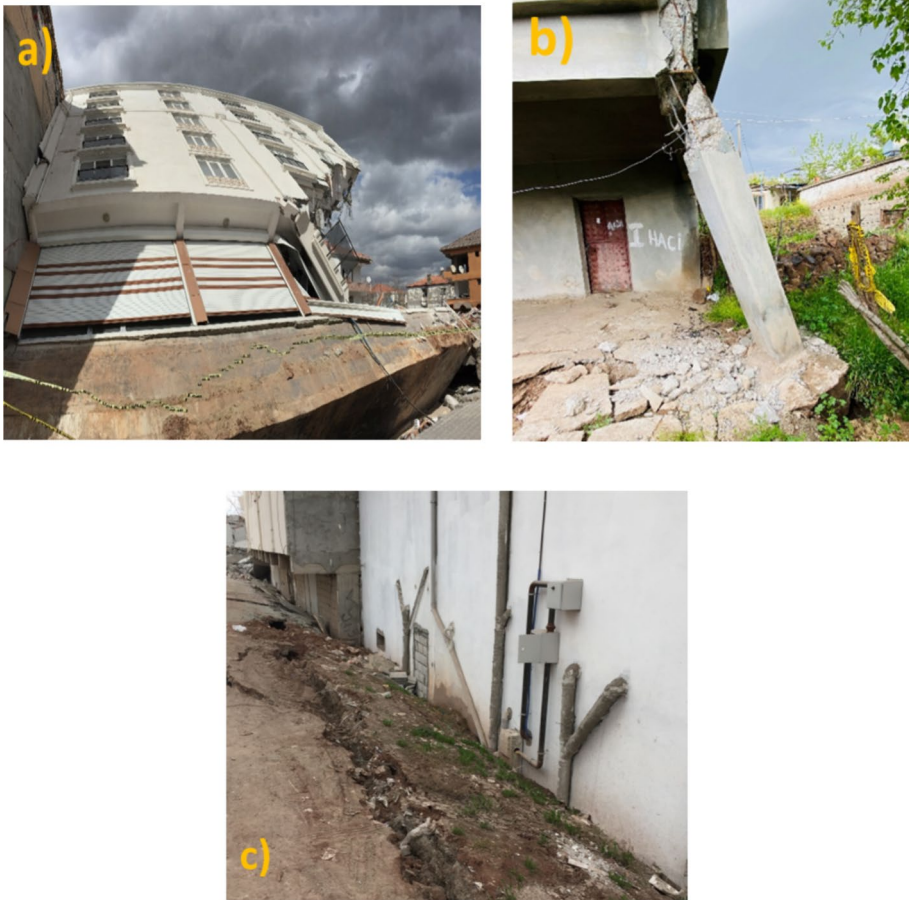
In the examinations carried out in the earthquake area, it was observed that the soils of the earthquake-affected areas had a high probability of liquefaction and their bearing capacity was weak. It has been determined that the foundation systems of structures built on agricultural lands are generally not chosen to suit the ground. When Fig. 32a is examined, the building was exposed to a wholesale collapse due to the lack of a basement and the effect of liquefaction on the ground. Figure 32b illustrates that the foundation made in the form of individual footing does not have the appropriate depth and foundation size, thus rotation of the foundation occurred and caused severe damage at

**Fig. 32** Damages arose from the Soil and Foundation system

the upper end of the column. Figure 32c shows a situation in which the foundation was not selected appropriately for the ground with insufficient bearing capacity, resulting in the building sinking into the ground.

Damage type	Recommendation/Solution
Damages arose from the soil and foundation system	On soils with a high probability of liquefaction, construction should not be carried out or the soil water should be removed, on soils with a low bearing capacity, the building should be constructed accordingly, a basement should be built, foundation depths and dimensions should be designed according to the bearing capacity of the soil
