# Vapor-Phase CMAS-Induced Degradation of Adhesion of Thermal Barrier Coatings

Vladimir Tolpygo<sup>1</sup>

**Abstract** An investigation of the interface degradation and failure of EB-PVD thermal barrier coatings (TBCs) during burner rig cyclic oxidation in the presence of calcium–magnesium–alumino-silicate (CMAS) deposits has been conducted. The formation of two compounds of major CMAS constituents, specifically  $MgAl_2O_4$  (spinel) and  $CaAl_2Si_2O_8$  (anorthite), was observed at the interface between the alumina scale and the TBC. Spallation occurred as a result of cracking and delamination primarily through the spinel layer. The tests showed more than a tenfold decrease in TBC life relative to the oxidation test without CMAS at the same temperature. It is demonstrated that this particular form of coating degradation occurs below the melting temperature of this particular CMAS composition and hence does not involve TBC infiltration by molten silicates. The likely mechanism of interface degradation, which involves vapor-phase transport of CMAS constituents as hydroxides, is proposed and discussed.

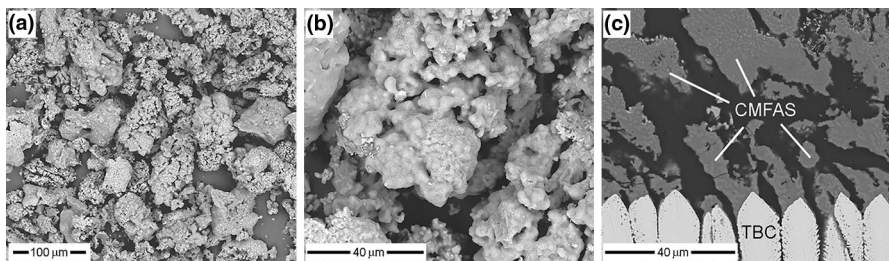
Analysis of CMFAS composition by EDX on cross sections, such as in Fig. 1c, shows somewhat different proportion of the oxides, which can be described as  $20\text{CaO}-10\text{MgO}-8\text{FeO}_{1.5}-22\text{AlO}_{1.5}-40\text{SiO}_2$  with minor additions of NaO (an

**Fig. 1** Morphology of CMFAS deposit indicating the absence of molten phase during testing at 1150 °C: lower (a) and higher magnification (b) SEM images; polished section of CMFAS on TBC surface (c)

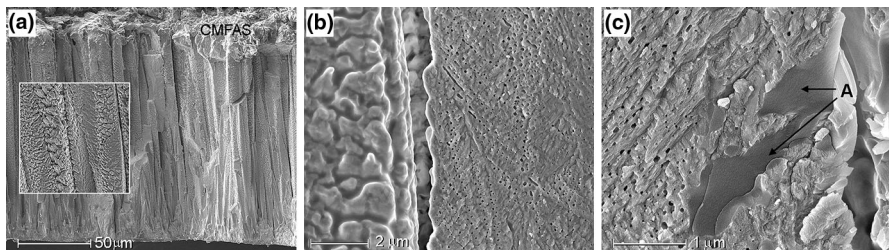
All the tests with CMFAS-enriched flame resulted in TBC spallation after less than 100 cycles, (<50 h at 1150 °C), which is less than a tenth of the average spallation life of this TBC system during regular burner rig oxidation at the same temperature. Analysis of spalled pieces (Fig. 2) indicates that stiffening of the coating is not a factor in TBC failure. The columns are still separated by inter-columnar gaps that are not filled with glassy phase, so strain compliance was probably not significantly affected by CMFAS. The higher magnification images in Fig. 2 show distinct feathery morphology of YSZ columns and individual precipitates attached to the columns. The concentration of major elements, measured by EDX, indicates that these particles can be identified as  $\text{CaAl}_2\text{Si}_2\text{O}_8$  (anorthite). In some cases, inclusions of zirconium silicate,  $\text{ZrSiO}_4$ , can also be found.

**Fig. 2** Microstructure of spalled TBC after CMFAS testing for 60 cycles at 1150 °C: **a** general view; **b** higher magnification showing fracture section through YSZ column and *open gap* between columns; **c** anorthite inclusion (marked A) attached to the column surface

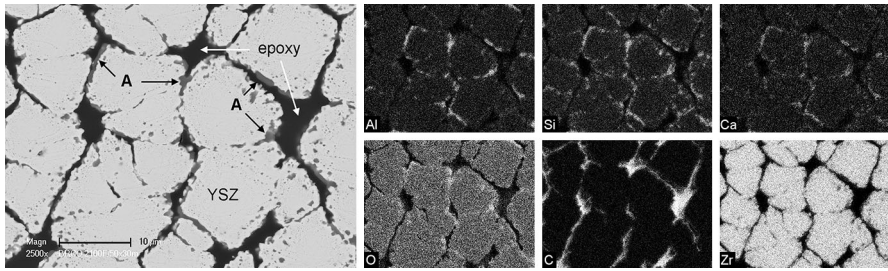
Another illustration of TBC morphology after CMFAS testing is shown in Fig. 3. This coating has been mounted in epoxy and polished at a small angle to the surface in order to expose the top view at different spans through TBC thickness. The taper section image and elemental maps confirm the presence of wide open gaps between YSZ columns (the map of carbon is included to demonstrate TBC infiltration by epoxy), with many anorthite particles around the columns. Interestingly, very little magnesium and iron can be found in the TBC interior, whereas both elements are present on the TBC surface. With no sign of CMFAS melt infiltration, the likely mechanism of anorthite formation is condensation of calcia, alumina and silica from the vapor phase.

**Fig. 3** TBC taper section (BSE mode) after CMFAS testing for 50 cycles at 1150 °C and EDX maps of selected elements, showing *open gap* between columns (infiltrated with epoxy) and individual precipitates of anorthite (A) around TBC columns

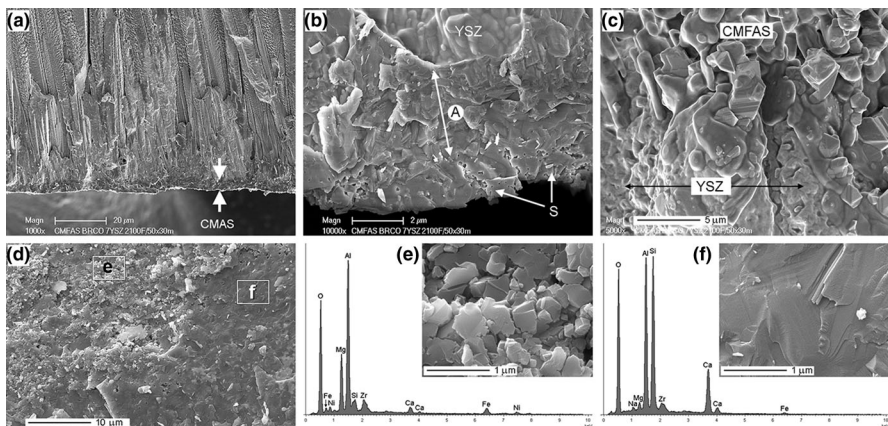
However, this layer consists of anorthite and spinel, as illustrated in Fig. 4b, whereas the alumina scale remains on the bar surface (not shown here). The flip side of the spalled TBC exposes two types of microstructure. One is highly porous  $MgAl_2O_4$  with some iron and nickel, consisting of sub-micron size crystals, as shown in Fig. 4e. The other is fully dense  $CaAl_2Si_2O_8$  with some Na and Mg, apparently as crystalline phase, based on the appearance of its fracture surface in Fig. 4f. The composition and crystalline structure of both layers have been confirmed by the TEM analysis [2]. The presence of nickel in the spinel layer, illustrated by the EDX spectrum in Fig. 4e, is noteworthy as will be discussed later. Hence, TBC failure occurs neither at the TBC-TGO interface, nor at the TGO-bond coat interface, as might be expected during regular oxidation tests, but rather through the layers of CMFAS oxides that develop between alumina and TBC.

**Fig. 4** Microstructure of spalled TBC after 50 cycles at 1150 °C: **a** general view showing a layer marked CMAS at the *bottom* of TBC; **b** higher magnification view of the layer (A anorthite, S spinel); **c** CMFAS deposit on TBC *top* surface; **d** underside of the spalled TBC exposing fracture surface with *rectangular boxes* of higher magnification images in **e** and **f** with corresponding EDX spectra of the selected areas

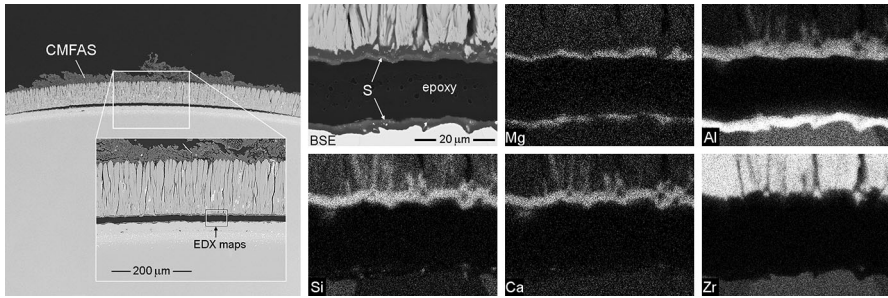
**Fig. 5** Cross section showing TBC buckling as a result of delamination through the spinel layer ( $S \text{ MgAl}_2\text{O}_4$ ). Note the presence of Mg and Al on both side of the crack

TBC spallation. This separation is a typical example of buckling failure as a result of thermal mismatch stress in the coating. The cross section and elemental distributions in Fig. 5 show that delamination occurs through the spinel layer, as illustrated by the Mg map, whereas the alumina scale remains fully adherent to the bond coat. The maps of silicon and calcium indicate location of the anorthite layer directly above the spinel.

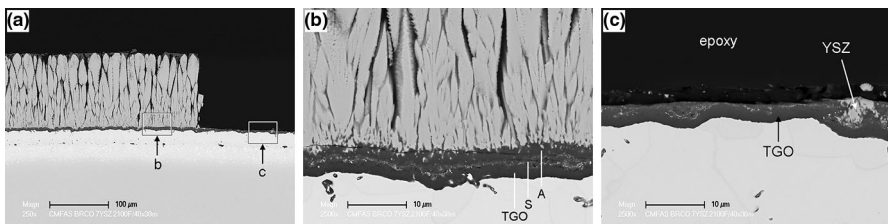
Another example of TBC failure is shown in Fig. 6. The higher magnification images of the interface in the vicinity of the spalled section confirm that delamination crack propagates above the TGO through the spinel layer. Apparently, the porous structure of  $\text{MgAl}_2\text{O}_4$  (Fig. 4e) is susceptible to cracking under thermal stresses, so the spinel layer becomes a “weak link” in the whole TBC system. The fact that the crack also propagates through the anorthite layer (Fig. 4d) and occasionally across YSZ (Fig. 6c) simply means that the fracture path does not follow all interface undulations.

It is important to point out that the alumina scale thickness in Fig. 6c is about  $2 \mu\text{m}$ , which is 3–4 times smaller than the critical TGO thickness upon TBC spallation during oxidation tests of similar systems without CMAS. It is clear that the CTE mismatch stress in alumina does not play a role in TBC spallation, since the scale remains adherent. Hence, the driving force for delamination is the stress in the TBC and especially in the dense layer of anorthite, which has thermal expansion coefficient ( $4.8 \times 10^{-6} \text{ C}^{-1}$  [4]) almost twice lower than alumina and spinel.

**Fig. 6** TBC spallation after 40 cycles at  $1150 \text{ }^\circ\text{C}$ : **a** general view with *rectangular boxes* corresponding to higher magnification images in **b** and **c**. The three-layer structure at the TBC-bond coat interface is shown in **b**: TGO— $\text{Al}_2\text{O}_3$ ; S— $\text{MgAl}_2\text{O}_4$ ; A— $\text{CaAl}_2\text{Si}_2\text{O}_8$

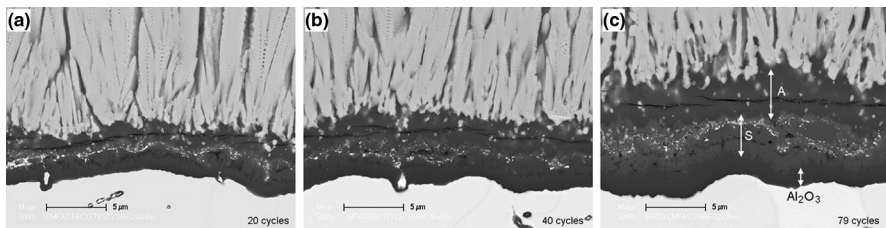
Several key features of the microstructures in Fig. 7 should be noted. First is the presence of fine particles in the mid-section of the spinel layer. These are precipitates of  $\text{HfO}_2$  and  $\text{ZrO}_2$  (with some yttrium). The hafnium oxide forms as a result of outward diffusion from the Hf-doped bond coat through the scale. In the absence of CMFAS, these particles would be located at the alumina–YSZ interface, but in the current conditions they are dispersed in the spinel layer. This may be an indication that spinel is growing inward and consuming the outer layer of  $\text{Al}_2\text{O}_3$  with  $\text{HfO}_2$  inclusions. The small amount of nickel in the spinel, noted in Fig. 4e, is also a sign that  $\text{MgAl}_2\text{O}_4$  incorporates a portion of the alumina TGO, which commonly has a small amount of nickel oxides at the outer surface.

**Fig. 7** Typical microstructures of CMFAS build-up at the interface between alumina TGO and TBC after 20 (a), 40 (b) and 79 cycles (S spinel, A anorthite). All images are taken at the same magnification. The bright precipitates in the scale are hafnia and zirconia

The cracks in the anorthite layer, seen in all images in Fig. 7, are likely a result of sectioning and polishing, which is not surprising because this layer is expected to be under very high compressive stress due to the thermal expansion mismatch between the superalloy and  $\text{CaAl}_2\text{Si}_2\text{O}_8$ . The actual delamination crack usually propagates through the porous spinel layer below, as demonstrated earlier. Note that there is almost no difference in thickness of the alumina scale between 10 h of exposure (Fig. 7a) and 39.5 h (Fig. 7c). In both cases, the scale is about 1.5  $\mu\text{m}$  thick, which confirms the hypothesis that the spinel layer consumes a portion of the alumina TGO. The combined thickness of the other two layers in Fig. 7(c) created as a result of CMFAS exposure is about 7 microns. For comparison, the scale thickness for the same TBC system without CMFAS is approximately 3  $\mu\text{m}$  after 79 30 min cycles at 1150 °C.

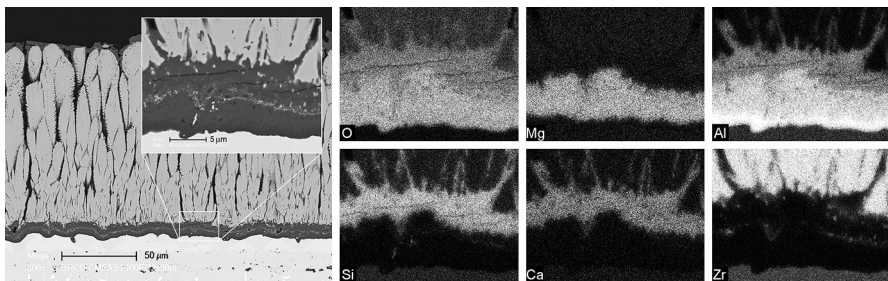
The cross section in Fig. 8 shows the microstructure and distribution of several major elements in the three-layer structure that develops between the bond coat and the TBC after 79 cycles at 1150 °C away from the failure site. A thick layer (4–5  $\mu\text{m}$ ) of spinel is illustrated by the map of magnesium, whereas the maps of silicon and calcium show the location of the anorthite layer above. It is important to note that the gaps between YSZ columns are also filled with anorthite in the bottom portion of the TBC. This feature becomes more distinct near the end of TBC life in the current CMFAS tests. Unlike the mid-span TBC sections that retain strain compliance (Fig. 3), the bottom layer adjacent to anorthite is almost fully dense.

**Fig. 8** TBC-polished cross section 79 cycles CMFAS testing at 1150 °C. The EDX maps of selected elements illustrate distribution of major constituents in the higher magnification *inset*

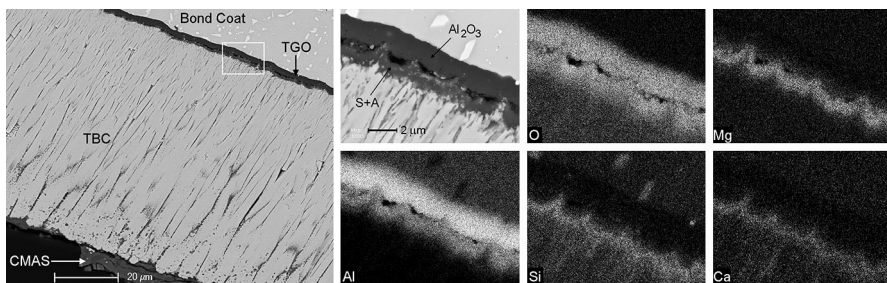
Finally, it is instructive to compare the CMFAS reaction with the TGO, examined during the burner rig tests, with one example of TGO degradation observed on TBC coated airfoils after engine operation in a dusty environment. Some areas on the pressure side of the airfoils exhibited TBC spallation. The cross section (away from the failure site) in Fig. 9 demonstrates similar build-up of spinel and anorthite on top of alumina TGO, whereas the inter-columnar gaps in the mid-span of the TBC are not filled by CMAS. The layers also incorporate small inclusions of zirconia, similar to the microstructures in Figs. 7 and 8. One notable difference from the burner rig results is that on the airfoil a distinct string of small pores developed between the spinel layer and alumina. It is visible on the high magnification insert, as well as oxygen and aluminum maps in Fig. 9. Microstructural analysis in the vicinity of spalled areas confirms that delamination occurs along the string of pores, i.e., at the alumina–spinel interface rather than through the spinel layer as in the laboratory tests.

**Fig. 9** TBC cross section on a high-pressure turbine blade after engine operation in CMAS-containing environment. The EDX maps of selected elements illustrate distribution of major CMAS constituents at higher magnification in the area outlined by the *rectangular box*. The alumina TGO and two-layer structure with spinel (S) and anorthite (A) are marked (the bond coat is at the *upper side* of the images). Note that silicon map also shows tantalum-rich gamma-prime grains in the bond coat as a result of overlap between Si and Ta peaks
