Understanding the Phenomenon of High Temperature Hydrogen Attack (HTHA) Responsible for Ferrite-Pearlitic Steels Damage

N. Chevreux¹ · C. Flament¹ · O. Gillia¹ · T. David¹ · R. Goti² · C. Le Nevé² · E. Andrieu³

Abstract

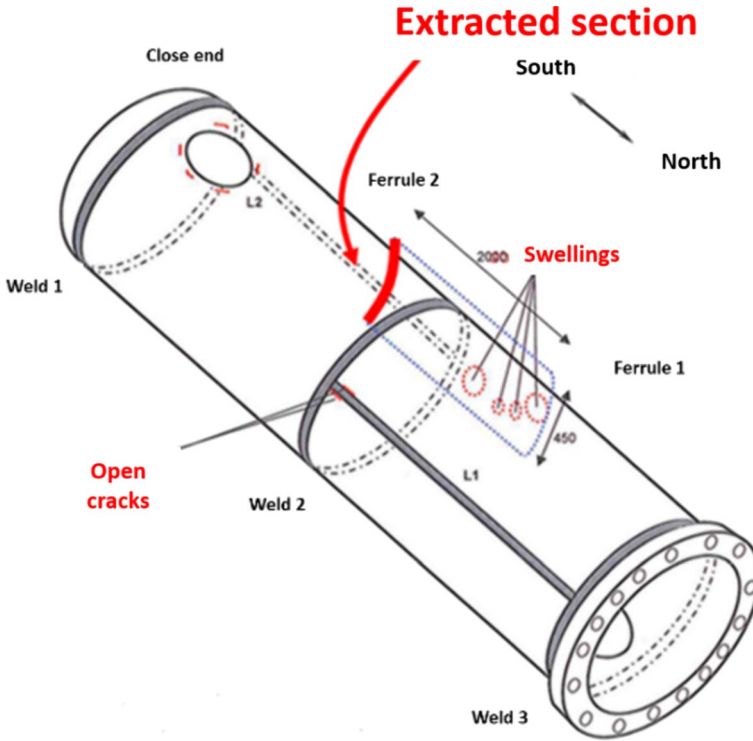
Fig. 1 0.5-Mo steel extracted section from a fluid heat exchanger

The 0.5-Mo pearlitic steel section characterized in this study was extracted from a 27-mm-thick fluid heat exchanger (as shown in Fig. 1) with a diameter of 750 mm. This exchanger was submitted to a temperature of 400 °C at an internal pressure of 20 bars with a H₂ partial pressure of 18 bars for a 37-year period. It contained both oil and H₂.

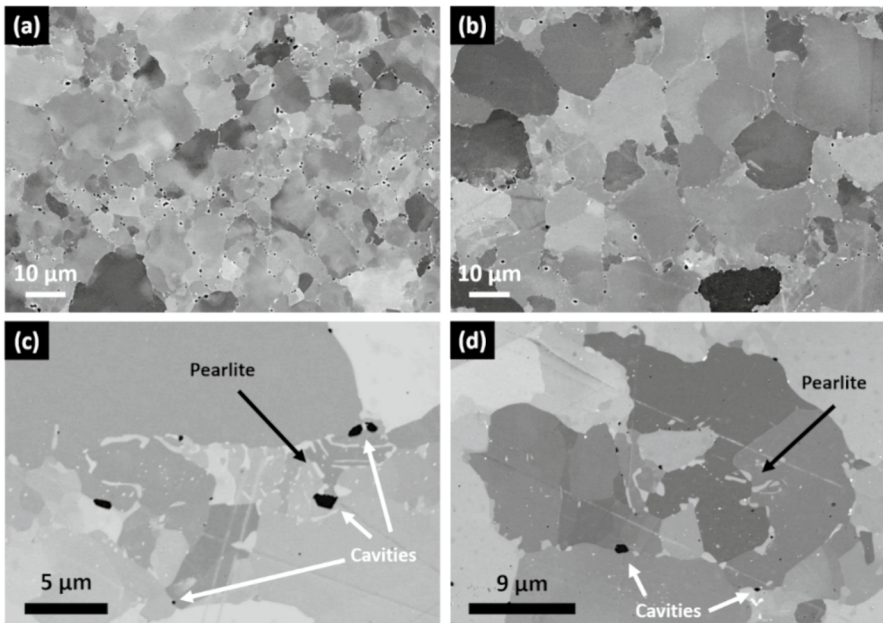
Samples from both the inner and the outer part of the pipe were examined by SEM. Carbides appear white and ferrite gray in Fig. 2a–d. Cavities, corresponding to the black spots pointed out in Fig. 2a–d, are mostly located at ferrite–pearlite grain boundaries and along carbides. Cavities are noticed both in the inner and outer parts of the exchanger. Still, in the outer part cavities are less numerous than in the inner part, see Fig. 2a and b. These cavities display diameters from few hundred nanometers up to 1 μm . No cracks in the depth of the material are observed. It seems that the attack is extremely heterogeneous as some grain boundaries of pearlite grains are completely cavities-free while few microns away other pearlite grain boundaries are presenting a profusion of cavities. The steel presents a ferrite-pearlitic microstructure. However, as shown in Fig. 2c–d no lath-like but globularized cementite carbides are noticed at grain boundaries. The morphology of carbides in the inner as well as the outer specimens might be related to the phenomenon of temper aging.

Fig. 2 SEM observations of the 0.5Mo steel after HTHA. Large-scale views of (a) the inner part and (b) the outer part of the fluid heat exchanger. Small-scale views of typical pearlitic grains morphology (c) in the inner part and (d) in the outer part of the exchanger

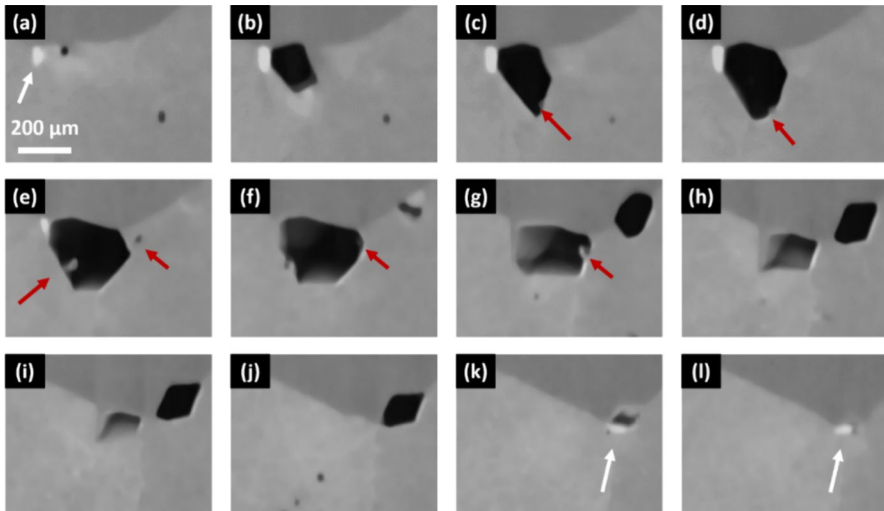
The industrial steel has been finely characterized thanks to the 3D FIB-SEM slice and view technique. Figure 3a–l shows 2D SEM successive slices taken after some steps of the ion abrasion in a zone unveiling two cavities. Cavities noticed at grain boundaries appear dark black on these images. These cavities are located in a triple grain boundary and are very faceted, which could be due to a growth following

Fig. 3 2D SEM images showing the link between different types of inclusions and cavity nucleation at grain boundaries

the closed packed plans of ferrite crystal structure. As long as the ion abrasion progresses, two different precipitate contrasts were exhibited as shown in Fig. 3 (i.e.) a white and bright one (white arrows) touching the edge of cavity and a dark gray one (red arrows) located in the cavity. Such a link between inclusions of AlN type and cavities has already been highlighted [1]. As their nature could not be determined by 3D FIB-SEM, TEM analysis was conducted in order to get complementary information about these different inclusions.

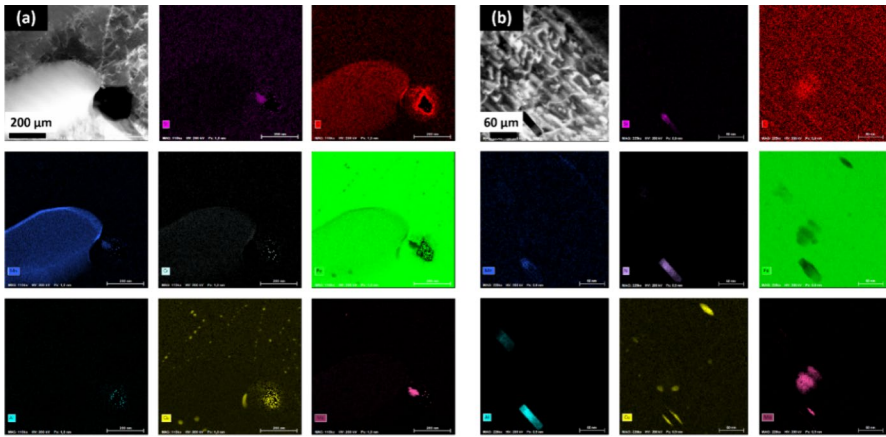
STEM-EDX maps were taken in two different zones. The first EDX map presented in Fig. 4.a was obtained in a cementite-attacked zone. It appears that the cementite is not only composed of Fe but also Mn, traces of Cr are also observed. The chemical analysis of the identified cavity exposes that there is no AlN inclusion in it. However, co-segregation of Mo and Si is observed. The carbon map gives the impression that this Mo inclusion contains carbon. Furthermore, Cu precipitates appear as well as in and around HTHA cavities. Small Cu-rich precipitates are noted at grain boundaries and in dislocations. A 70-nm curvy and elongated Cu precipitate seems to be present in the cavity. The second zone examined was taken in a completely cavity-free ferrite grain, as shown in Fig. 4b. EDX mapping shows first a rod like AlN inclusion where Si, Cu, and Mo segregated along. A second precipitate rich in Mo and C appears. It is assumed to be Mo_2C carbides. Cu segregated around this Mo-rich precipitate. Finally, a 50-nm-long inclusion rich in Cu is present in the ferrite matrix.

Fig. 4 STEM-HAADF and EDX maps **(a)** of a cavity containing a Mo-rich inclusion. **(b)** Different precipitates in a cavity-free ferrite grain

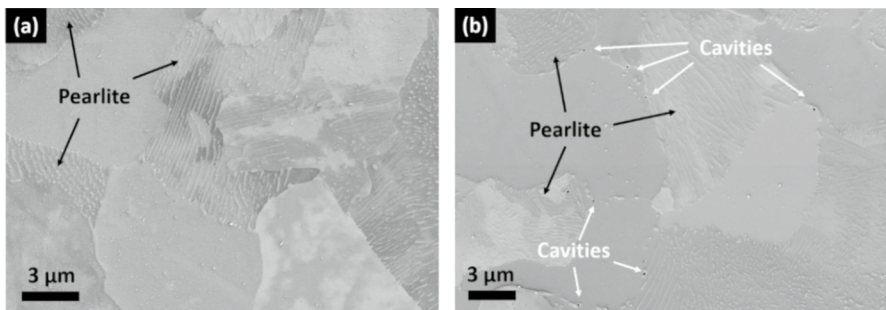
SEM observations of the SA516 steel reveal that the brand new material exhibits a typical ferrite-pearlitic microstructure. $(Fe,Mn)_3C$ type carbides were confirmed by TEM (not shown in this article). To begin with, for a same H_2 partial pressure of 69 bars and for a same number of cycles it appears that specimens aged at 400 °C display a greater number of cavities compared to those aged at 304 °C which has none, as shown in Fig. 5a and Fig. 5b. As anticipated, most attacked samples exhibit cavities mostly at ferrite–pearlite grain boundaries along carbides as well as triple grain boundaries, especially nearby large carbides.

Fig. 5 SEM–secondary electrons images of the SA516 steel aged under $PH_2=69$ bars. **a** After 5 cycles of 300 h at 304 °C. **b** After a first cycle of 300 h at 327 °C followed by 4 cycles of 300 h at 400 °C

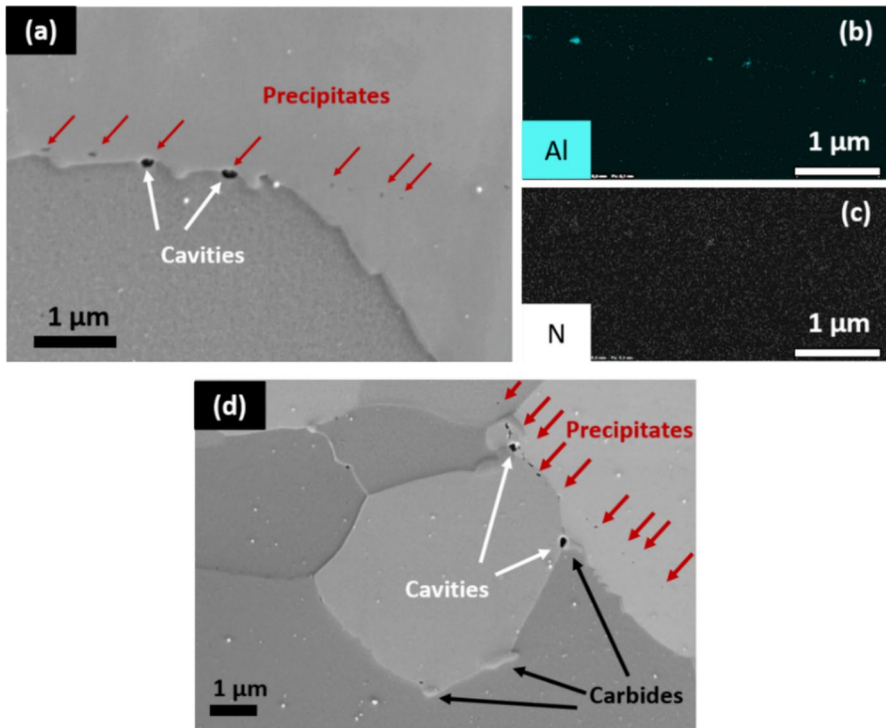
Furthermore, it emerges in 400 °C-aged specimens that presumed HTHA cavities are located at the junction of carbides at grain boundaries with an alignment of small inclusions, see Fig. 6a–d. SEM–EDX analysis identified them as AlN inclusions.

Fig. 6 SEM images of the SA516 steel aged under PH2=69 bars: **a** 300 h at 327 °C then 300 h at 400 °C (1000 psi). **b,c** Al and N SEM–EDX maps suggesting AlN precipitates in voids. **d** 300 h at 327 °C followed by 4cycles of 300 h at 400 °C

Additionally, SA516 aged steels display cavity nucleation along AlN plans, which tends to confirm the initiating role of precipitates. These observations are similar to what has been seen in a previously studied 0.5-Mo pearlitic steel in which numerous cavities were identified at the intersection of AlN inclusions enriched planes and pearlite grains [1]. Thus, AlN inclusions distributed in former austenitic grain boundaries [23, 24] seem to be initiators of HTHA cavities. AlN–matrix interface may trap elements such as Cr, Cu, and Mo much larger than H. Thus, hydrogen could be trapped at such interface nearby a carbide, having access to a significant amount of carbon to form CH_4 . To enable the formation of CH_4 molecules, a certain available space is required. Vacancies clusters that might be present at the AlN–matrix interface may allow the formation of early cavities filled with CH_4 and then coupled with the high internal CH_4 pressure be a driving force behind their
